EARTH DAMS: GEOTECHNICAL CONSIDERATIONS
IN DESIGN AND CONSTRUCTION

Submitted to the Faculty of the Graduate College
of Oklahoma State University
in partial fulfillment of the requirements
for the Degree of
DOCTOR OF PHILOSOPHY
December, 1984

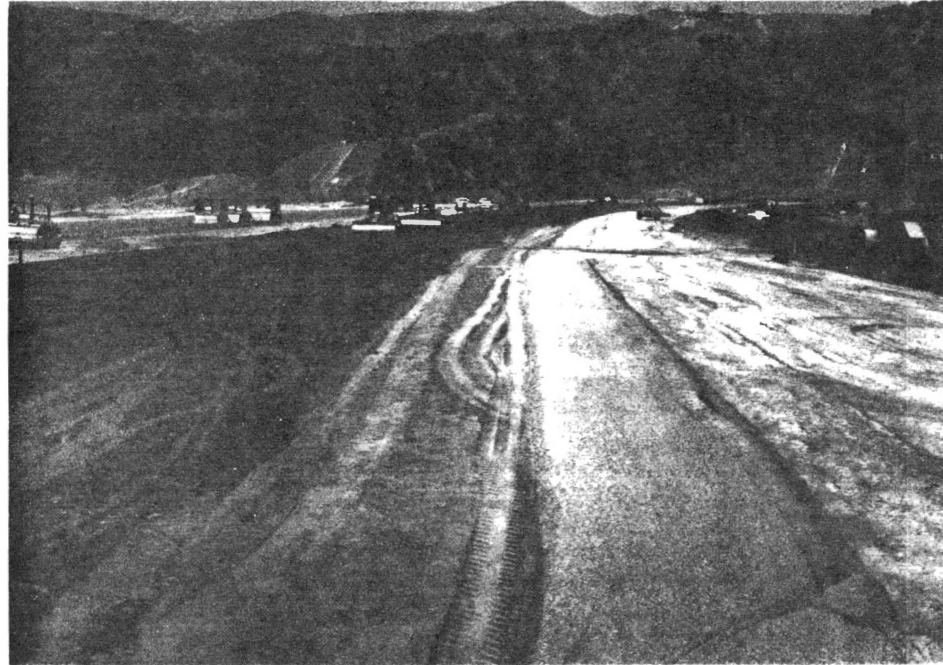
Figure 34. Vertical Filter and Drain, Warm Springs Dam,
California.

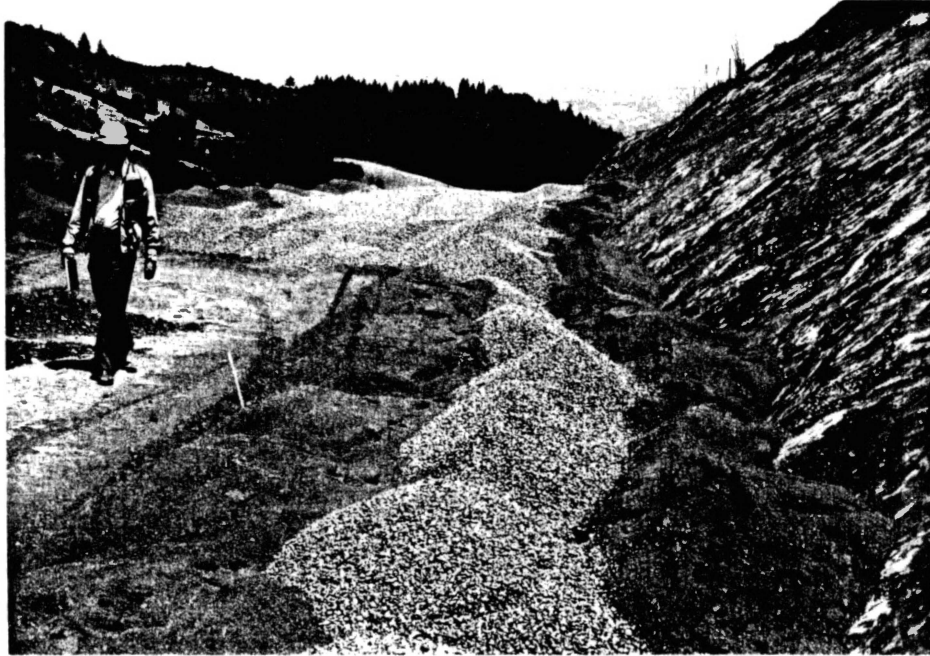
Figure 35. Abutment Drain Between Filter Zones, Warm Springs Dam, California.

Zones of transition material, or filters, must be provided between embankment zones of greatly differing gradations in order to prevent migration of material from one zone to another. The only recorded failures of earth dams which contained no transition zones between the impervious core and a pervious downstream zone were earth-rock dams which contained a downstream rockfill zone into which impervious material migrated (57). Many earth dams are constructed with a multiple-stage drain system with a distinct, very pervious drainage layer to provide ample pore spaces for water conveyance and a distinct, less pervious filter to prevent migration of fines. The two-stage drainage system, of a filter and a drain, for Warm Springs Dam can be seen in Figure 34. The horizontal filter blanket, which extended up the abutment, was a multiple-stage system consisting of a drain flanked by filters as seen in Figure 35.

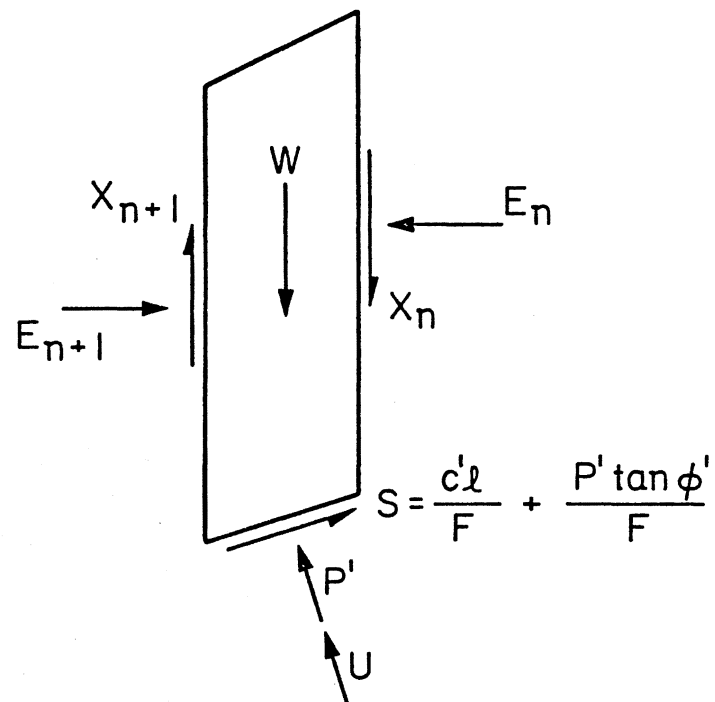
Figure 42. Forces on an Individual Slice for Stability Analysis Methods Employing Slices.

Circular Arc Analysis. The most common method of stability analysis for earth embankments involves an analysis of a finite number of slices within a circular arc mode of failure. The division of the circular arc into finite slices and the forces acting on one of those slices are shown in Figure 42. A number of limit equilibrium methods have been developed to analyze the overall stability of embankment slopes and the majority of methods is listed in Table IV. These methods of slope stability analysis have four characteristics in common (21): (1) all use the same definition of the factor of safety,

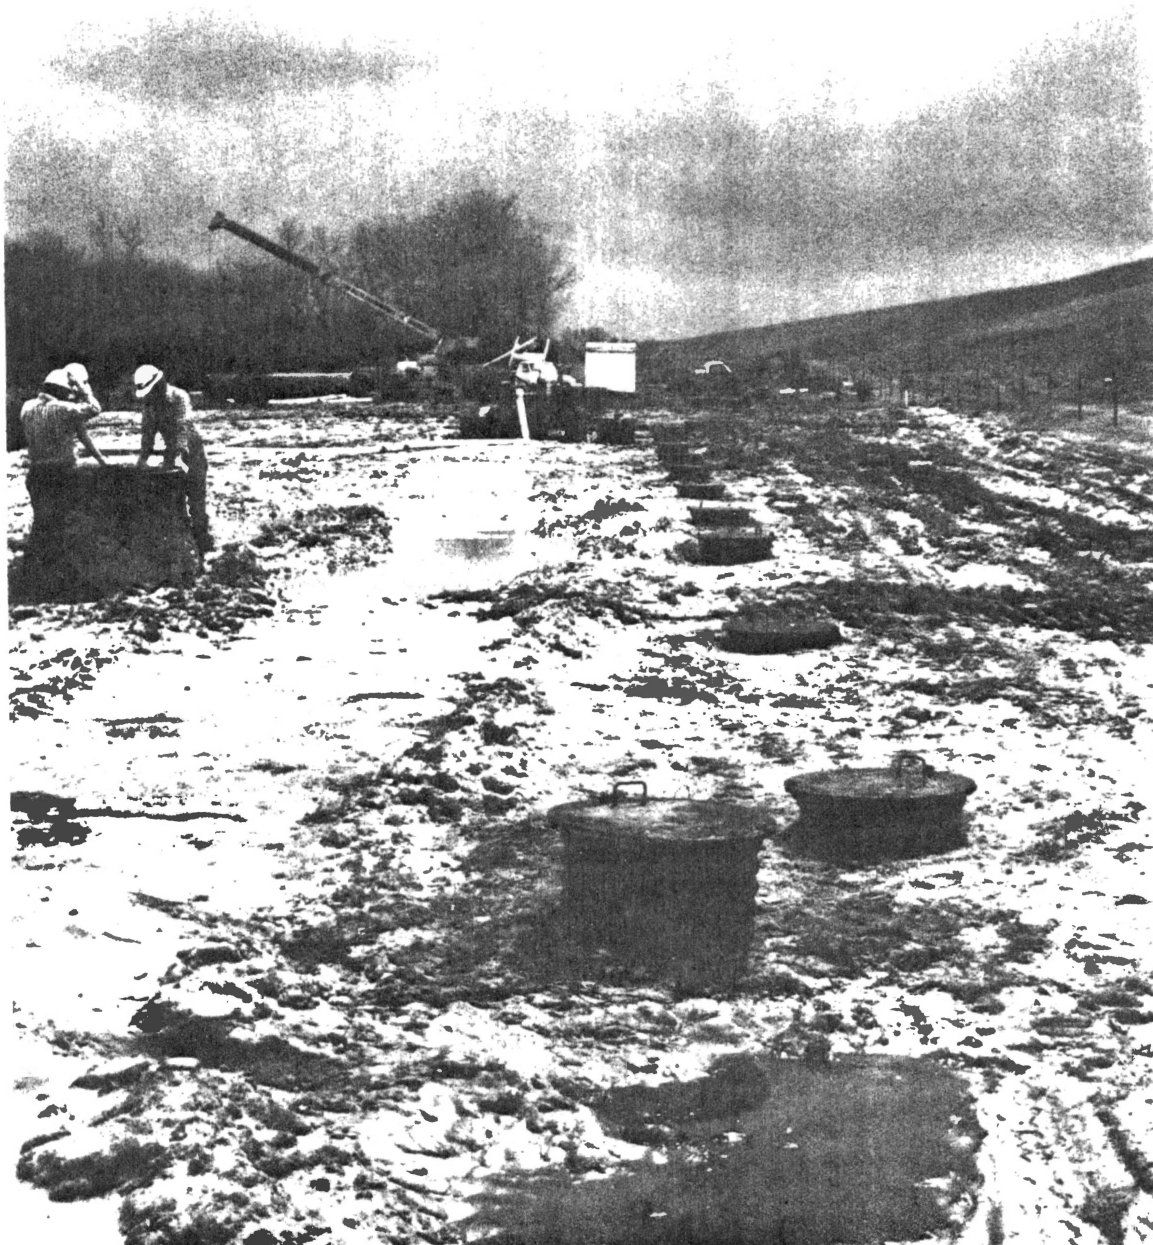
Figure 94. Protected Toe Drain and Relief Well System at Denison Dam.

Vandal-proof design has become a most important feature of civil works projects. Exposed relief wells, for example are vulnerable to vandalism. The resistance to vandalism afforded by covered perforated-pipe toe drains, particularly if the pipe also serves as the header pipe for relief wells, is perhaps its biggest advantage over toe ditches. Also, covering or inclosing relief wells can protect the well pipe since polyvinyl chloride and acrylonitrile-butadiene-styrene are now the common materials for relief well risers and header pipes. Both materials are subject to deterioration from the ultraviolet radiation of direct sunlight. The PVC relief wells recently installed in a vandal-prone area below Denison Dam are covered by locked, 18-inch diameter, corrugated metal manholes which are anchored in 12 inches of concrete at the base of the manhole. Figure 94 shows the covered relief wells below Denison Dam. The relief wells are connected to an ABS-truss header pipe which in turn is connected to a corrugated metal manhole with discharge through a grate-covered corrugated metal pipe outlet (149).

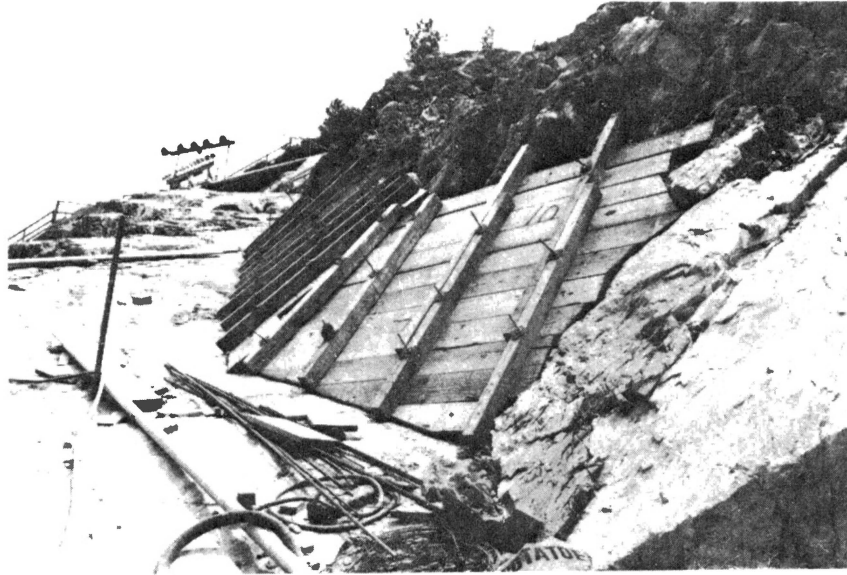
(a) Formwork for Lean-Mix Concrete Placement.

(b) Lean-Mix Concrete in Rockfill Zone.

Overhangs should be removed to eliminate their interference with adequate compaction of impervious material. Overhangs left in place within the cutoff trench at Wolf Creek Dam, Figure 100, contributed to the massive underseepage problems experienced at that dam (28). Near-vertical abutments should be excavated to more gentle slopes for better compaction and to reduce cracking in the embankment core. High cliffs at the left abutment of Black Rock Dam in Connecticut were flattened approximately to a 1V-on-1H slope (113). The maximum slope of abutments for adequate contact with clay embankment cores is about 70 degrees (128). At damsites where excavation is not feasible to reduce the abutment slope, placement of reinforced concrete, as shown in Figure 101, will adequately provide both reduction in abutment slope and backfill of localized depressions.

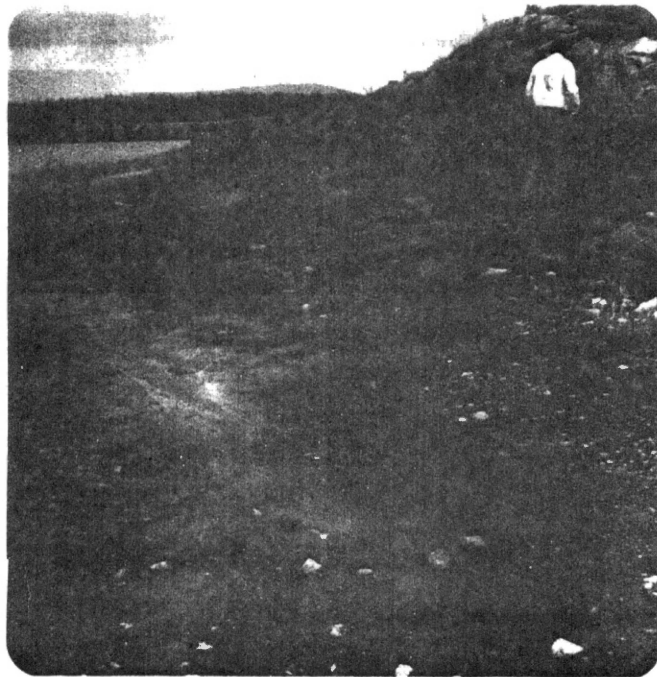
Figure 127. Small Alluvial Fans Beyond Pipe Exits in Dispersive Clay, Wister Dam, Oklahoma.

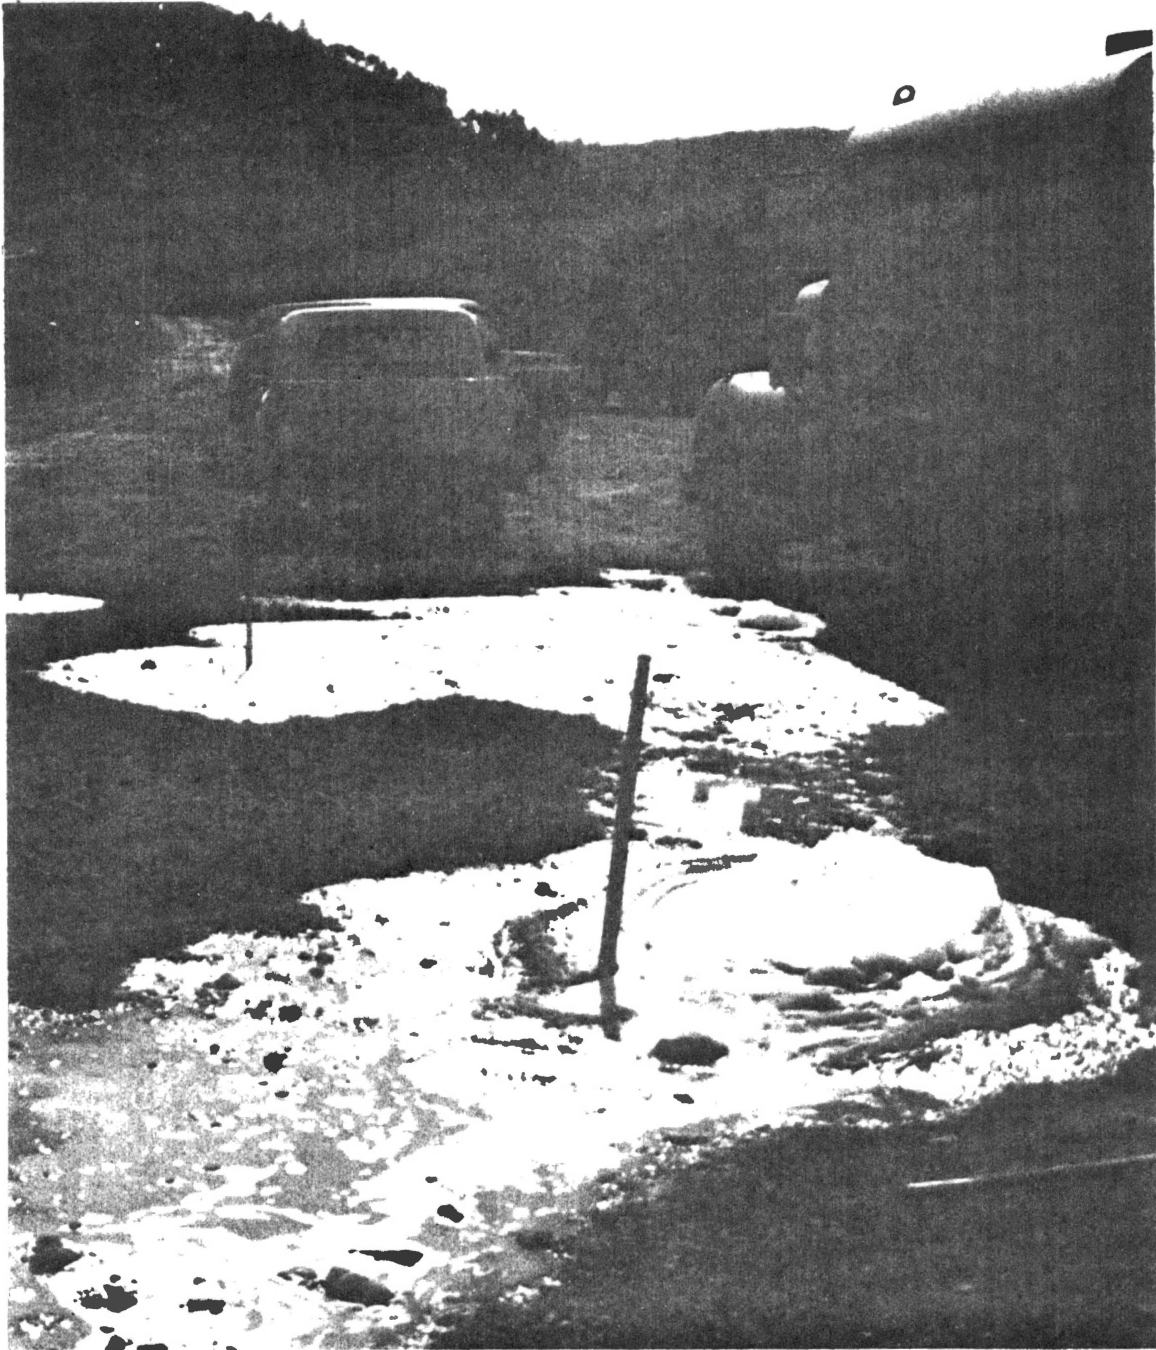
Figure 134. Drilling Fluid Discharge at Crest due to Hydraulic Fracturing of Embankment during Piezometer Installation, Warm Springs Dam, California.

resulted in considerable fracturing of the embankment as the drill holes squeezed closed. Drilling fluid was recovered from a previously installed inclinometer casing over 100 feet away (218). A similar situation occurred at Warm Springs Dam in California during drilling operations to install piezometers within the earthfill. The drilling fluid was under high pressures for effective removal of drill cuttings and, when the drill hole caved, substantial cracking of the embankment occurred as shown along the crest in Figure 134. After the piezometer installation was completed, a testpit was excavated adjacent to the piezometer riser to evaluate the extent of fracturing. Drilling fluid which had been retained in embankment fractures may be seen emitting into the testpit in Figure 135. Investigation confirmed that the hydraulic fracturing was limited only to the upper portion of the upstream random shell and had not violated the integrity of the impervious core (123).

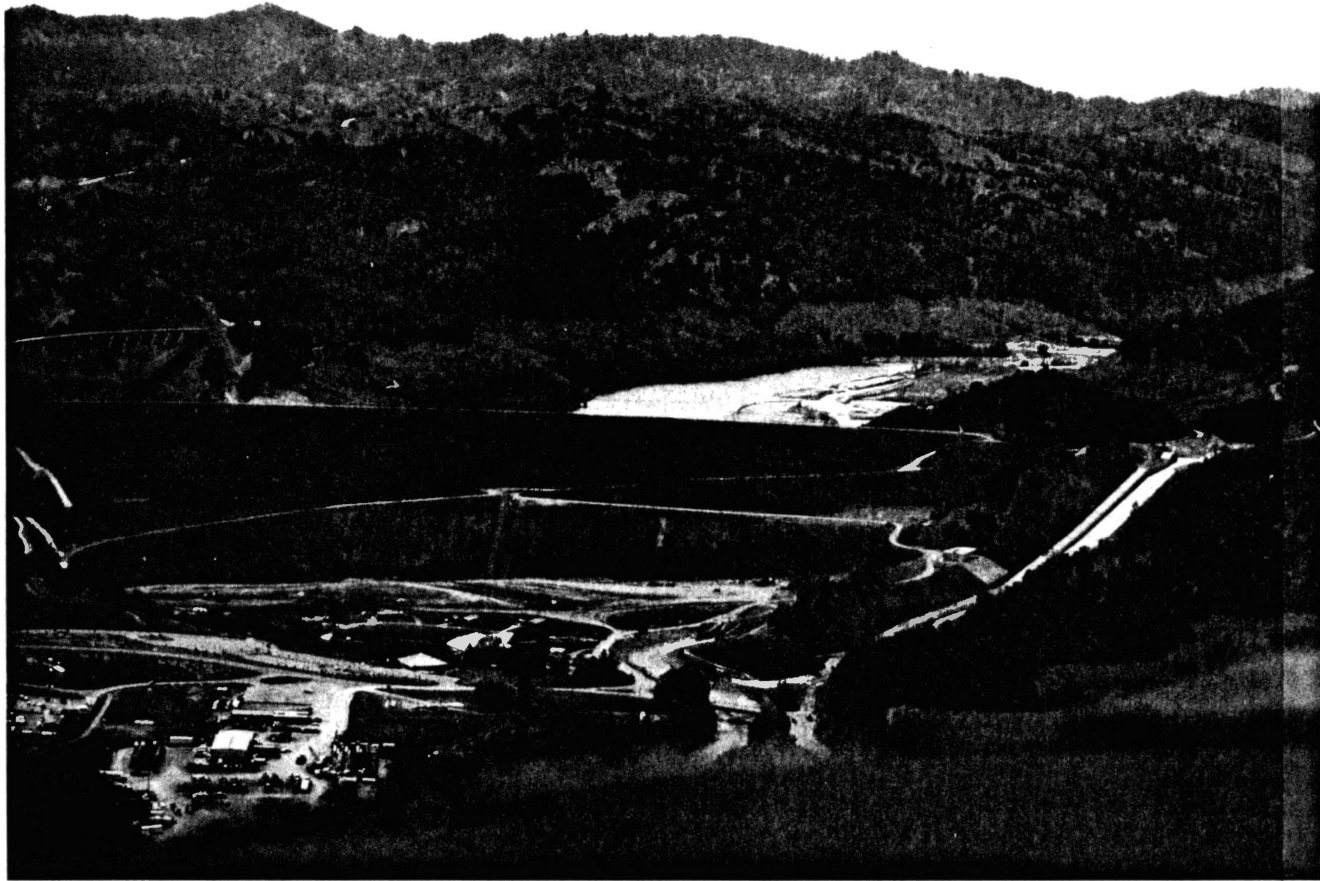
Figure 138. Warm Springs Dam - Lake Sonoma, California.

Warm Springs Dam in California, Figure 138, is the most recently completed earth dam within the United States; the embankment was completed in 1983. The design and construction of Warm Springs Dam incorporated the very latest state-of-the-art design processing systems and construction monitoring system. Warm Springs Dam also incorporated the latest state-of-the-art empirical design features which were developed through experience which dates back to, and beyond, Fort Peck Dam.
