ANALYSIS OF FABRIC-REINFORCED EMBANKMENT TEST
SECTION AT PINTO PASS, MOBILE, ALABAMA

Submitted to the Faculty of the Graduate College
of the Oklahoma State University
in partial fulfillment of the requirements
for the Degree of
DOCTOR OF PHILOSOPHY
July, 1979

This study is concerned with design, analysis, and construction of a fabric-reinforced earth embankment test section constructed on very soft foundation materials. The primary purpose of the study was to develop and verify technically feasible design and construction criteria for fabric-reinforced embankments. Analysis of test section behavior was conducted by modifying conventional Corps of Engineers design techniques.

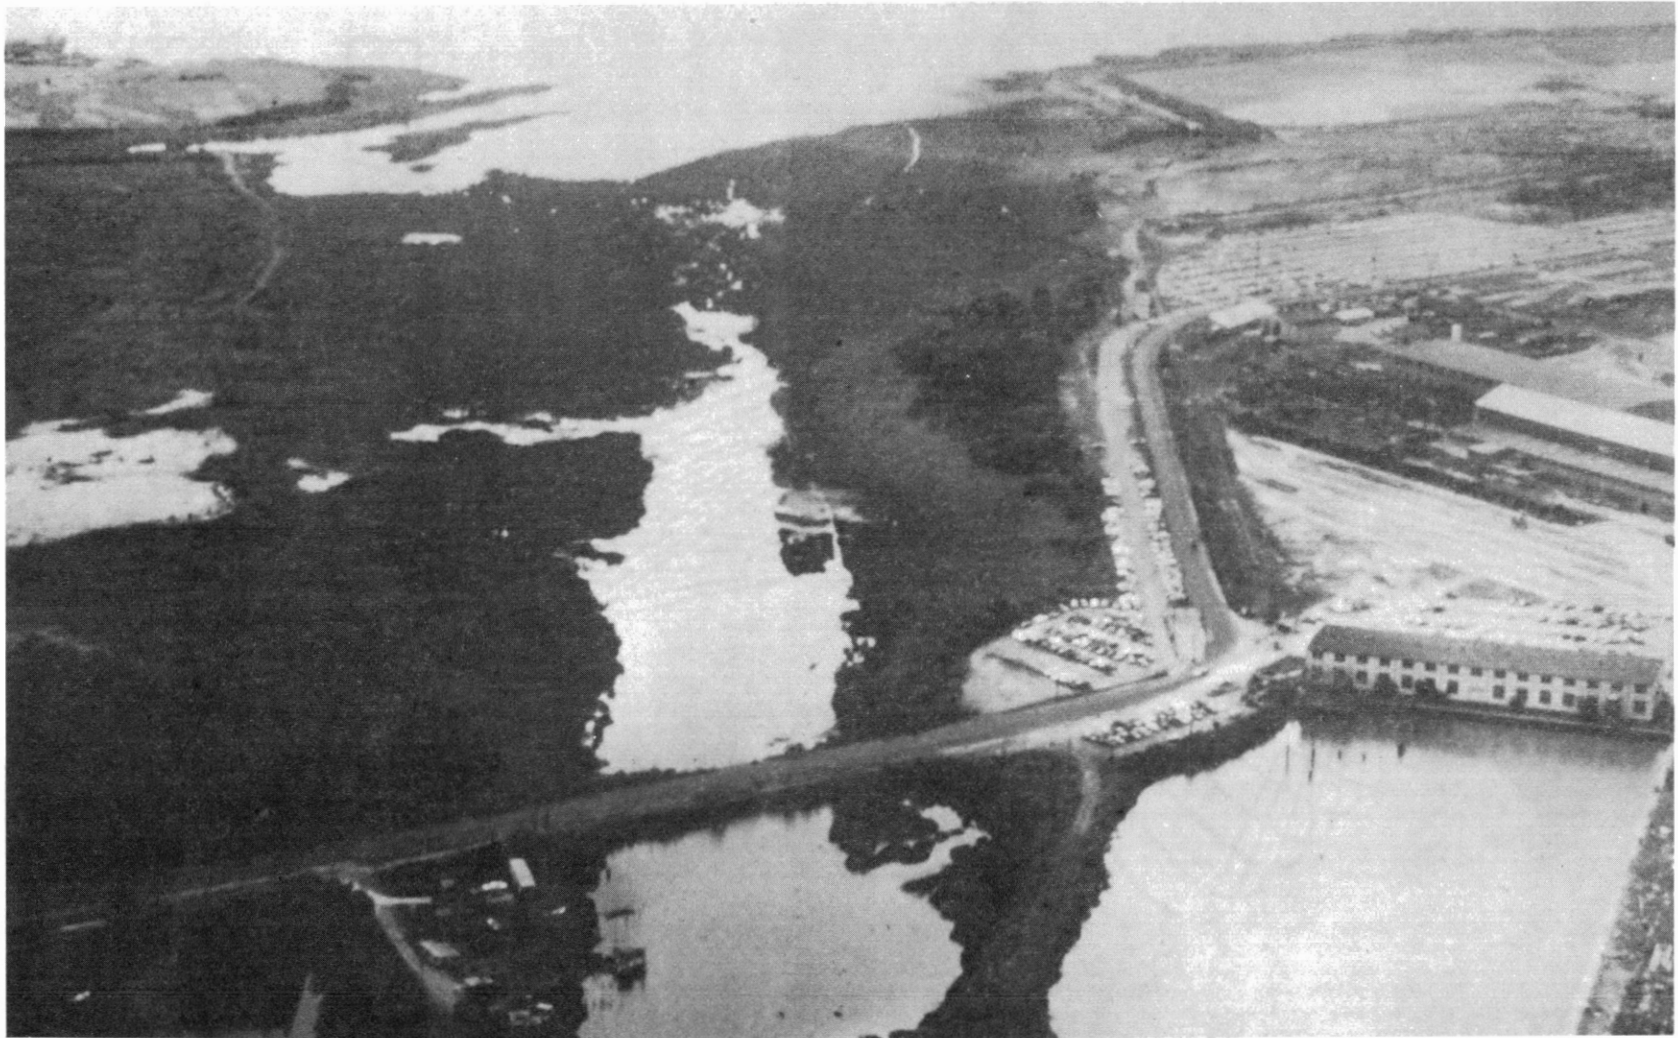
Figure 2. Aerial View of Pinto Pass Looking East to West. Embankment Test Section was Constructed Across Pinto Pass at About Top Quarter Point of the Photograph

Figure 1. Figure 2 is an aerial view of Pinto Pass, while Figure 3 is a preconstruction ground view of the area where the test section was built. It may be noted in the photographs that the proposed test section was constructed across an intertidal area; existing ground elevations over most of the alignment ranged between el 1.5 and el -1.0.

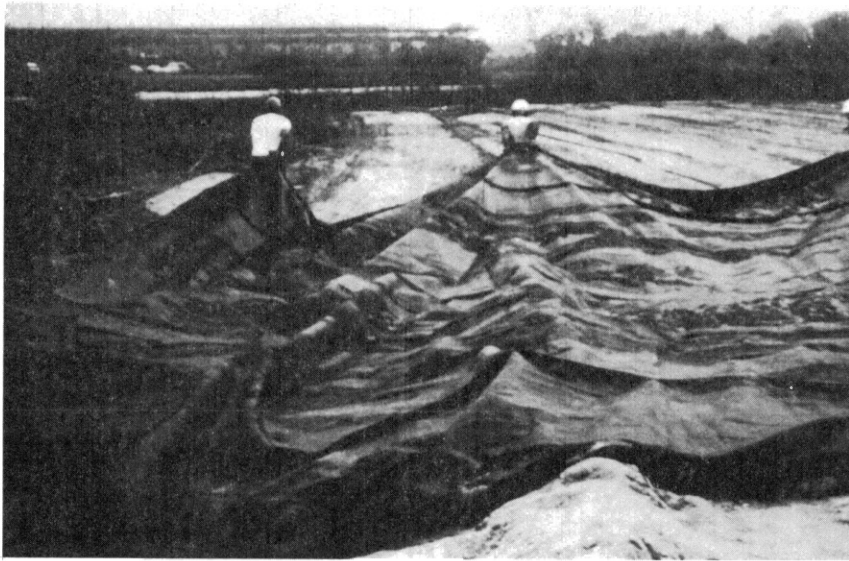
Figure 45. Advance Type I Fabric Being Placed, with Seams Perpendicular to Longitudinal Axis of Embankment, onto Sand Working Table

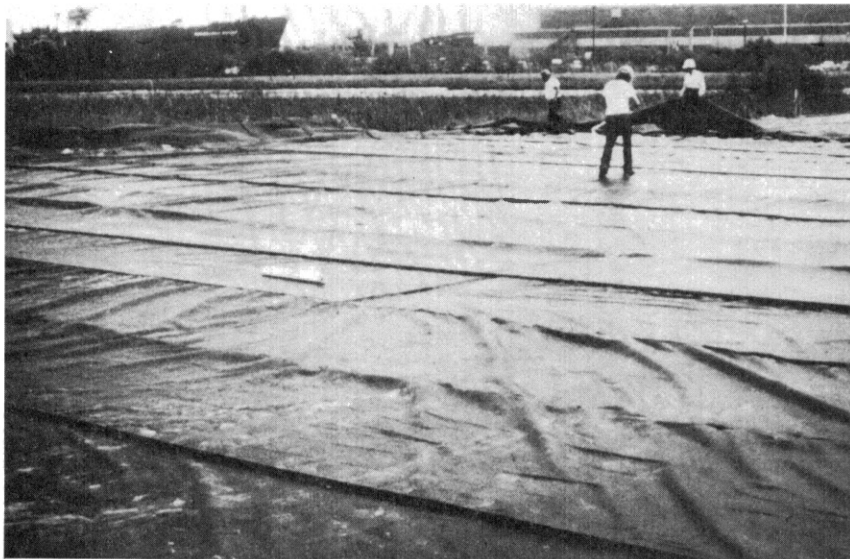
Figure 46. Placement of Advance Type I Fabric Prior to Placement of Fill Material

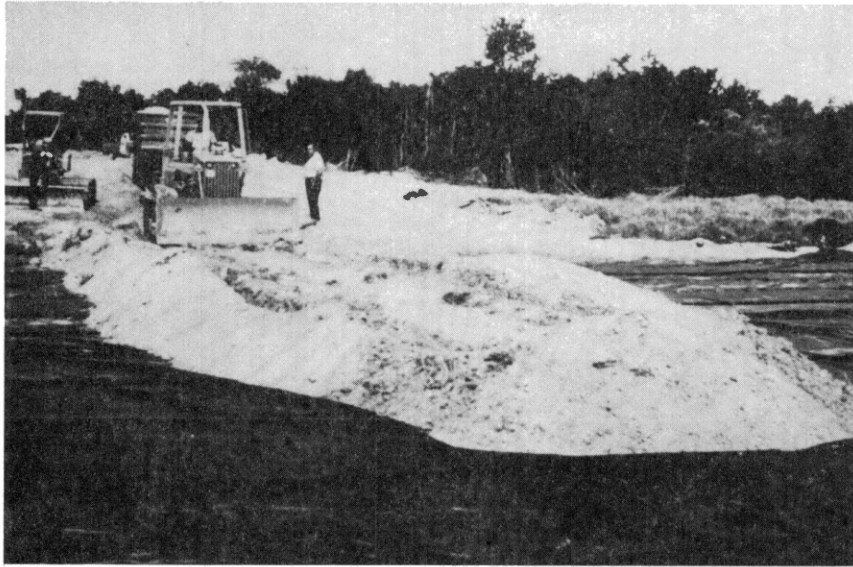
Figure 47. Construction of Parallel Haul Road at Toe of Embankment

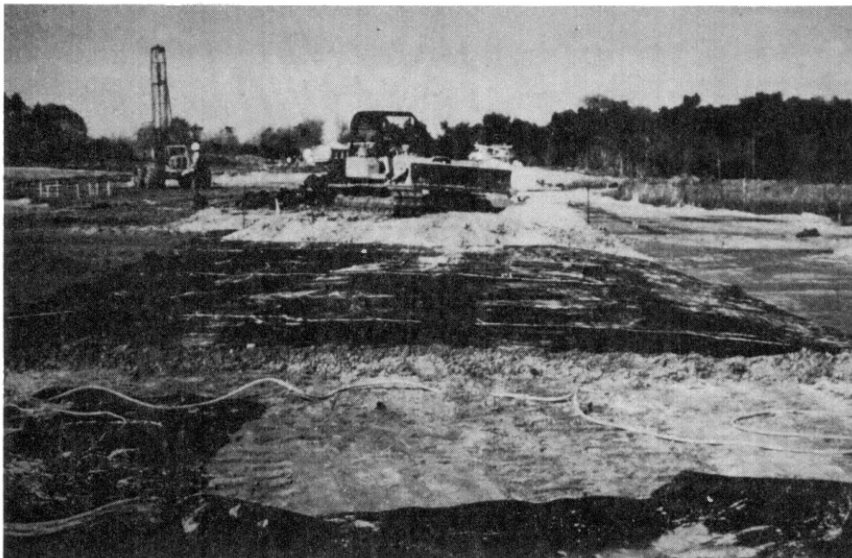
Figure 48. Fabric Folded Back into Toe of Structure to Serve as an Anchor to Prevent Fabric from Slipping

It is recommended that the fabric foldback construction procedure at each toe of the embankment be eliminated and adequate truck support be provided by placing a strip of fabric wide enough to carry a dump truck (15 ft) along the toe parallel with the dike alignment, with about 1 ft of sand between the transverse dike reinforcement and the parallel upper strip. This procedure will provide a double fabric-reinforced haul road without causing a construction bottleneck.

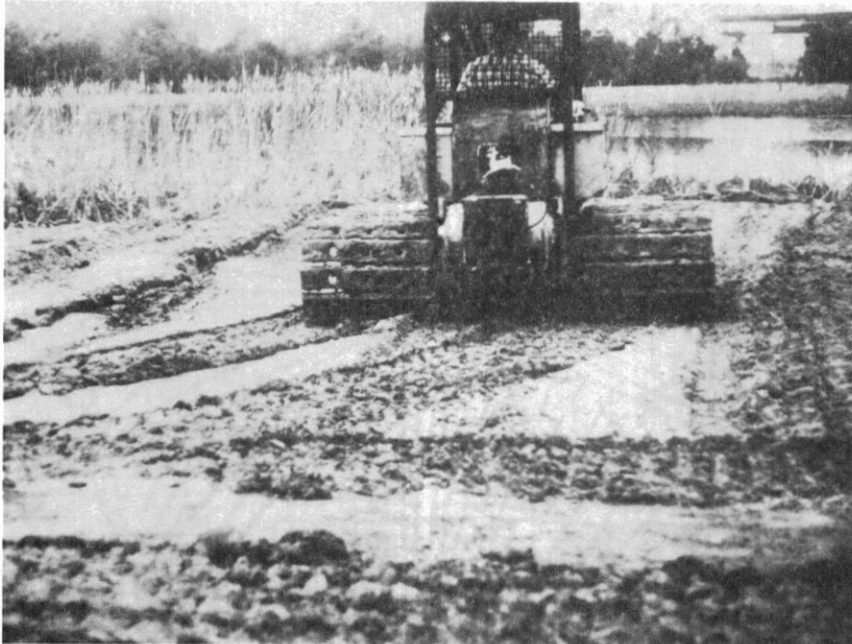
Figure 49. Dozer Advancing Sand Working Table Toward Pinto Pass Channel

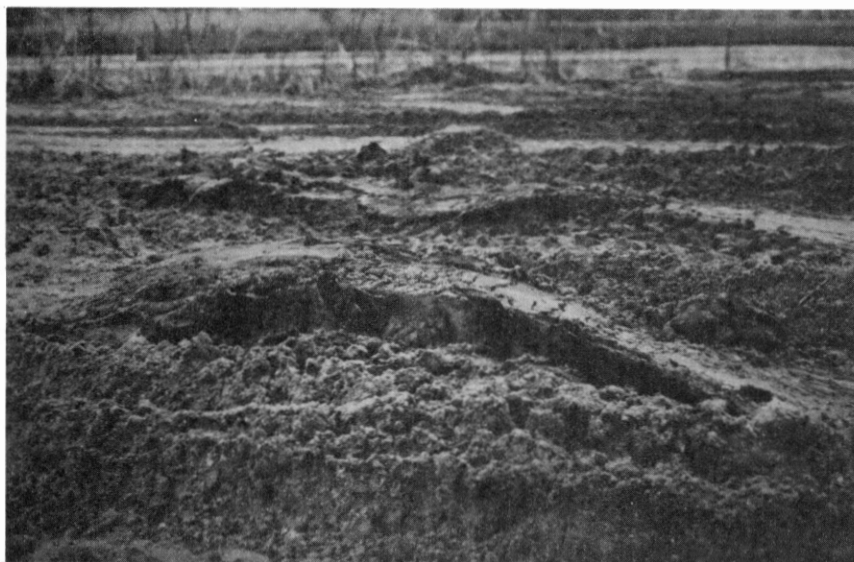
Figure 50. Mud Ways Breaking through Sand Working Table from too Many Passes by Dozer in Spreading Material

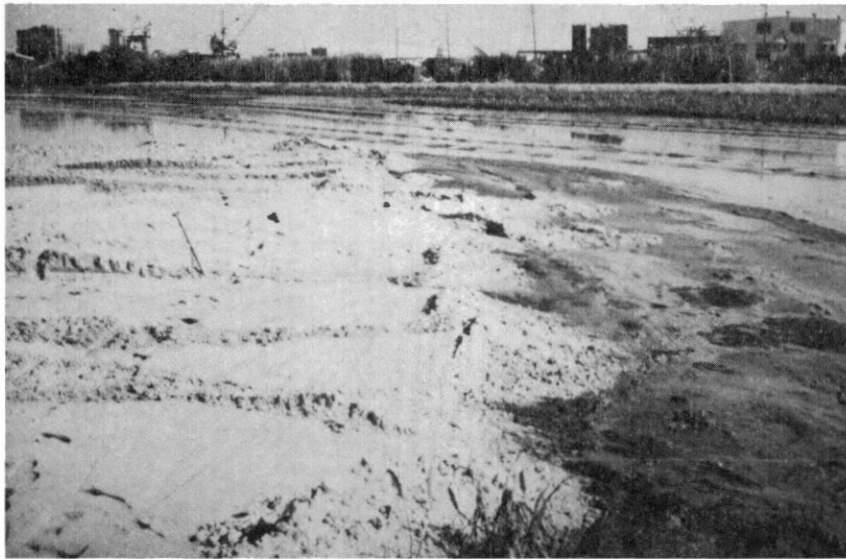
Figure 51. Termination of Sand Working Table at Edge of Pinto Pass Channel

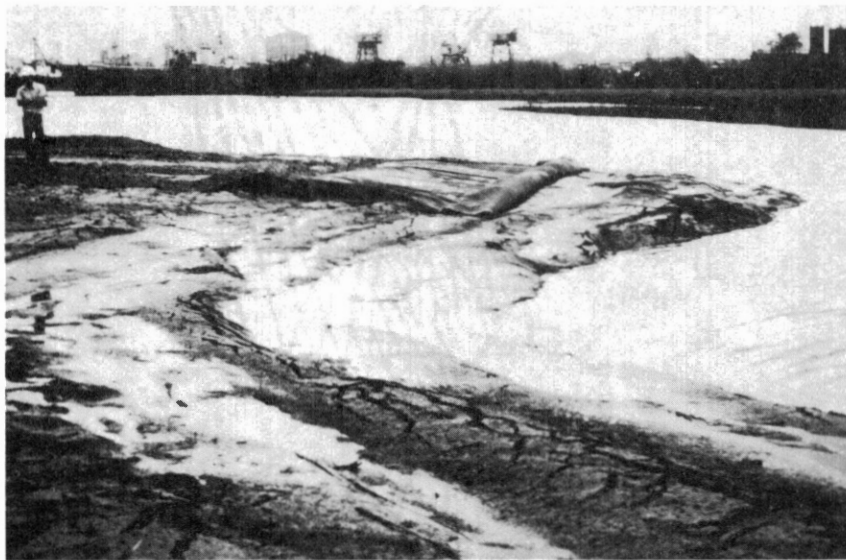
Figure 52. Polyfilter X Fabric Being Rolled onto Advancing Mud Wave Caused by Fill Material and Fabric Displacement of Soft Foundation Materials

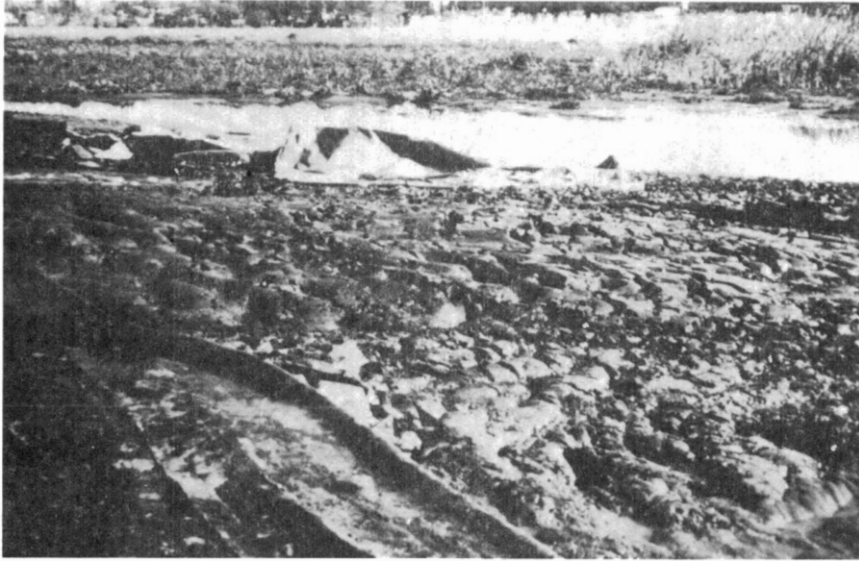
Figure 54. Nicolon 66475 Fabric after Placement and Folding Back for Sewing on Advancing Mud Wave

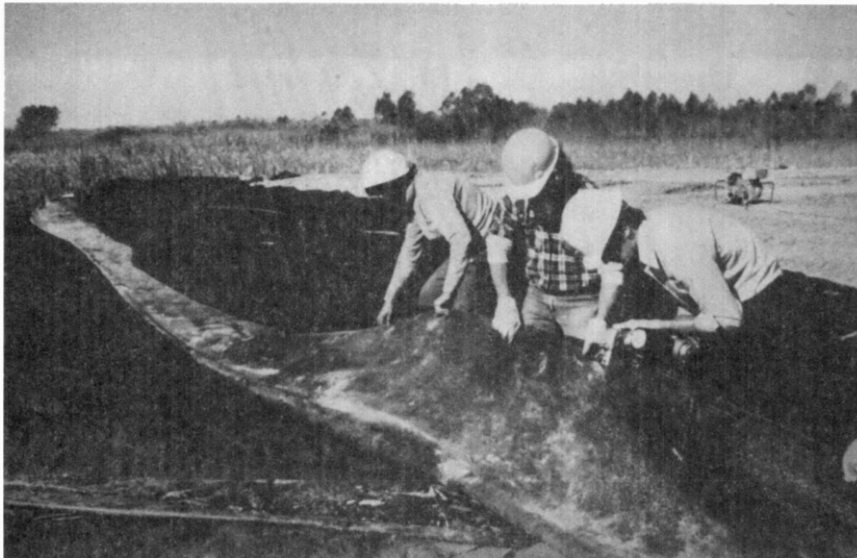
Figure 55. Nicolon 66475 Fabric Edge Being Sewn Together Prior to Folding the Newly Sewn Fabric Forward

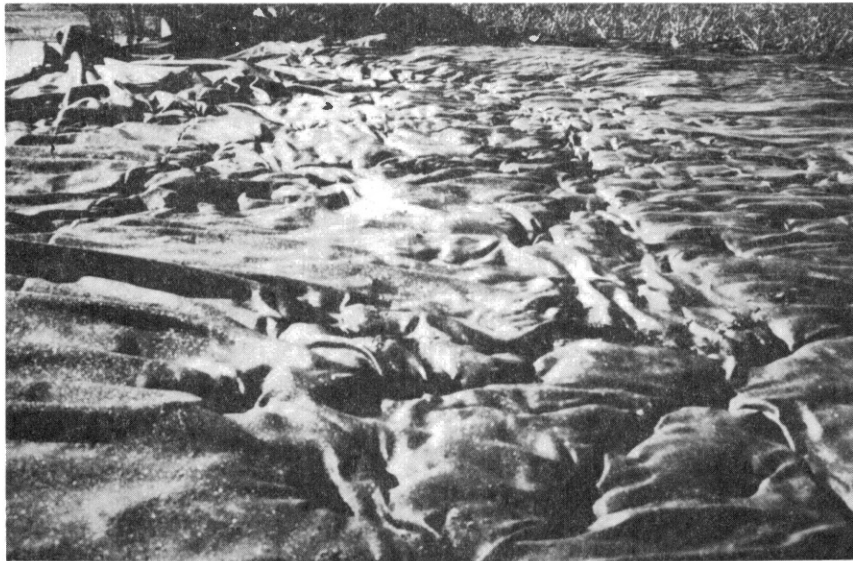
Figure 60. Footprints in Fabric Laid onto Advancing Mud Wave

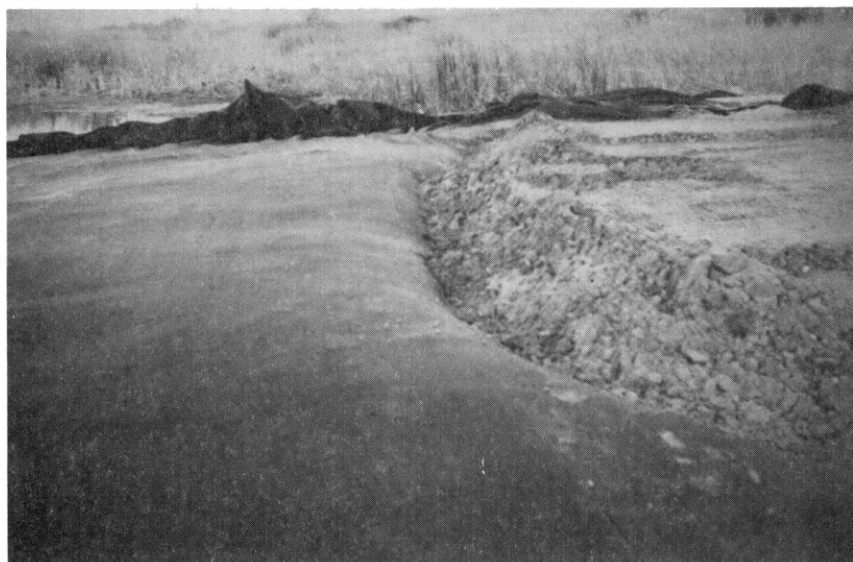
Figure 61. Fabric Being Stretched by Placement of Fill Material on Advancing Mud Wave Beneath the Fabric

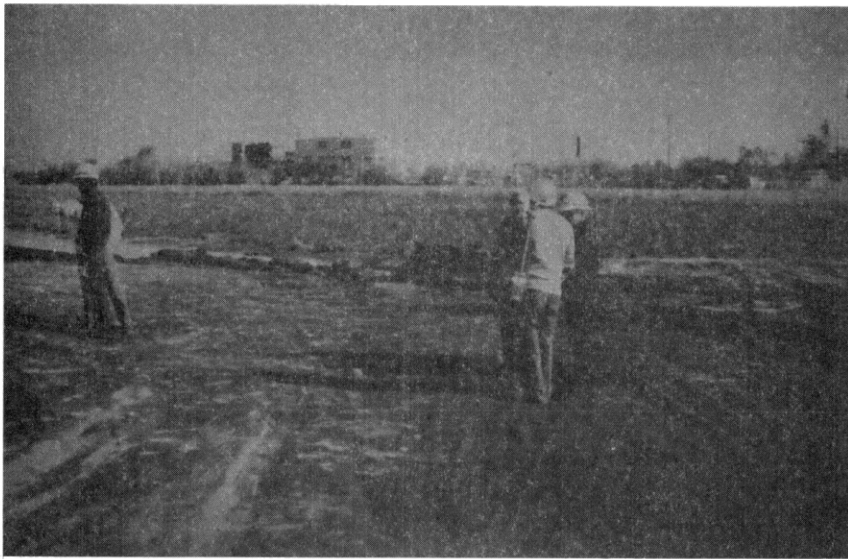
Figure 62. Nicolon 66475 Fabric, Placed Over Soft Foundation Material, Supporting Men

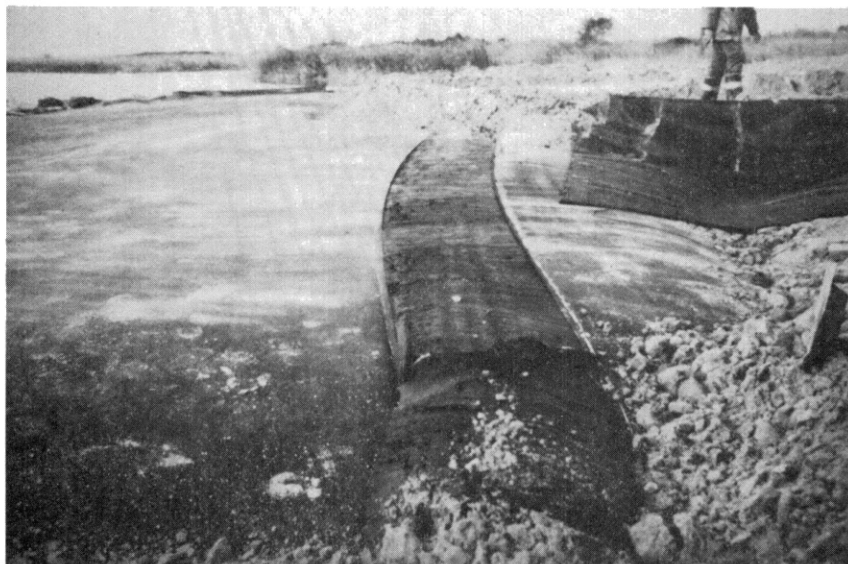
Figure 63. Fabric Seam Field-sewn with Improper Thread Caused Failure to Occur Before Thread Was Replaced with Proper Type

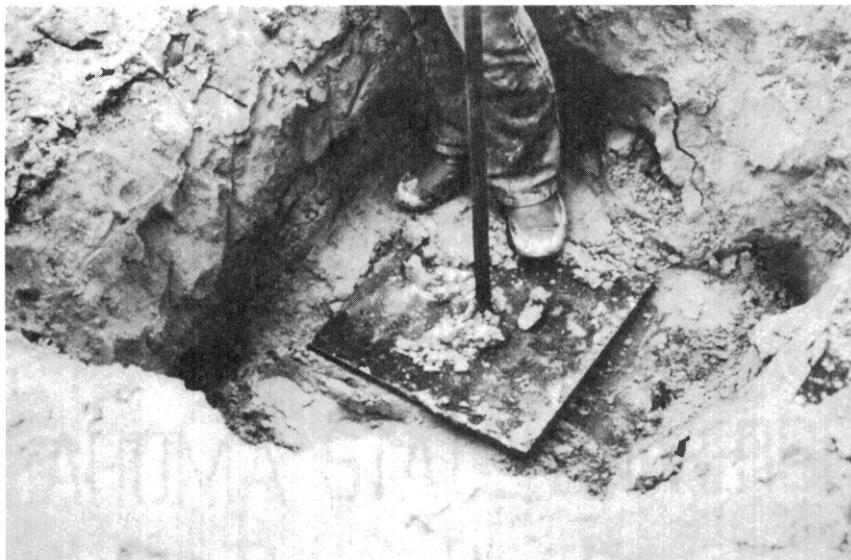
Figure 65. Settlement Plate Being Installed on Fabric

fabric and a survey of the vertical and horizontal positions recorded. Figure 65, Appendix B, shows a typical settlement plate being installed.

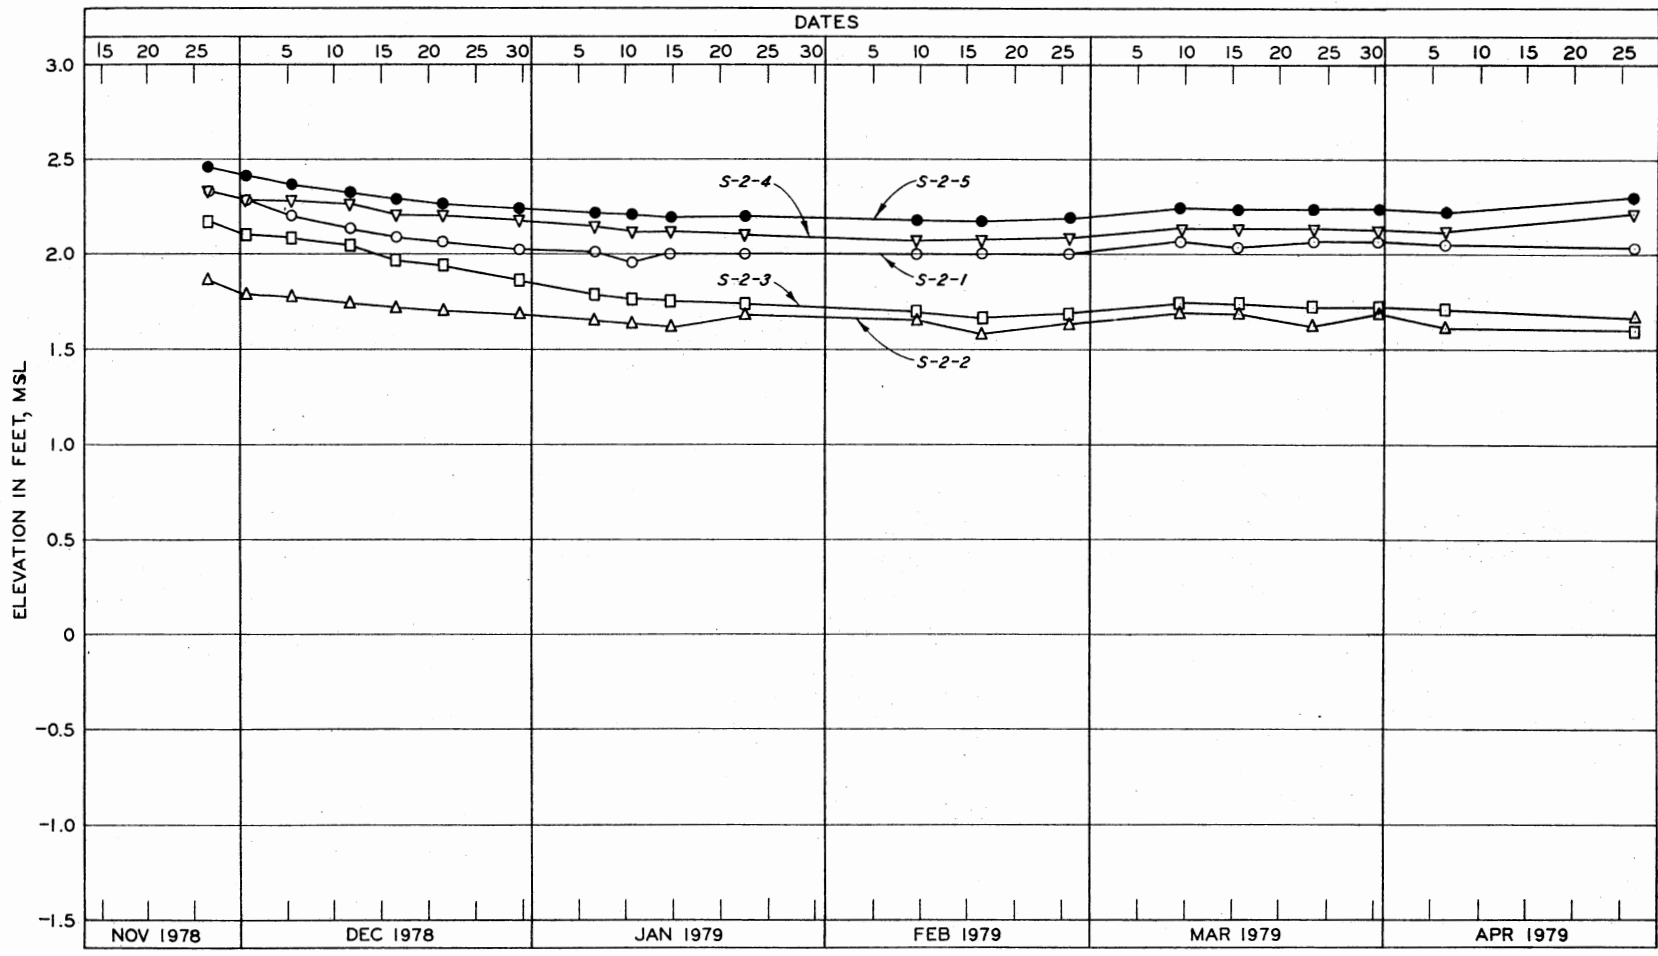
Figure 69. Settlement versus Time for Settlement Plates S-2-1 through S-2-5
