SEISMIC VULNERABILITY OF RESIDENTIAL STRUCTURES IN NICARAGUA

A DISSERTATION

A DISSERTATION APPROVED FOR THE
SCHOOL OF CIVIL ENGINEERING AND ENVIRONMENTAL SCIENCE

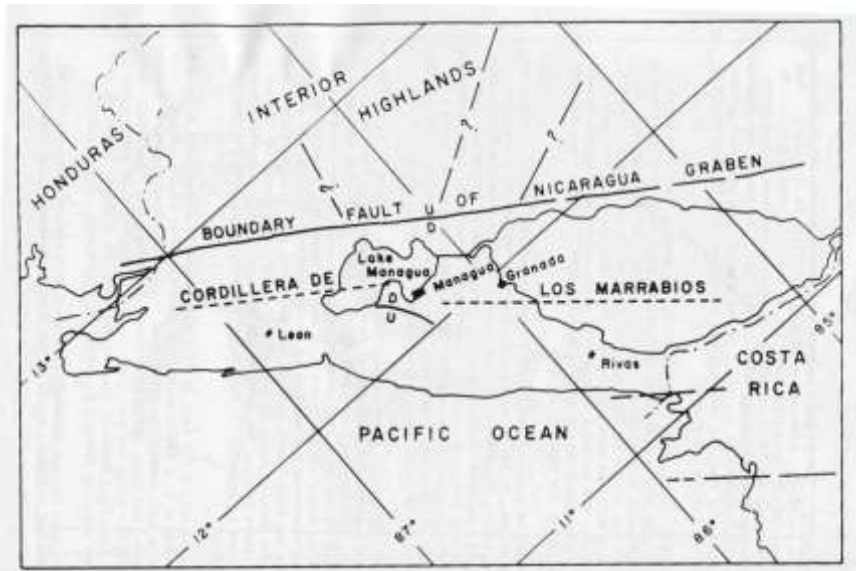
Figure 3.6. Boundary fault and Cordillera de Los Marrabios (Saint-Amand, 1973)

The Graben contains a boundary fault nearly parallel with a string of volcanoes called the “Cordillera de Marrabios.” From this fault there are many cross faults (Plakfer, 1972; Saint-Amand, 1972)

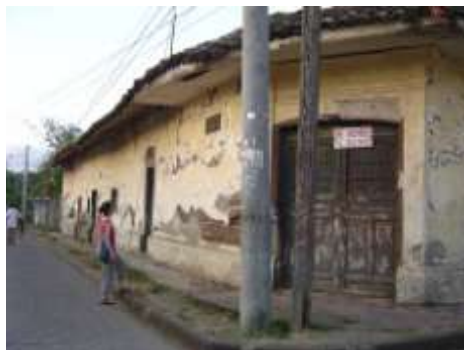
Figure 3.19. Taquezal construction, Rivas, Nicaragua

Chamorro (1973) describes the earthquake of 1931 as destroying most buildings made of adobe and stone construction, while the taquezal construction fared better. Partly because of this and partly because it was a vernacular solution to the construction problem, taquezal became the primary type of construction for the next 15 years. During that time, some twenty concrete buildings and a few steel buildings were constructed in the city of Managua by foreign engineers (Chamorro, 1973).

Figure 3.19 shows an example of taquezal construction.

Teran (1973) reported that taquezal construction was devastated by the earthquake in 1972. 95% of the total number of deaths occurred in taquezal structures. Several American engineers have stated that taquezal construction should not be used in earthquake areas. Amand stated “Damage to houses made of taquezal was extreme!”

Amrhein et al stated “This mode of construction (taquezal) was the major cause of the high death toll and, as stated previously, should be banned in earthquake-prone areas such as Managua.” Still some engineers have a different view. Periera and Creegan (1973) stated “By way of history, taquezal had performed well in the terremoto of 1931 - and because of that record was the popular structural system during that reconstruction. For all that you will hear about it, it is our position that when properly designed, constructed and maintained taquezal is a fine system...and very appropriate for the tropics – especially in the pre “air-conditioned” era.” But the operative words in that description are “designed” and “maintained.” There were a lot of bad connections in the taquezal homes. But perhaps more importantly, the timber structure hidden under plaster and in intimate contact with earth since its construction

was rotten (Periera and Creegan, 1973). Dry rot, insect damage and water damage was the general condition. The implication here is that these structures would not have been killers had the terremoto of 1972 been in 1936. Therefore the lesson to be learned relates to maintenance.

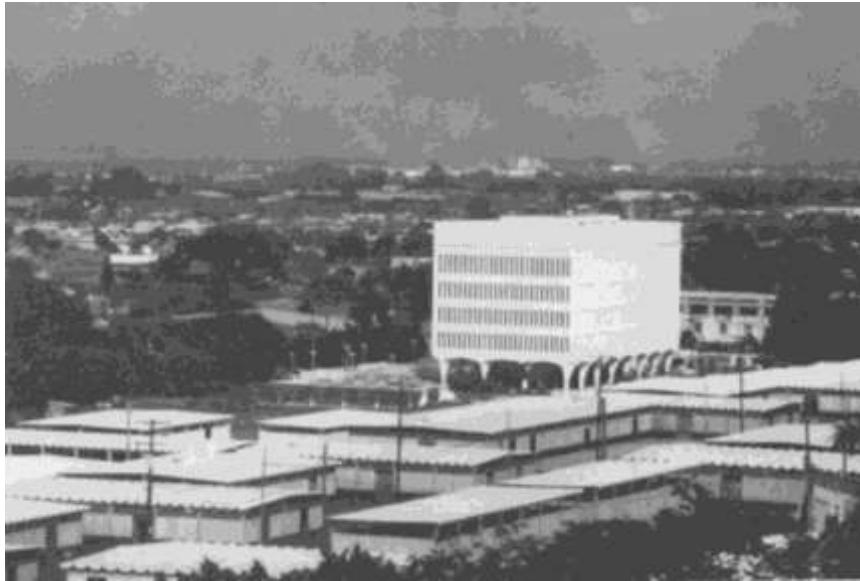
This was shown again when comparing the Enaluf building with the La Protectora building and the INSS building. The Enaluf building utilized both shear walls and frames while the other two buildings relied on frames alone. Although there was some damage to the Enaluf building the same performance pattern was repeated (Wright 1973; Sozen and Matthiesen 1975).

Figure 3.21. ENALUF (Light and Power) Building, notice the soft first story (Sozen and Matthiesen, 1975).

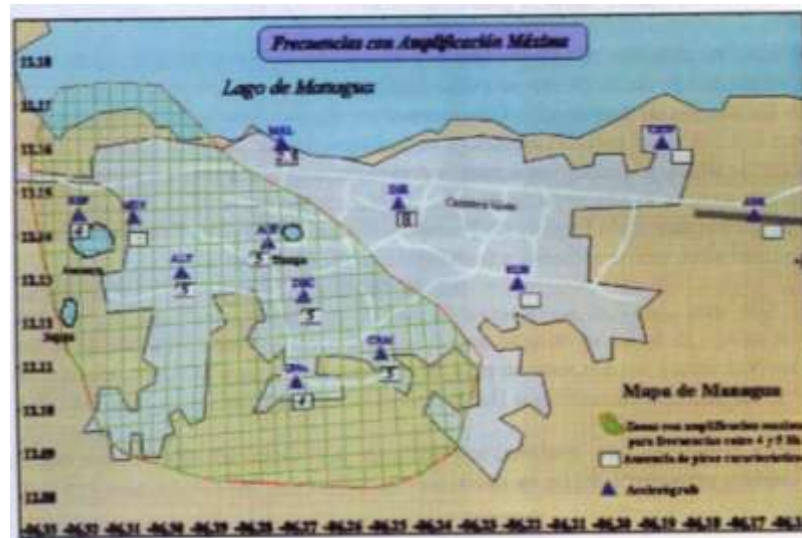
Figure 3.25. INETER microzonation map (INETER, 2000)

Later the government agency Instituto Nicaragüense de Estudios Territoriales (INETER), built on this work and performed tests to determine the horizontal and vertical wave components (H/V Method) and from this calculated soil amplification factors for the city of Managua. This resulted in only one seismic amplification zone for the city of Managua.

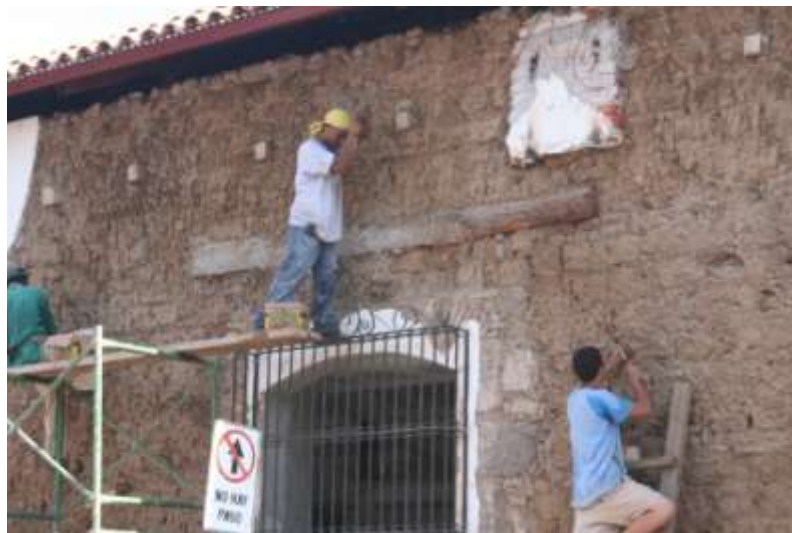
Adobe buildings are constructed using bricks of dried soil. Rammed earth buildings (also called tapial in Spanish) are constructed by compacting soil between forms and then removing the forms.

Figure 4.1. Adobe building in Leon, Nicaragua undergoing repairs

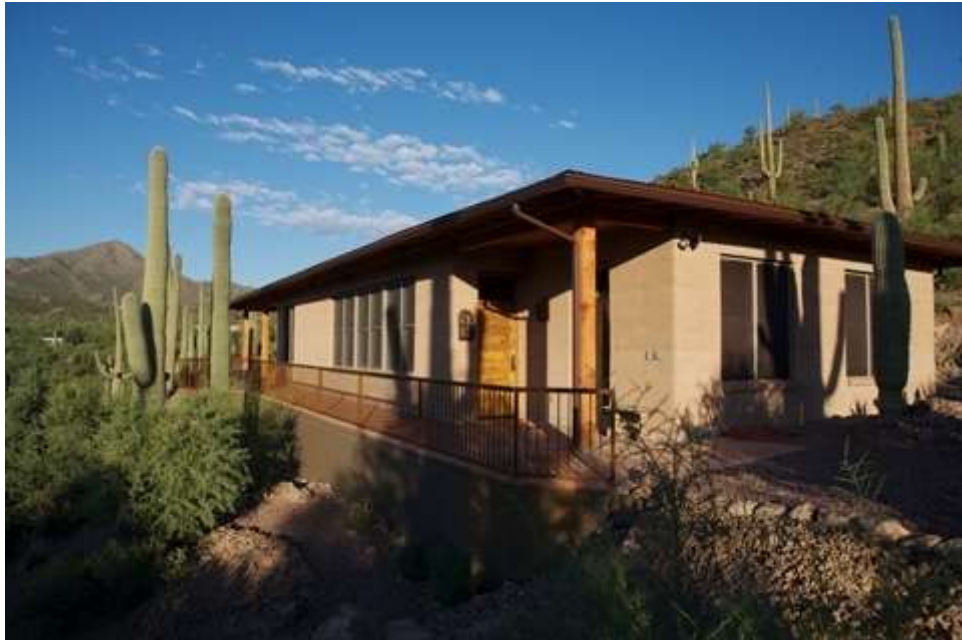
Figure 4.2. Rammed earth home in the Southwestern United States
<http://www.rammedearth.com/gallery.html>

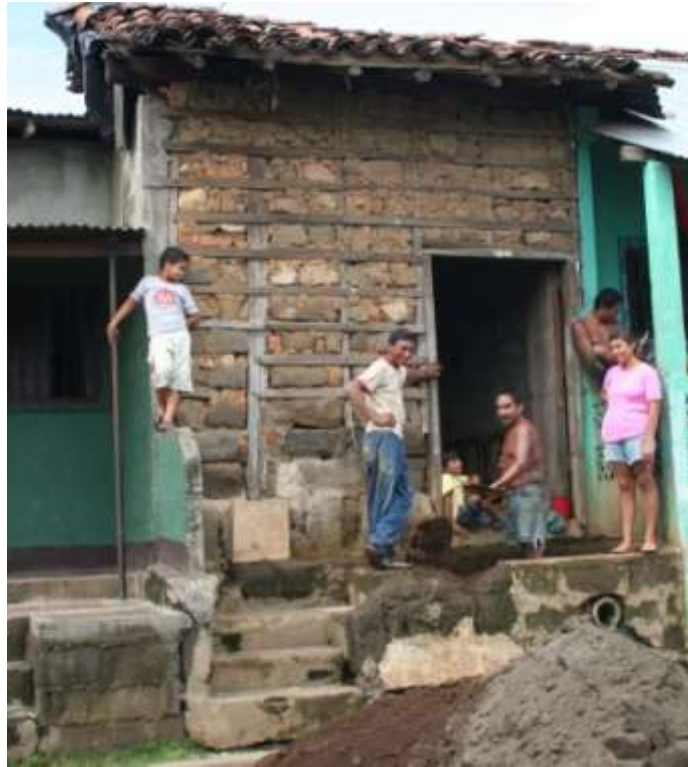
Taquezal buildings are constructed by erecting a framing system of wood (usually cut) and then packing that frame with mud and sometimes stones. The term taquezal seems to be specific to Central America and specifically Nicaragua, but the construction practice occurs in other parts of the world. Bahareque buildings are similar to taquezal except they are framed of bamboo and then packed with mud.

Figure 4.3. Taquezal house in Leon, Nicaragua undergoing repairs

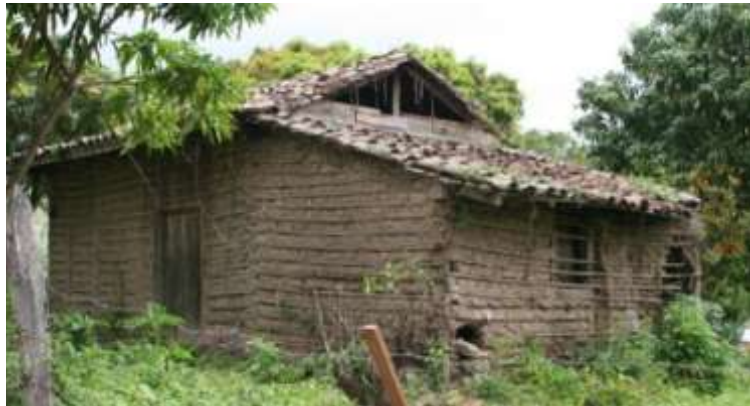
Figure 4.4. Baharaque building in San Ramon, Nicaragua

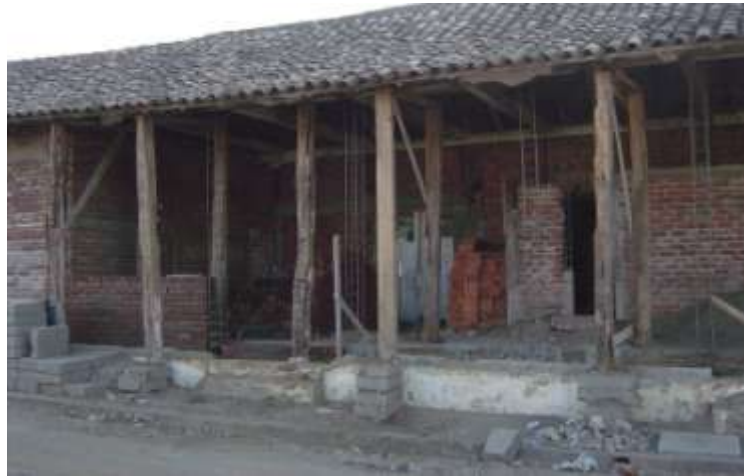
Another method of retrofitting is to confine the adobe or taquezal with concrete frames or to remove the adobe entirely and replace with concrete frames in-filled with masonry (also called confined masonry). Confined masonry has shown to perform better than adobe. Vera and Miranda (2004) tested adobe walls and confined adobe walls and found the confined walls had significantly improved ductility and energy absorption but had similar ultimate loads.

Figure 4.14. Retrofitting by removing taquezal walls and replacing with confined masonry

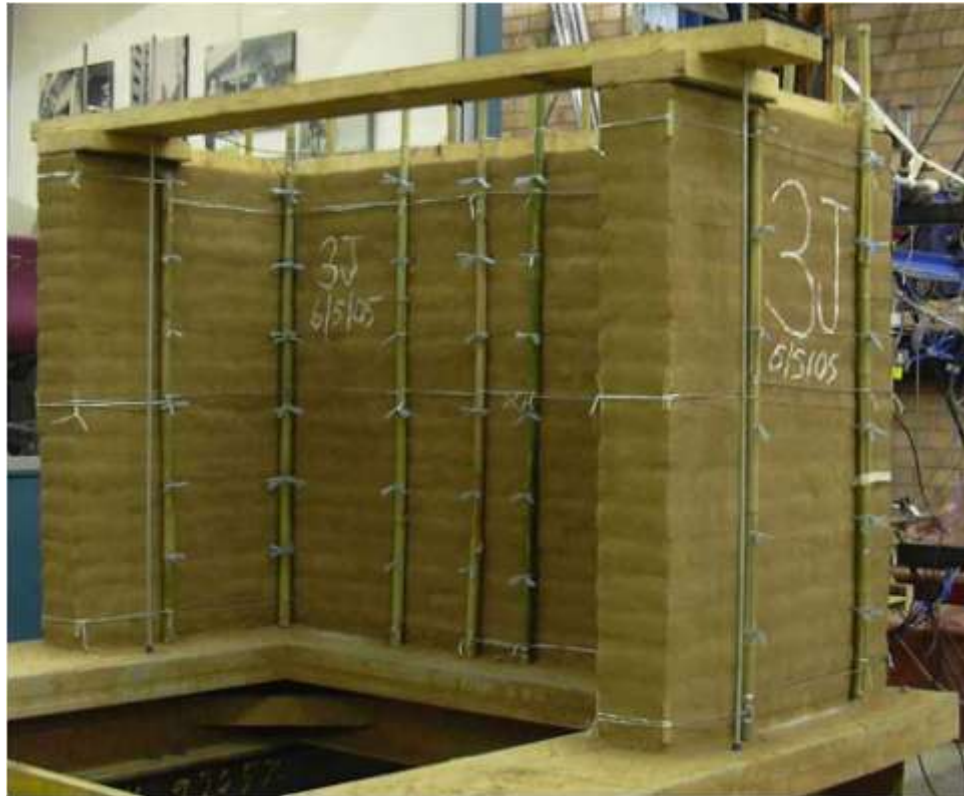
An earthen structure with vertical (and sometimes additionally horizontal) wood elements increases the structural capacity of the building under seismic loads. Performance is better when these elements are installed in the building during construction of the building (Dowling, 2004; Yamin, 2004). The wood elements provide some elasticity much the way steel provides elasticity in reinforced concrete. However horizontal and vertical wood members applied to the building later as retrofitting did increase the performance of the building, but did not prevent collapse (Yamin, 2004).

Figure 4.15. Adobe test structure with bamboo external reinforcing (Samali et al 2006)

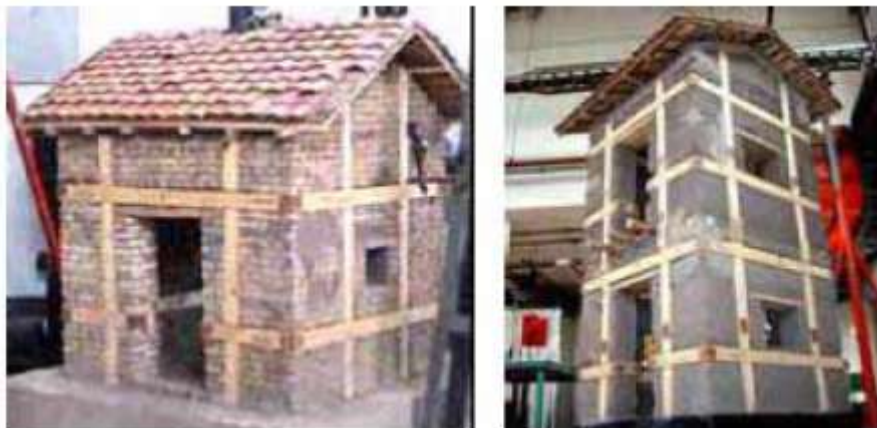
Figure 4.16. Adobe test structure with wood reinforcement (Yamin et al 2004)

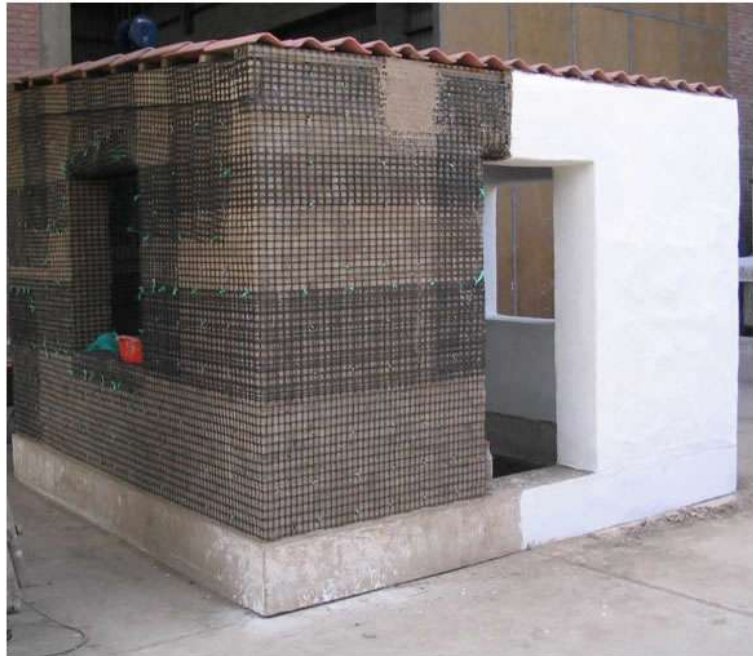
retrofitting. When well applied and good contact is made with the wall, it increases the structural capacity of the wall, but otherwise it still confines the wall and keeps the rubble from falling on the occupants. (Blondet, 2006; Diaz 2007)

Figure 4.17. Adobe test structure with mesh reinforcement (Blondet 2006)

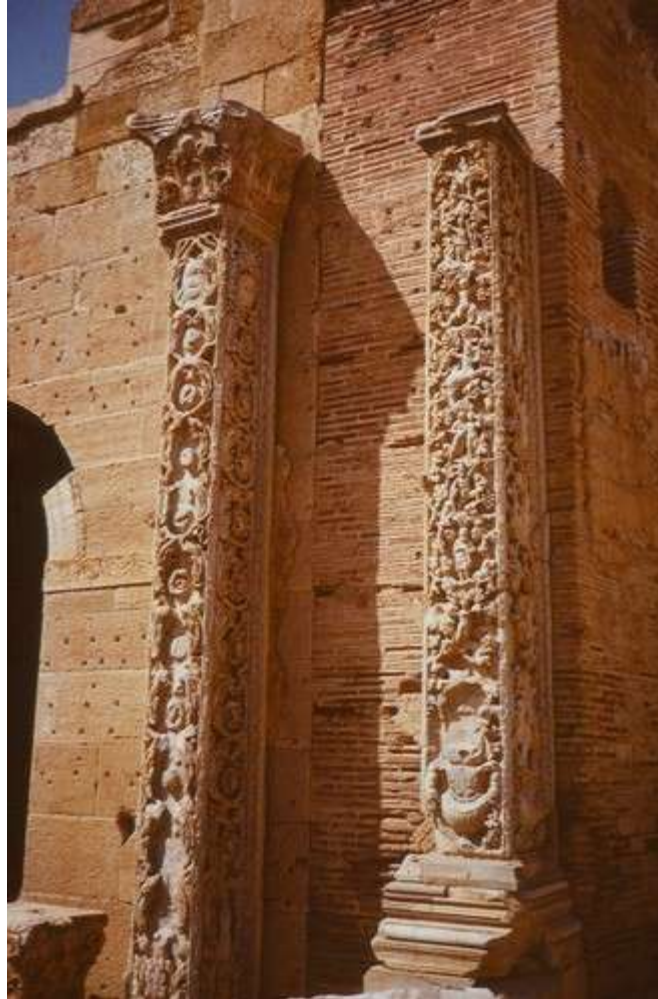
Installing Pilasters is another possibility. Since Pilasters are generally on the outside of a building it is possible to add them later as a retro-fitting measure, however creating a solid tie to the existing building would be a challenge.

Figure 4.18. Photo of pilaster retrofit example

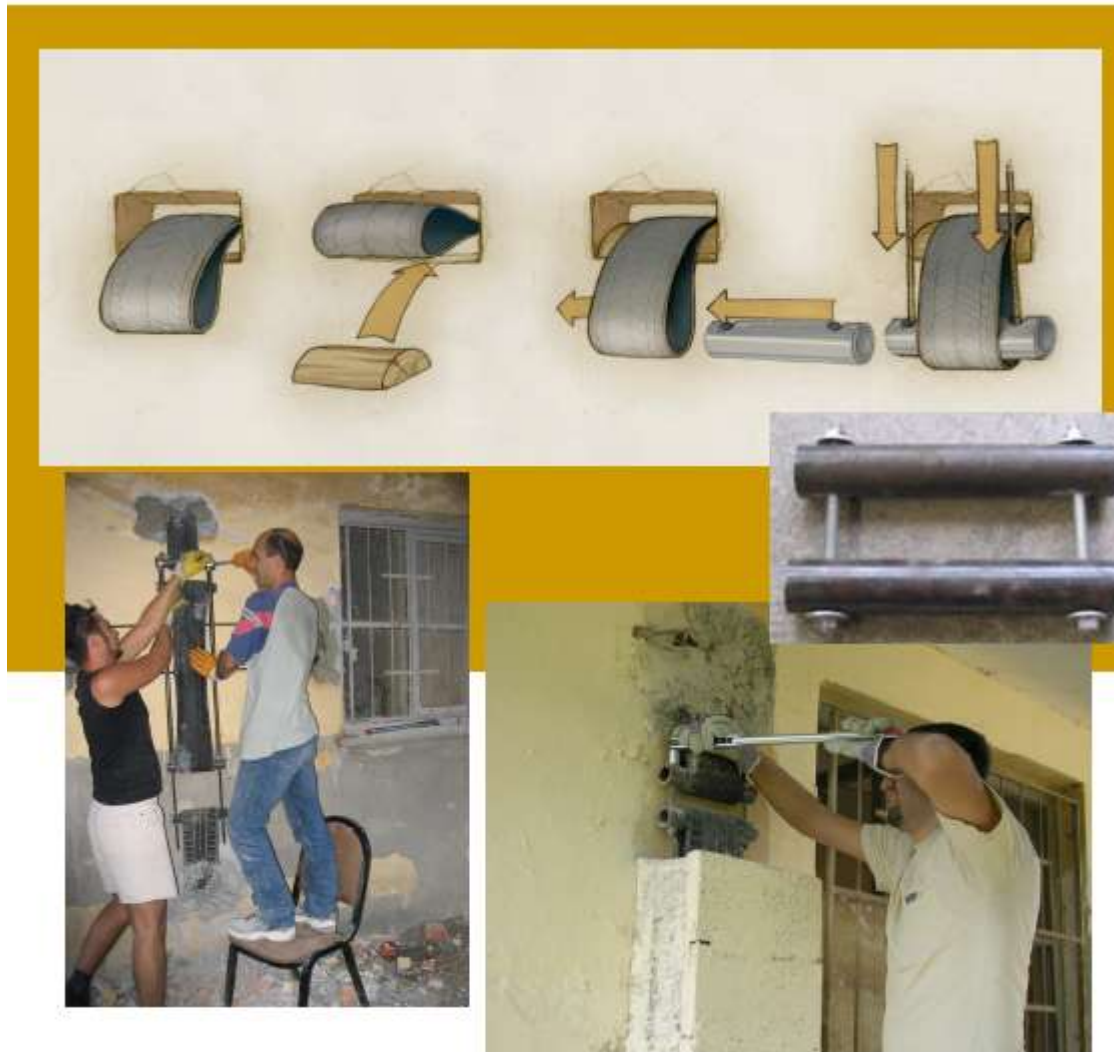
At Middle East Technical University (METU) in Ankara, Turkey, an innovative approach to retrofitting earthen structures has been explored. Professor Turer (2003) and his colleagues at METU are using old tires to strap down the building

walls and increase the state of compression in the walls. The downside to this method is that it requires making large holes in the wall and then installing straps that must be covered. Also there is some maintenance involved in making sure the walls stay tensioned.

Figure 4.19. Building retro-fit using scrap tires (Turer, 2003)

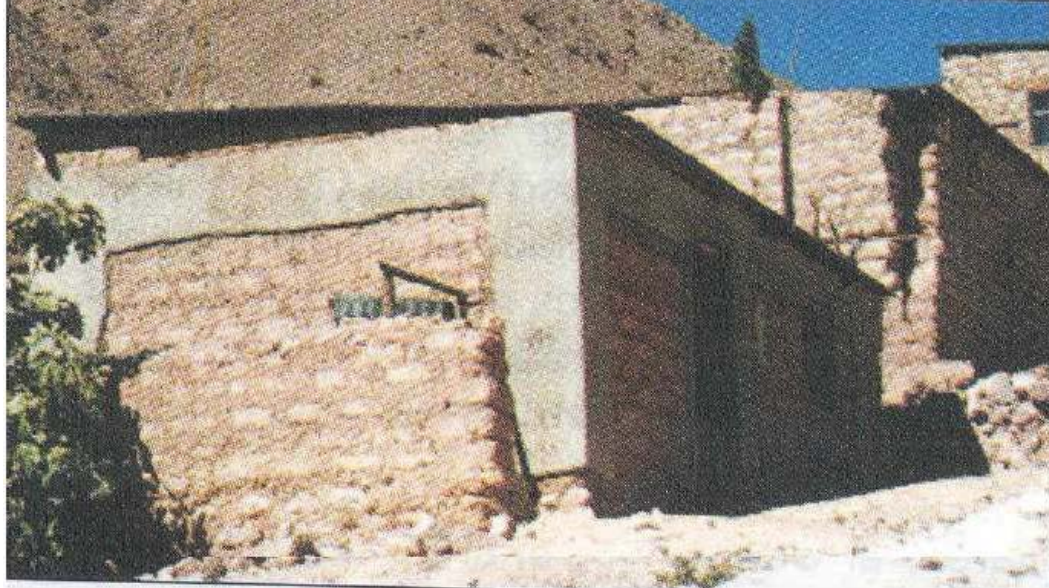
Adobe retrofitting techniques were put to test during the 2001 Arequipa earthquake. Before this earthquake many adobe structures were retrofitted with steel wire mesh and mortar forming vertical and horizontal bands. This is the retrofitting technique shown in figure 4.11.

Figure 4.20. Rehabilitated adobe dwelling (San Bartolome, 2004)

The rehabilitated houses performed well and were not damaged. The nearby adobe structures that were not rehabilitated, were severely damaged or collapsed (San Bartolome, 2004).

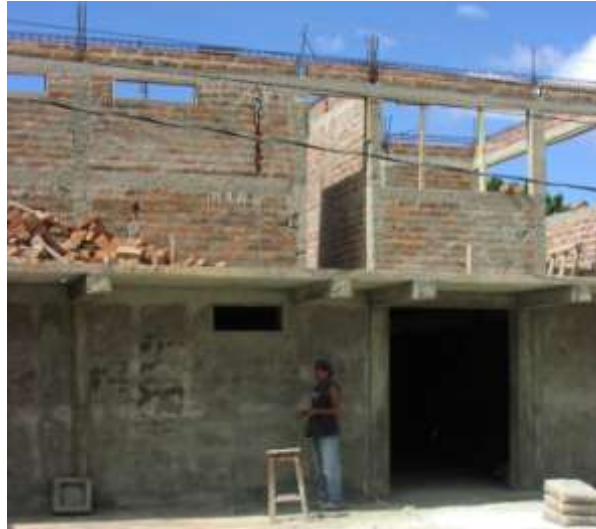
Confined masonry construction is becoming more prevalent in many developing countries. The term, confined masonry, also called masonry-in filled frames, refers to concrete or steel frames filled in with non-structural masonry walls.

Figure 5.1. Confined masonry construction, San Juan del Sur, Nicaragua

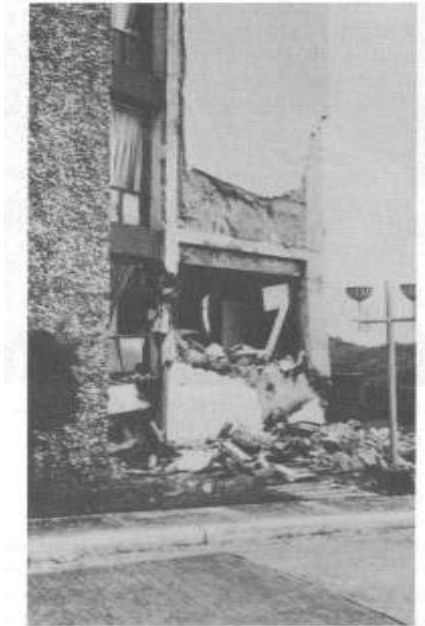
result in shedding of masonry inside the building or into the streets below, either of which are hazardous. This type of failure is shown in figure 5.3.

Figure 5.3. Failure of lower level of masonry-infilled reinforced concrete frame (Paulay 1992)

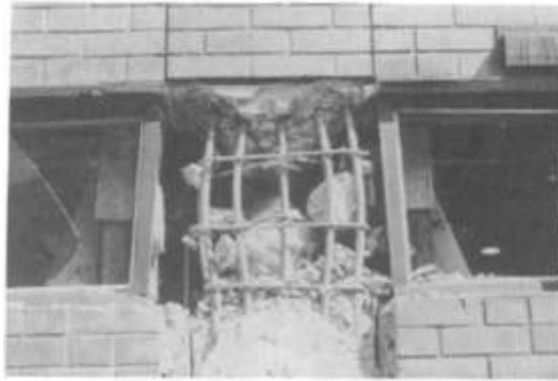
If the structure is not designed for this higher shear force, shear failure can be expected. This higher shear force is accompanied by lower ductility. Figure 4 is an example of this type of failure.

Figure 5.5. Short column failure (Paulay 1992)

This type of design error is called short columns. It is very common in school buildings and has been seen in Nicaragua also.

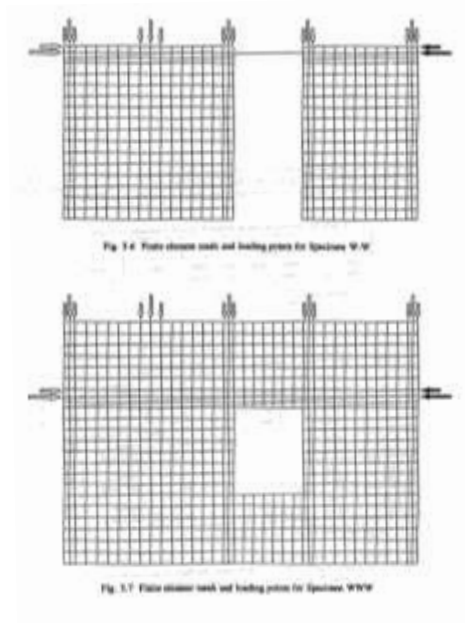
Figure 5.23. Model details (Ishibashi and Katsumata, 1994)

11. External forces in the vertical direction were divided into three components and were applied to the nearest three nodes to the loading points of the experiments. Horizontal loads were divided in two concentrated forces and were applied to two nodes. This is shown in figures 5.22 and 5.23.

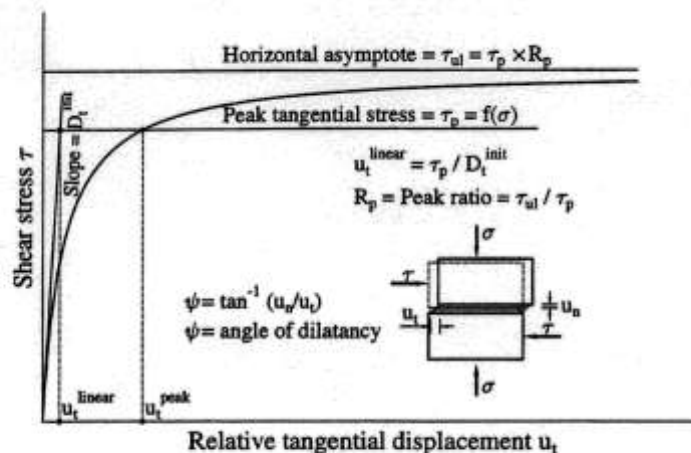
FIGURE 2-5 Pre-peak shear stress versus relative displacement relation.

Figure 5.28. Shear stress vs. relative displacement (Mosalam, 1997)

From the figure 5.27 distinct stages can be identified: contact, development of separation, and complete separation. In the tangential direction, the stress vs. relative displacement relationship was assumed nonlinear elasto-plastic following the Mohr-Coulomb criterion supplemented with softening criteria for cohesion and for internal friction.

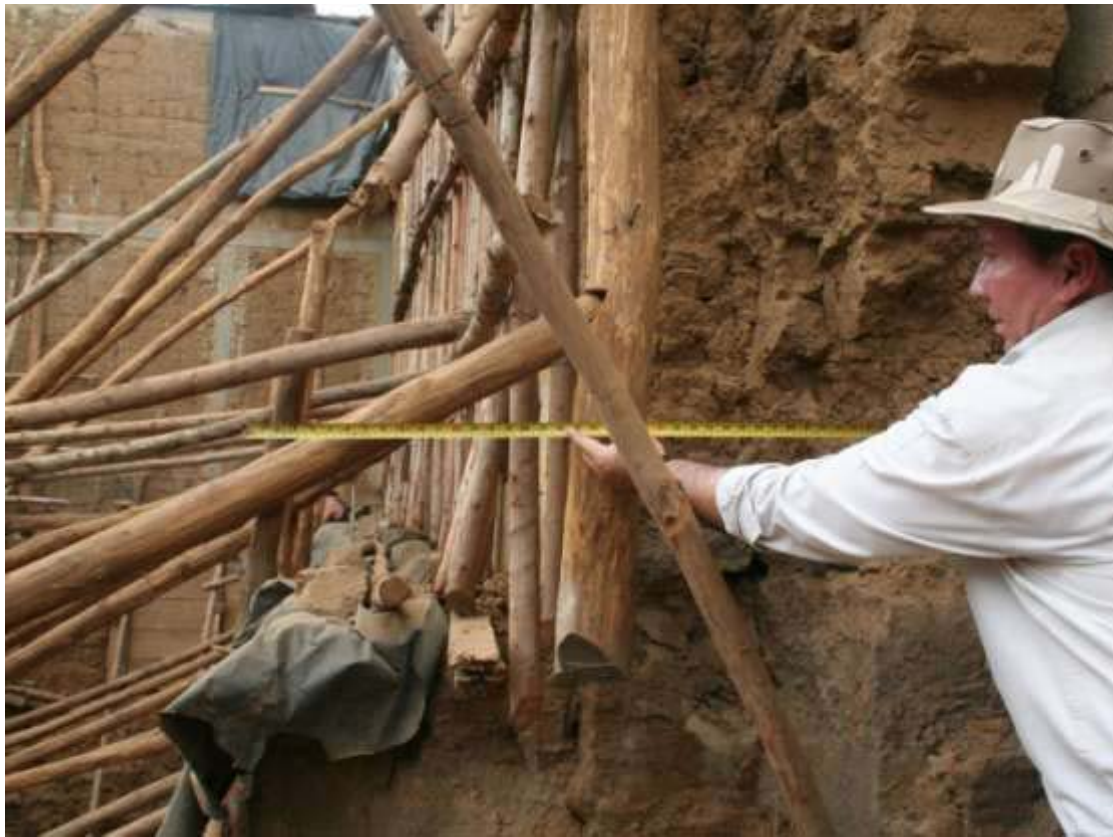
Figure 7.3. Construction manager in front of the collapsed adobe wall

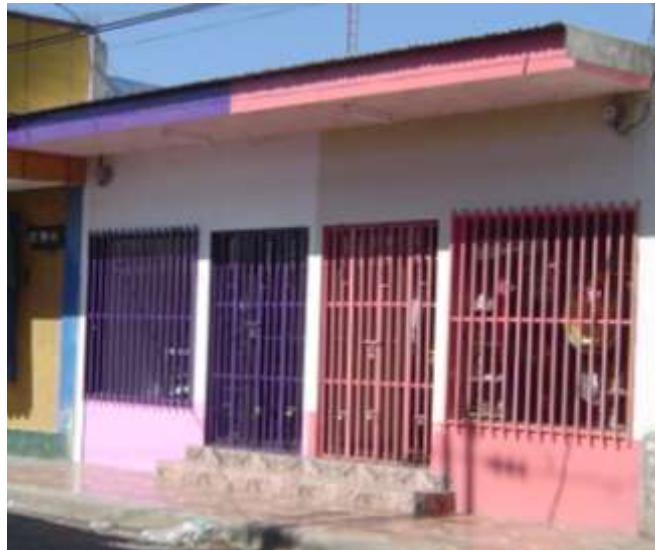
To investigate these questions, a typical Nicaraguan concrete building was chosen from the town of Rivas. This structure seems typical, the size is average, the openings are representative, and it is a simple design made from reinforced concrete.

Figure 8.1. Typical concrete building chosen for analysis

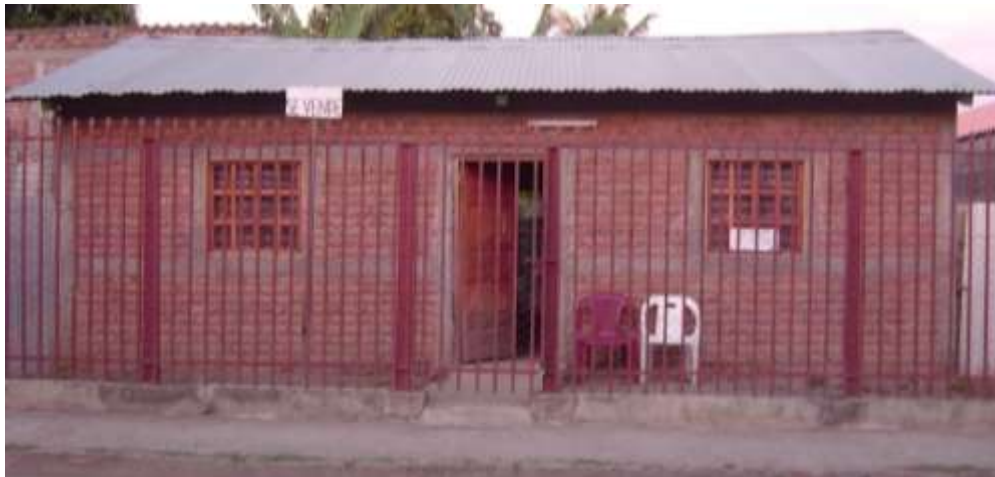
Figure 8.30. Confined masonry building in Rivas, Nicaragua

In recent years, concrete frames with brick infills have become a popular method of construction in Nicaragua. These types of buildings have proven to hold up better than earthen buildings in earthquakes and are relatively easy to construct

The geometry of the building was scaled from the photograph and was assumed to be as shown in figure 8.30.

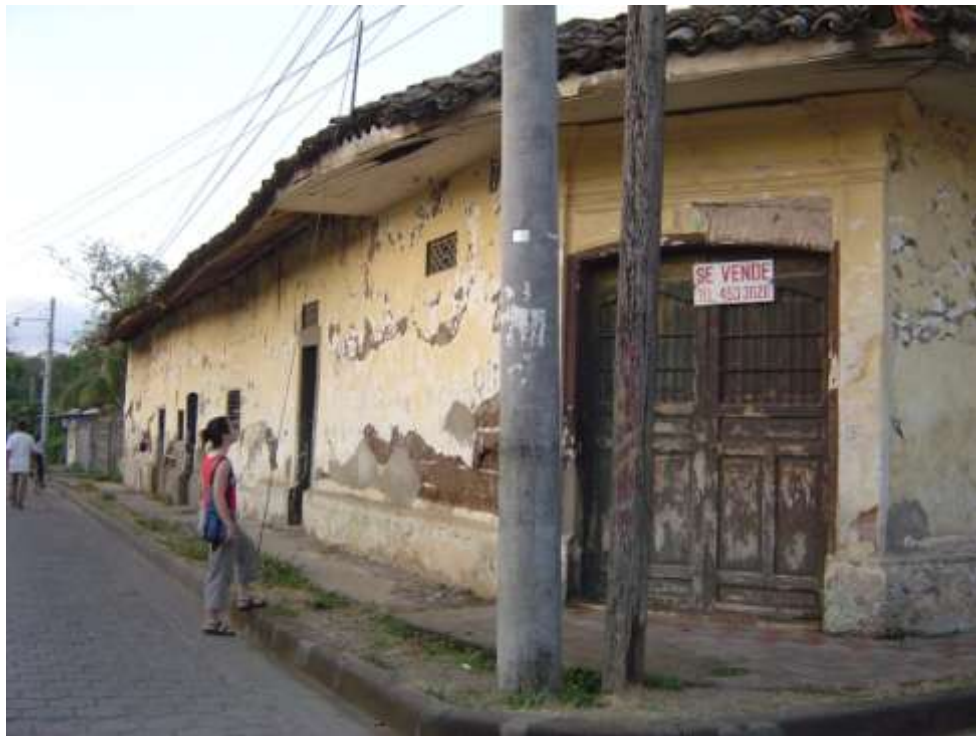
Figure 8.48. Taquezal building, Rivas, Nicaragua

To create a model of a taquezal building the details of some common buildings in Rivas, Nicaragua were used. The nature of the construction of taquezal buildings was observed by documenting various damaged or unmaintained buildings.

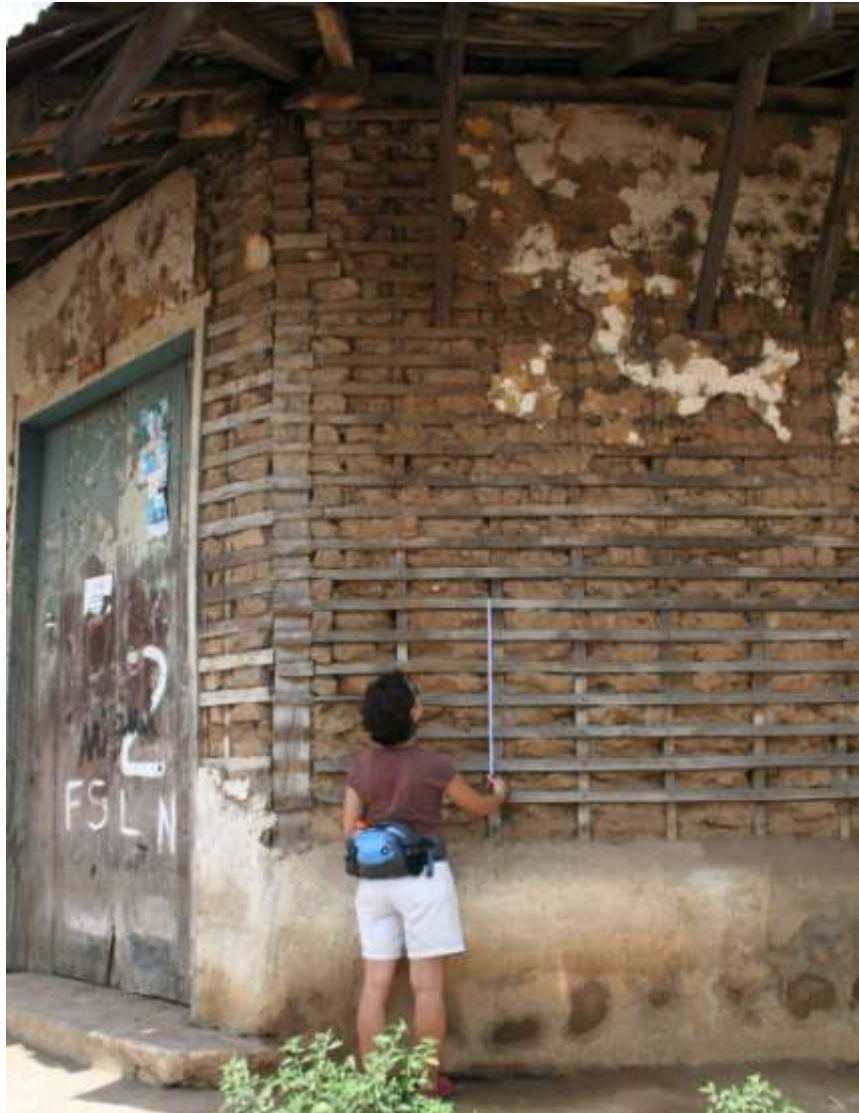
Figure 8.51. Typical taquezal framing used for model

The framing of the building was estimated from photographs of taquezal buildings like the one shown in figure 8.51.

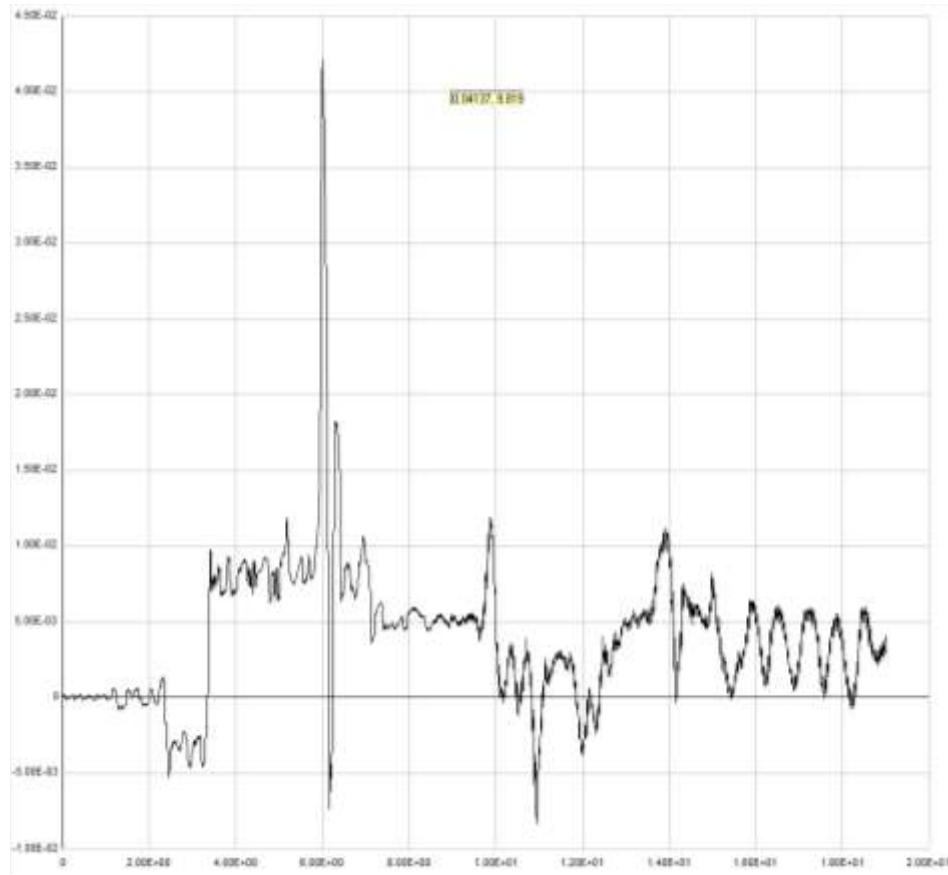
Figure 8.67. Taququezal lateral earthquake simulation

The taquezal building was analyzed dynamically using the Managua earthquake of 1972. The results for the lateral and longitudinal direction are shown in figures 8.67 and 8.68.

The maximum deflection recorded in the lateral direction is 0.42 inches. This equates to a drift ratio (deflection/height) = $(.042''/(15' \times 12)) = 0.0023$. This drift ratio is close to the value set for life safety, 0.0022, which confirms the results from the earthquake. The buildings that were well maintained performed fairly well, but buildings that had damaged or rotted columns suffered greater damage.

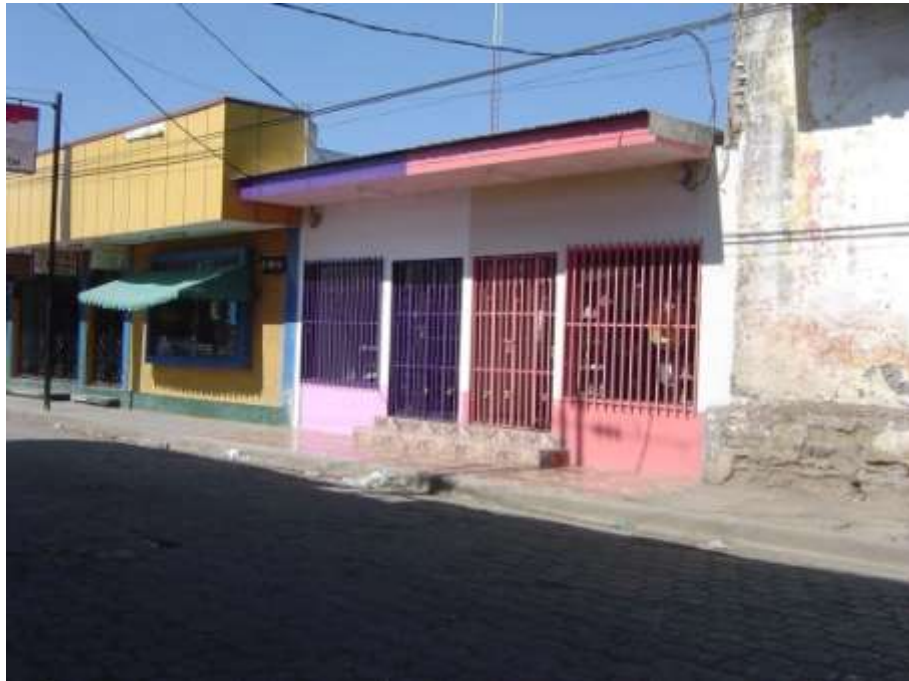
Figure 9.1. Concrete building

Four of the building types were selected and analyzed. They include: reinforced concrete, confined masonry, taquezal, and rammed earth (tapial).
