EVALUATION OF SPECIALIZED CONCRETES FOR THE REPAIR OF DAMAGED
CONTINUITY JOINTS IN PRESTRESSED GIRDER BRIDGES

A THESIS

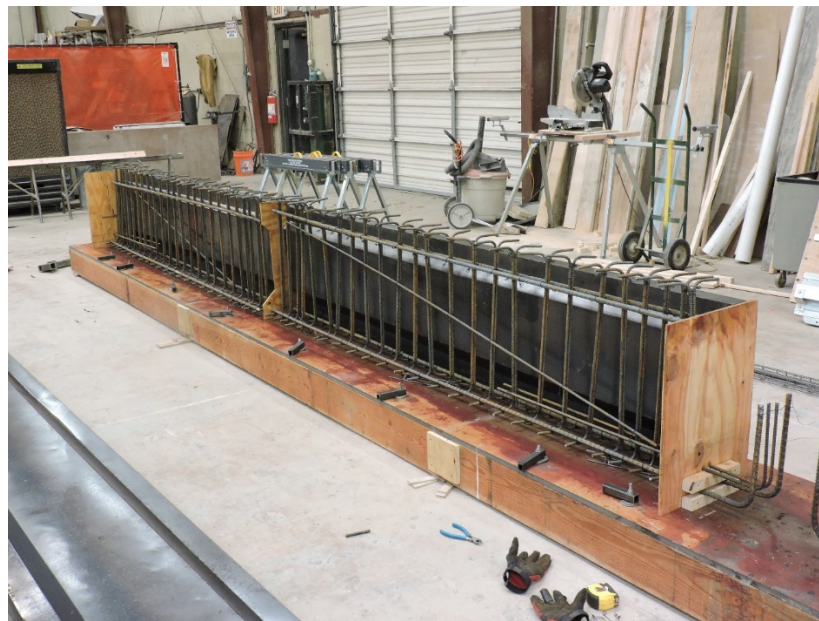
Figure 3-15: Rebar Cages Within Formwork

Metal formwork for the casting was used to house the cages for the specimens. Used in previous research and built by an undergraduate student at the University of Oklahoma, these forms are 18' in length with the AASHTO Type II profile. This allows for two half-length specimens to be cast at the same time. A total of four forms were used, yielding four half-length specimens per concrete pour. Figure 3-15 shows the arrangement of cages placed within the form.

Notice how two specimens are built using this formwork. A plywood divider between the two specimens, seen in the center of the metal form, separates the two specimens throughout the casting and curing processes. A No. 3 bar extends diagonally across each cage to alleviate any racking that may occur during the handling and placement of the cages. This reinforcement is not intended to be of any structural benefit after placement of cages within the formwork.

The plywood shown at the end of the forms not only keeps concrete from escaping during the casting process but also aligns the bottom longitudinal reinforcement. This alignment of the hooked ends of the reinforcement was crucial in that it allowed two half-length specimens to mate well prior to casting the deck and continuity joint. Baling wire was also wrapped around the hooked ends in order to keep them from shifting and rotating. A closer look at the formwork and hooked is shown in Figure 3-16.

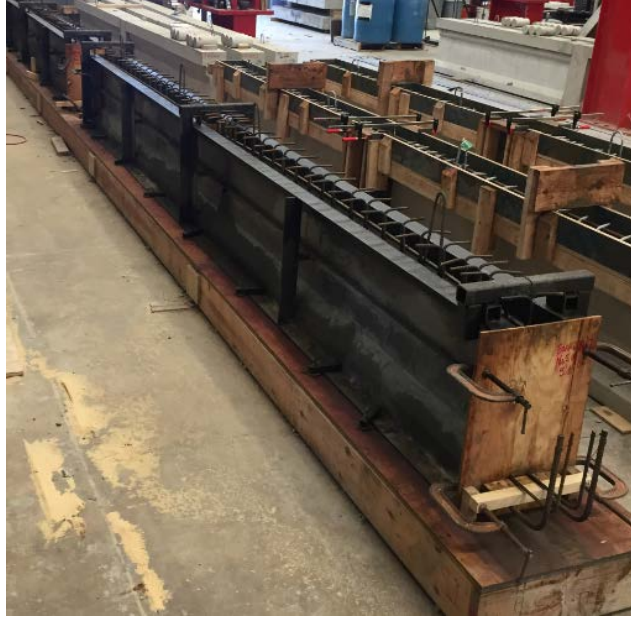
Figure 3-18: Specimens Ready for Casting

Plywood and construction grade lumber platforms were built for the casting process. These platforms allowed the specimens to sit level by way of shims beneath. Additionally, the platform let the metal forms to be clamped down ensure dimensional accuracy and stability throughout the casting process. To restrain the formwork from bulging away from the girder’s centerline due to head pressure during the pouring process, square steel tube stock was fabricated to clamp across the tops of the formwork. Figure 3-18 below shows these clamps and the final stage of the formwork prior to casting.

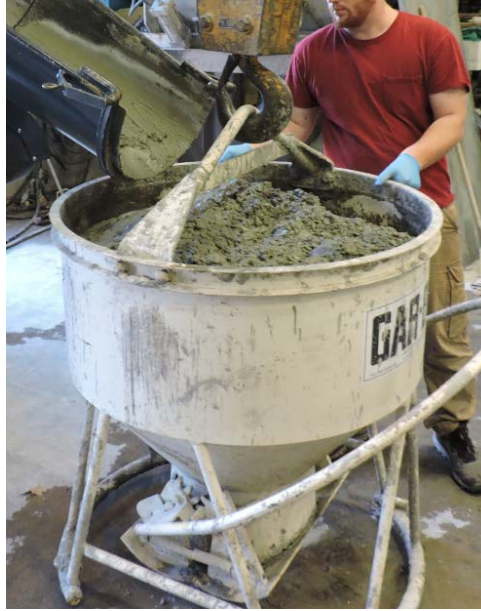
Figure 3-19: Filling Round-Gate Bucket with Concrete

Each half-length specimen needed 6.61 ft³ of concrete. An additional 0.88 ft³ was used to fill three cylinders for compression testing for each pour. To expedite the casting process, the concrete was transported across the lab using a large, round-gate bucket attached to a top running single girder overhead crane. Figure 3-19 shows the concrete flowing from the truck's discharge chute to the round-gate bucket.

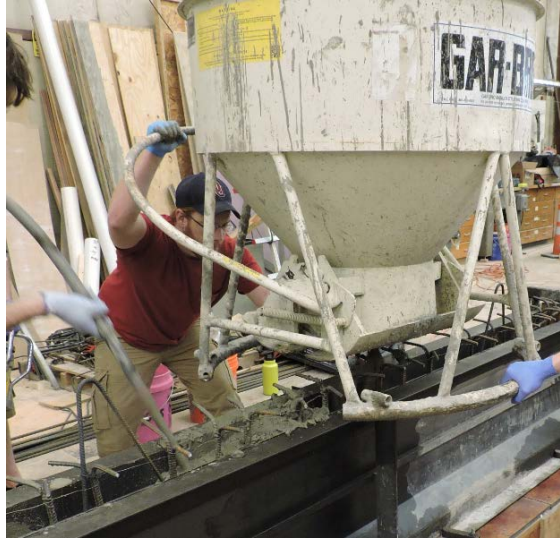
Figure 3-20: Pouring & Vibrating Concrete into Girder Formwork

Using the overhead crane to transport the concrete to the girder forms, the concrete was then discharged. This process was a four-person operation. One person manned the crane and moved the bucket down the girder while another released the concrete into the formwork. Once a sufficient amount of concrete was placed, the bucket was moved down the girder to begin adding more concrete into the formwork. Following behind this process was a two-person crew using a concrete vibrator. While one operated the vibrating end of the machine, another held the motor and supplied electrical power when needed. This process reduces the internal friction of the mix and removes any air pockets formed within the fresh concrete.

Figure 3-20 shows the previously mentioned process in motion. There was one thing worth noting while pouring the concrete into the formwork. In order to allow the fresh concrete to flow unobstructed down through the girder's web and to the bottom flange, one of the top longitudinal No. 5 bars was removed. This increased the clearance of which the concrete could flow. Once the formwork was just about full of concrete, these bars were then re-tied to their original location. This was a relatively simple task, as the concrete was only filled up to the top of the formwork seen in the figure.

Also shown in Figure 3-20 are hooks to aid in transporting the specimens using the overhead crane. These hooks were made from No. 3 bars and extend 9" down into the girder and 3" above the eventual deck. Finally, the top surface of the girder was roughened which is the interface where the deck meets the girder. Transport hooks and two sets of poured girders are shown in Figure 3-21.

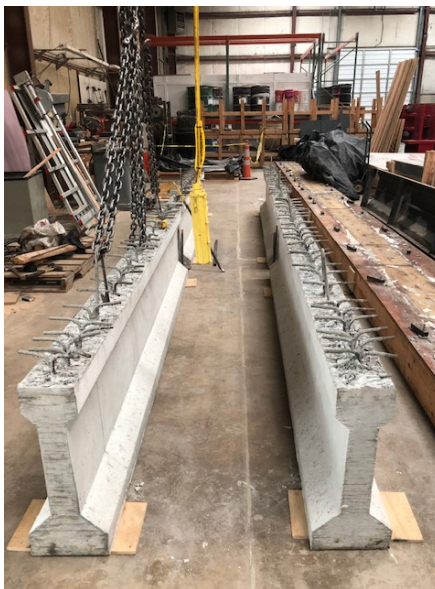
Figure 3-22:Half-Length Girder Specimens After Moist Cure

The half-length girder specimens were moist cured for seven days. Wet burlap was placed over all exposed concrete and was monitored throughout the seven days. In addition to the wet burlap, plastic sheeting covered the specimens to mitigate the evaporation of water. After the seven-day moist cure the half-length girders were stripped of all formwork and were ready to be joined together, as shown in Figure 3-22.

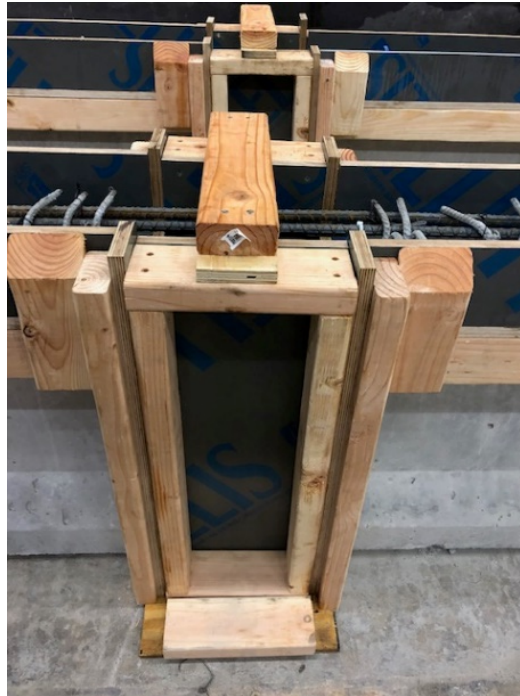
Figure 3-24: Continuity Joint Formwork

Plywood and construction grade lumber was again used to create the formwork for the continuity joint. Because the joint is a rectangular prism that extends out from either side of the bells and webs of the two half-length specimens, sheets of plywood were cut in the shape of the outer girder profile, including the deck. This allowed containment of the pour on the faces perpendicular to the length of the specimen. Plywood and lumber were used to house the two faces running parallel to the length of the specimens. Figure 3-24 shows how the continuity joint formwork comes together. The sheet of plywood on the floor was used for two reasons. The plywood maintained that the joint stay level with the two half-length girder specimens and allowed a stop block of wood at the base of the larger face of the joint. Much like the C-shaped clamps built for the top of the half-length

Figure 3-24 shows a piece of lumber stretched across the top of the joint. This lumber was set in place to keep the forms from bowing out during the pour. One problem with this method was that during the pour the round-gate bucket would drop concrete onto the wood and not into the joint. An easy remedy to this problem used in the pours to follow was to use a two F-style clamps across the joint, which worked very well.

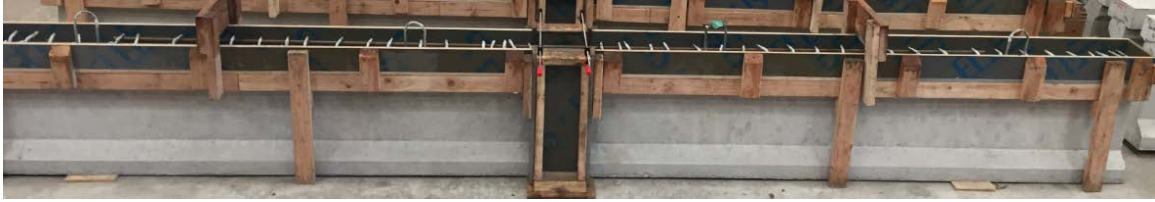
Figure 3-25: Deck Formwork

After the half-length girder specimens were set in place with the mating hooked ends, the formwork for the deck was built. The formwork design was simple and built from plywood and construction lumber. Spanning the length of the half-length girders, 2x4s were used as the formwork of the underside lip of the deck. The deck is 9” wide, which protrudes 1.5” away from the top bell of the girder. Plywood cut to length was attached to these 2x4’s which encapsulated the side faces of the deck. These plywood pieces were 4.625” tall, the same height as the finished deck, and gave a perfect reference to trowel

the fresh concrete across. The deck design was also based on previous research (Casey, 2019). This system of formwork was set in place by way of supports acting as stilts. These stilts not only held the formwork in place but allowed the formwork to be installed without directly anchoring into the specimen. This aided in the process of demolding the specimens and the reuse of the formwork. Figure 3-25 shows the specimens ready for concrete placement.

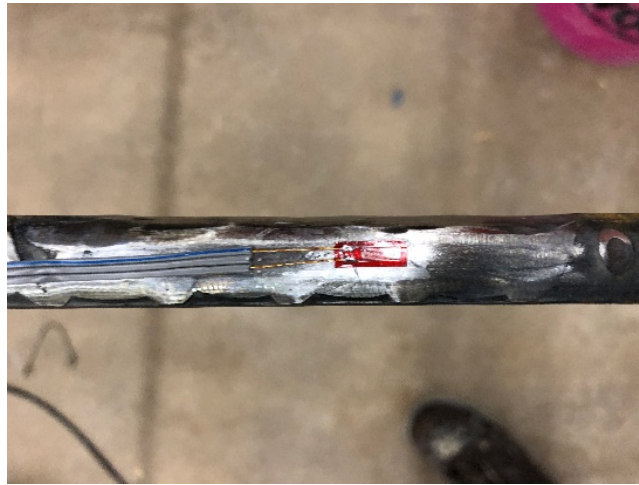
Figure 3-26: Strain Gauge Glued to Longitudinal Reinforcement

Two strain gages, Figure 3-26, were applied to two of the deck reinforcement bars over the joint. One strain gauge was installed on one of the outer bars, and another on one of the inner bars. The gages were placed at the midpoint of each bar after the appropriate amount of grinding, sanding, and cleaning (lacquer thinner, acid, base) was applied to the area of interest. The midpoint of each bar corresponded to the center of the joint; the data that would come from this location is desired specifically for the second load case where the deck bars are supposed to fail after the joint has been repaired.

Cyanoacrylate (CA) glue was used to adhere the strain gauge to the bar surface, Figure 3-26. Once the adhesive had time to dry completely, the strain gauge was covered in room-temperature-vulcanizing silicone (RTV). This provided the strain gauges a seal to mitigate water intrusion and also a bit of protection from falling concrete during pouring, Figure 3-27. The silicone was left to cure overnight and was then wrapped with aluminum tape. Zip ties were used to connect the strain gauge wires to the rebar and

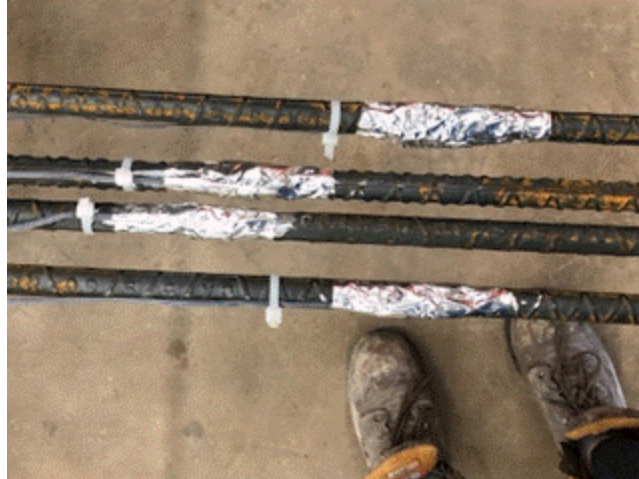
Figure 3-28: Strain Gauges Attached to Longitudinal Reinforcement Ready for Install

provide strain relief if the wires are pulled during the placement of the concrete (Figure 3-28).

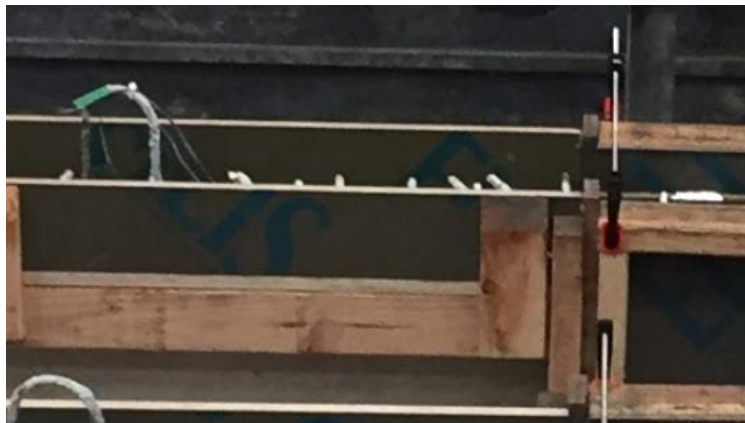
Figure 3-29: Strain Gauge Wires Before Casting

The longitudinal reinforcement was installed, as shown in Figure 3-30, and tied to the stirrups. The strain gauge wires were incrementally zip tied down the longitudinal reinforcement to the first transport hook. Tape was used to cover the exposed strain gauge wires, labeling either inner or outer bar, and additional zip ties were used to attach the wires to the top of the transport hooks. This process kept the strain gauge wires protected throughout the pour and would allow access to the wires after the concrete cures. Figure 3-29 shows a strain gauge emerging from the top of the deck and tied to a transport hook.

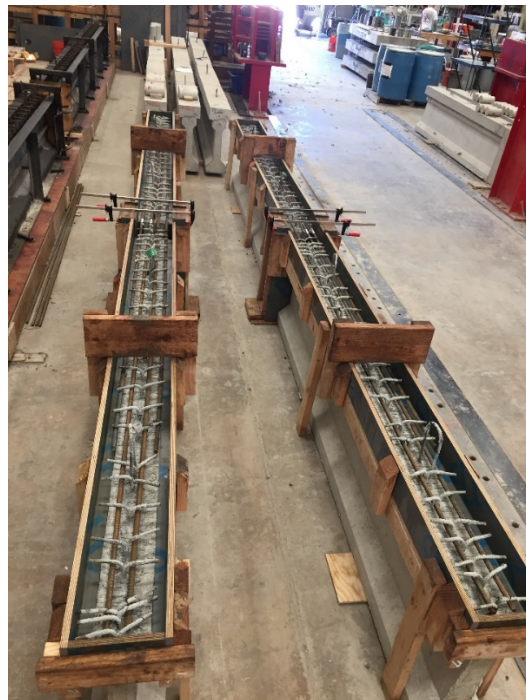
Figure 3-31: Two Girder-Joint-Girder Specimens Prior to Casting

Additional C-shaped clamps were built from 2x4's and 2x6's. These were used to keep the sides of the formwork from bulging throughout the casting process. One clamp per half-length specimen proved to be sufficient and was placed at each of their midspans. The clamps and the final formwork setup, ready for casting, are shown in Figure 3-31.

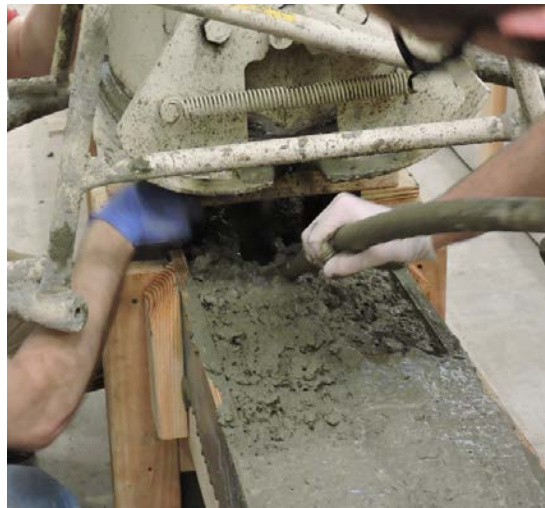
Figure 3-32: Vibrating the Joint During Casting

An amount of 5.5 ft³ of concrete was needed for casting each deck and an amount of 1.17 ft³ of concrete was needed for casting each joint, totaling 6.6 ft³ for each full specimen. The process for casting the deck and joint was very much like casting the half-length girder specimens. The four-person crew had the same tasks as they did for the girder pour. One thing noted while casting the first deck and joint was that the clearance needed for vibrating the joint was hindered by concrete poured along the deck above the girder beforehand. This is shown in Figure 3-32.

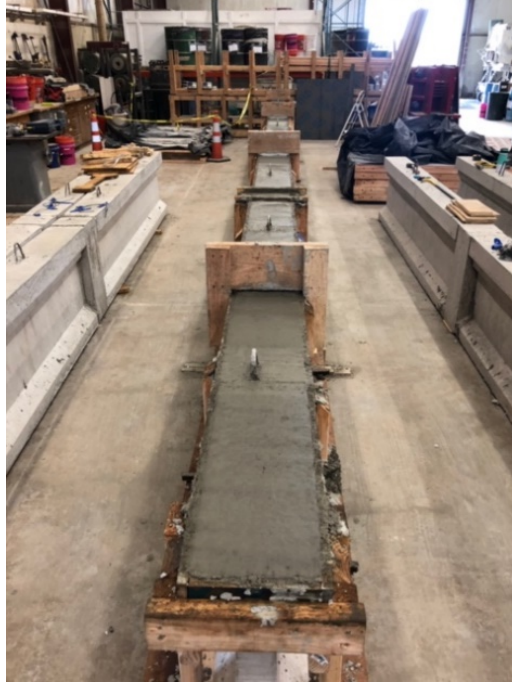
Figure 3-33: Girder-Joint-Girder Specimen After Final Casting

The team decided that pouring the continuity joint prior to the deck along the girders allowed for better clearance for vibrating. This proved to be successful, and the method was used for the rest of the full-specimen castings. Figure 3-33 shows the complete girder-joint-girder specimen after final casting.

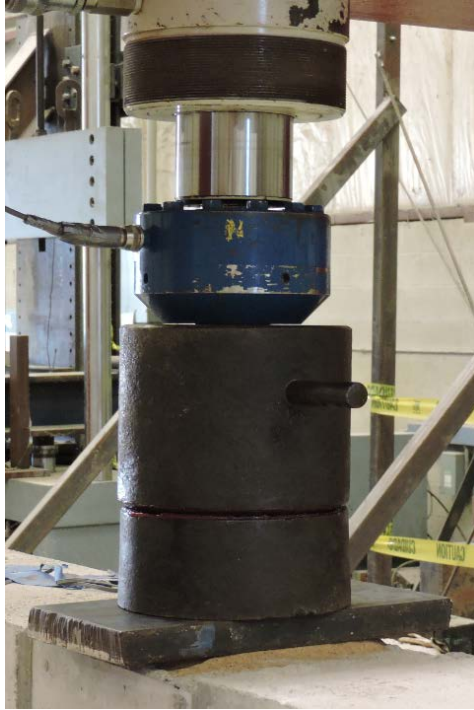
Figure 4-1:Hydraulic Ram, Load Cell, Spacer, and Metal Plate Setup

A 50-kip capacity calibrated load cell was placed directly below the hydraulic ram to monitor and record the applied load. A ½" layer of sand was placed between a 1" thick metal plate and the specimen's deck. This layer of sand allowed the plate to be leveled by hand prior to placement of a cylindrical swivel spacer and load cell allowing the load to be normal to the surface of the deck of uniform area. The swivel spacer also allowed the load applied to make minor rotational adjustments for stability through the load path to the girder specimen. This setup is shown in Figure 4-1

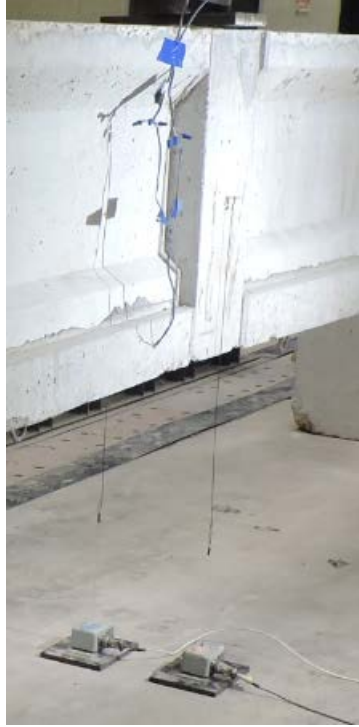
Figure 4-3: Wire Potentiometer Setup

Two wire potentiometers were placed on each side of the girder-joint-girder specimen at midspan to measure deflection while testing. Steel angles were epoxied to the face of the continuity joint to allow the wire potentiometers to connect to the specimen. This setup is shown in Figure 4-3.

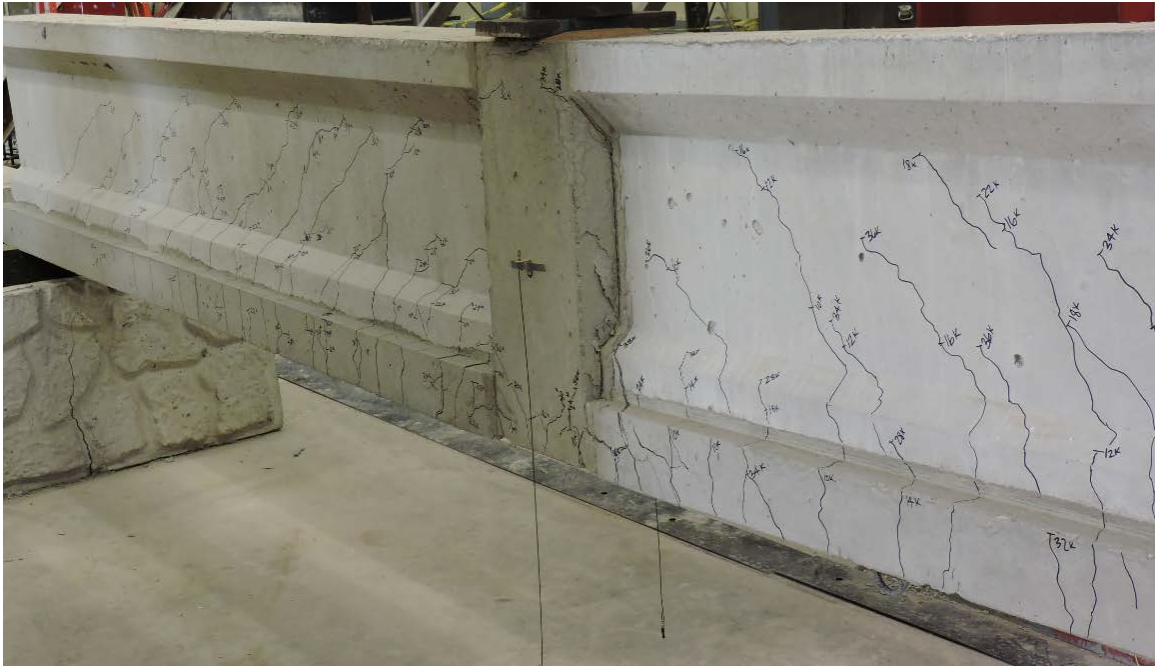
Figure 4-5: C1 Shear Cracking

Initial shear cracking was observed within the web of the specimen at 10-kip loading and continued to propagate diagonally upward as the loading progressed. The vast majority of the shear cracking developed within the web occurred between 14-kip and 36-kip of loading. Traced and marked with the corresponding loading increment, the shear cracking is shown in Figure 4-5.

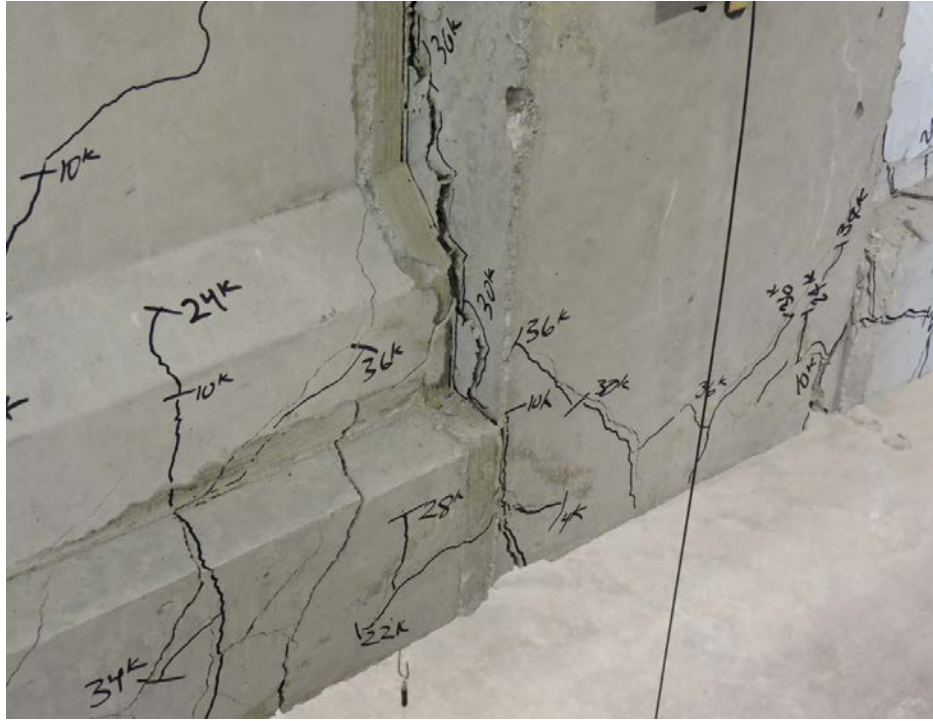
Figure 4-7: CI Cracking at Girder-Joint Interface (Left Side)

These cracks continued to grow with increased loading. Flexural cracks at the girder-joint interface were observed on both sides of the specimen. As loading increased, these cracks not only continued propagating upward on the interface but also increased in width, showing visible joint separation (Figure 4-7 and Figure 4-8).

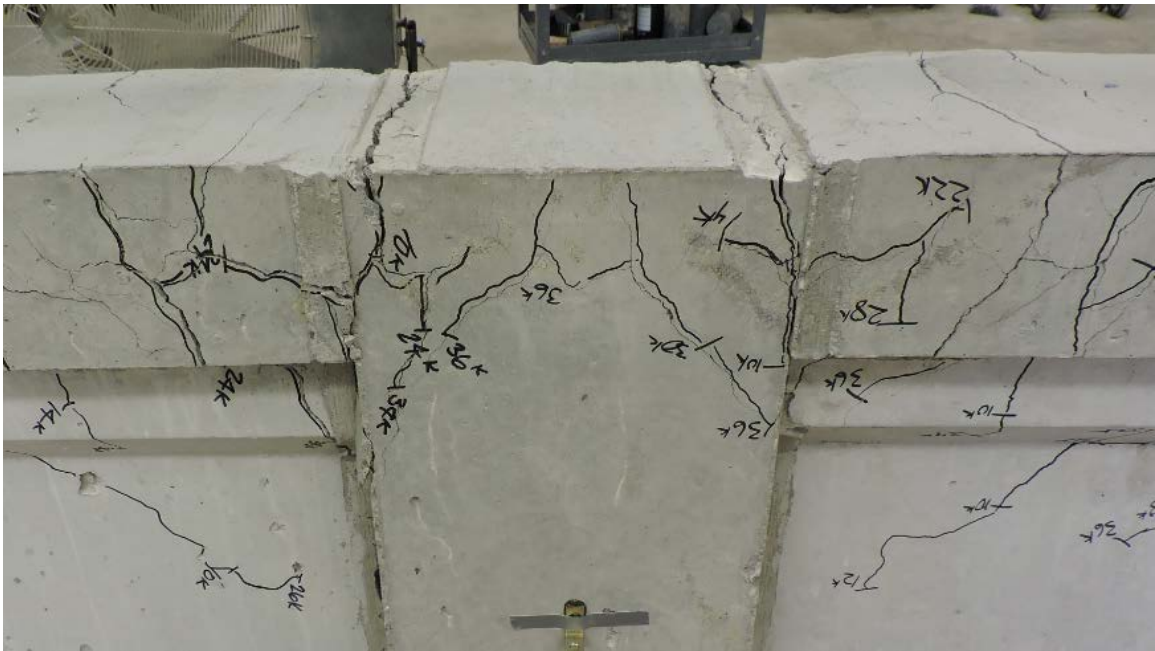
Figure 4-9: C1 Girder-Joint Interface Cracking across the Deck

Figure 4-9 shows the girder-joint interface flexural cracking across the deck. This photo was taken after the specimen had been unloaded, removed from beneath the loading frame, and flipped right side up. The large cracks across the top of the deck indicate that the continuity joint had begun to detach from the two half-length girders. Figure 4-10 shows the overall girder-joint-girder specimen after testing.

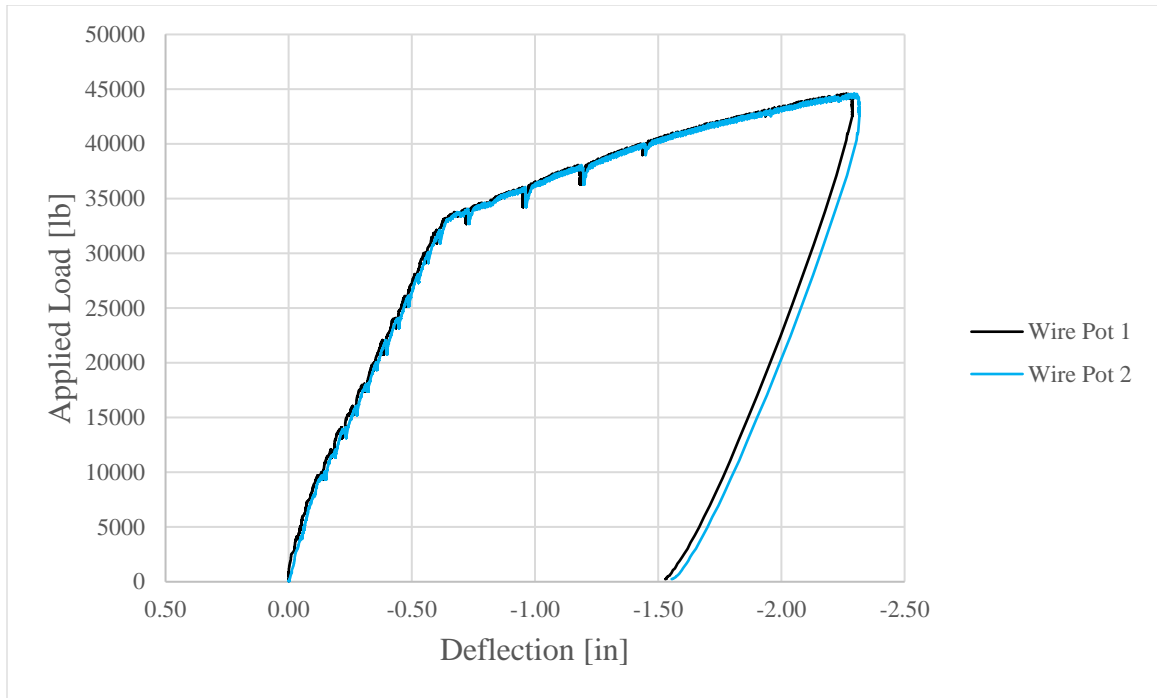
Figure 4-11: C1 Load-Deflection Curve

Control specimen C1 showed a ductile behavior after 33,086 lb were applied, and had an ultimate load capacity of 44,601 lb. At the ultimate load, C1 had deflected an average of 2.28". Figure 4-11 shows the load-deflection curve of C1, which is typical of a beam flexural failure.

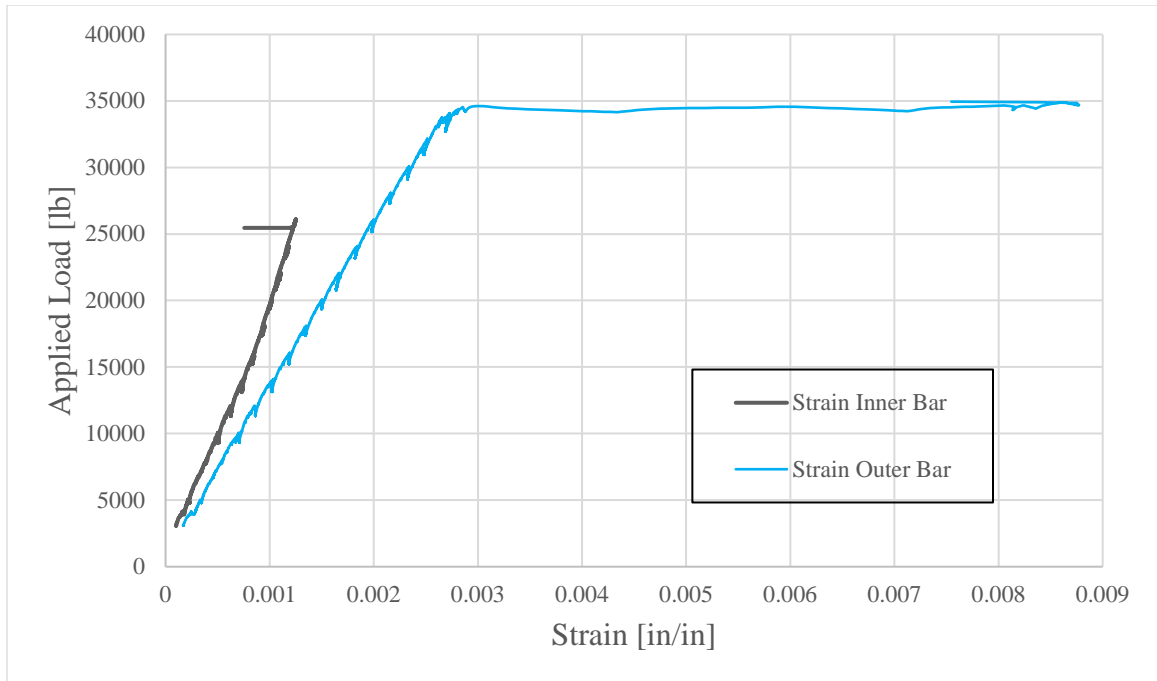
Figure 4-12: C1 Load-Strain Curve

The outer longitudinal reinforcement for negative moment bending began to yield at a loading of 27,716 lb. This was the point at which the strain in the steel reached 0.00218 in/in. Figure 4-12 shows a plot of the load-strain curve of control specimen C1. The inner reinforcement's strain gauge appears to have lost signal during the loading process. There are a number of reasons this may have happened, which include detaching from the rebar, or an open circuit caused by a shifting of the strain gauge wires within the specimen. The complete set of load-strain curves can be found in the Appendix.

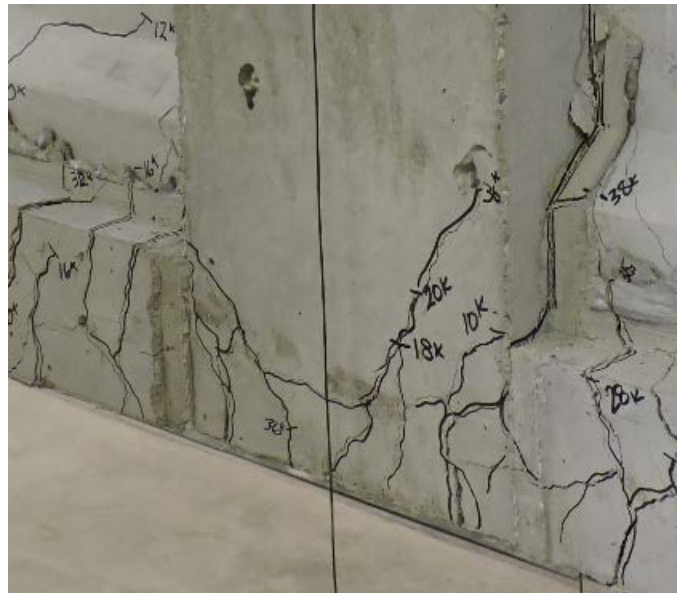
Figure 4-14:C2 Initial Cracking in Continuity Joint

At the same 10-kip loading interval, initial flexural cracking began to form in the continuity joint (Figure 4-14).

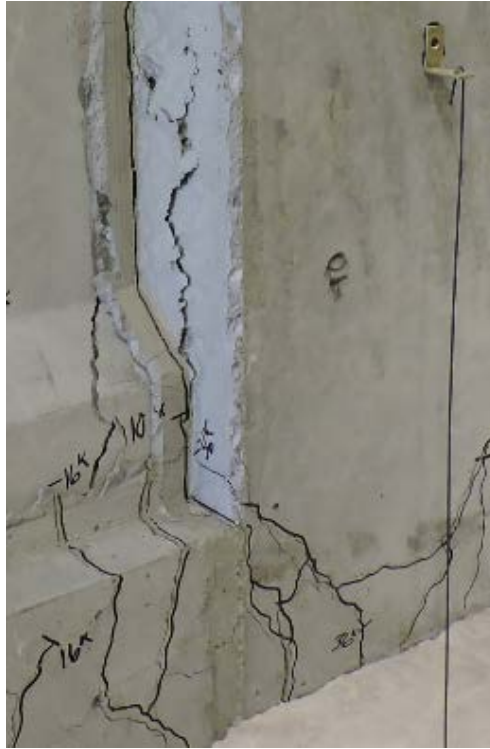
Figure 4-15: C2 Cracking at Girder-Joint Interface (Left Side)

These cracks continued to grow with increased loading. Flexural cracks at the girder-joint interfaced were observed on both sides of the specimen. As loading increased, these

cracks not only continued propagating upward on the interface but also increased in width (Figure 4-15 and Figure 4-16).

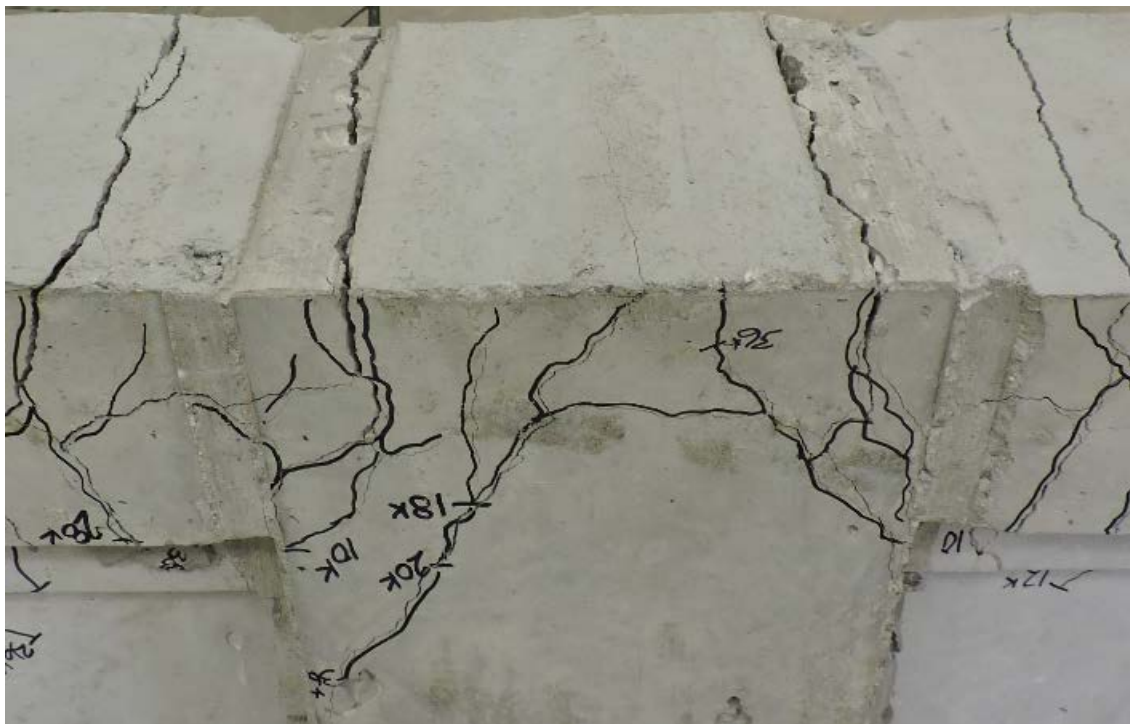
Figure 4-17: C2 Girder-Joint Interface Cracking Across the Deck

Figure 4-17 shows the girder-joint interface flexural cracking across the deck. This photo was taken after the specimen had been unloaded, removed from beneath the loading frame, and flipped right side up. The large cracks across the top of the deck indicate that the continuity joint had begun to detach from the two half-length girders. Figure 4-18 shows the overall girder-joint-girder specimen after testing.

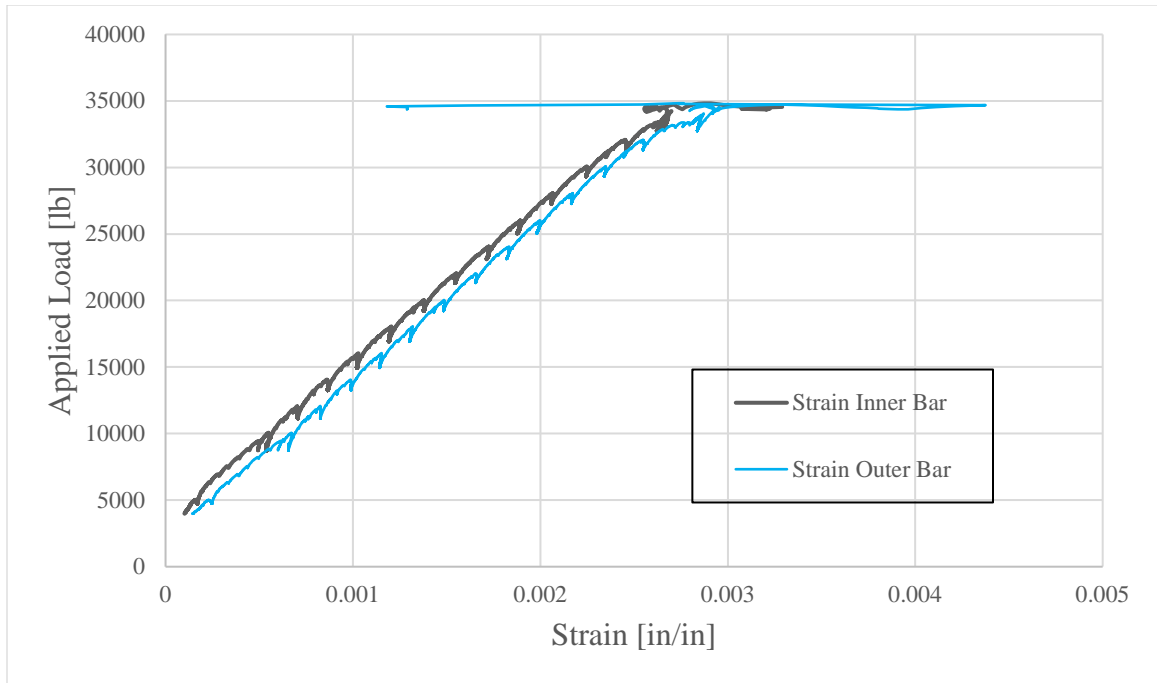
Figure 4-20: C2 Load-Strain Curve

The inner longitudinal reinforcement for negative moment bending began to yield at a loading of 29,232 lb. The outer longitudinal reinforcement began to yield at a loading of 28,042 lb. These were the points at which the strain in the steel reached 0.00218 in/in. Figure 4-20 shows a plot of the load-strain curve of control specimen C1.

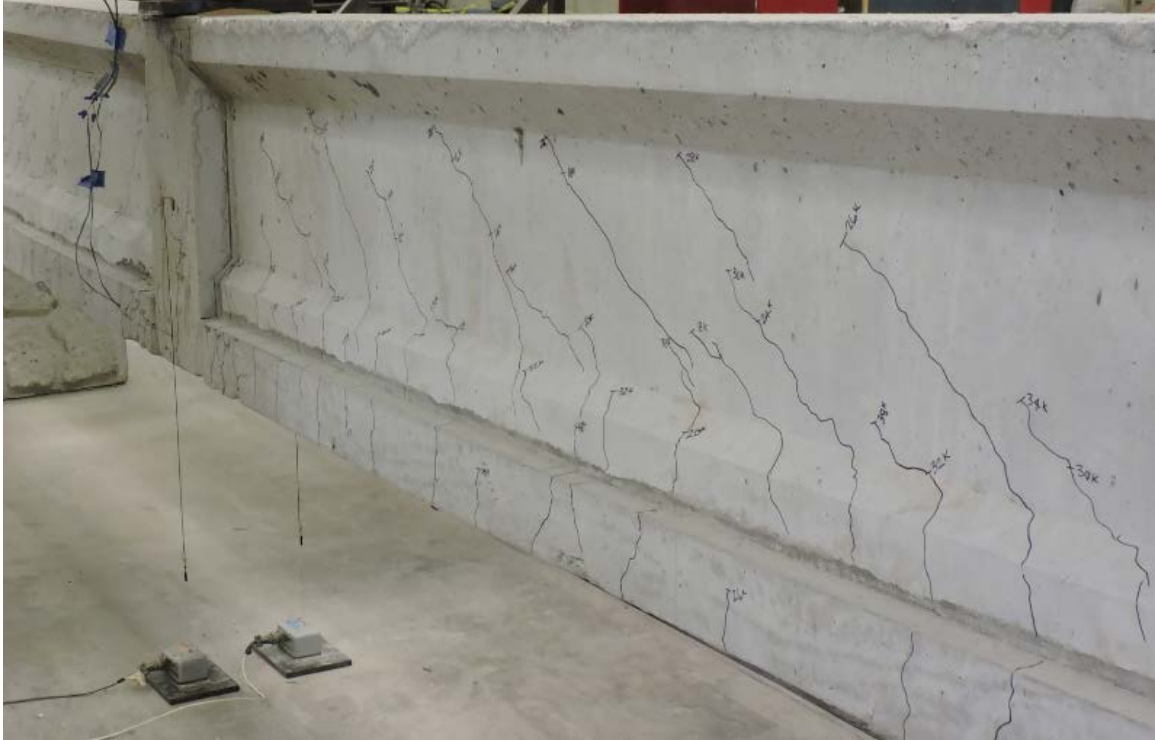
Figure 4-21: C3 Shear Cracking

Initial shear cracking was observed within the web of the specimen at 10-kip loading and continued to propagate diagonally upward as the loading progressed. The vast majority of the shear cracking developed within the web occurred between 12-kip and 36-kip loading. Traced and marked with the corresponding loading increment, the shear cracking is shown in Figure 4-21.

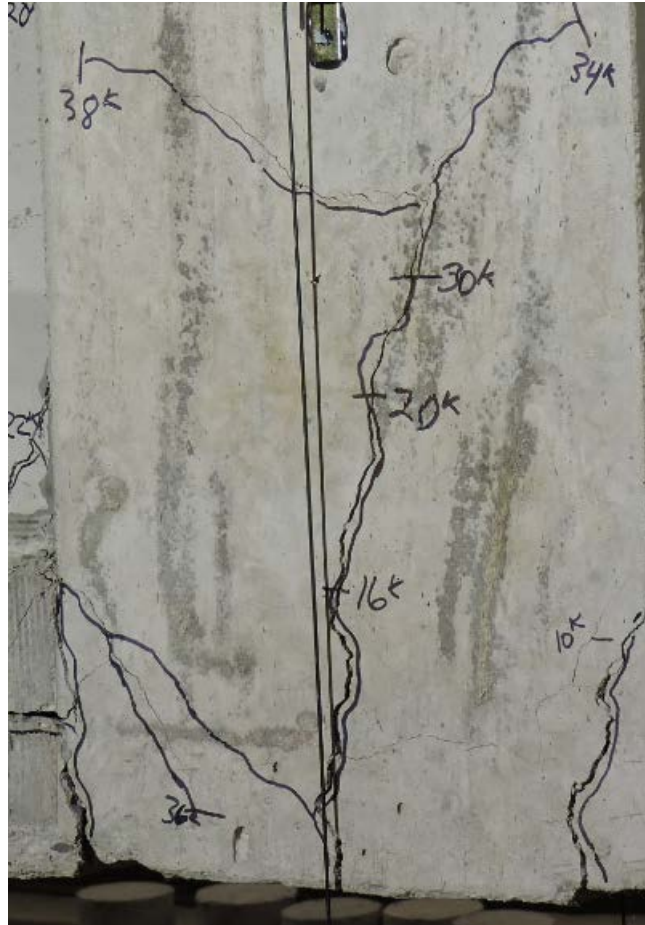
Figure 4-22: C3 Cracking in Continuity Joint

At the same 10-kip loading interval, initial flexural cracking began to form in the continuity joint. At the 16-kip loading increment a flexural crack propagated straight upward from the center of the continuity joint. This significant crack continued until 30-kips of load was applied before branching off into two flexure-shear cracks. These cracks terminated at 38-kip and 34-kip loading (Figure 4-22).

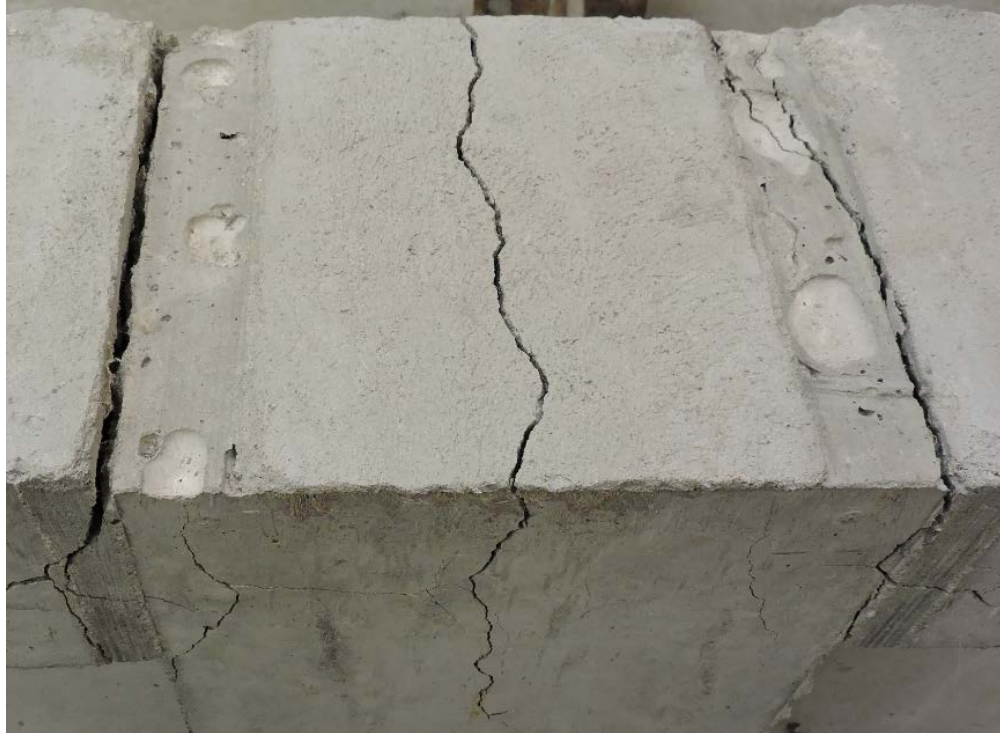
Figure 4-23: C3 Girder-Joint Interface and Centerline Cracking Across the Deck

Flexural cracks at the girder-joint interface were observed on both sides of the specimen. As loading increased, these cracks not only continued propagating upward on the interface but also increased in width, showing visible joint separation. Figure 4-23 shows the girder-joint interface flexural cracking across the deck. The centerline flexural crack can also be seen. This photo was taken after the specimen had been unloaded, removed from beneath the loading frame, and flipped right side up. The large cracks across the top of the deck indicate that the continuity joint had begun to detach from the two half-length girders. Figure 4-24 shows the overall girder-joint-girder specimen after testing.

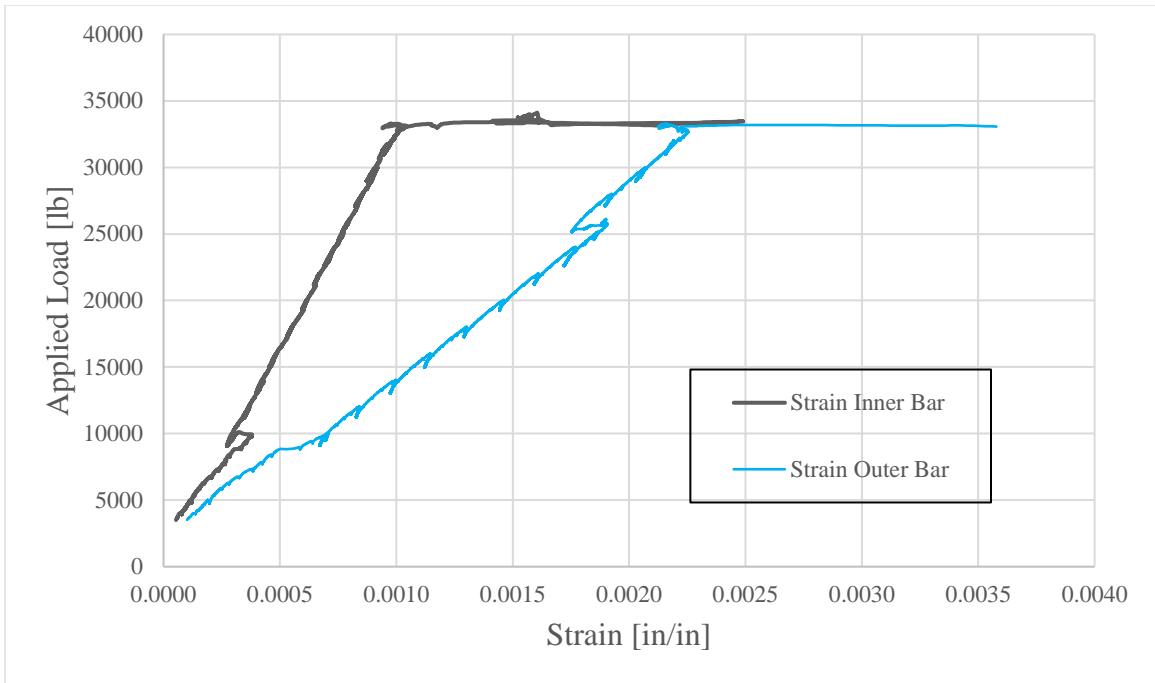
Figure 4-26: C3 Load-Strain Curve

The inner longitudinal reinforcement for negative moment bending began to yield at a loading of 29,418 lb, which is inconsistent with the other strain gauge and all strain gauges from the other two control specimens. This may indicate a faulty reading. The outer longitudinal reinforcement began to yield at a loading of 31,322 lb. These were the points of which the strain in the steel reached 0.00218 in/in. Figure 4-26 shows a plot of the load-strain curve of control specimen C1.

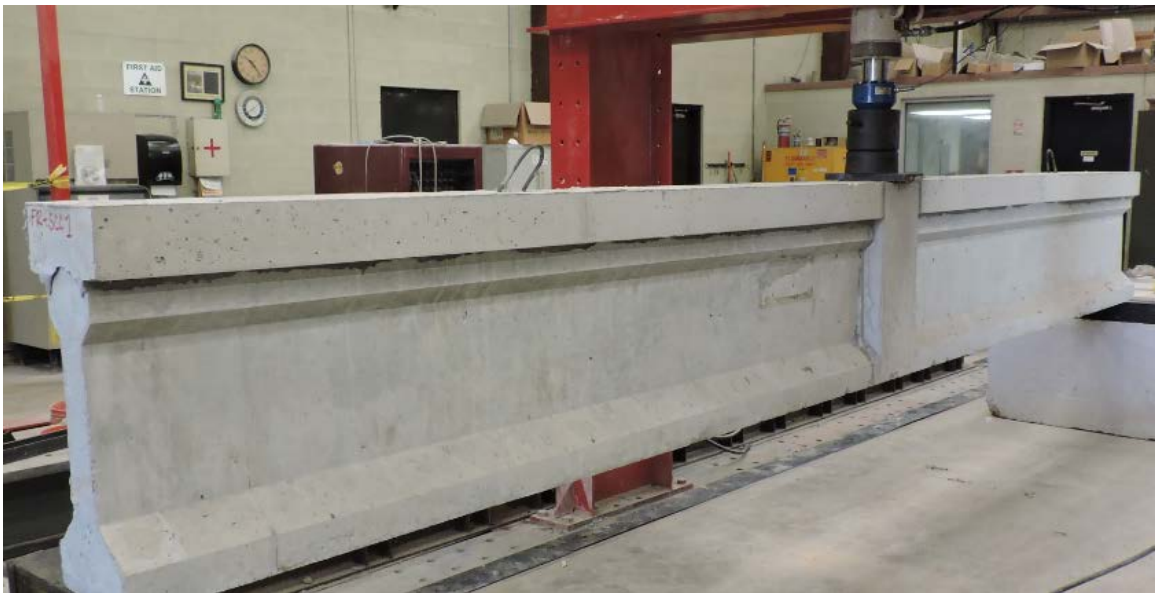
Figure 4-28: Initial Setup Before Testing for Girders to Be Repaired

The remaining nine girder-joint-girder specimens were loaded to induce cracking within their continuity joints. This process simulated the time-dependent effects out in the field which cause the bottom of the continuity joint to crack due to induced positive moment. Unlike the control group, the remaining nine specimens were loaded in positive moment bending. The data acquisition system was used in conjunction with the load cell only for these tests, outputting the load at which a sufficient amount cracking within the continuity joint replicated in-situ damage.

Besides loading in positive moment bending, the testing arrangement and procedure for the initial cracking of the repair girders was identical to that of the control specimens. Figure 4-28 shows this setup, which was used for all nine girder-joint-girder specimens.

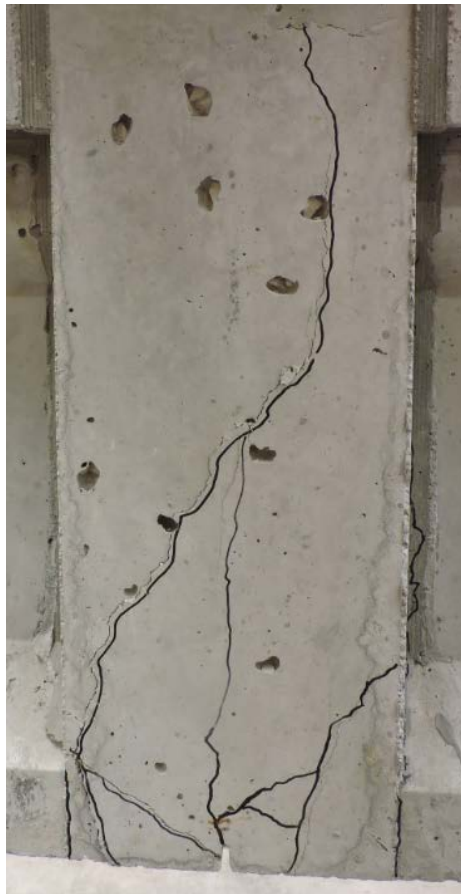
Figure 4-29:R1-J3 Rear Joint Face Initial Cracking

The first set of three specimens cracked were to be repaired with ultra-high-performance concrete (J3). At an applied load of 22,987 lb, sufficient cracking within the continuity joint of specimen R1-J3 had been achieved. Figure 4-29 through Figure 4-31 show joint cracking for R1-J3.

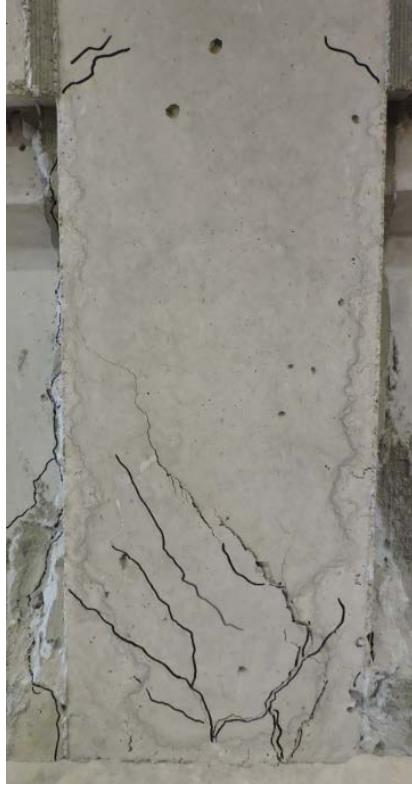
Figure 4-32:R2-J3 Front Joint Face Initial Cracking

At an applied load of 23,020 lb, sufficient cracking within the continuity joint of specimen R2-J3 had been achieved. Figure 4-32 through Figure 4-34 show joint cracking for R2-J3.

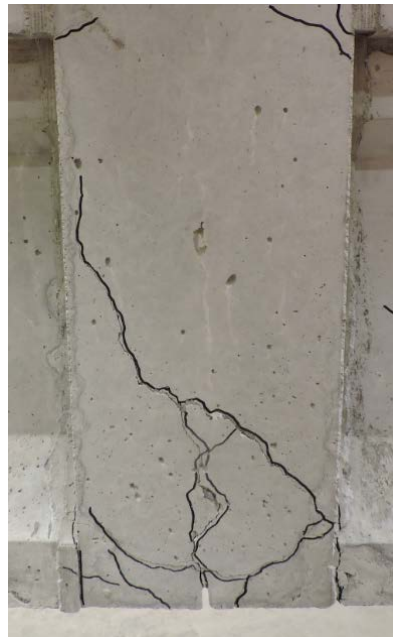
Figure 4-35:R3-J3 Front Joint Face Initial Cracking

At an applied load of 20,060 lb, sufficient cracking within the continuity joint of specimen R3-J3 had been achieved. Figure 4-35 through Figure 4-37 show joint cracking for R3-J3.

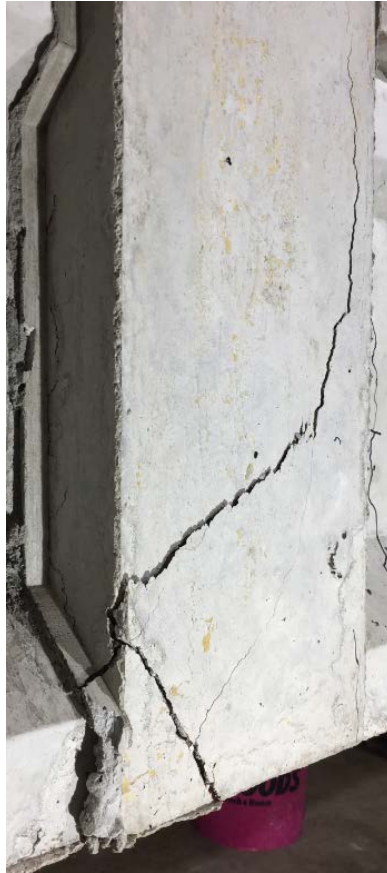
Figure 4-38:R1-FRSCC Front Joint Face Initial Cracking

The second set of three specimens cracked were to be repaired with fiber-reinforced self-consolidating concrete (FRSCC). At an applied load of 27,520 lb, sufficient cracking

within the continuity joint of specimen R1-FRSCC had been achieved. Figure 4-38 through Figure 4-40 show joint cracking for R1-FRSCC.

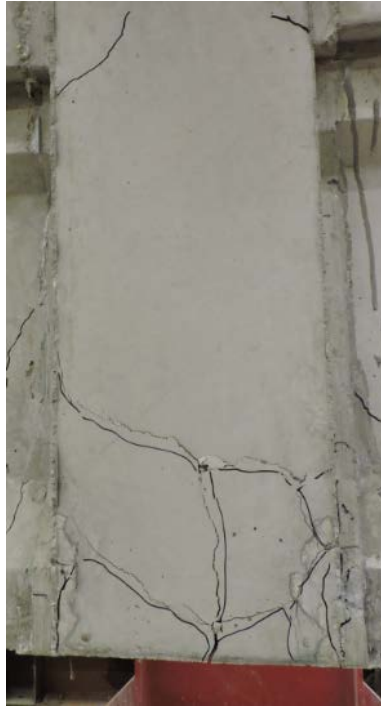
Figure 4-41:R2-FRSCC Front Joint Face Initial Cracking

At an applied load of 21,430 lb, sufficient cracking within the continuity joint of specimen R2-FRSCC had been achieved. Figure 4-41 through Figure 4-43 show joint cracking for R2-FRSCC.

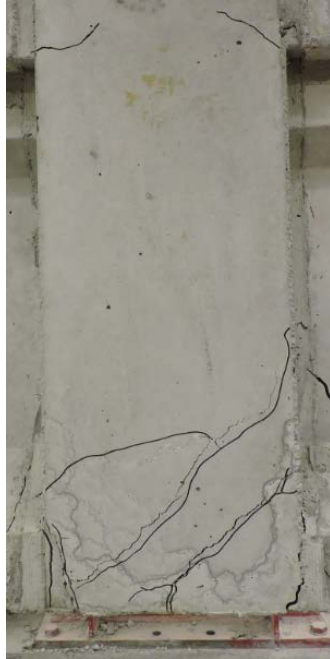
Figure 4-44:R3-FRSCC Front Joint Face Initial Cracking

At an applied load of 21,415 lb, sufficient cracking within the continuity joint of specimen R3-FRSCC had been achieved. Figure 4-44 through Figure 4-46 show joint cracking for R3-FRSCC.

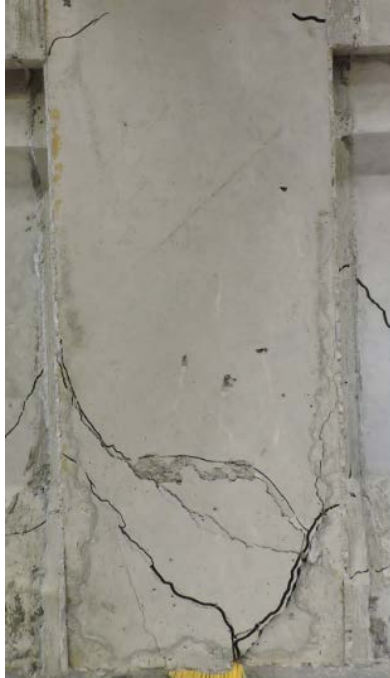
Figure 4-47:R1-PHOS Front Joint Face Initial Cracking

The third set of three specimens cracked were to be repaired with magnesium-alumino-liquid phosphate concrete (Phoscrete). At an applied load of 25,200 lb, sufficient amount of cracking within the continuity joint of specimen R1-PHOS had been achieved. Figure 4-47 through Figure 4-49 shows joint cracking for R1-PHOS.

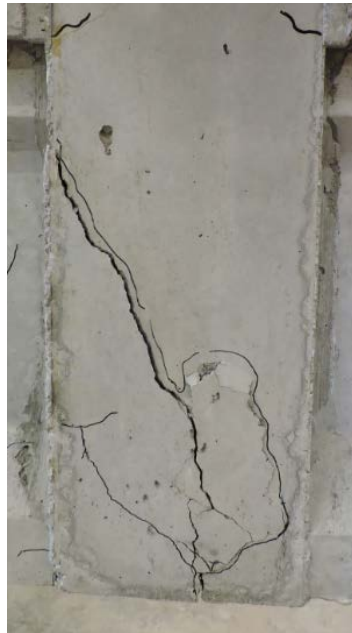
Figure 4-50:R2-PHOS Front Joint Face Initial Cracking

At an applied load of 24,720 lb, sufficient cracking within the continuity joint of specimen R2-PHOS had been achieved. Figure 4-50 through Figure 4-52 show joint cracking for R2-PHOS.
