EVALUATION OF SPECIALIZED CONCRETES FOR THE REPAIR OF DAMAGED
CONTINUITY JOINTS IN PRESTRESSED GIRDER BRIDGES

A THESIS

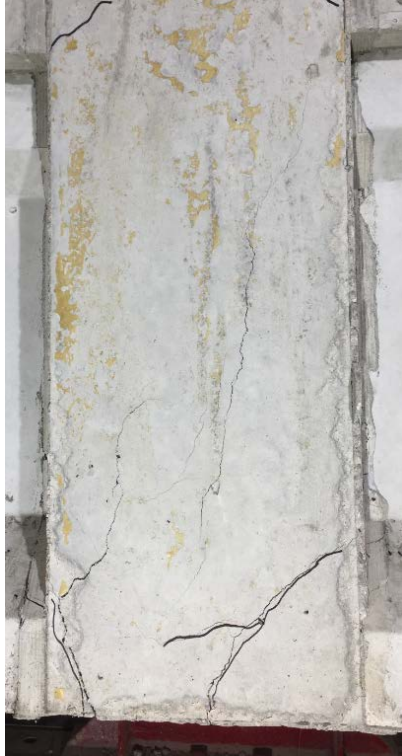
Figure 4-53:R3-PHOS Front Joint Face Initial Cracking

At an applied load of 25,180 lb, sufficient cracking within the continuity joint of specimen R3-PHOS had been achieved. Figure 4-53 through Figure 4-55 show joint cracking for R3-PHOS.

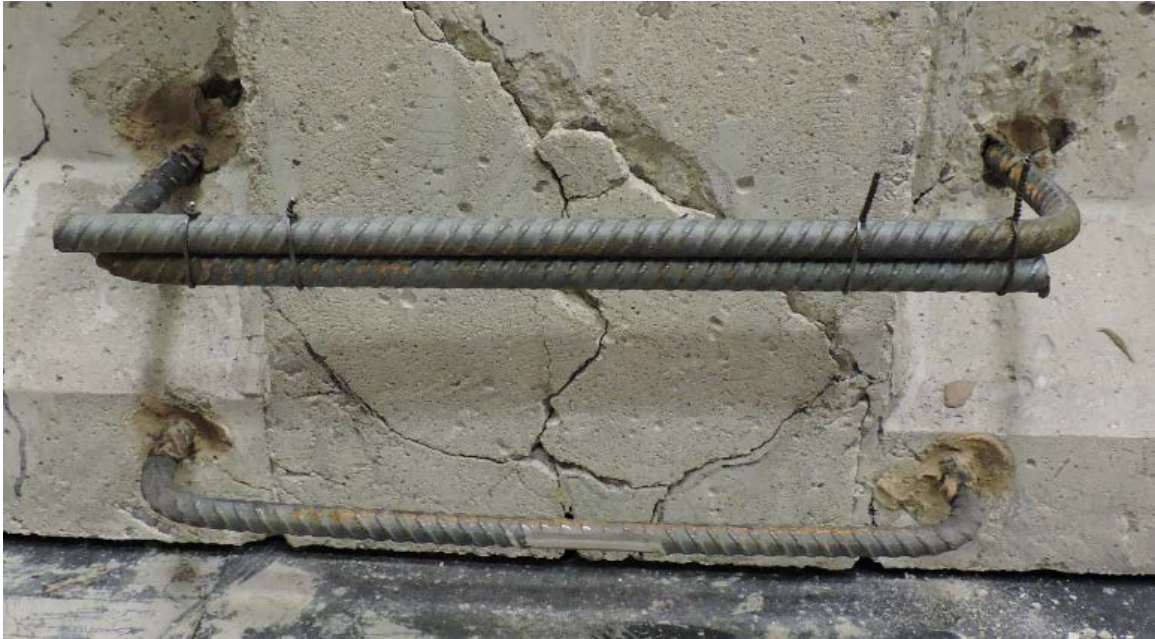
Figure 5-8: Installation of Repair Reinforcement

No. 4 bars were installed as designed. Approximately 1 oz. of adhesive was used in each hole to anchor the reinforcement. The top reinforcing bars were tied together and

orientated as horizontally as possible. Each reinforcing bar was left overnight to cure before any additional work on the specimens continued. Figure 5-8 shows the installation of the repair reinforcement.

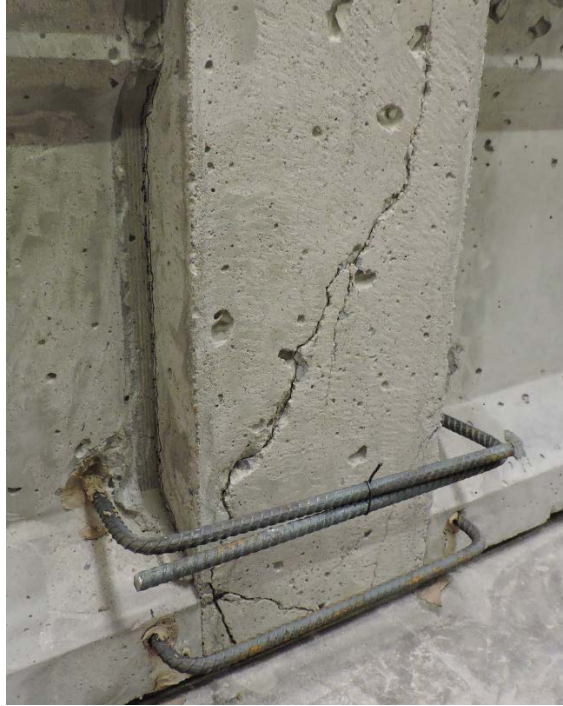
Figure 5-9: Roughened Surface of Areas to Be Repaired

A diamond grinding wheel was used with an angle grinder to roughen the repair surface. This process was done to increase the interface bond between the repair concretes and the cracked specimens, allowing for shorter lap length the design calculation. After roughening each surface, a water only pressure washer was used to eliminate concrete dust trapped within the concrete pores left by the grinding wheel. Figure 5-9 shows the roughened surface of a girder-joint-girder specimen.

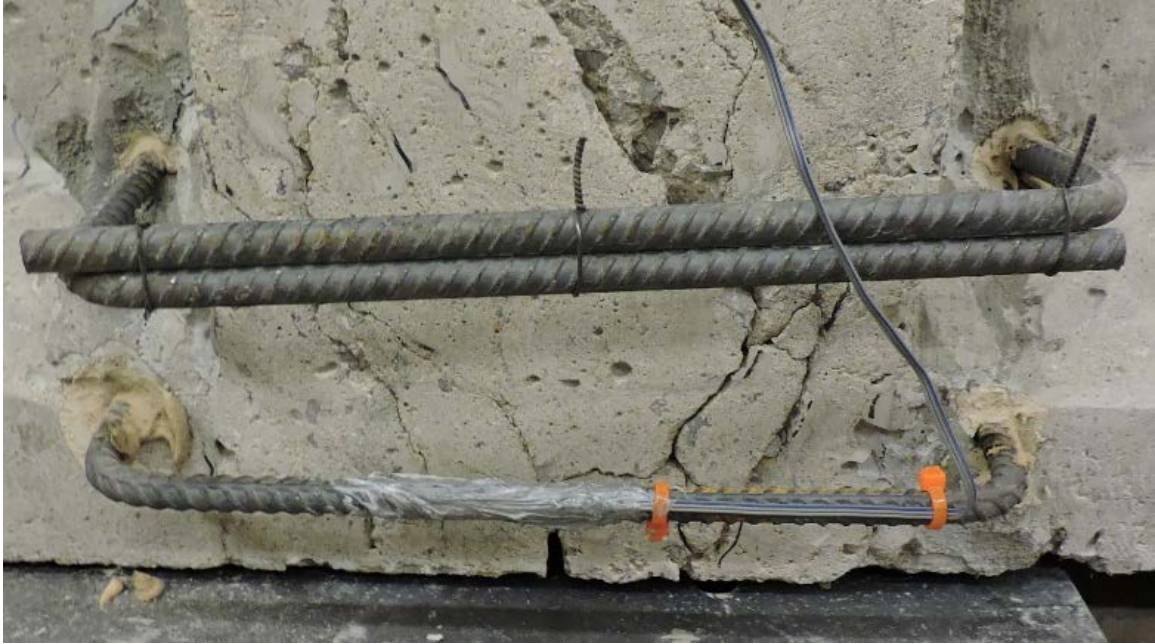
Figure 5-10: Strain Gauge Installed on Repair Reinforcement

One strain gauge was installed on one bottom repair bar of each specimen using the same procedure as previously stated. To ensure a smooth surface to adhere to, sanding the location of the strain gauge was done after installation. This order of operations allowed any scratches or markings created while installing, tying, grinding, or pressure washing to be removed prior to placing the strain gauges. Figure 5-10 shows the final set up of the repair reinforcement strain gauges.

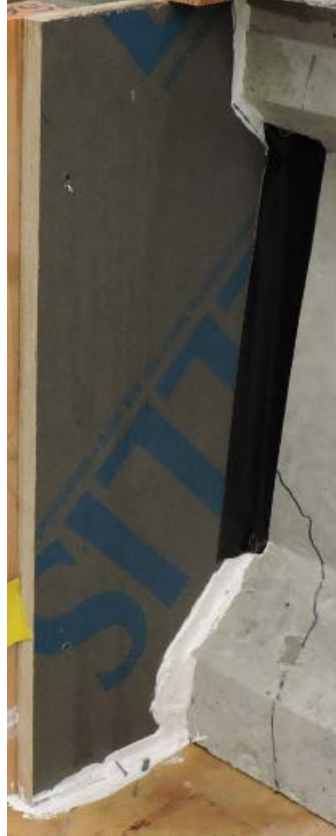
Figure 5-11: Repair Formwork for Side Face

Plywood and construction grade lumber was again used to create the formwork for the continuity joint repair. Much like the formwork to create the initial continuity joint, sheets of plywood were cut in the shape of the outer girder profile. The only difference in these shapes were that they extended farther away from the girder and did not include the profile of the deck above. Because these pieces were for reuse and that each girder profile was not exactly the same, silicone was used to fill any gaps between the side formwork and the girder specimens. In addition to the silicone, high-strength adhesive tape was used to hold the side formwork to the web of the specimens. Figure 5-11 shows how the repair formwork mates with the girder profile.

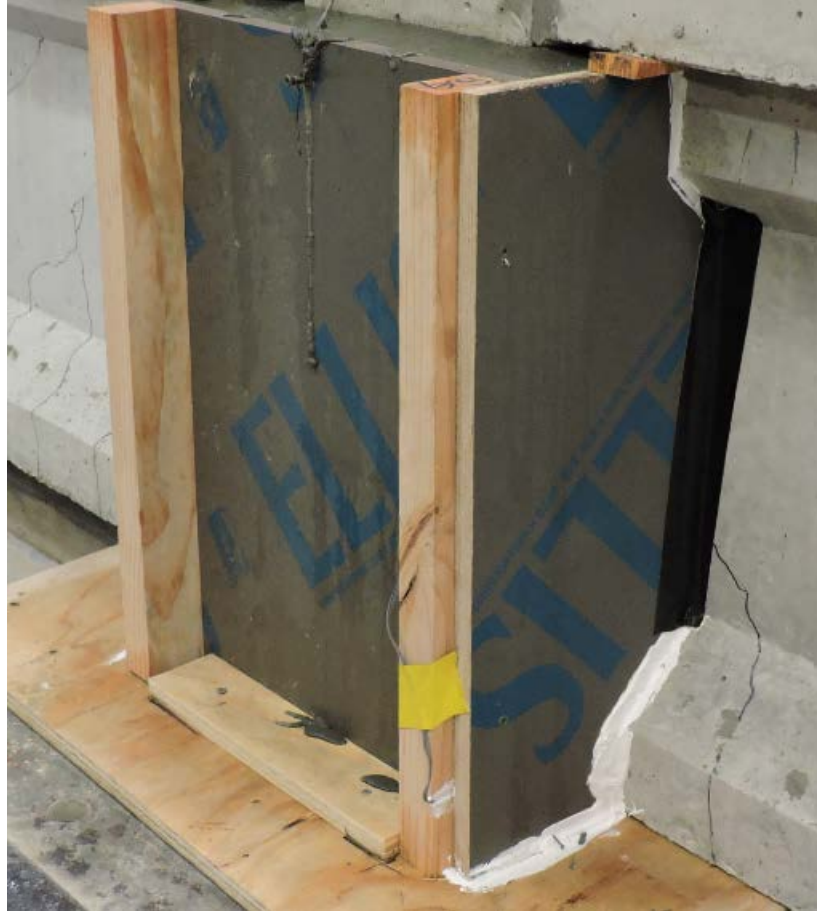
Figure 5-12: Repair Joint Formwork Final Setup

The front face formwork of the repair was built much like the initial continuity joint's formwork. The outer dimensions of this formwork were 18" wide by 22.5" tall. A small cut was made 3" above the bottom of the 2x4 formwork to allow the strain gauge wires to pass through. This passage was also filled with silicone to mitigate any leak of repair concrete.

A sheet of plywood on the floor was once again used for the repair pours. The stop block would not allow movement of the formwork due to head pressure during the pour, and silicone was used between the base and the side pieces. Small wooden wedges were used between the top of the formwork and the bottom of the deck. These helped keep pressure between the formwork and the floor plywood. Figure 5-12 shows the final setup of the joint repair formwork.

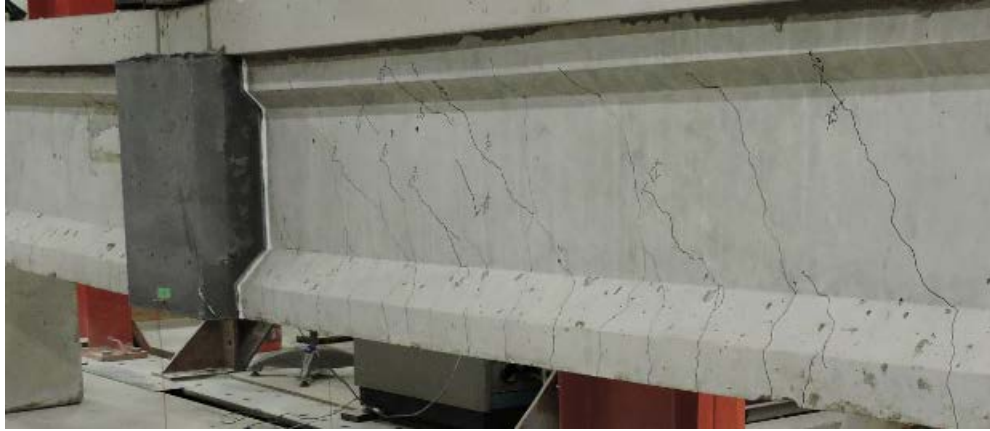
Figure 6-1:R1-J3 Shear & Flexural Cracking

R1-J3 was tested to failure in positive moment bending. Shear cracking and flexural cracking were observed during testing on the girder webs and either sides of the of the repaired continuity joint, respectively, and are shown in Figure 6-1.

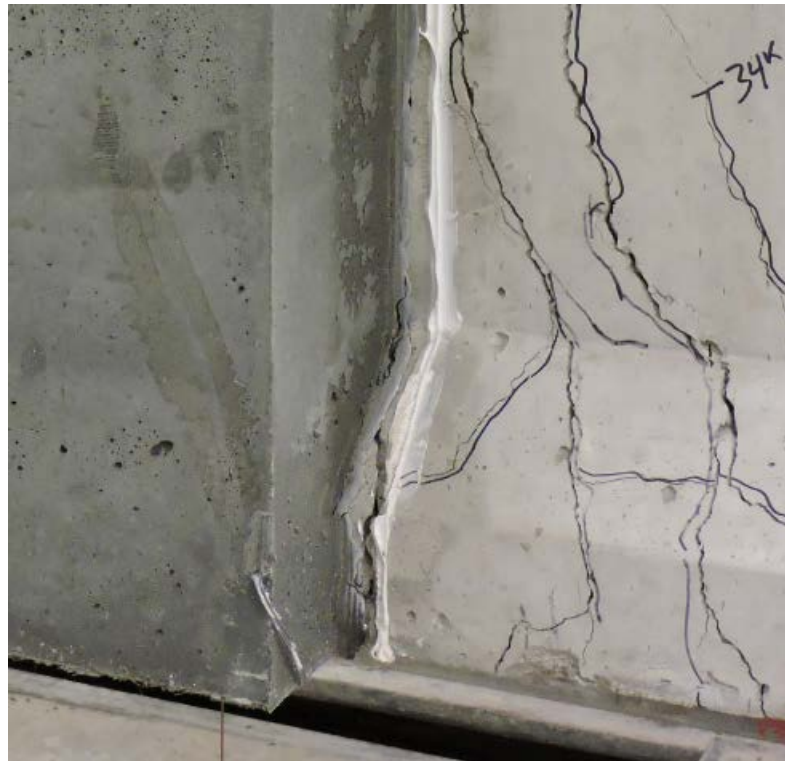
Figure 6-2:R1-J3 Girder-Joint Interface Crack (Right)

There were no noticeable cracks on the longitudinal face of either side of the repair joint. Small surface cracks were observed on the transverse faces of the joint. Large cracks at the girder-joint interfaces continued to widen for the duration of the testing process. These cracks are shown in Figure 6-2 and Figure 6-3.

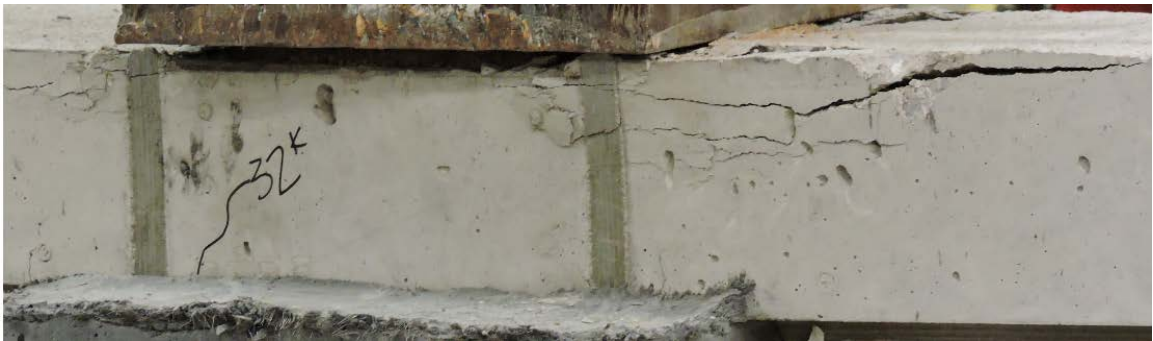
Crushing of the deck was observed in the compression zone on either side of the steel loading plate and is shown in Figure 6-4. This is common for a flexural failure after significant yielding of the flexural reinforcement and resulting strains. Figure 6-5 shows the overall girder-joint-girder repair specimen after testing. Note the failed specimen appears to consist of three separate members – each half girder and the continuity joint.

Figure 6-4:R1-J3 Deck Crushing

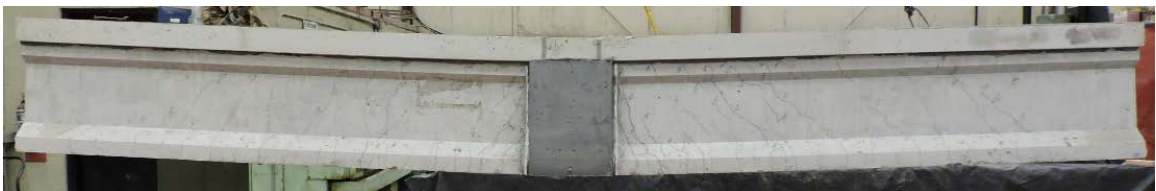
Figure 6-5:Deflected Shape of R1-J3

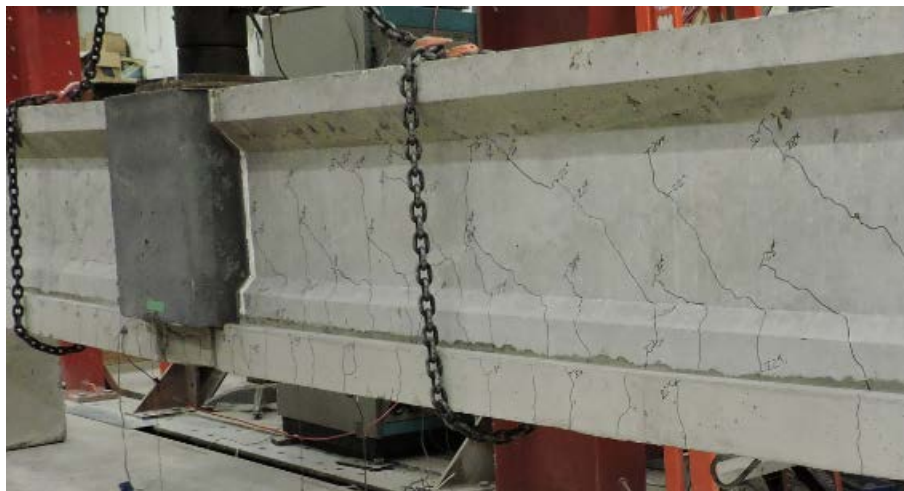
R2-J3 was tested to failure in negative moment bending. Shear cracking and flexural cracking were observed during testing on the girder webs and either sides of the of the repaired continuity joint, respectively, and are shown in Figure 6-8.

Figure 6-8: R2-J3 Shear & Flexural Cracking

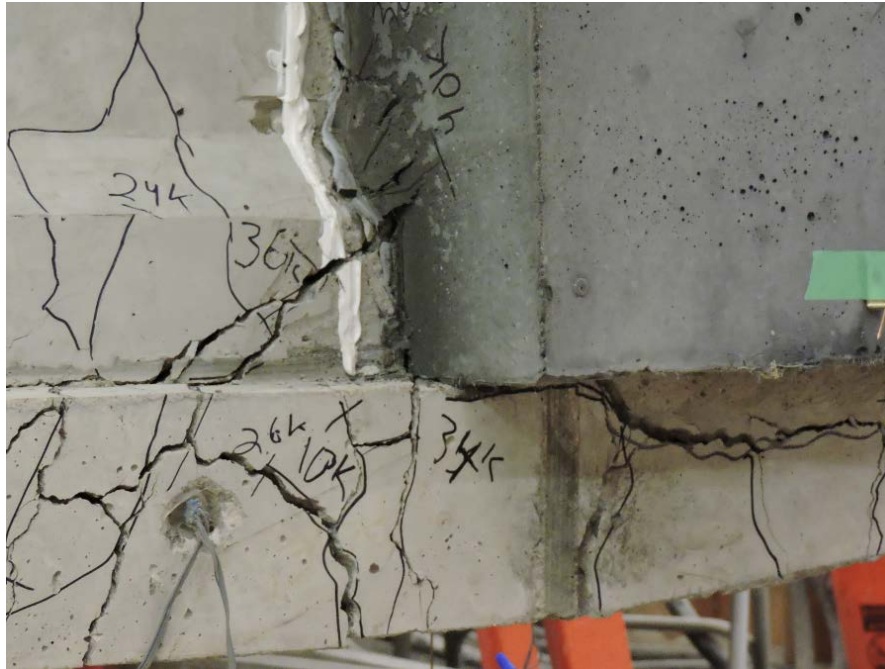
Figure 6-9:R2-J3 Girder-Joint Interface Cracking (Front Left)

Small surface cracks were observed on the transverse faces of the joint. Large cracks at the girder-joint interfaces continued to widen for the duration of the testing process. These cracks are shown in Figure 6-9, Figure 6-10, and Figure 6-11. Significant flexural cracks within the deck are shown in Figure 6-9 and Figure 6-11.

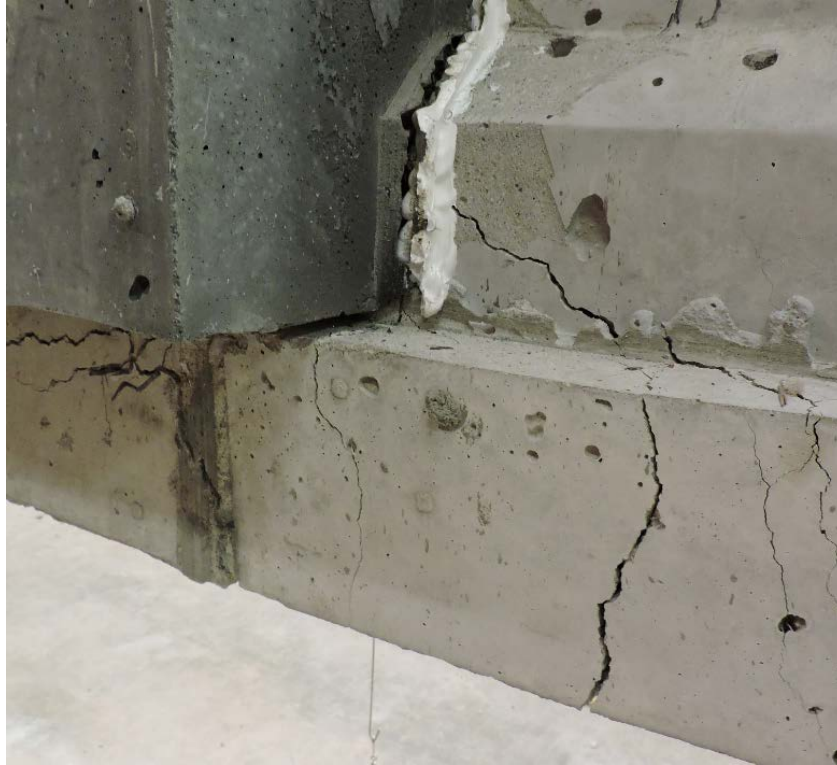
Figure 6-10:R2-J3 Girder-Joint Interface Cracking (Front Right)

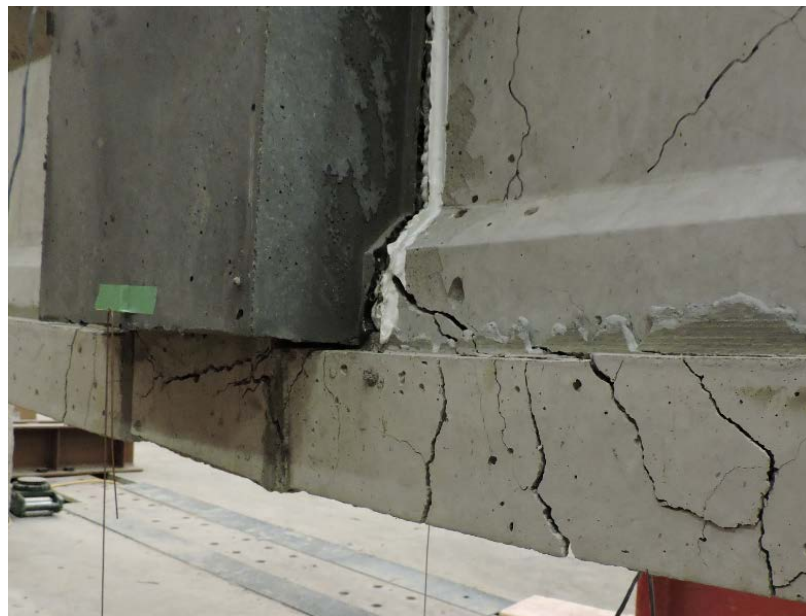
Figure 6-11:R2-J3 Girder-Joint Interface Cracking (Back Right)

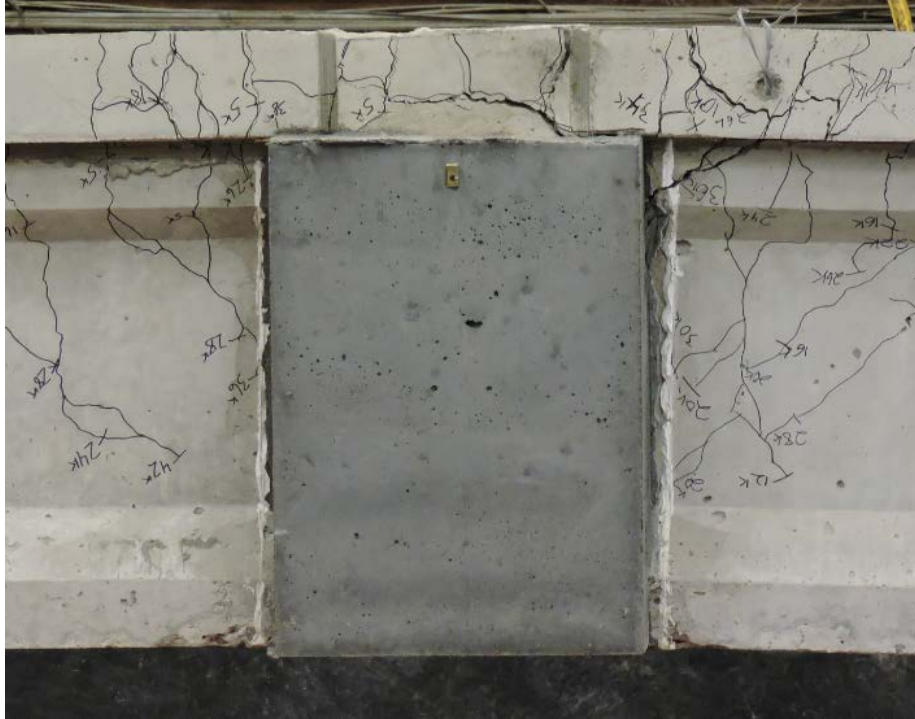
Shown in Figure 6-12, no noticeable cracks on the longitudinal face of either side of the repair joint were found.

Figure 6-12:R2-J3 Continuity Joint Repair After Testing

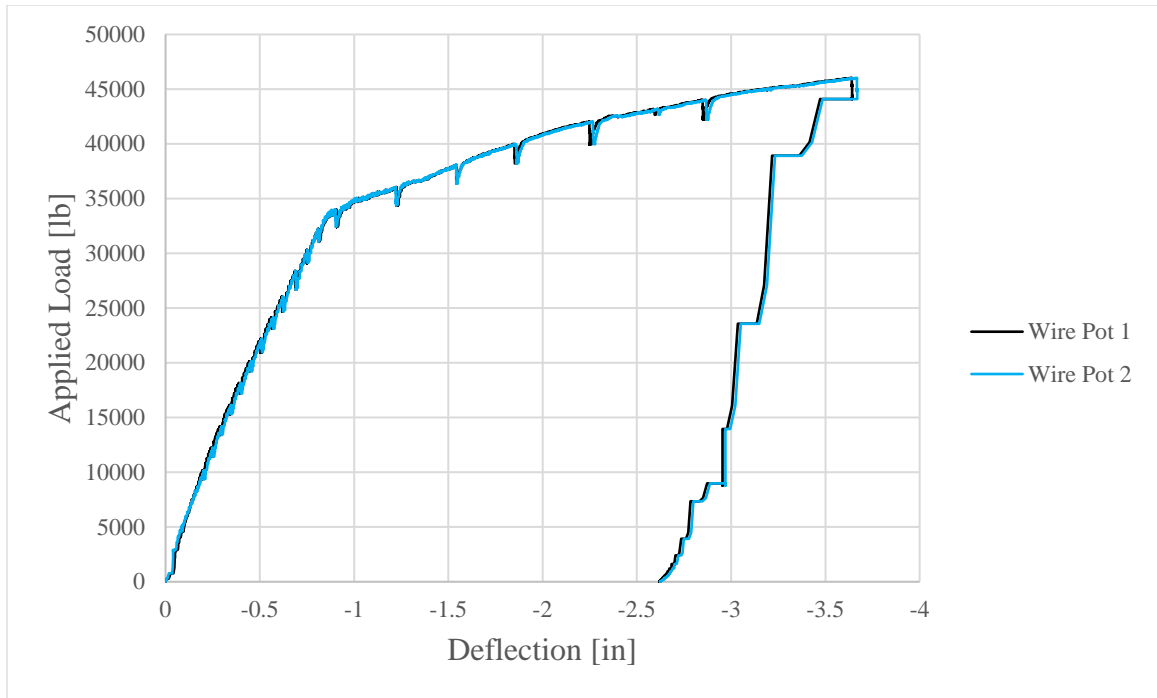
Specimen R2-J3 showed a ductile behavior after 33,426 lb were applied, and had an ultimate load capacity of 46,024 lb. At the ultimate load, R2-J3 deflected an average of 3.65". Figure 6-14 shows the load-deflection curve of R2-J3, which is very typical of a beam flexural failure.

Figure 6-14: R2-J3 Load-Deflection Curve

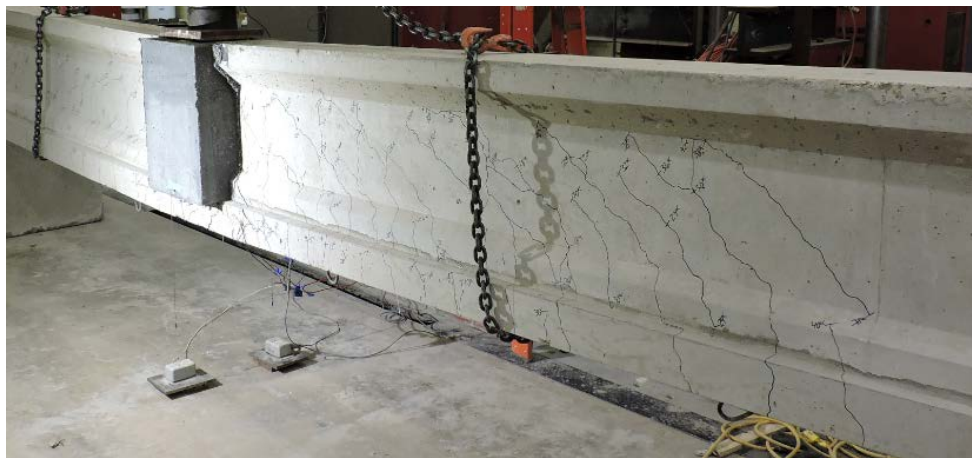
R3-J3 was tested to failure in negative moment bending. Shear cracking and flexural cracking were observed during testing on the girder webs and either sides of the of the repaired continuity joint, respectively, and are shown in Figure 6-16

Figure 6-16:R3-J3 Shear & Flexural Cracking

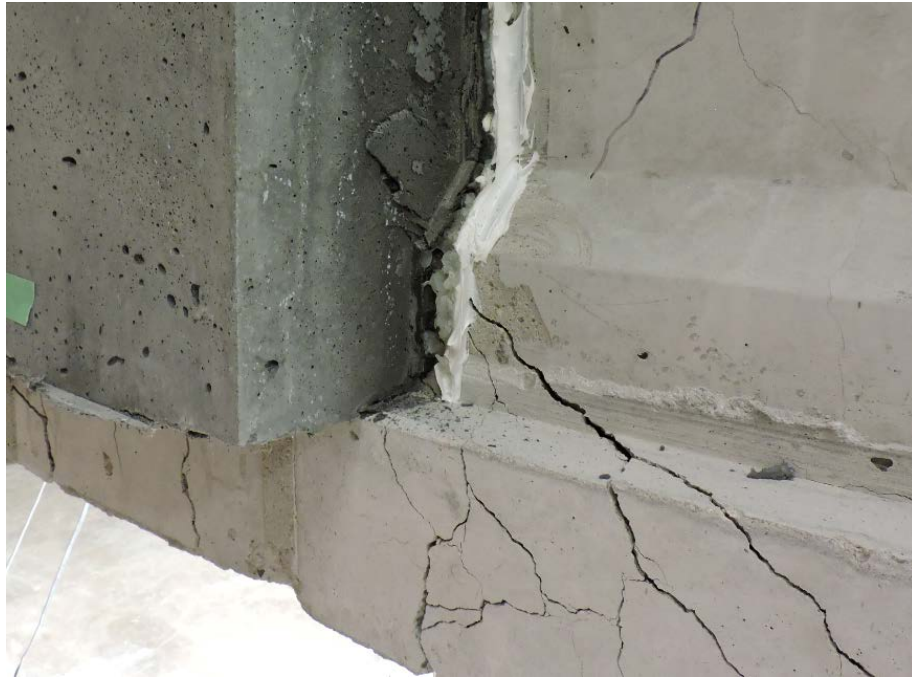
Figure 6-17:R3-J3 Girder-Joint Interface Cracking (Right)

Small surface cracks were observed on the transverse faces of the joint. Large cracks at the girder-joint interfaces continued to widen for the duration of the testing process.

These cracks are shown in Figure 6-17 and Figure 6-18. Additionally, significant flexural cracks within the deck are shown in Figure 6-19

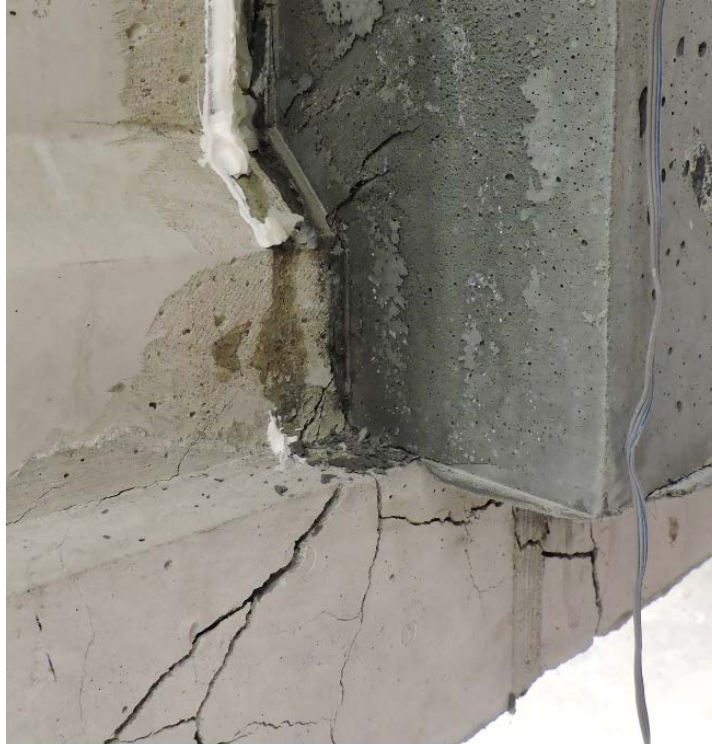
Figure 6-18:R3-J3 Girder-Joint Interface Cracking

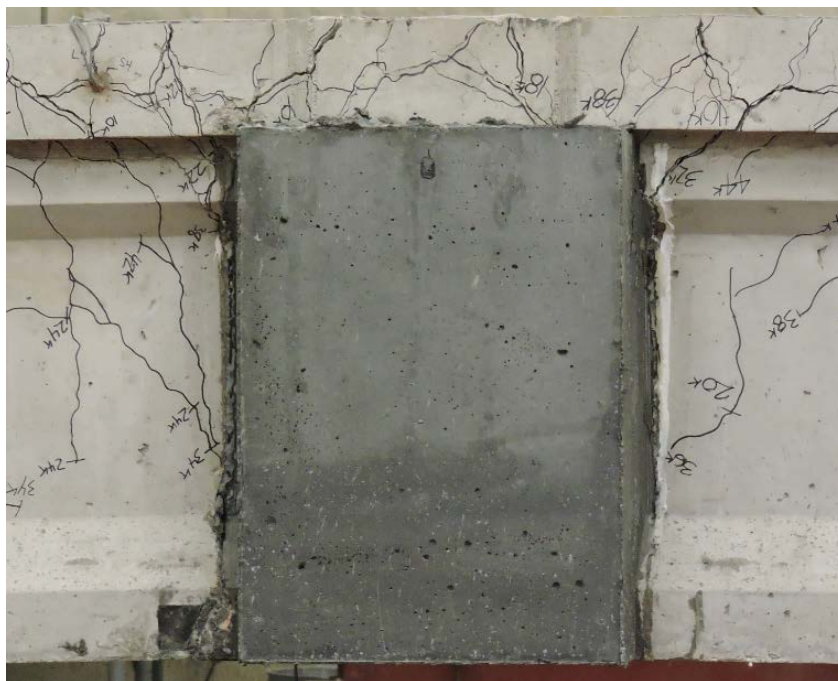
Figure 6-19:R3-J3 Continuity Joint Repair After Testing

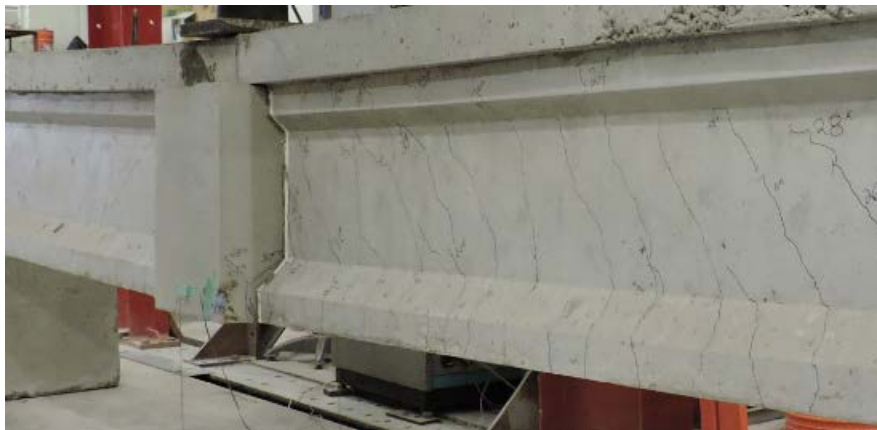
R1-FRSCC was tested to failure in positive moment bending. Shear cracking and flexural cracking were observed during testing on the girder webs and either sides of the of the repaired continuity joint, respectively, and are shown in Figure 6-23.

Figure 6-23:R1-FRSCC Shear & Flexural Cracking

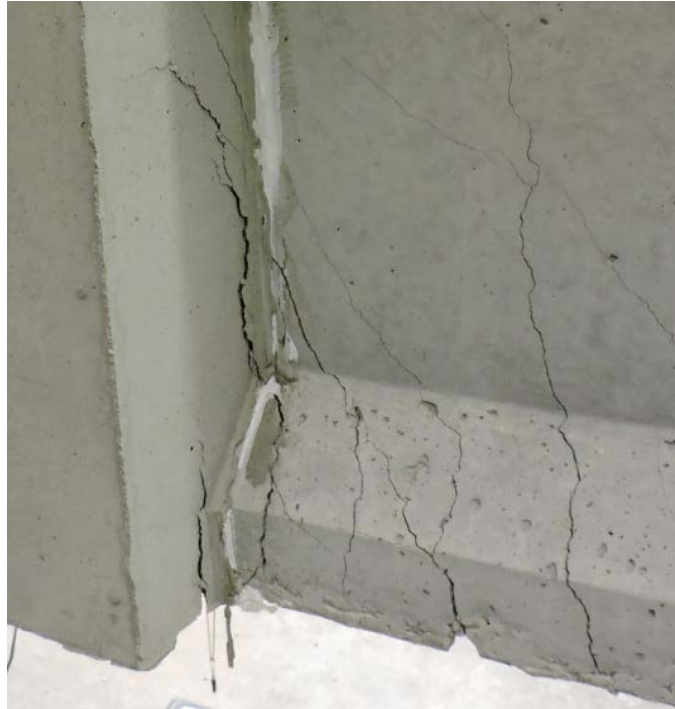
Figure 6-24:R1-FRSCC Joint Transverse Face Cracking (Back Right)

There were no noticeable cracks on the longitudinal face of either side of the repair joint. Flexural cracks were observed on the transverse faces of the joint and at the girder-joint interface. These cracks are shown in Figure 6-24, Figure 6-25, and Figure 6-26

Flexural cracks from Figure 6-24 extended through the entire girder-joint-girder specimen and is explicitly shown in Figure 6-27.

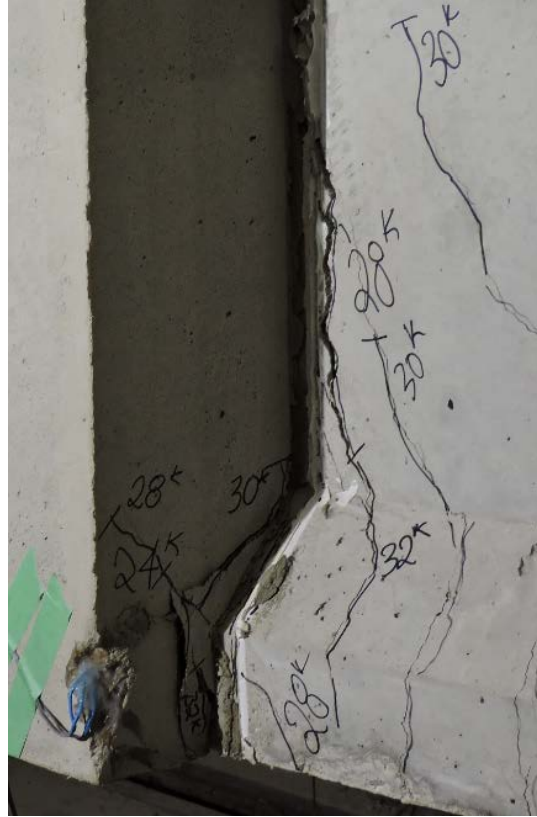
Figure 6-25: R1-FRSCC Girder-Joint Interface Cracking (Front Right)

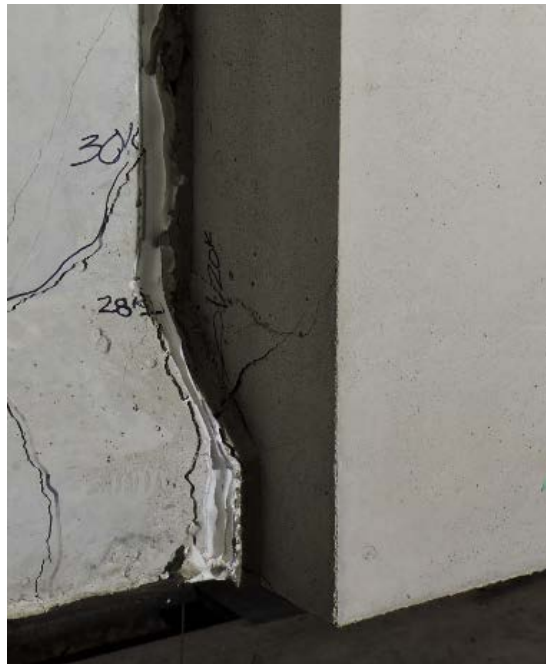
Figure 6-26: R1-FRSCC Girder-Joint Interface Cracking (Front Left)

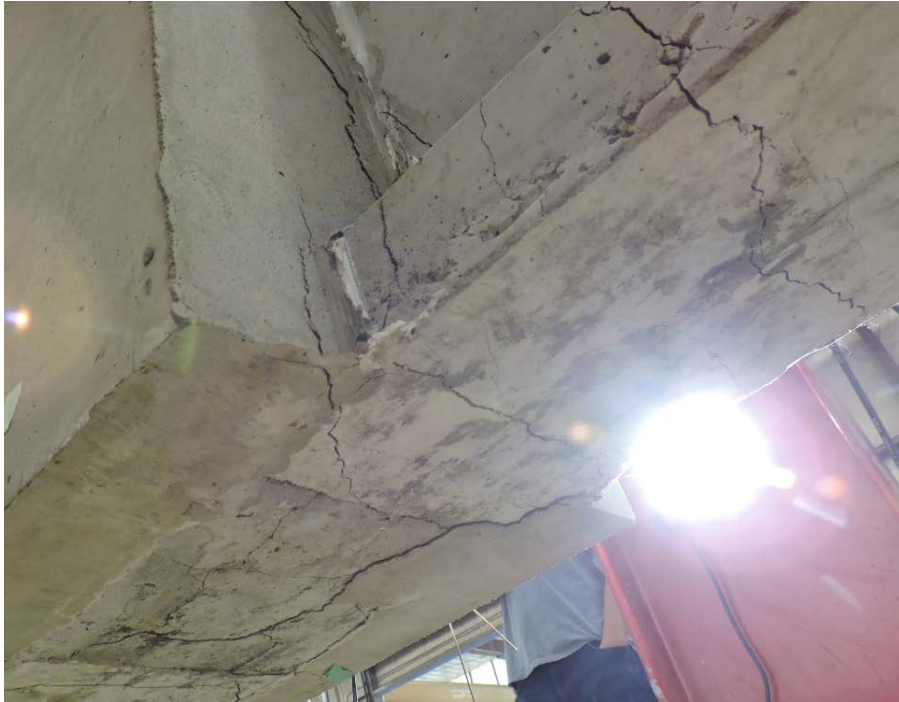
Figure 6-27:R1-FRSCC Flexural Cracking Through Entire Specimen

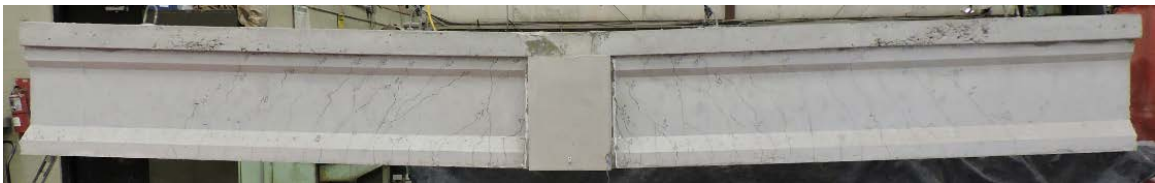
Figure 6-28 shows the overall girder-joint-girder repair specimen after testing. Note the failed specimen appears to consist of three separate members – each half girder and the continuity joint.

Figure 6-28:Deflected Shape of R1-FRSCC

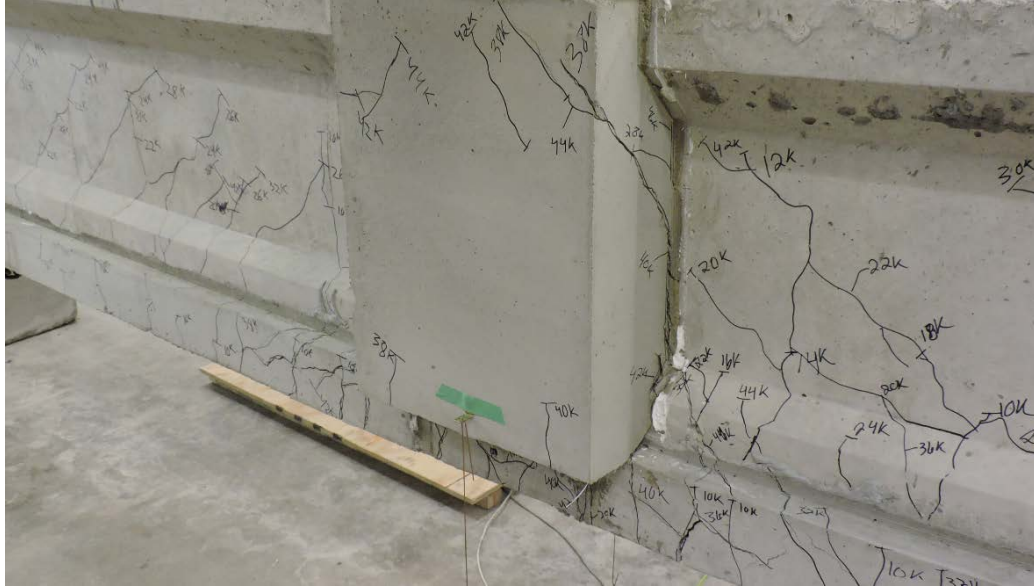
R2-FRSCC was tested to failure in negative moment bending. Shear cracking and flexural cracking were observed during testing on the girder webs and either sides of the of the repaired continuity joint, respectively, and are shown in Figure 6-31.

Figure 6-31: R2-FRSCC Shear & Flexural Cracking

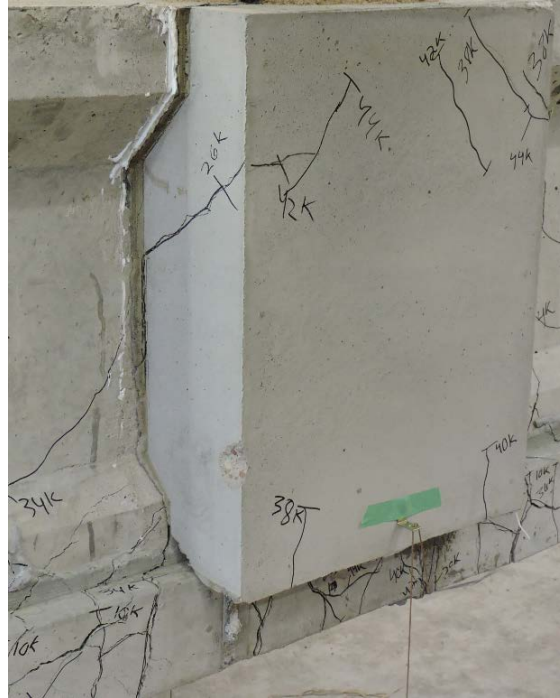
Figure 6-32: R2-FRSCC Joint Cracking, Longitudinal & Transverse Faces (Front Left)

Significant flexural cracking was observed on all four transverse faces of the continuity joint. These cracks also extended onto the longitudinal faces of the continuity joint and can be seen in Figure 6-32, Figure 6-33, Figure 6-34, and Figure 6-35. Note that additional longitudinal face cracks and a substantial amount of flexural cracking within the deck can also be seen.

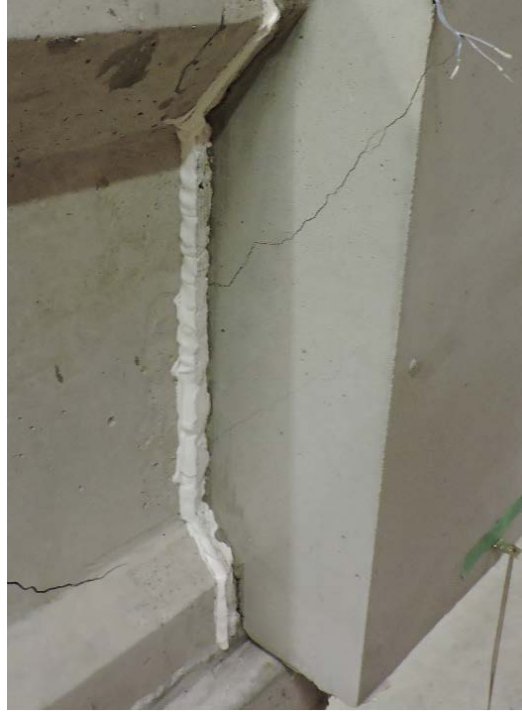
Figure 6-34:R2-FRSCC Joint Cracking, Longitudinal & Transverse Faces (Back Left)

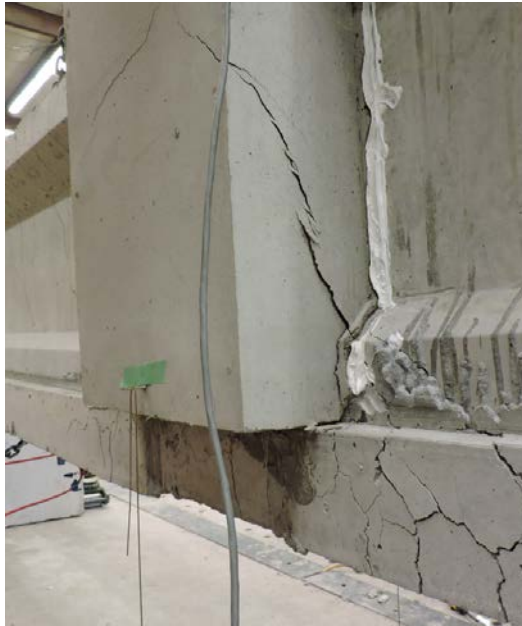
Figure 6-35:R2-FRSCC Joint Cracking, Longitudinal & Transverse Faces (Back Right)

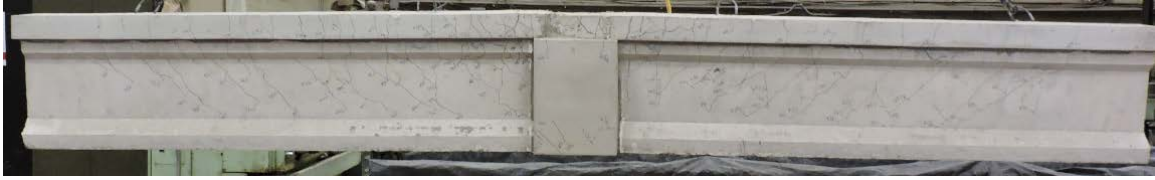
Figure 6-36 shows the overall girder-joint-girder repair specimen after testing.

Figure 6-36: Deflected Shape of R2-FRSCC

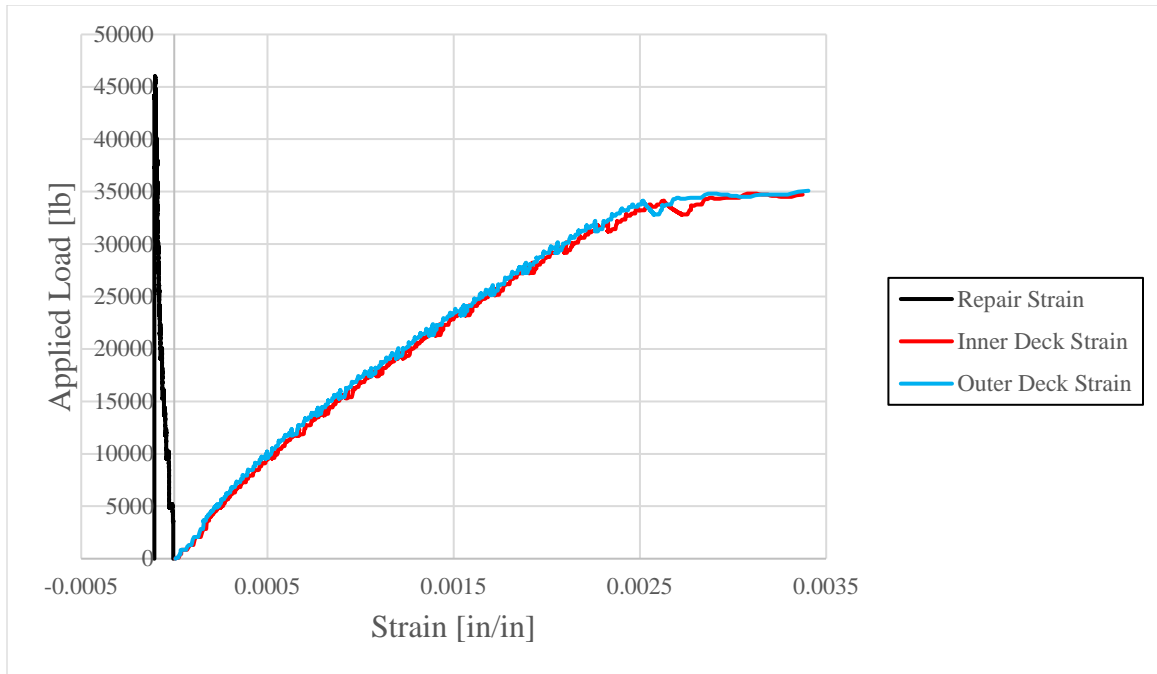
The repair reinforcement underwent compression strain and had a maximum strain of -0.000107 in/in. The outer longitudinal reinforcement in the deck began to yield at a loading of 29,340 lb. The inner longitudinal reinforcement in the deck began to yield at a loading of 29,552 lb. Figure 6-38 shows a plot of the load-strain curves of repair specimen R2-FRSCC. The load-strain curves have been truncated for ease of the reader's interpretation. The complete set of load-deflection curves can be found in the Appendix.

Figure 6-38: R2-FRSCC Load-Strain Curve

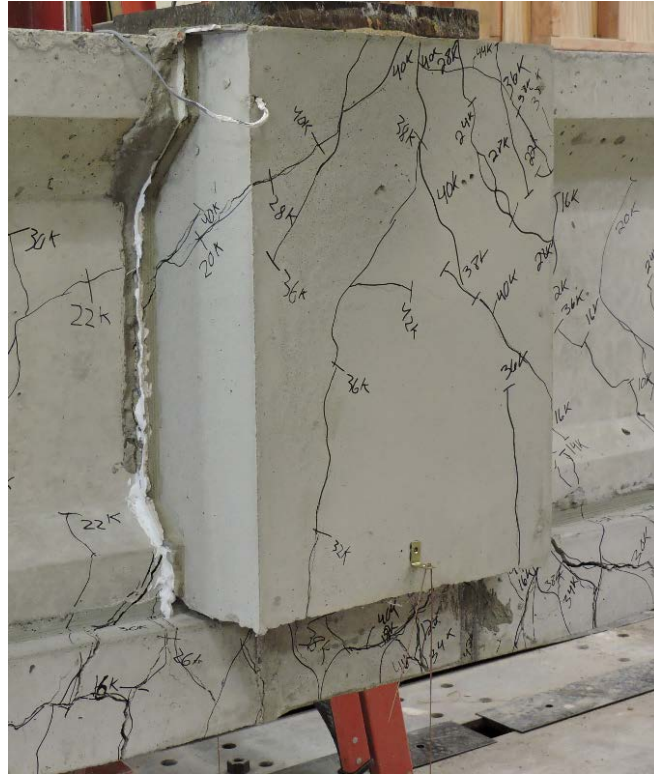
Figure 6-40:R3-FRSCC Joint Cracking, Longitudinal & Transverse Faces (Front Left)

Significant flexural cracking was observed on all four transverse faces of the continuity joint. These cracks also extended onto the longitudinal faces of the continuity joint and can be seen in Figure 6-40, Figure 6-41, and Figure 6-42. Note that additional

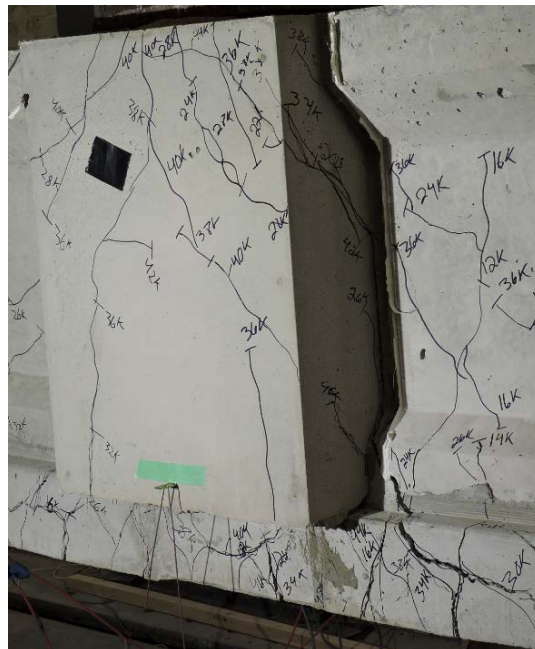
Figure 6-41:R3-FRSCC Joint Cracking, Longitudinal & Transverse Faces (Front Right)

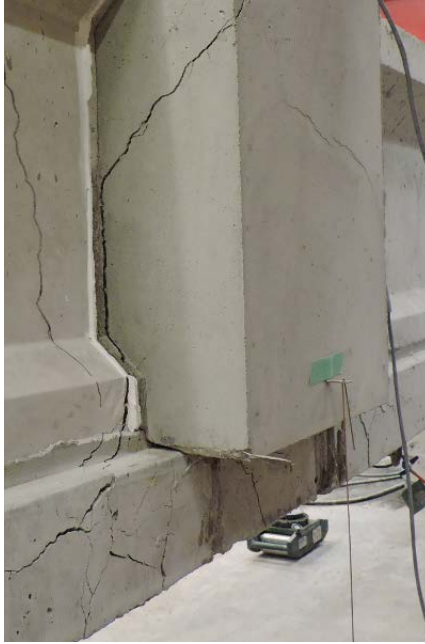
Figure 6-42:R3-FRSCC Joint Cracking, Longitudinal & Transverse Faces (Back Left)

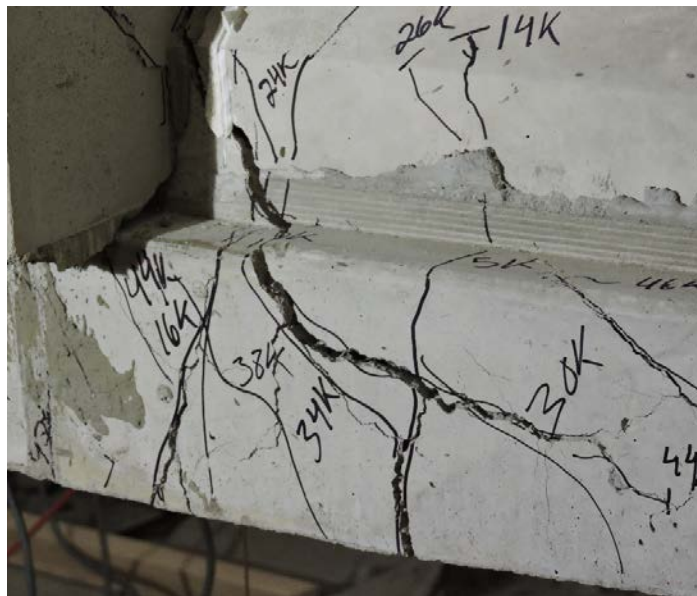
A considerable crack formed within the deck, just outside of the continuity joint, and continuously widened throughout the loading process. This crack propagated upward and into the joint which can be seen in Figure 6-43.

Figure 6-43:R3-FRSCC Deck Cracking

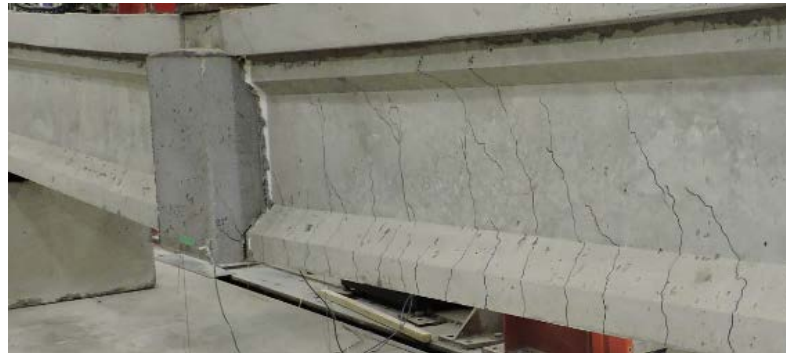
Figure 6-46: R1-PHOS Shear & Flexural Cracking

R1-PHOS was tested to failure in positive moment bending. Shear cracking and flexural cracking were observed during testing on the girder webs and either sides of the of the repaired continuity joint, respectively, and are shown in Figure 6-46.

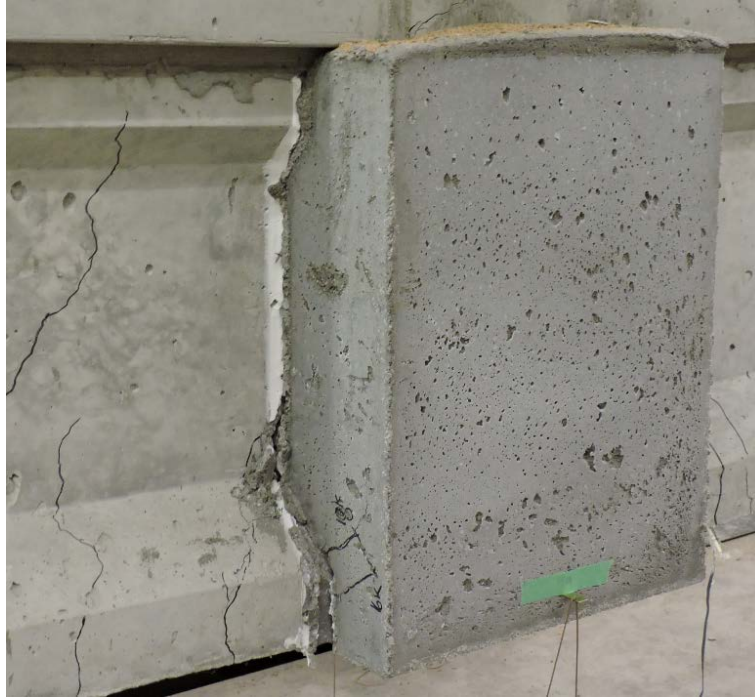
Figure 6-47:R1-PHOS Girder-Joint Interface & Joint Transverse Face Cracking (Front Left)

There were no noticeable cracks on the longitudinal face of either side of the repair joint. Flexural cracking was observed on all four transverse faces of the continuity joint. None of these cracks appeared to have extended onto the longitudinal faces of the continuity joint as shown in Figure 6-47, Figure 6-48, Figure 6-49, and Figure 6-50.

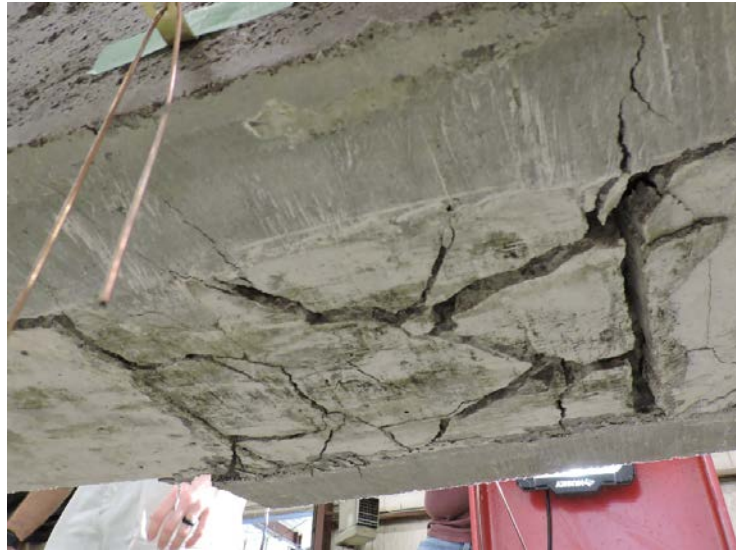
Figure 6-51:R1-PHOS Girder-Joint Separation

Significant cracking within the bottom bell of the girder-joint-girder specimen was observed at the location of the continuity joint. The two original half-girder specimens separated away from the joint under loading. The bottom of the original and repaired continuity joint is shown in Figure 6-51.

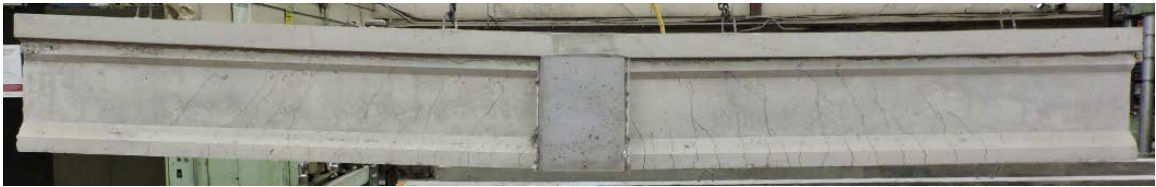
Figure 6-52:Deflected Shape of R1-PHOS

Figure 6-52 shows the overall girder-joint-girder repair specimen after testing. Note the failed specimen appears to consist of three separate members – each half girder and the continuity joint.

- All positive moment repair specimens' deflected shapes appear to consist of three separate segments – each half girder and the continuity joint.

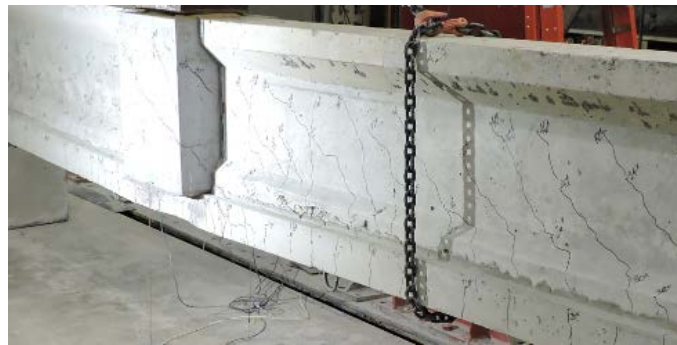
Figure 6-55: R2-PHOS Shear & Flexural Cracking

R2-PHOS was tested to failure in negative moment bending. Shear cracking and flexural cracking were observed during testing on the girder webs and either sides of the repaired continuity joint, respectively, and are shown in Figure 6-55.

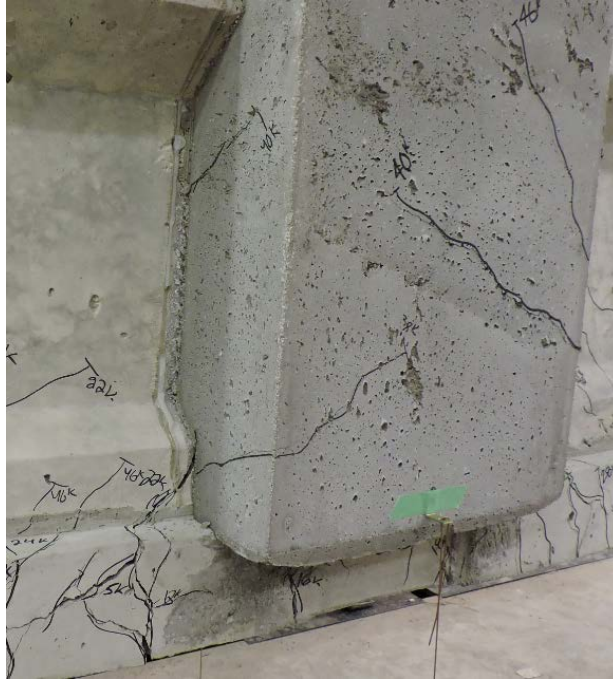
Figure 6-56: R2-PHOS Joint Cracking, Longitudinal and Transverse Faces (Front Left)

Flexural cracking was observed on all four transverse faces of the continuity joint. Many of these cracks also extended onto the longitudinal faces of the continuity joint and can be seen in Figure 6-56, Figure 6-57, and Figure 6-58. Note that additional longitudinal face cracks can also be seen.
