EVALUATION OF SPECIALIZED CONCRETES FOR THE REPAIR OF DAMAGED
CONTINUITY JOINTS IN PRESTRESSED GIRDER BRIDGES

A THESIS

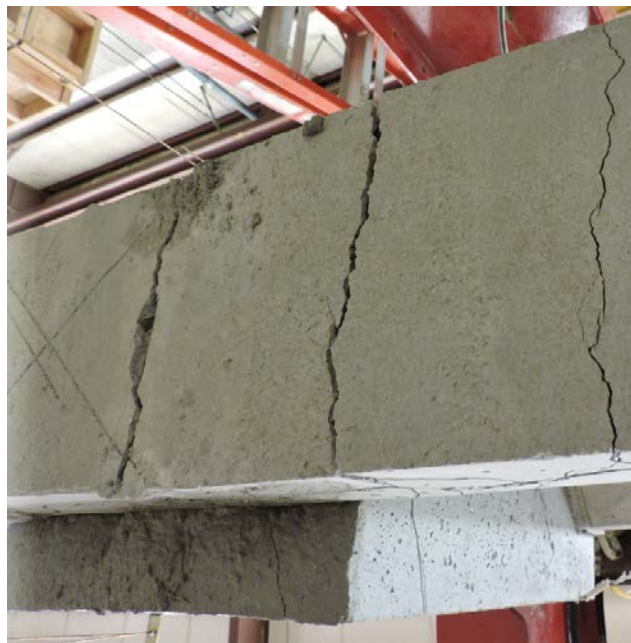
Figure 6-59:R2-PHOS Deck Cracking

Flexural cracking extending across the deck is shown in Figure 6-59.

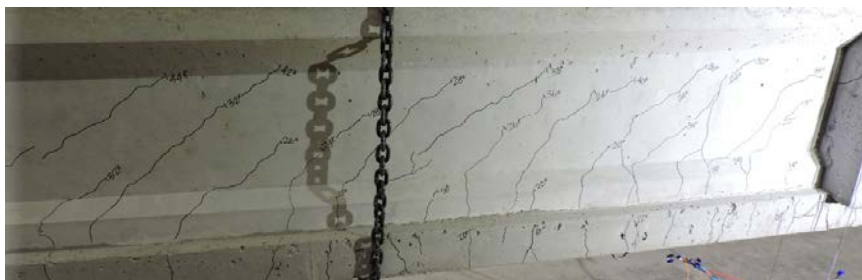
Figure 6-63:R3-PHOS Shear & Flexural Cracking (Front Left)

R3-PHOS was tested to failure in negative moment bending. Shear cracking and flexural cracking were observed during testing on the girder webs and either sides of the repaired continuity joint, respectively, and are shown in Figure 6-63 and Figure 6-64.

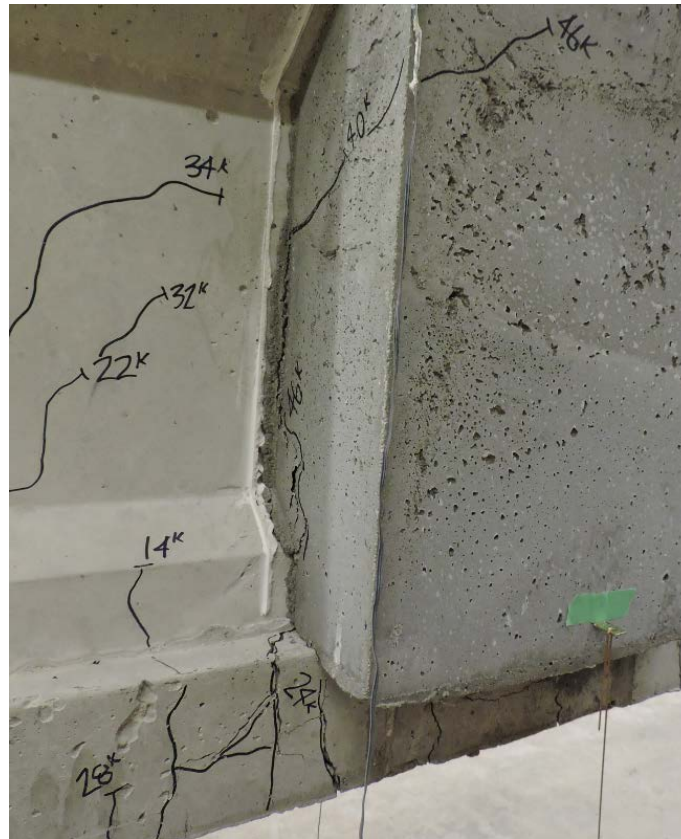
Figure 6-65:R3-PHOS Girder-Joint Interface Cracking (Front Left)

Limited flexural cracking was observed on the longitudinal and transverse faces of the repaired continuity joint. The only considerable crack at the girder-joint interface is shown in Figure 6-65. This crack initiated at the deck, propagated upward and across the joint's transverse face, and terminated on the longitudinal face of the joint around a loading of 46 kips.

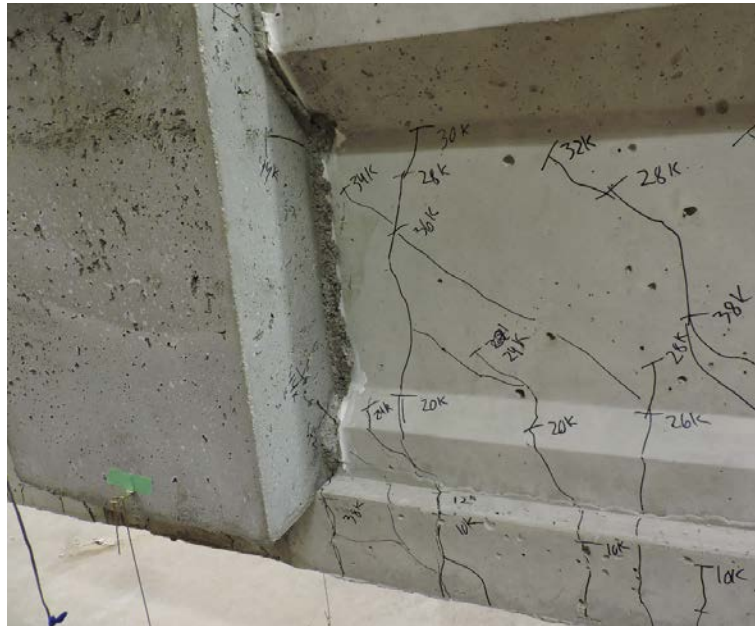
Figure 6-66:R3-PHOS Joint Transverse Face Cracking (Front Right)

Flexural cracking of the other transverse faces of the joint are shown in Figure 6-66, Figure 6-67, and Figure 6-68.

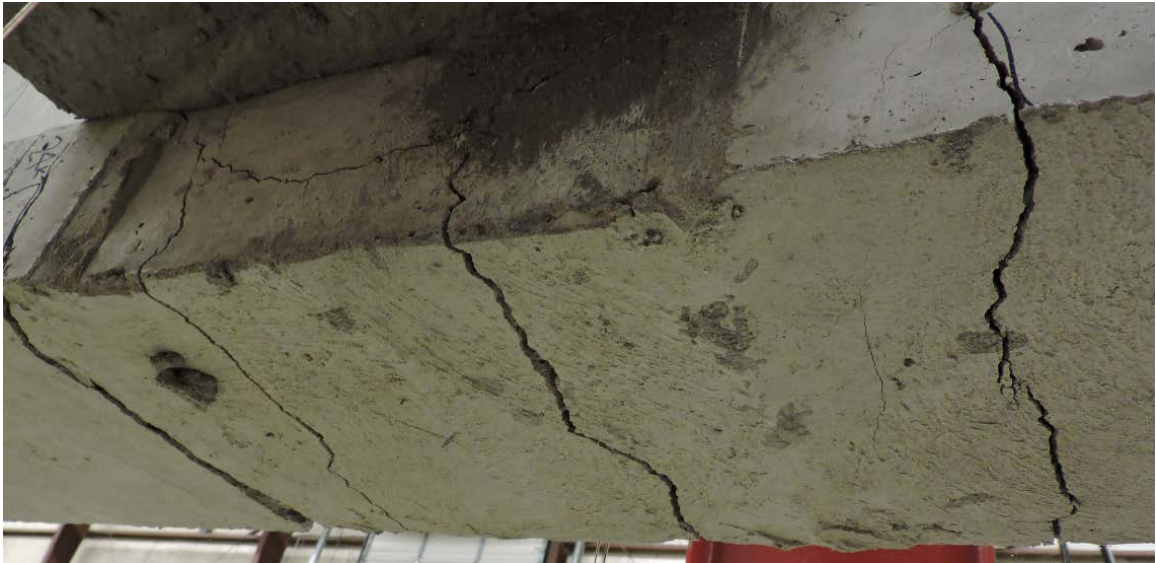
Figure 6-69:R3-PHOS Deck Cracking

Flexural cracking extending across the deck is shown in Figure 6-69
