SHAKE TABLE TESTING OF SCALED RAMMED EARTH MODELS

A THESIS

A THESIS APPROVED FOR THE
SCHOOL OF CIVIL ENGINEERING AND ENVIRONMENTAL
SCIENCE

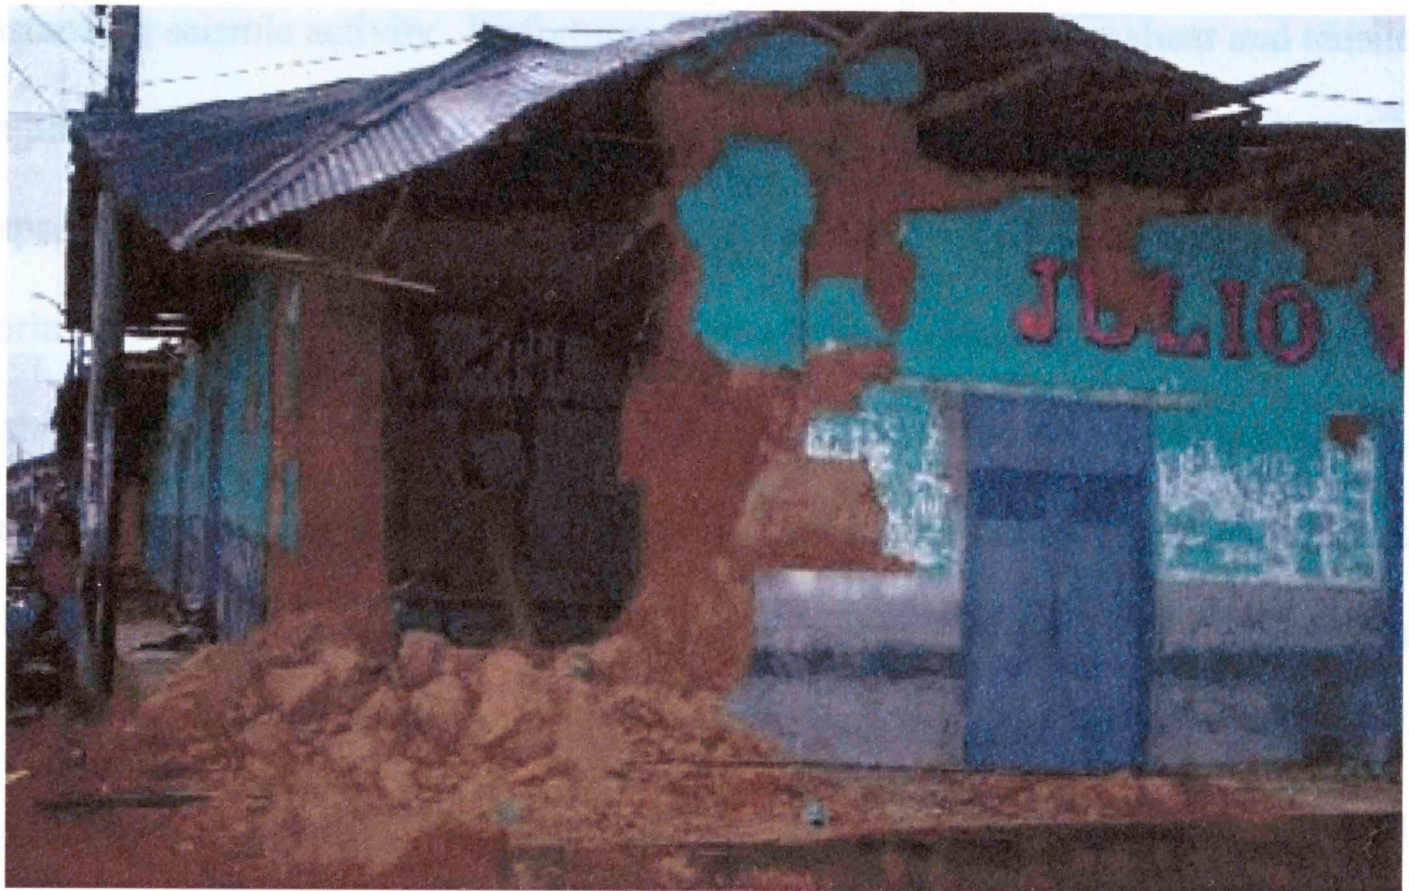
Figure 1.1: Earthquake damage to rammed earth in Peru (www.lamasperu.com)

Of all forces of nature with the potential to destroy homes, earthquakes seem to strike the most fear because of their inherent element of surprise. Earthquakes are relatively few and far in between but their effects can range from generating a queasy feeling in the stomach to structural collapse for several miles. Industrialized nations like the United States, Europe and Australia have building codes to provide guidelines for construction of housing, with architects and engineers to ensure the safety of the design. In some developing nations however, like Peru or Nicaragua, residential structures can still be constructed by the homeowner without any engineering or building code. Earthen construction is popular in these areas because of the availability of the main material: earth. The homeowner can use soil that is abundantly available on site. Unfortunately earthen construction does not perform well in seismic areas. Of the different types of earthen construction, rammed earth was chosen for this particular study because it is still used in some developing nations where earthquakes can be severe, yet its structural behavior as a whole during an earthquake is not widely understood (**Figure 1.1**).

initial expectations, crack locations such as at the door opening were within expectations since rammed earth is weak in shear and tension. In addition, when compared back to Figure 1.1, model failures at the corners resembled failures in the field. If confirmed by

The rammed earth models were expected to fail at the fundamental frequency. Instead, results from Tests 2-4 showed that models failed at approximately 10-12 Hz, or two times the measured fundamental frequency. Further research would be required to confirm and/or explain this phenomenon. Although failure frequencies did not meet initial expectations, crack locations such as at the door opening were within expectations since rammed earth is weak in shear and tension. In addition, when compared back to **Figure 1.1**, model failures at the corners resembled failures in the field. If confirmed by

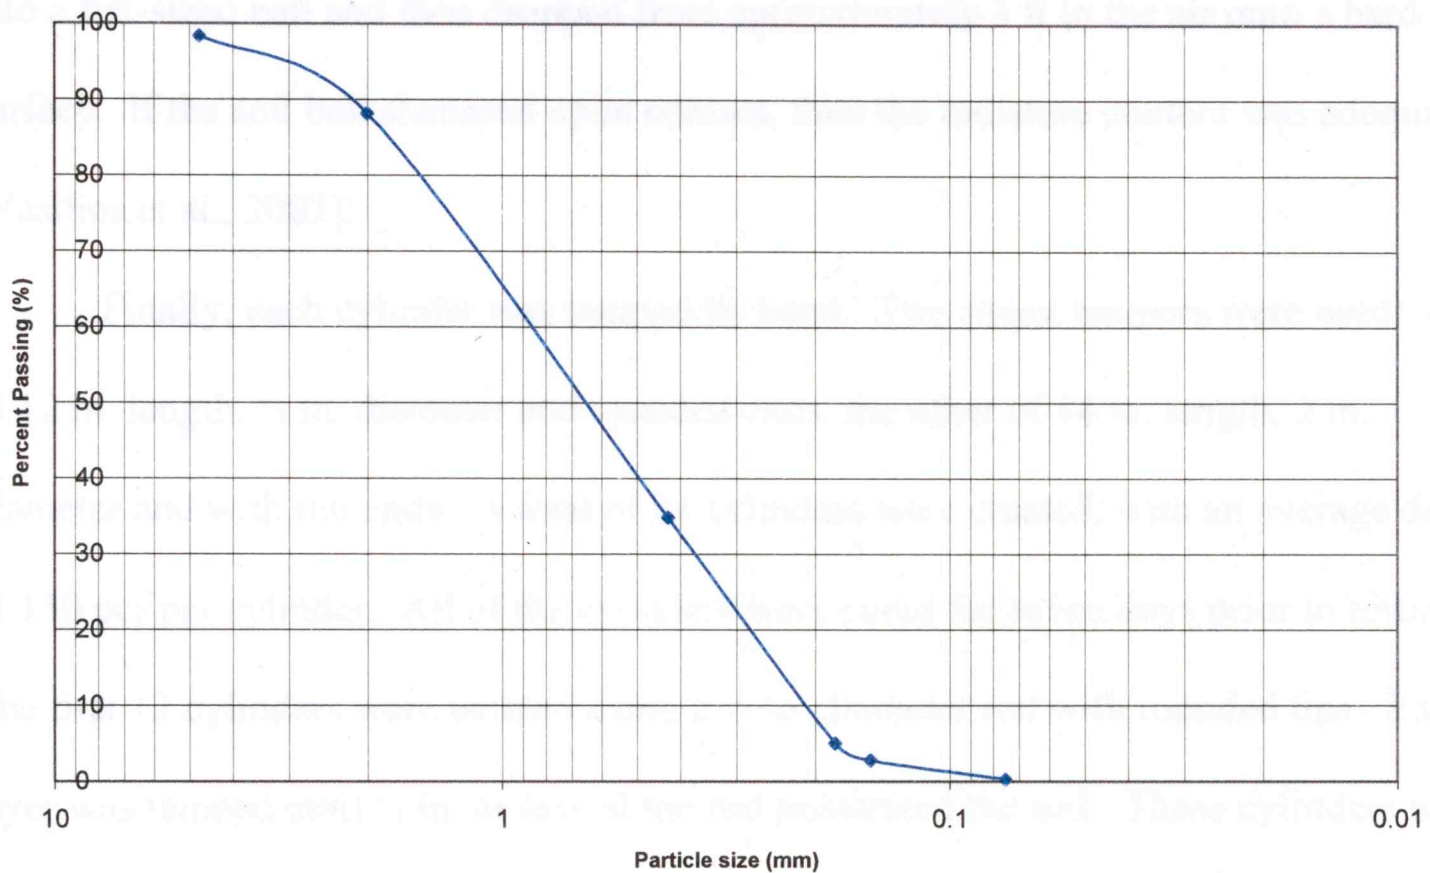
Figure 2.1: Sieve analysis of sand

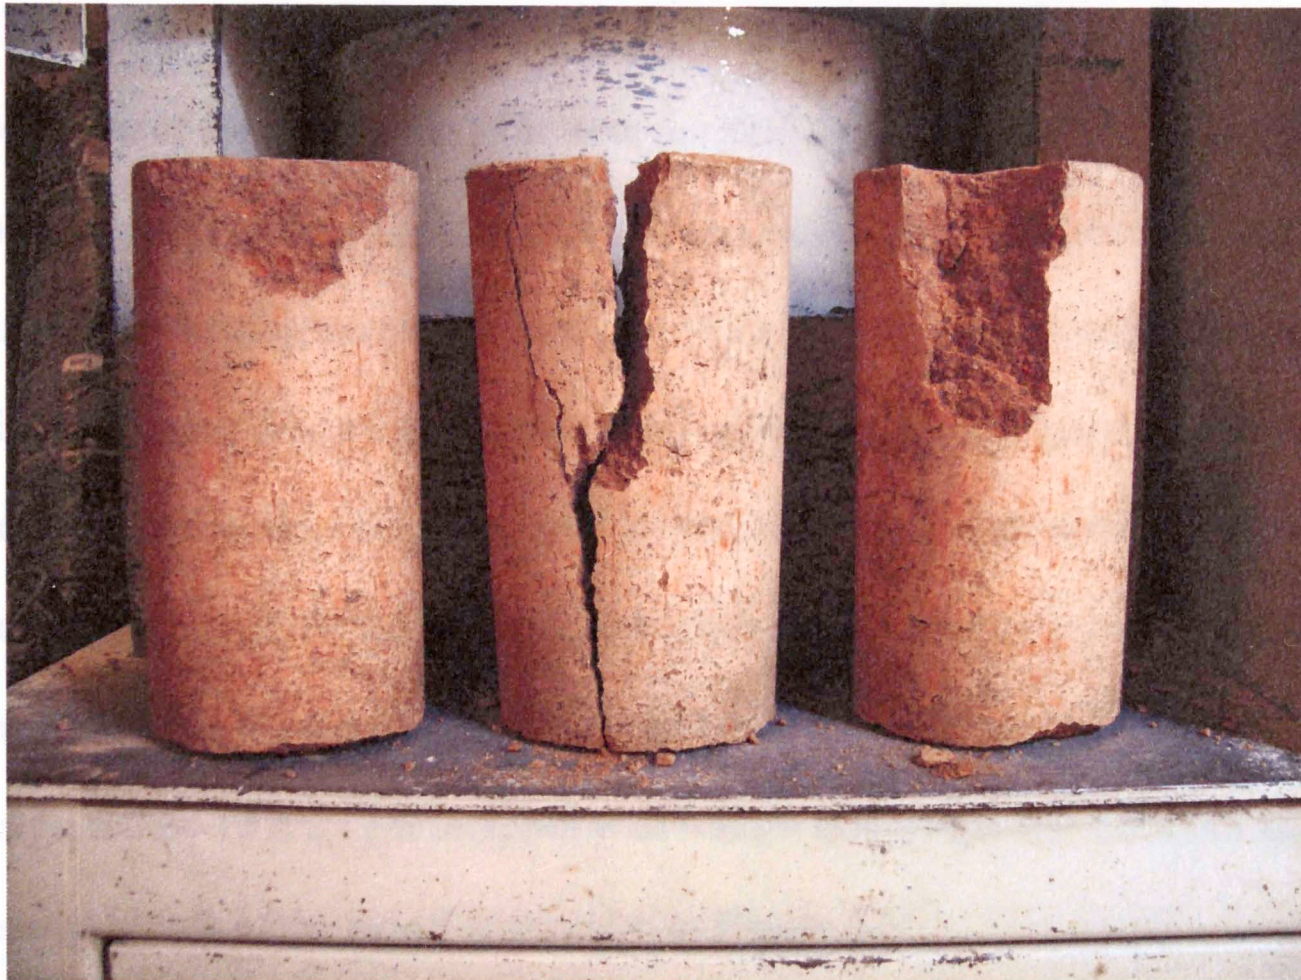
Figure 2.2: Typical failures of test cylinders

was selected for the sake of a more economical design. Proportion values were based upon the field-tested optimum moisture contents, compressive strength and what might be more economically feasible for a homeowner in a developing nation. Although proportions were based upon total weight instead of dry weight, the moisture content in each soil was low upon visual inspection because each soil was stored outside in the summer heat. The test cylinders failed either by splitting or by shear near the corner. Failure by shear at a corner was most common. Typical failures in cylinders are shown in **Figure 2.2**.

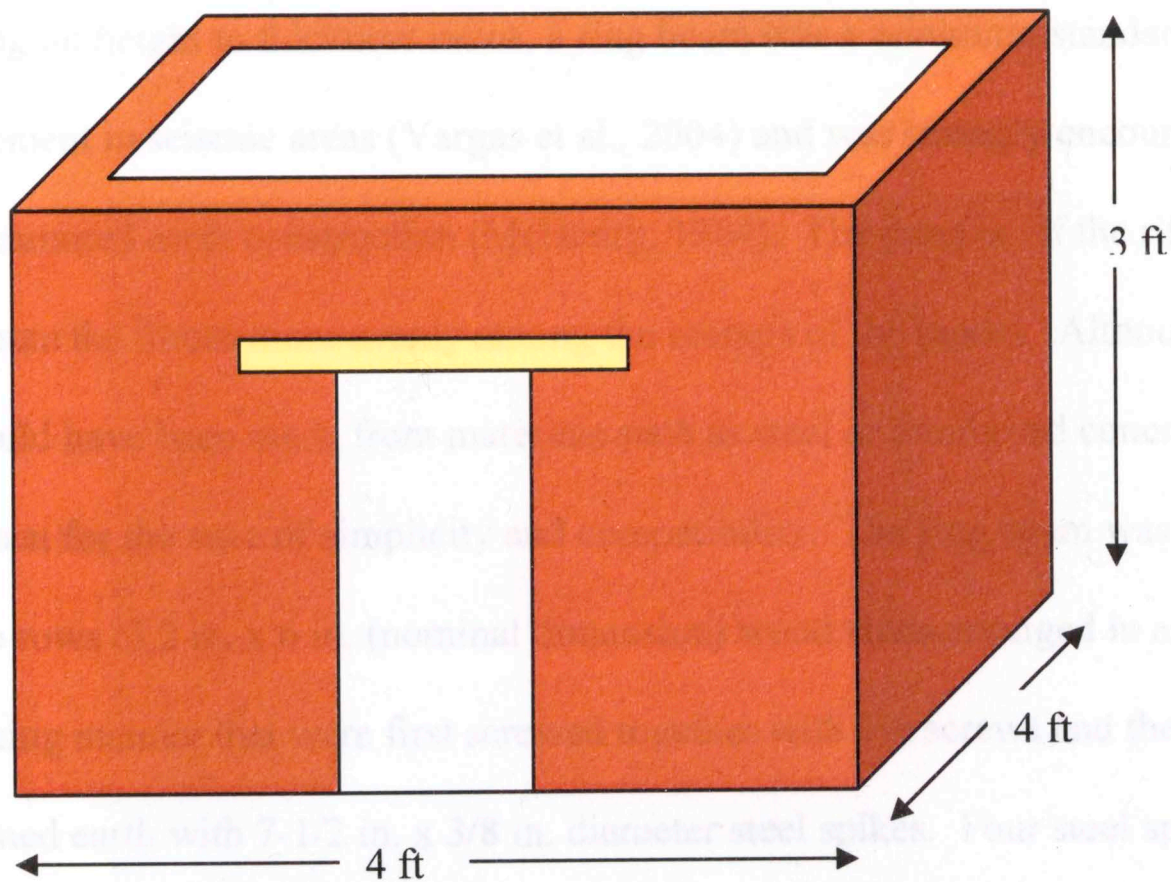
Figure 2.3: Typical geometry used for rammed earth models

Geometry of the model was based upon current rammed earth building dimensions, recommendations based upon the Peruvian building code for seismic adobe, and the size of the shaketable platform. According to McHenry (1984) rammed earth buildings typically were no more than 2 stories in height, had wall thicknesses between 10 in. and 24 in., and needed to maintain a height-to-thickness slenderness ratio of 15 or less. Based upon the Peruvian code (Vargas et al., 2004) door openings were recommended to be no more than one third of the width of the wall, and must be centered in the wall. Finally, the size of the shaketable platform was 4 ft in width and 6 ft in length. Based upon all the above criteria, the model geometry design was 4 ft x 4 ft x 3 ft

x 0.5 ft in length, width, height, and thickness, respectively. One door opening was centered in one of the shear walls. The door opening measured 1 ft in width and 2.33 ft (28 in.) in height. The doorway included a wooden lintel beam of 18 in. in length, providing a 3 in. bearing length on either side of the door opening. Current standards in the United States required a minimum of 8 in. bearing length (McHenry, 1984). Since the model was designed as 1/3 scale, the 3 in. bearing length on the model would equate to a 9 in. bearing length on the full scale prototype. The intent was to create a simplified house at 1/3 scale, although realistically the full-size version of the model would have been only a room: 12 ft x 12 ft footprint with walls 9 ft in height and 1.5 ft (18 in.) in thickness. A sketch of the model is provided in **Figure 2.3**.

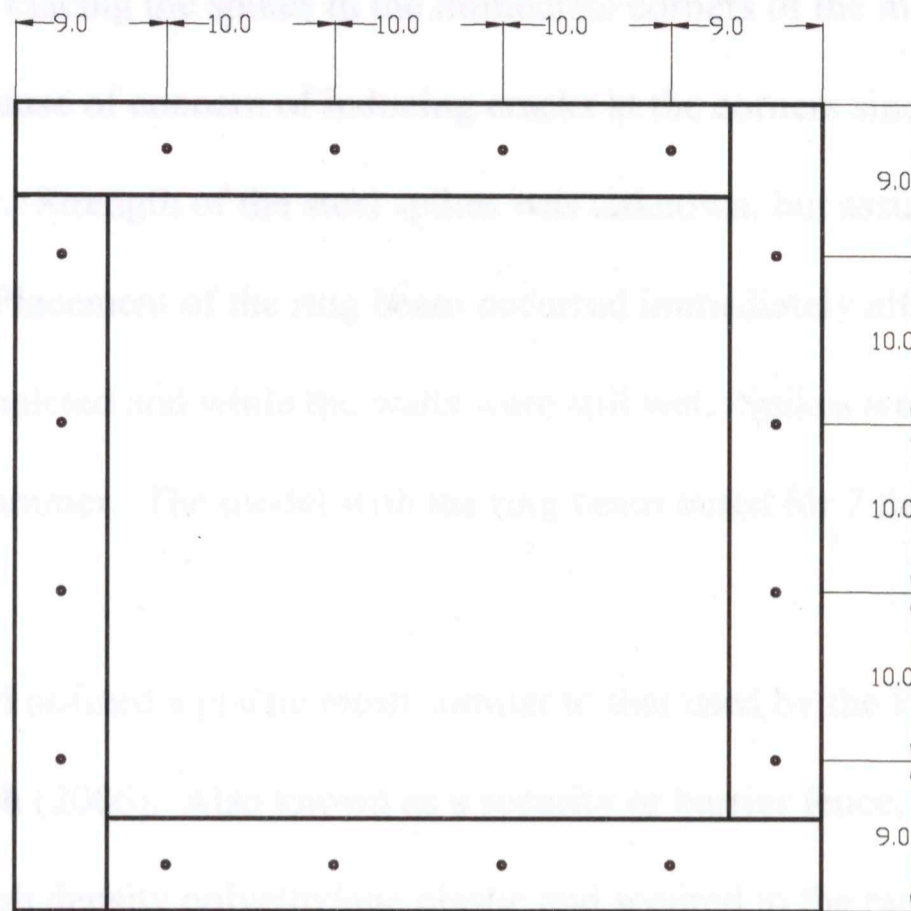
Figure 2.4: Plan view sketch of ring beam

A ring beam was chosen as the type of reinforcement for the third model because depending on height to thickness ratios, a ring beam was a minimum standard of reinforcement in seismic areas (Vargas et al., 2004) and was strongly encouraged in modern rammed earth construction (McHenry, 1984). The purpose of the ring beam was to distribute the forces more evenly among the corners of the model. Although the ring beam could have been made from materials such as steel or reinforced concrete, wood was chosen for the sake of simplicity and compatibility. The ring beam was designed with two rows of 2 in. x 6 in. (nominal dimension) wood studs arranged in an interlocking manner that were first screwed together with 3in screws and then secured to the rammed earth with 7-1/2 in. x 3/8 in. diameter steel spikes. Four steel spikes were placed per wall, through pre-drilled holes in the wood, at a spacing of 9 in. from each end and 10 in. spacing in the center (**Figures 2.4 and 2.5**).

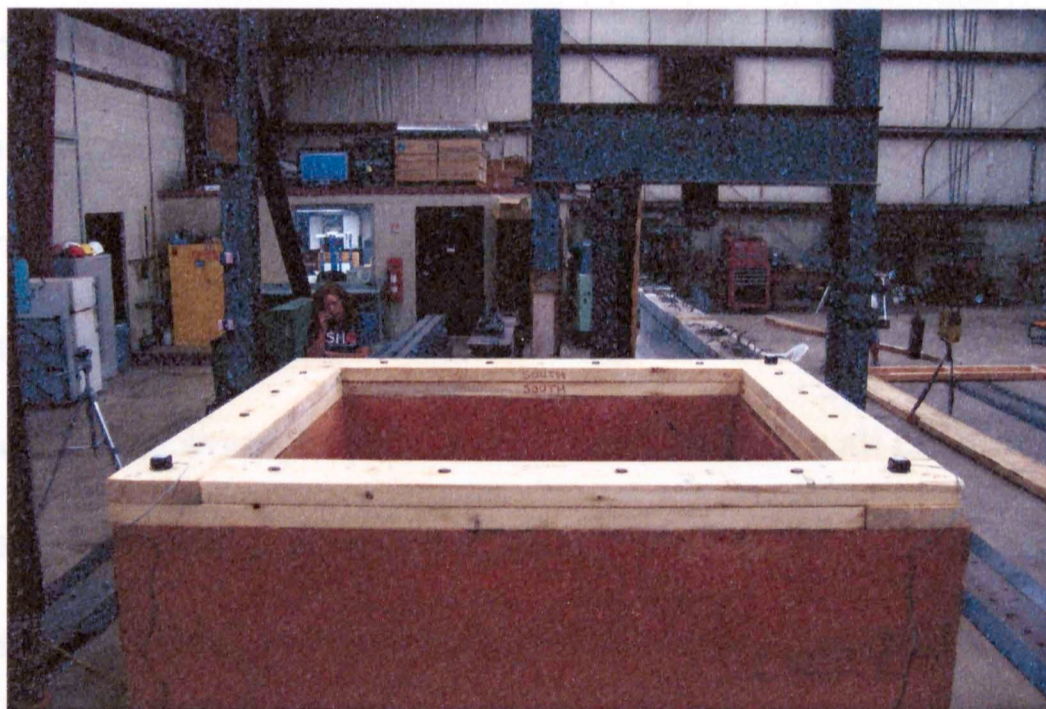
Figure 2.5: View of Ring beam on Test 3 model with accelerometers

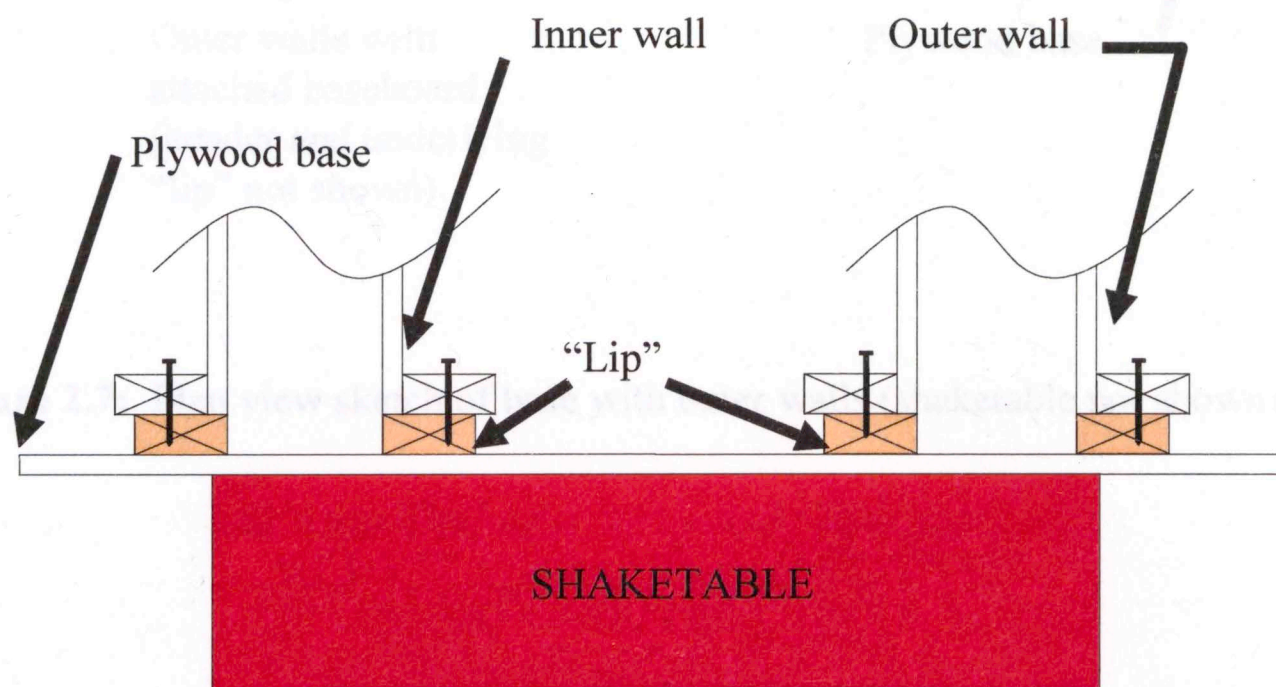
Figure 2.6: Cross-section of shaketable platform with plywood base

To construct the models, wooden formwork was used similar to that used for concrete. Wall panels were made of $\frac{3}{4}$ in. plywood and 2 in. x 4 in. studs. The base consisted of plywood bolted directly to the table with $\frac{3}{8}$ in. diameter bolts (A325) and $\frac{3}{8}$ in. washers. Screwed to the base was a “lip” built from 2 in. x 4 in. (nominal dimension) wood studs. The “lip” was created to secure the rammed earth to the shaketable and transfer the base shear into the model (**Figure 2.6 and Figure 2.7**).

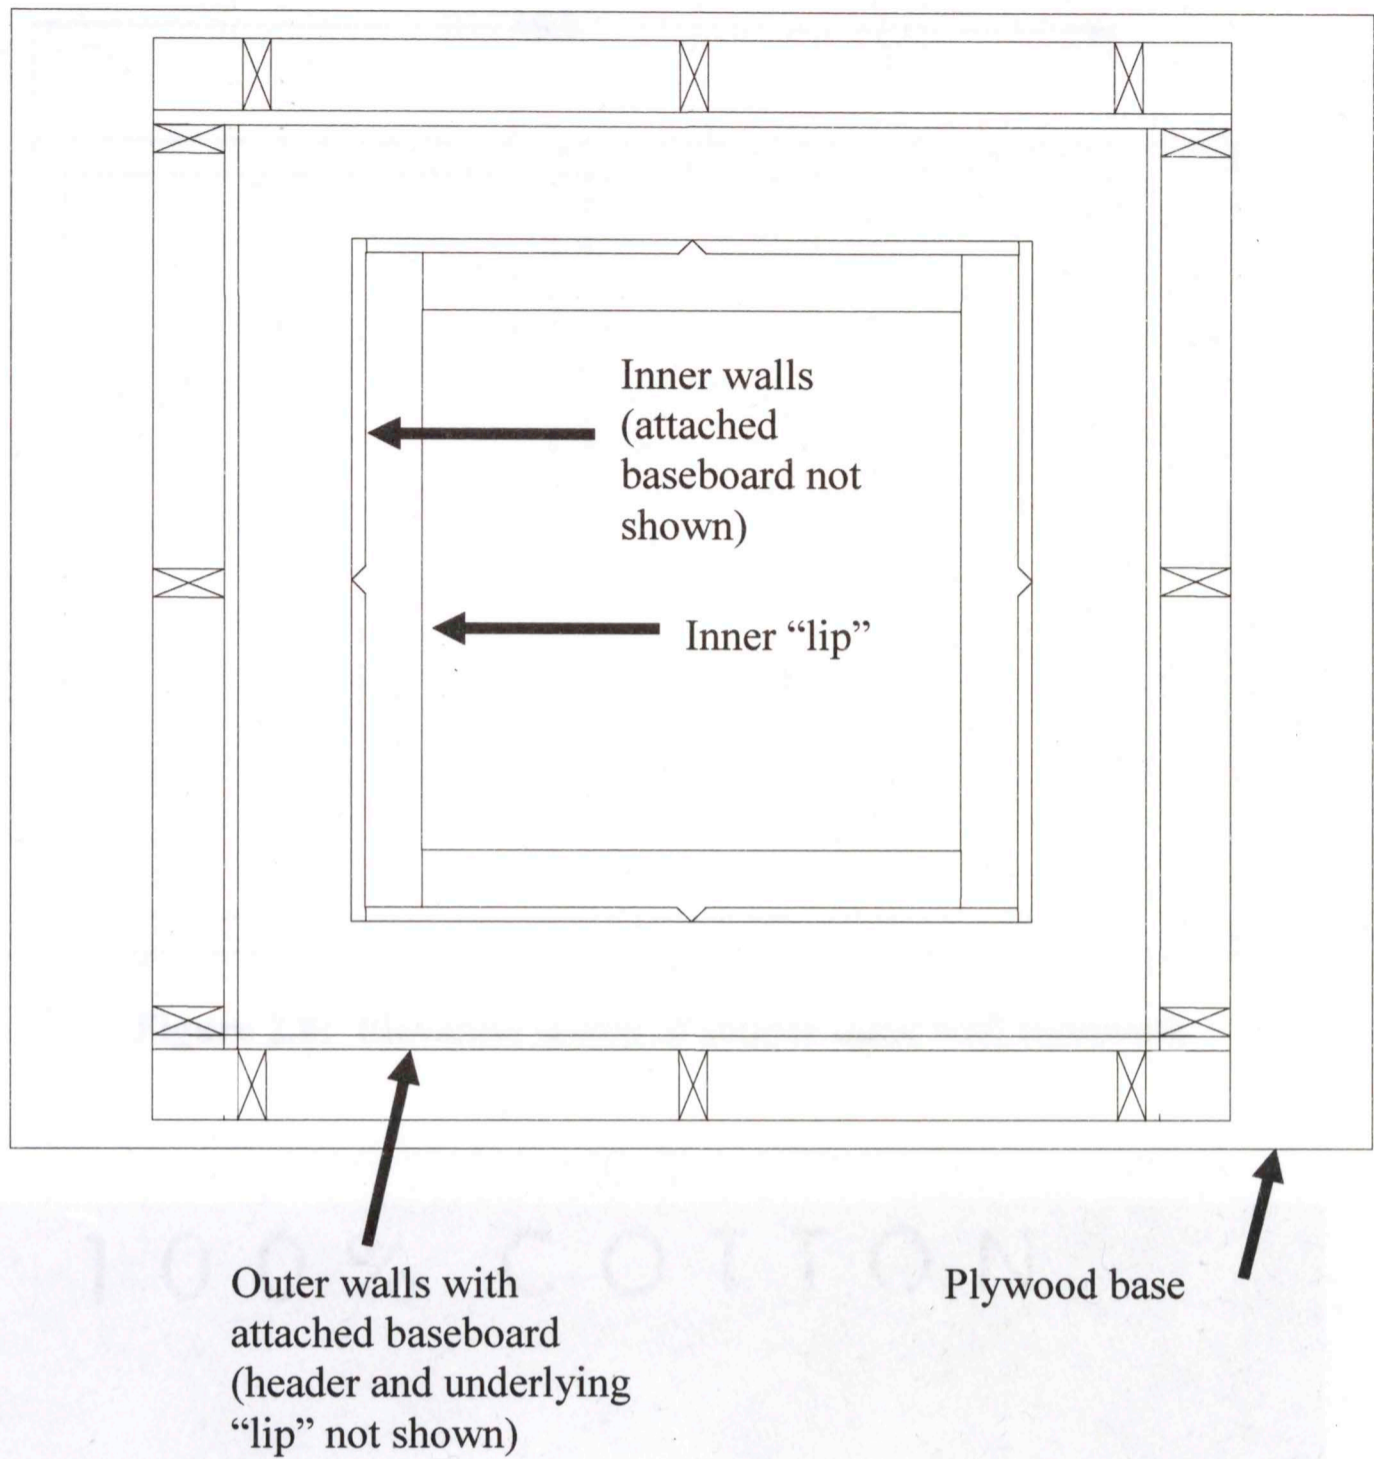
Figure 2.7: Plan view sketch of base with outer walls (shaketable not shown)

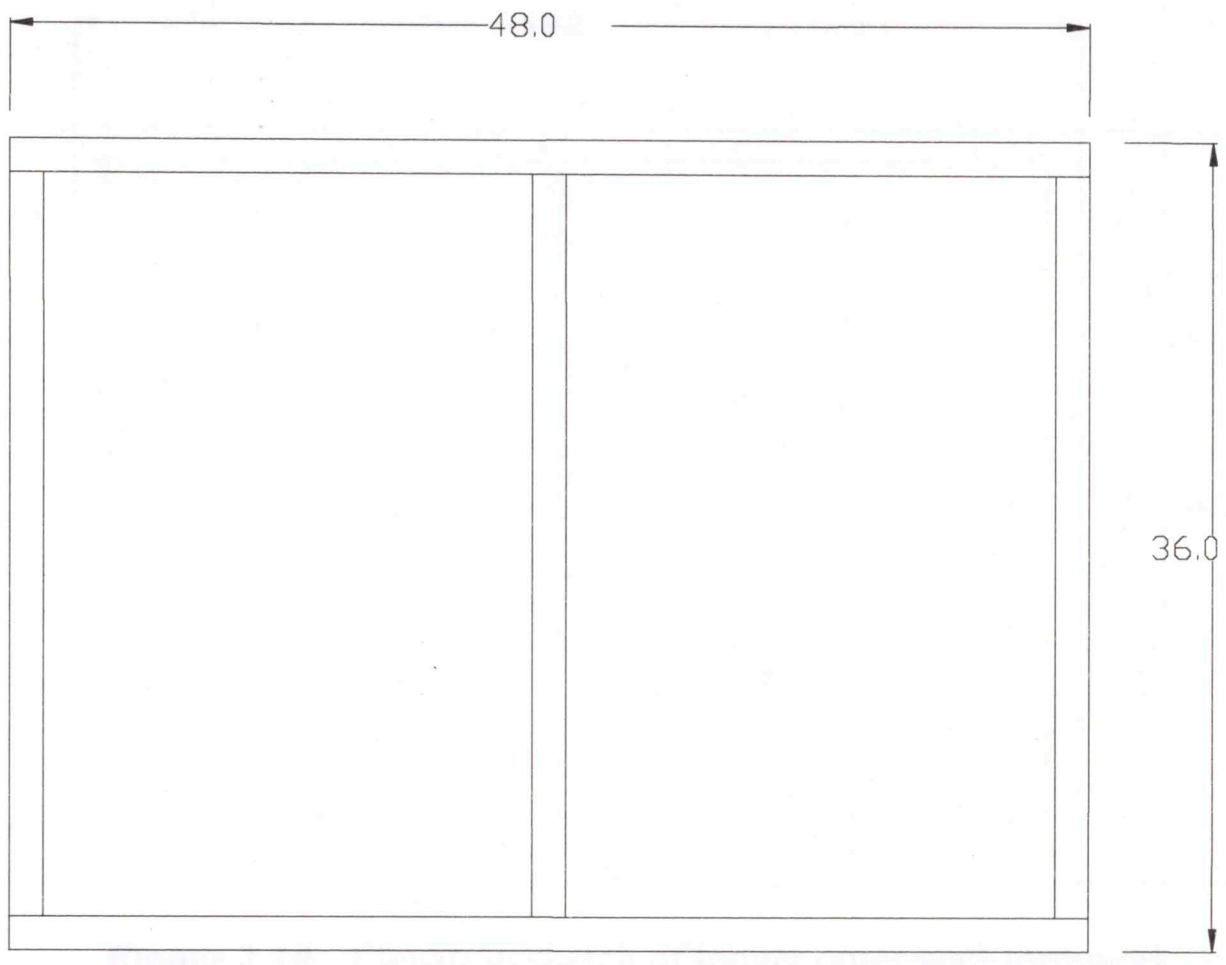
Figure 2.8: Elevation sketch of shorter outer wall formwork

Formwork walls were designed to be reused. The outer walls were bolted together with $\frac{3}{4}$ in. diameter bolts, while the inner walls were attached by 3 in. lag screws and $\frac{1}{4}$ in. bolts and washers. Sketches of the walls with the corresponding pictures are provided in **Figures 2.8 through 2.13**.

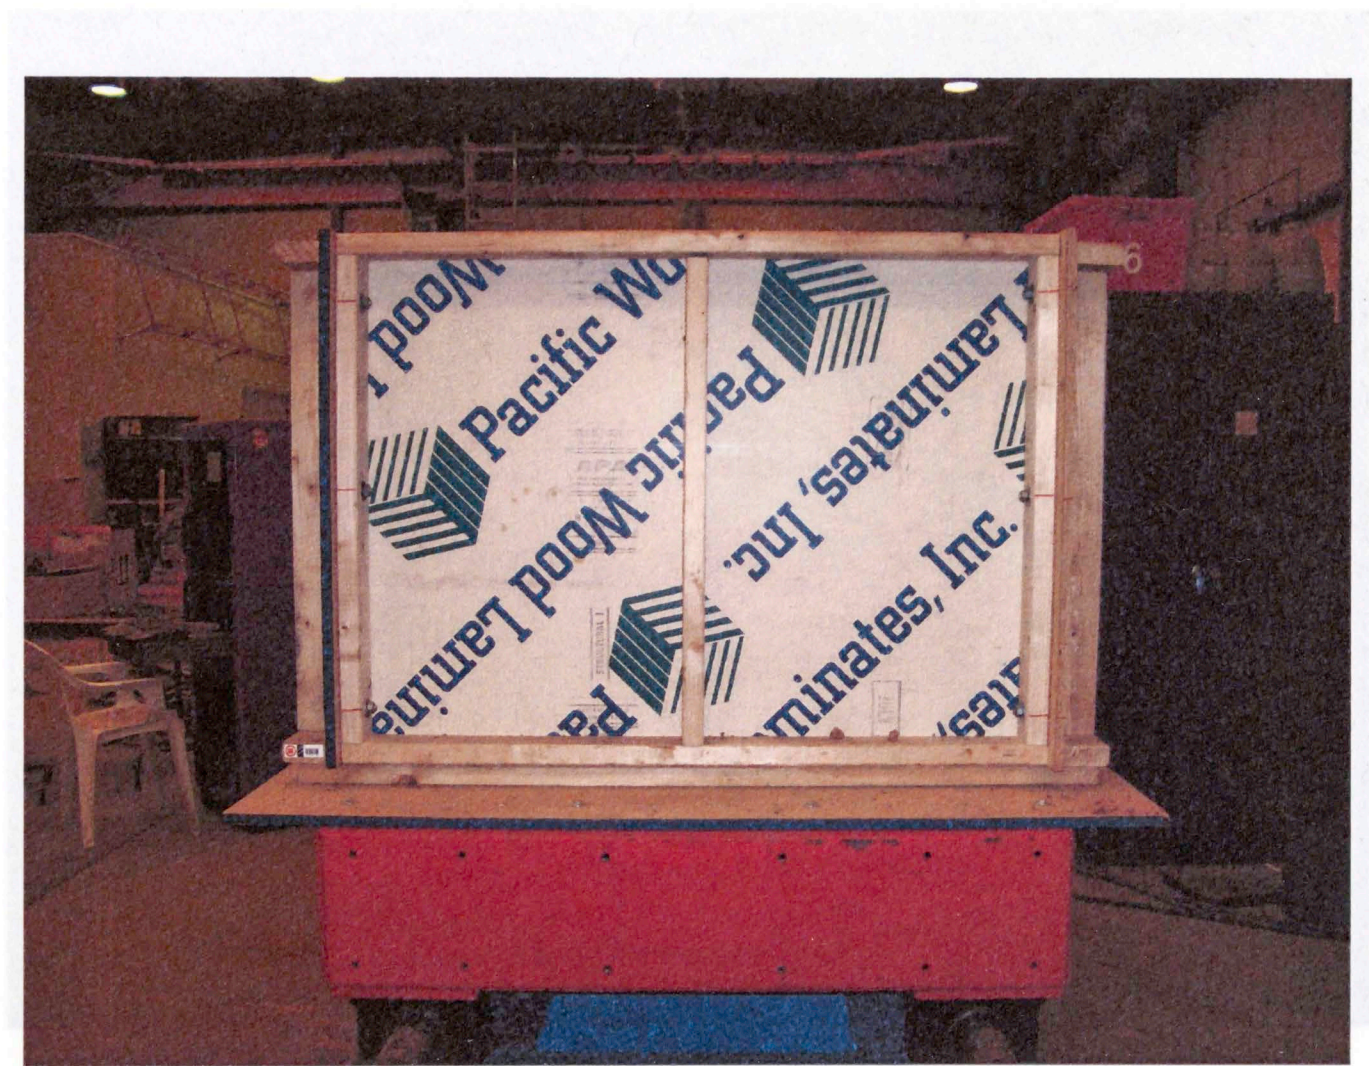
Figure 2.9: Picture of shorter outer wall formwork

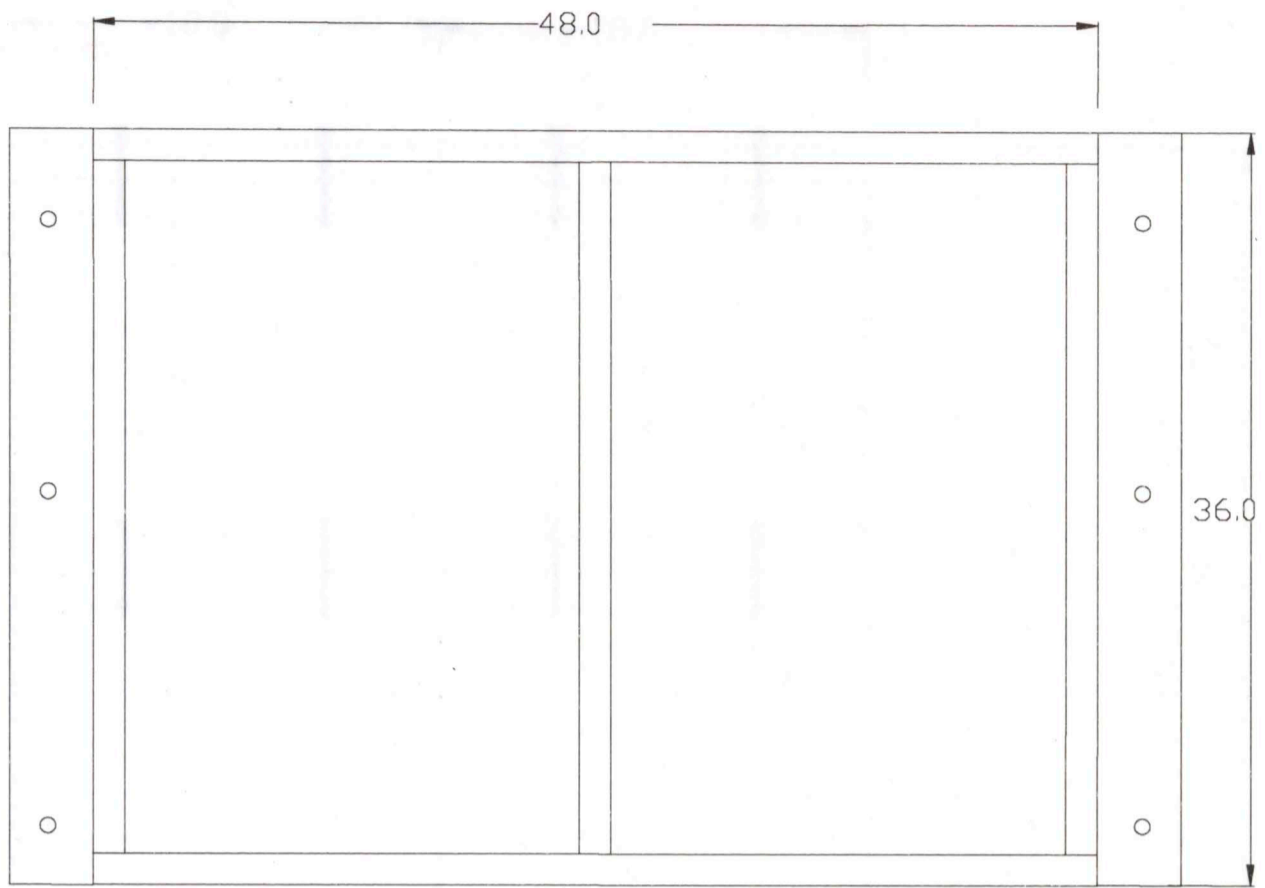
Figure 2.10: Elevation sketch of longer outer wall formwork

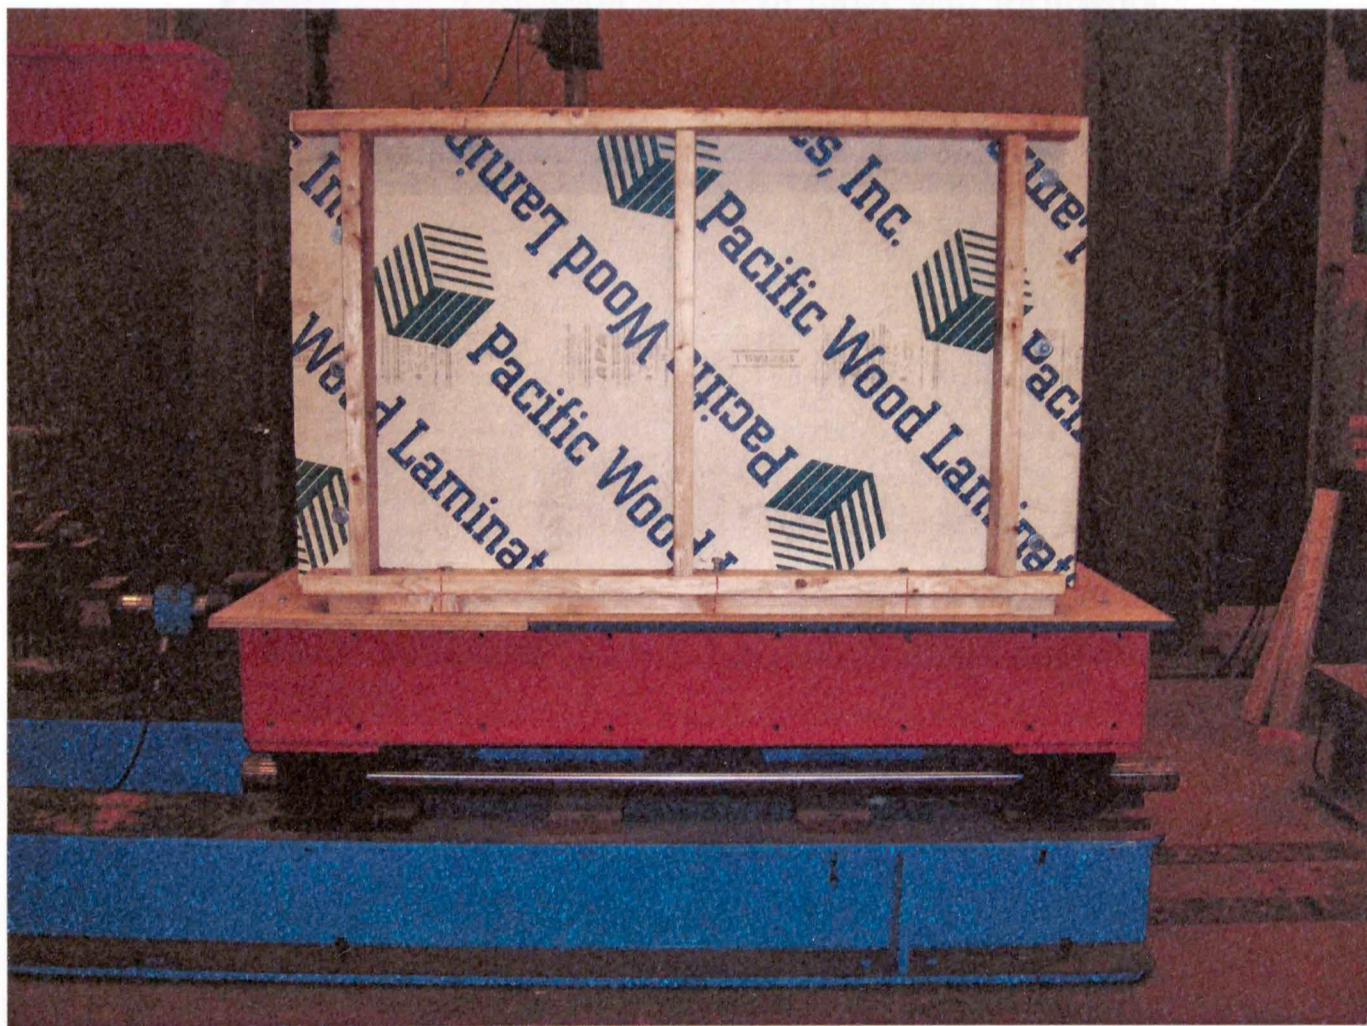
Figure 2.11: Picture of longer outer wall formwork

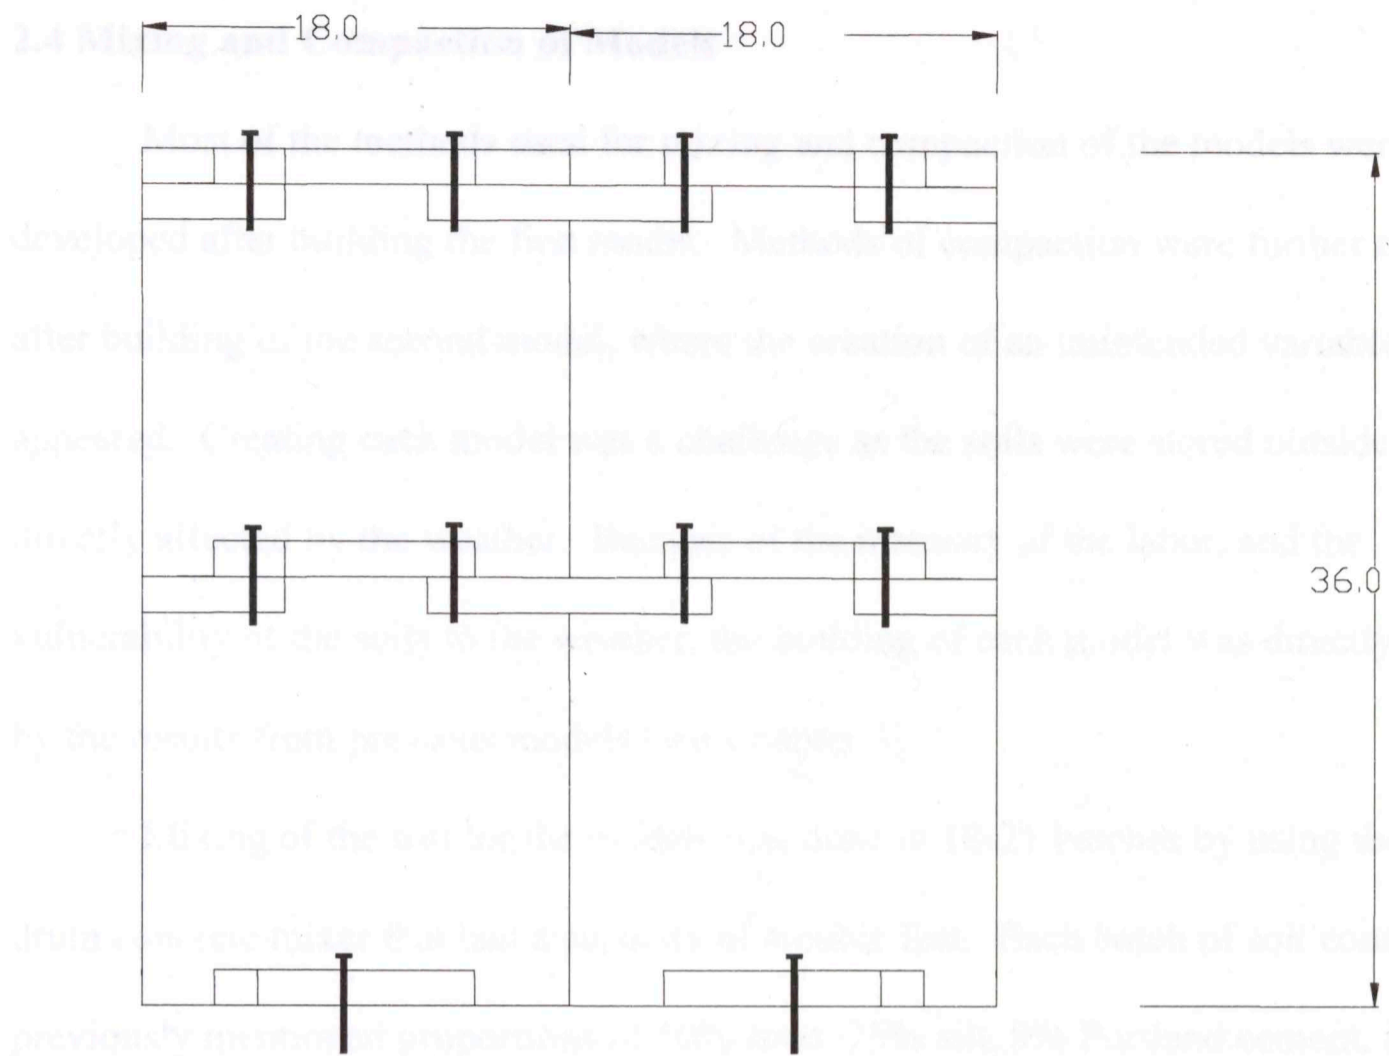
Figure 2.12: Elevation sketch of inner wall formwork

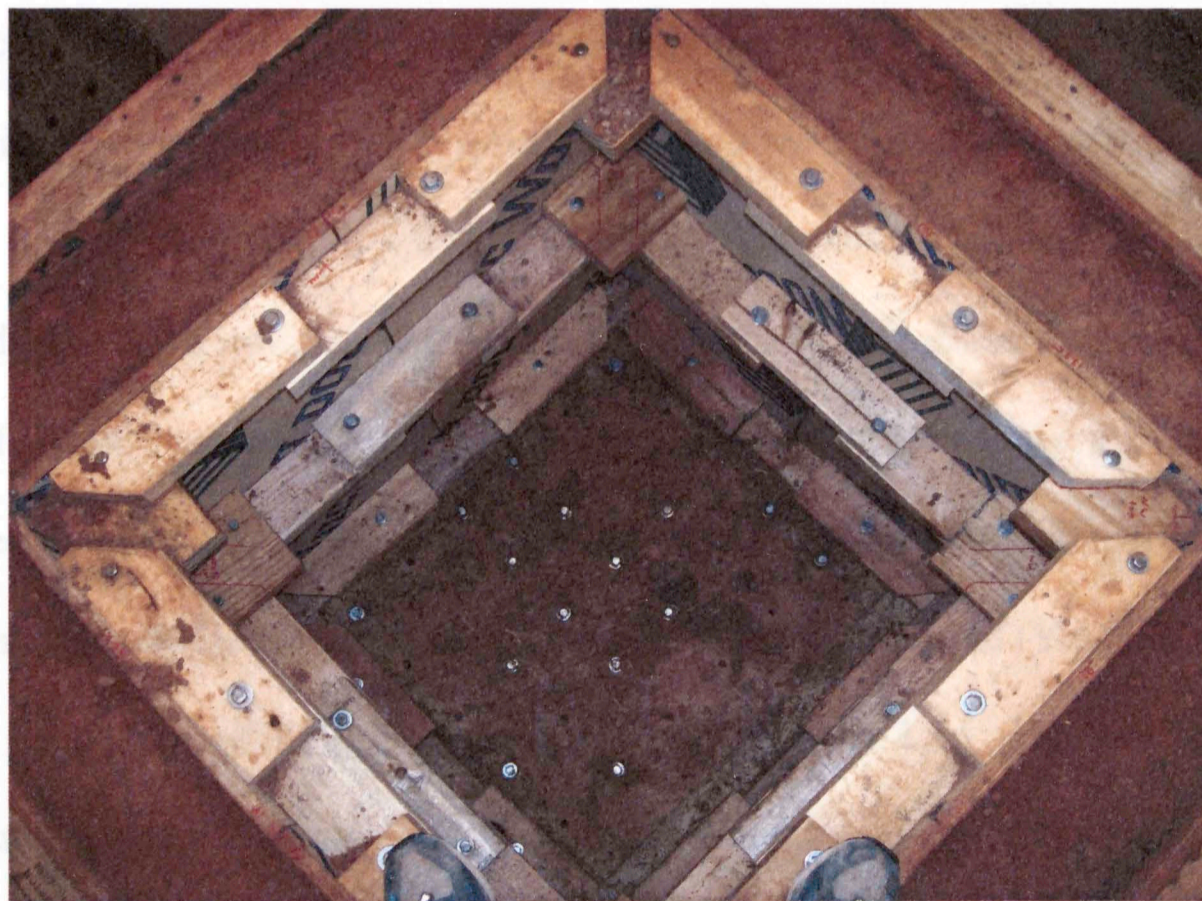
Figure 2.13: Plan view picture of all inner wall formwork (Test 1)

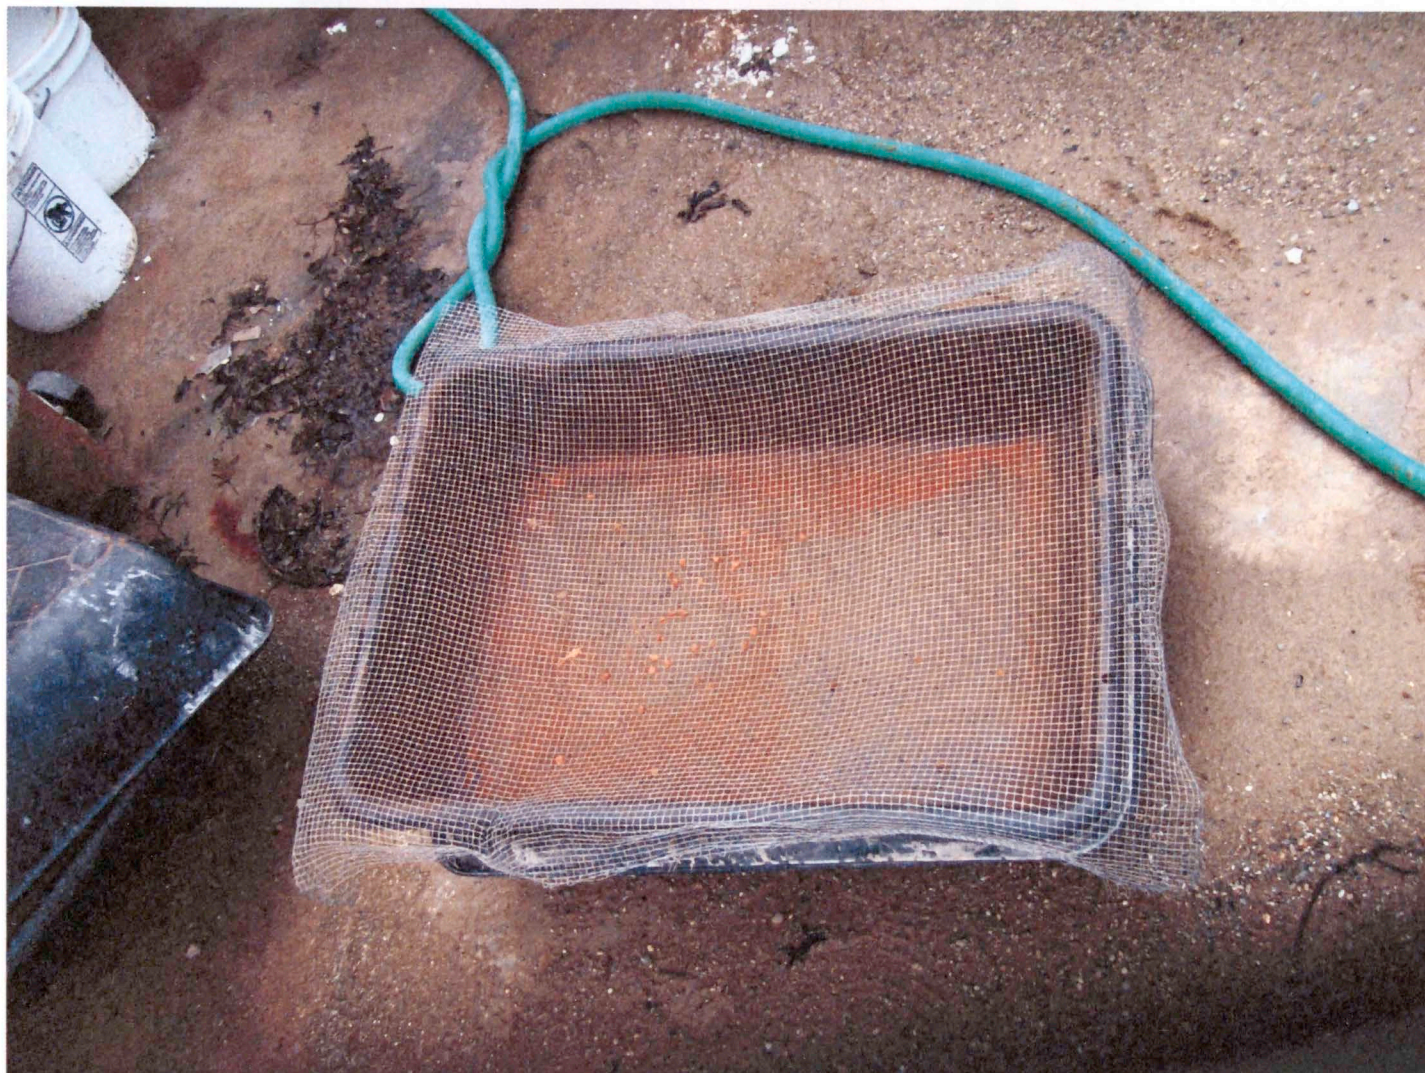
Figure 2.14: Picture of 1/4 in. wire mesh used to sieve the clay

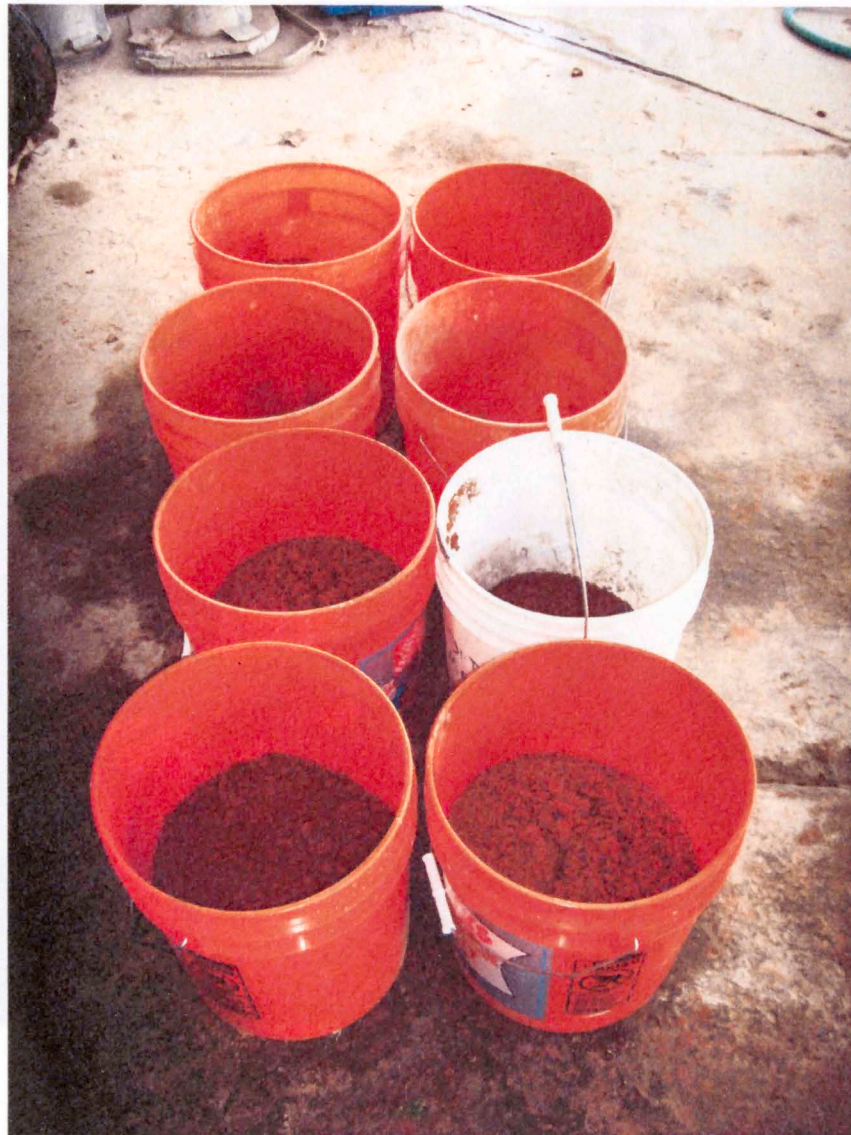
Figure 2.15: Typical layout of soil batch (equivalent to one compacted layer)

Mixing of the soil for the models was done in 18-21 batches by using the vertical drum concrete mixer that had a capacity of 4 cubic feet. Each batch of soil contained the previously mentioned proportions of 50% sand, 25% silt, 9% Portland cement, 8% clay and 8% water by total weight. Based upon a 130 pcf density, estimated from the test cylinders, the percentages equated to: 96.6 lbs of sand, 48.2 lbs of silt, 17.3 lbs of type II Portland cement, 15.4 lbs of clay and 15.4 lbs of water. The sand was stored in an outdoor pile, open to the changes in weather. The silt was stored in aluminum garbage cans with lids, although stormy winds occasionally removed the lids and wet the silt. Because the silt had a low plasticity, wet silt was tolerable and easier to mix than dry silt. The clay for Test 1 was not processed and had a moisture content above the plastic limit, but for Test 2, 3 and 4 the clay was dried and pulverized to pass through a ¼ in. wire mesh (similar to a # 4 sieve) until more than 80% of the clay passed (Vasilios et al., 2003). A photograph of the wire mesh is provided in **Figure 2.14**. The amount of water was adjusted during mixing depending on visible moisture content of the silt and field optimum moisture content tests of the rammed earth mixture. Weights of soil were total

weight as opposed to dry weight. Photographs of a typical batch layout and the vertical drum mixer are provided in **Figures 2.15** through **2.17**.

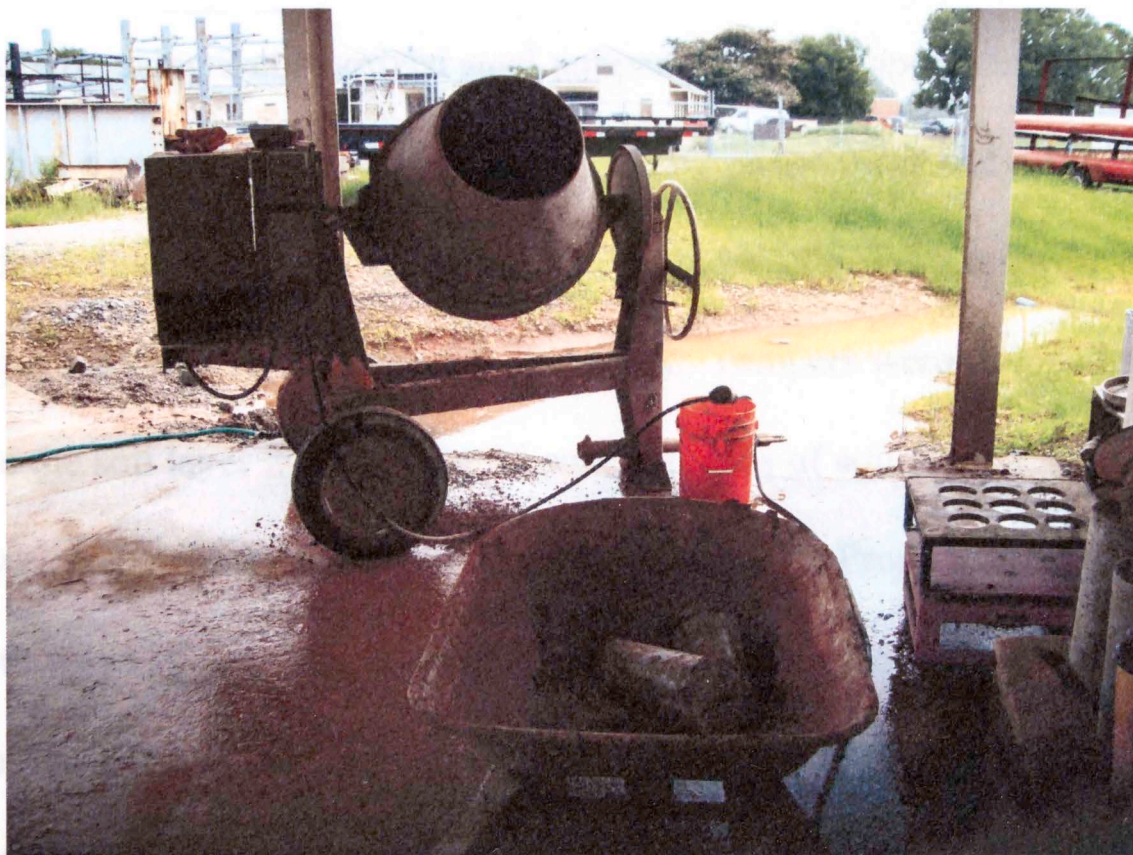
Figure 2.16: Vertical drum mixer, wheelbarrow and scoops for mixing and transporting
