SHAKE TABLE TESTING OF SCALED RAMMED EARTH MODELS

A THESIS

A THESIS APPROVED FOR THE
SCHOOL OF CIVIL ENGINEERING AND ENVIRONMENTAL
SCIENCE

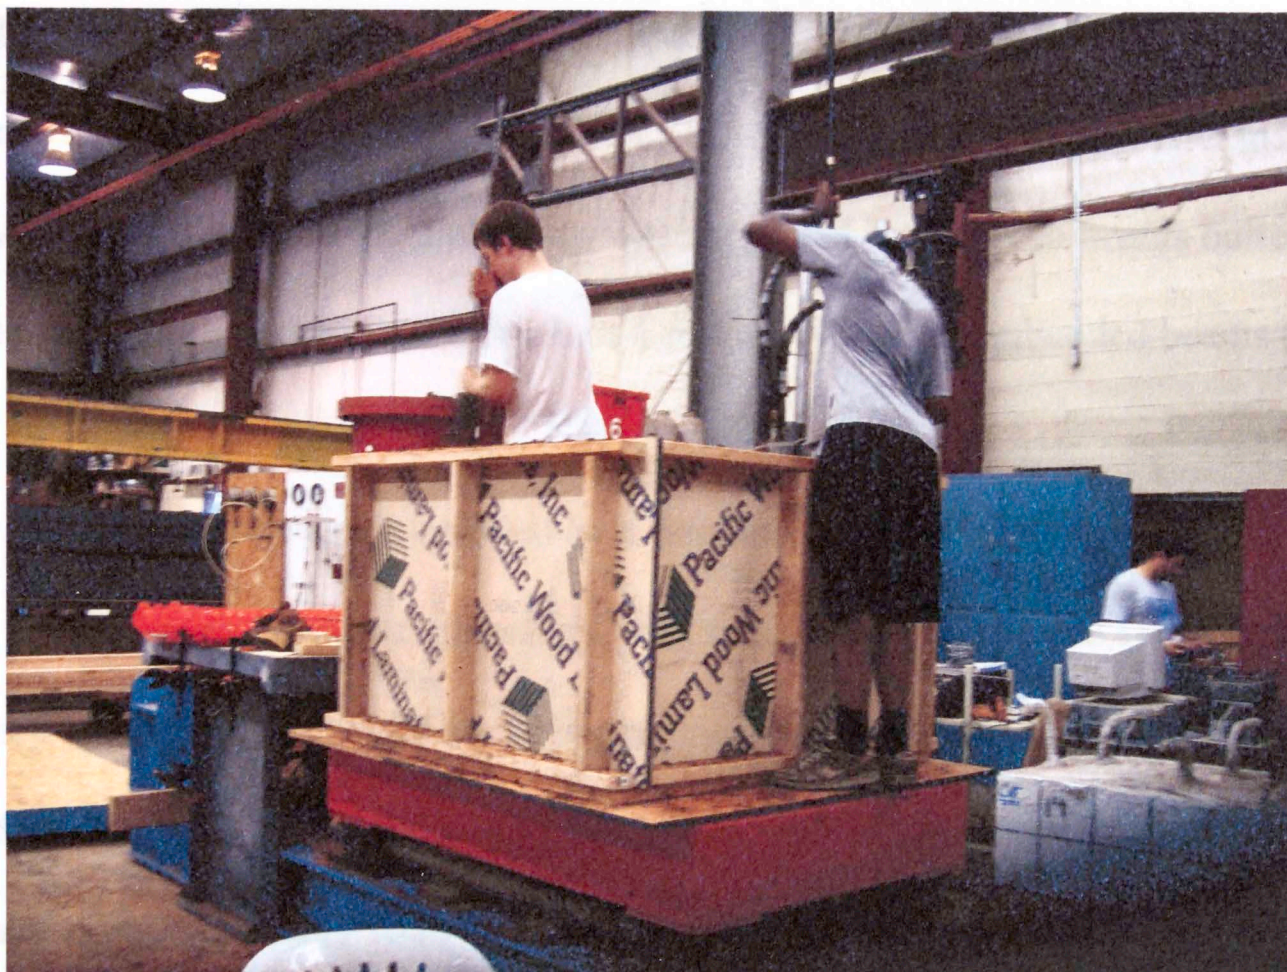
Figure 2.20: Compaction of soil with steel tampers

After mixing, the soil was transported with a wheelbarrow and gradually scooped, distributed and compacted into layers (**Figures 2.17** through **2.20**). Compaction was done manually by using 2 customized steel tampers weighing approximately 15 lbs each. One tamper had a rectangular footprint of 5inx6in while the other had a similar area but with a rounded-edge rectangular footprint. The rounded-edge tampers were cut from circular tampers in order to fit inside the formwork. Tampers were dropped at 6-12 inches above the soil layer 20 times per 36 square inches of soil area (Vargas, 1992). Each layer was approximately 2 in. thick after compaction. Projected density of the rammed earth was 130 pcf. The process of mixing and compaction was continuous and ranged from 6 to 12 hours of work, depending on the number people assisting. Because of the heavy materials and constant manual labor, it was impossible to maintain a

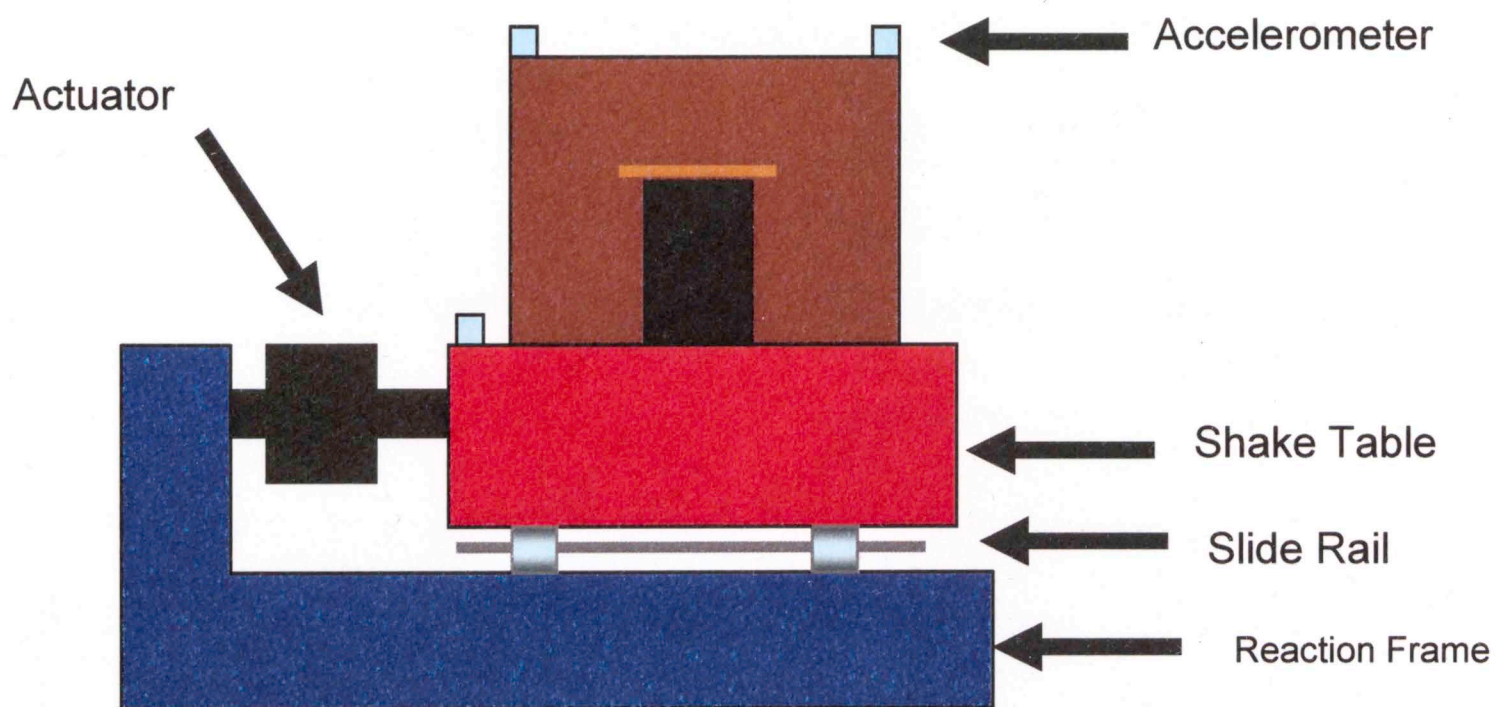
Figure 2.21: Elevation view sketch of test setup

Before each shaketable test, pictures were taken of each wall of the model. Any pre-existing cracks were outlined with a marker, and each wall was labeled as North, South, East or West. After each test, more pictures were taken of each wall of each model to record locations of all visible cracks. Sketches and photographs of the test setup are provided in **Figures 2.21** through **2.23**.

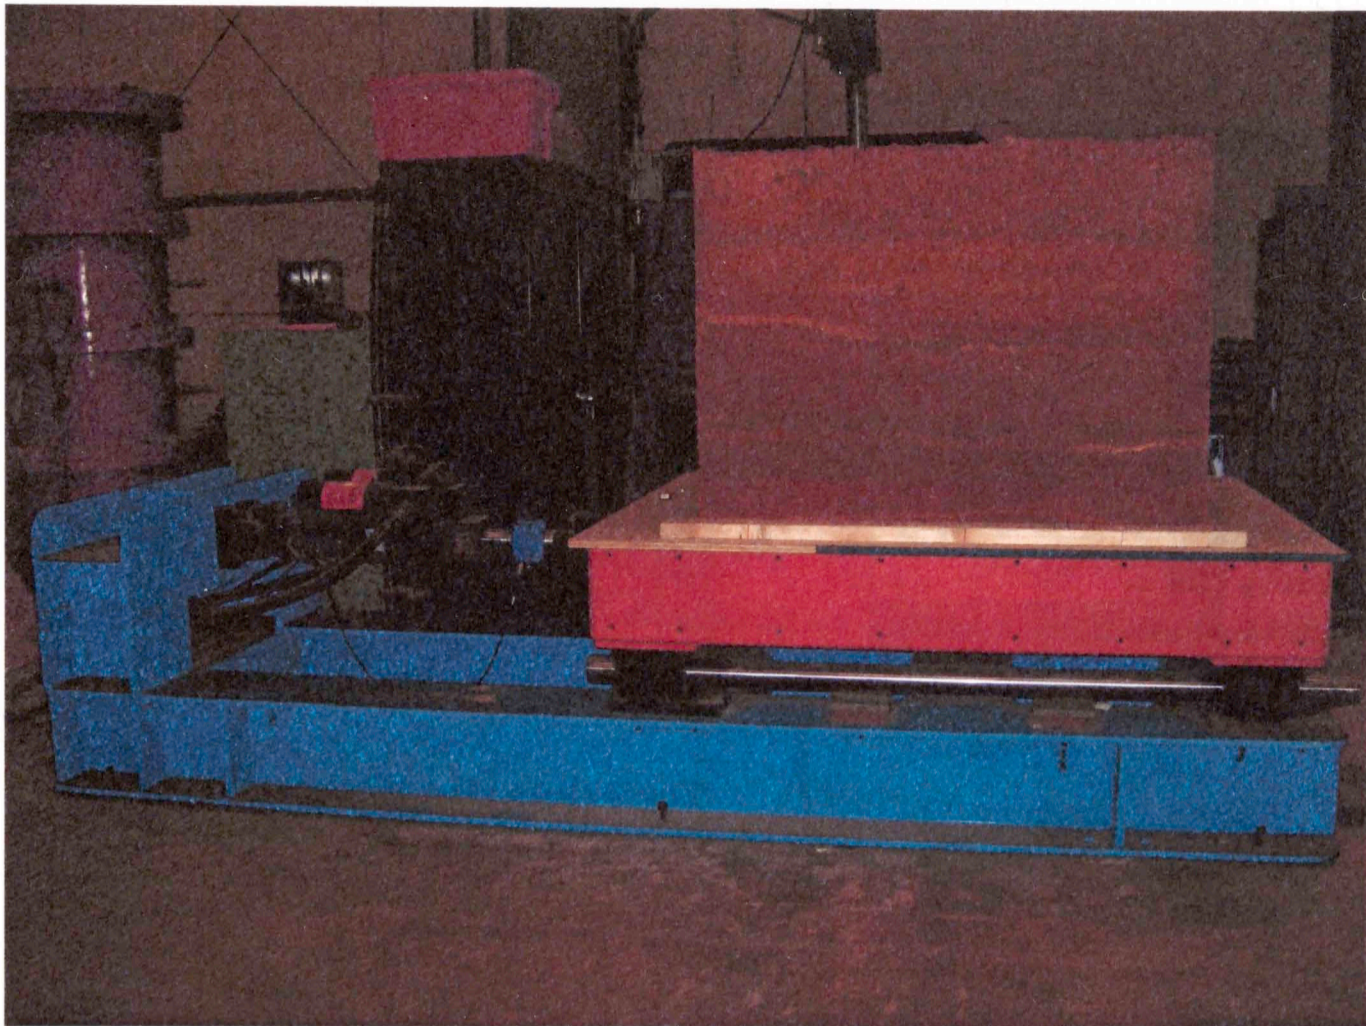
Figure 2.22: Photograph of test setup

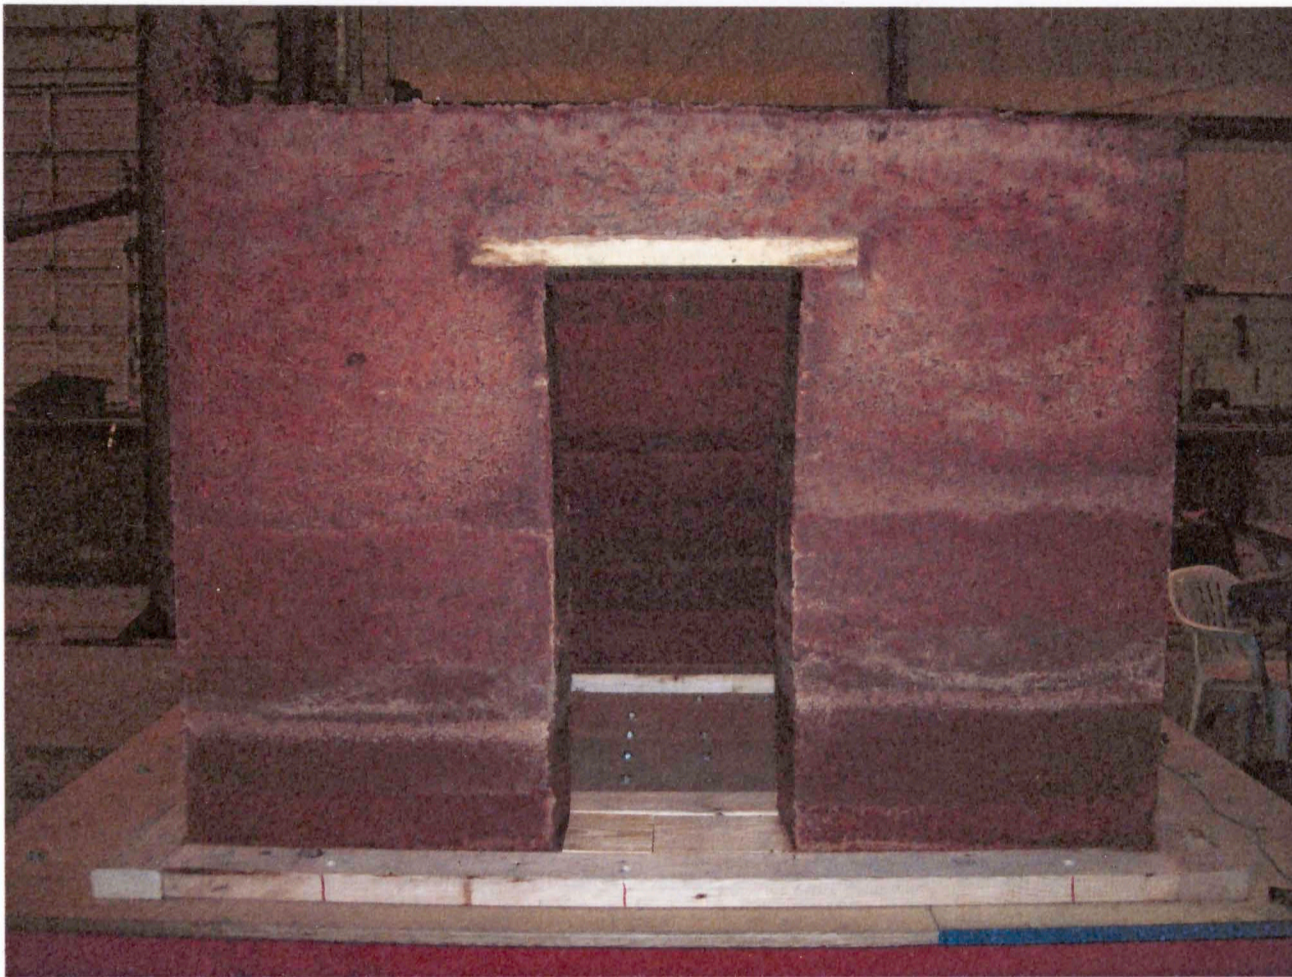
Figure 3.1: Test 1 view of east wall before test

Prior to testing, the door opening was bowed and exhibited a few shrinkage cracks (**Figure 3.1**). The fundamental frequency was measured between 5Hz and 6Hz. Test 1

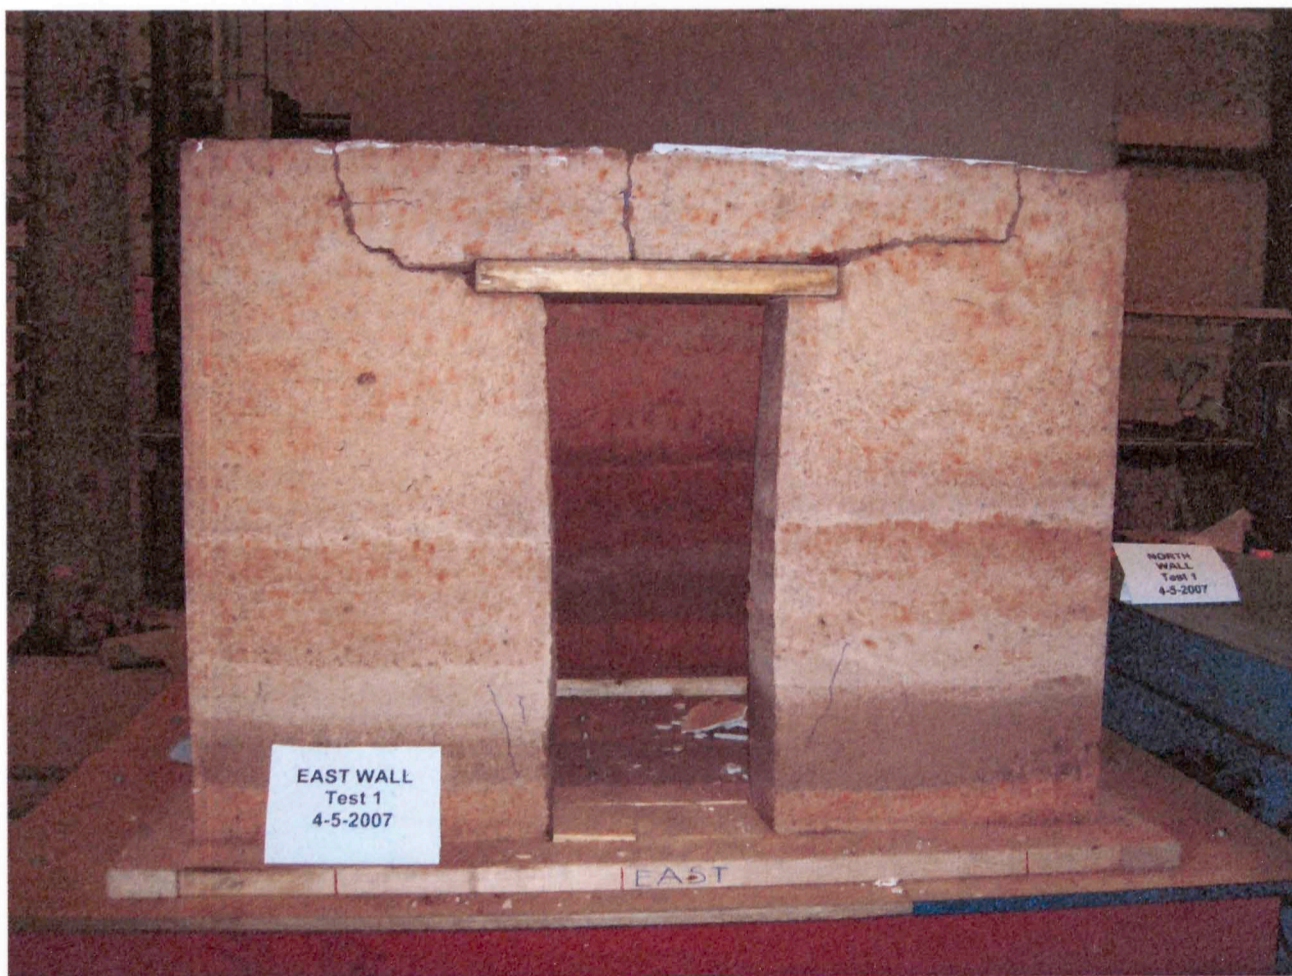
Figure 3.2: Test 1 cracks above lintel in east wall after test

Figures 3.2 through 3.5 show the failures observed on the east wall. The diagonal crack north of the lintel continued until it reached the reentrant corner at the

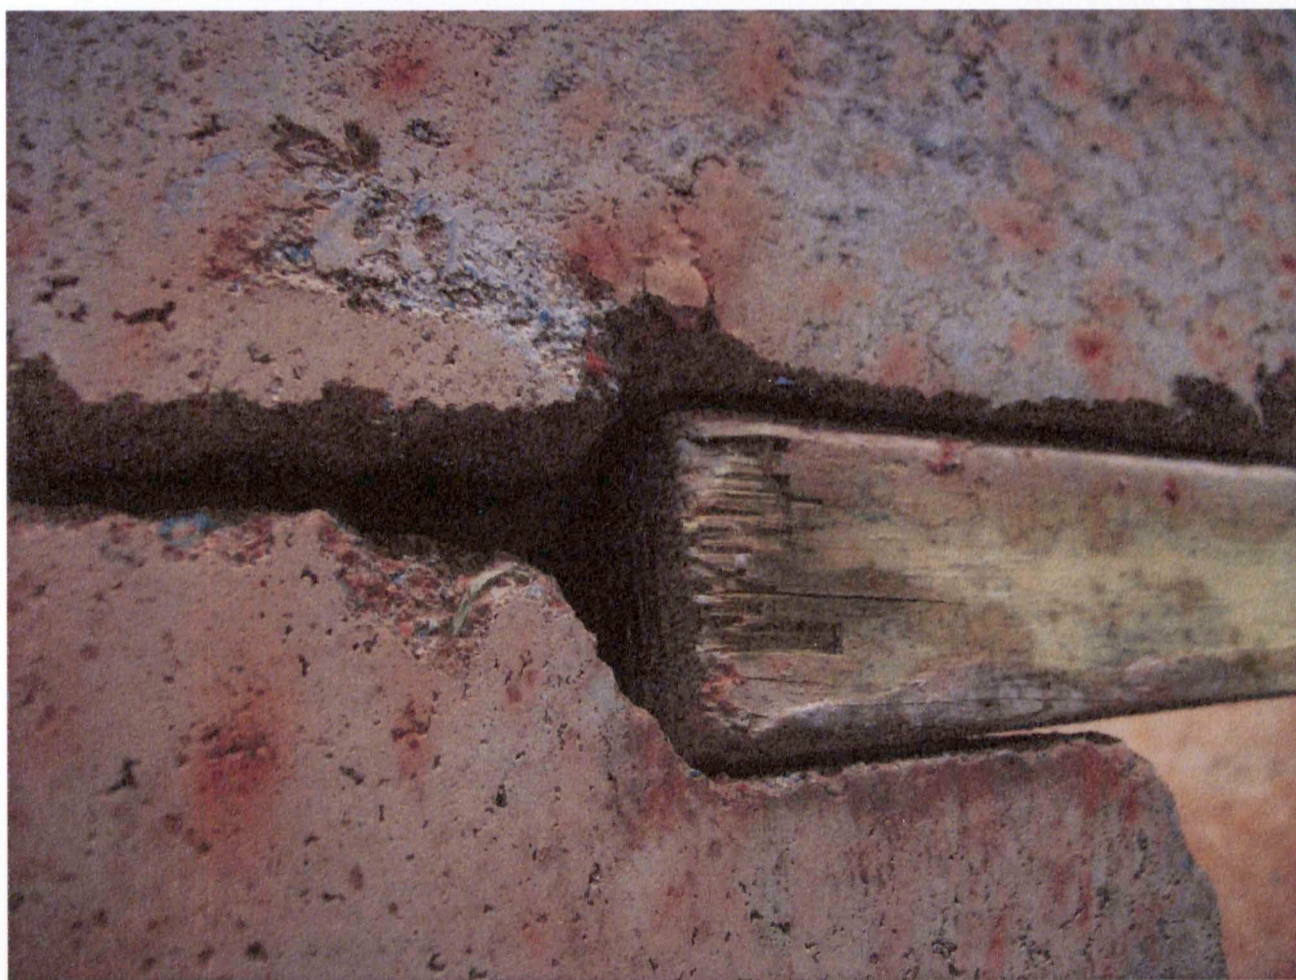
Figure 3.4: Test 1 closeup view of exterior crack near lintel

northeast end of the model. A close-up view was taken at the exterior wall on the southeast corner, near the lintel, where the cracks eroded during testing (**Figure 3.4**). Also found along the cracked surfaces were isolated “balls” of silt as seen in **Figure 3.5**. The silt was originally recorded to have a low plasticity, and the balls of silt were easily crushed between the fingers. **Figure 3.13**. The collapse of the lintel was apparent at

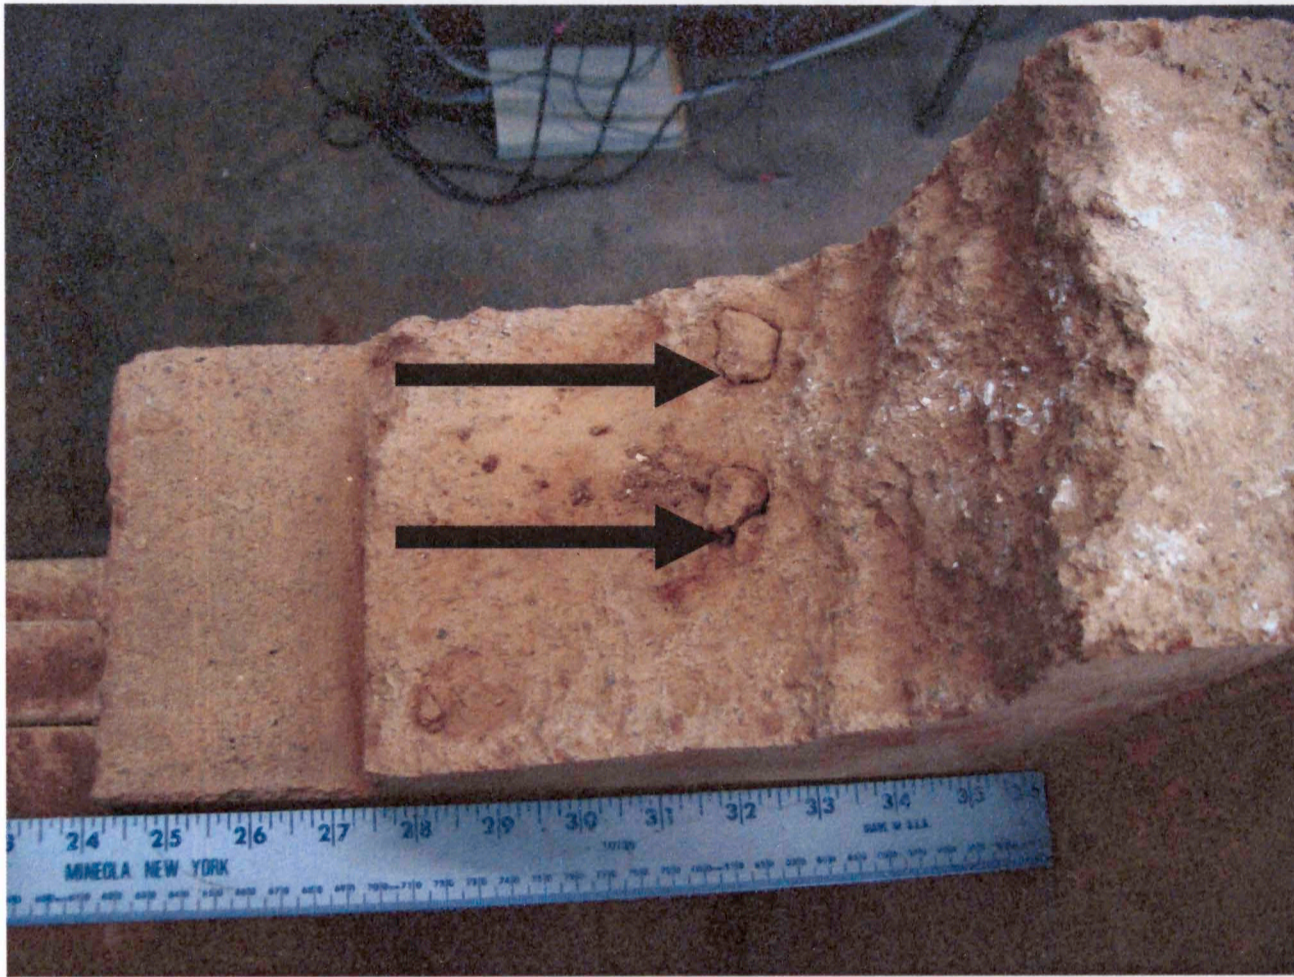
Figure 3.5: Test 1 view of two balls of silt along cracked surface in SE corner

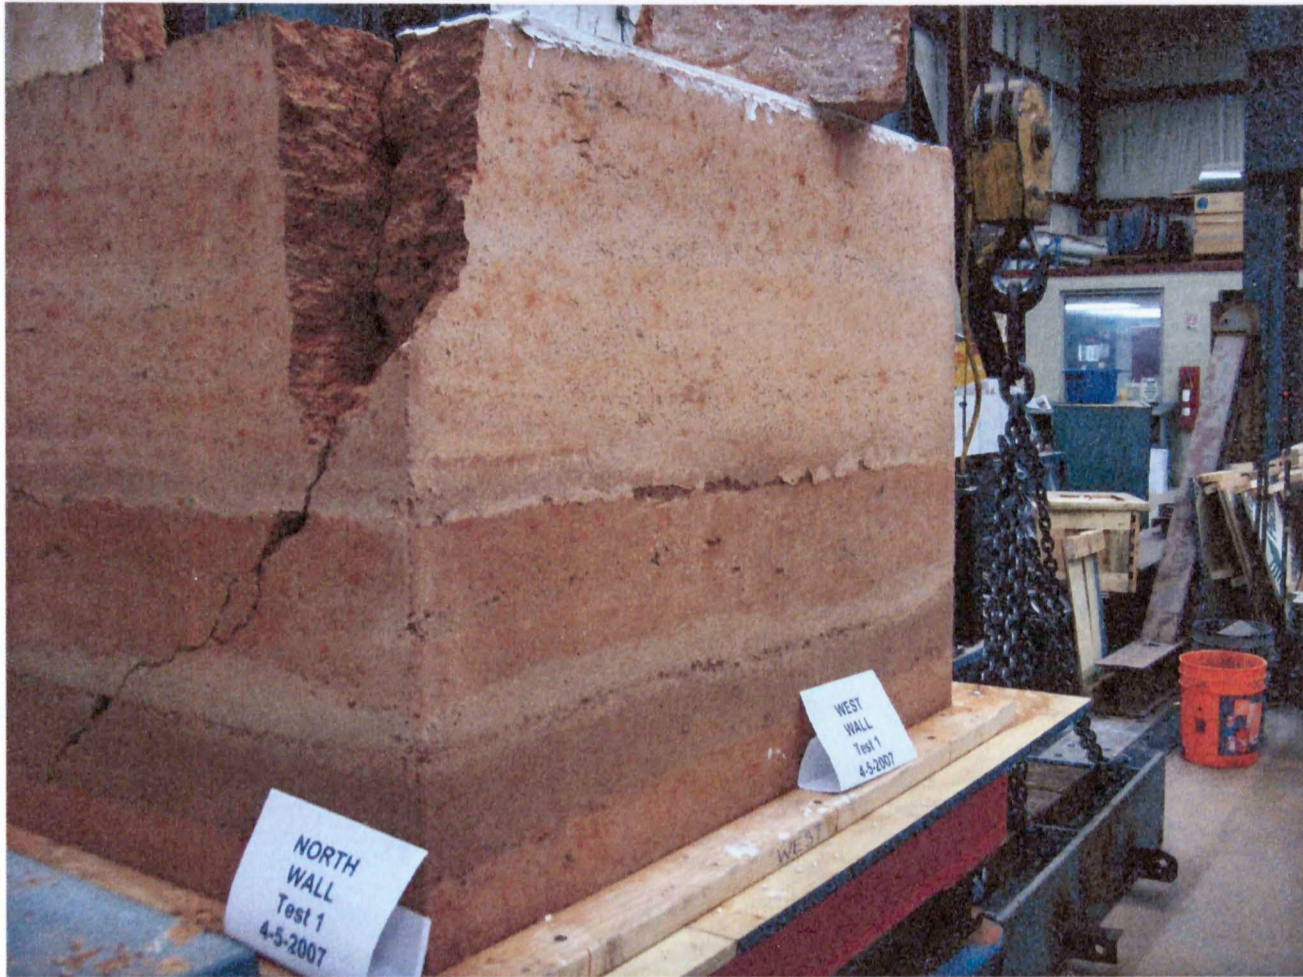
Figure 3.7: Test 1 elevation view of cracked northwest corner after test

Failure at the northwest corner of the model was localized, as seen in **Figures 3.7 and 3.8**. Vertical cracks were contained above the midheight of the model, as seen in **Figure 3.9**. A diagonal crack occurred at the lower half of the north wall. On the outside of the north wall, the diagonal crack was approximately at a 45 degree angle (**Figure 3.10**). Upon inspection of the interior of the north wall, the crack was horizontal along the grey third layer, or the layer in which the clay was omitted (**Figure 3.11**). The transition from a diagonal crack on the north wall to a vertical crack at the reentrant corner occurred approximately at midheight of the northwest corner. Rammed earth layers were visibly less defined above midheight of the model (**Figure 3.8**).

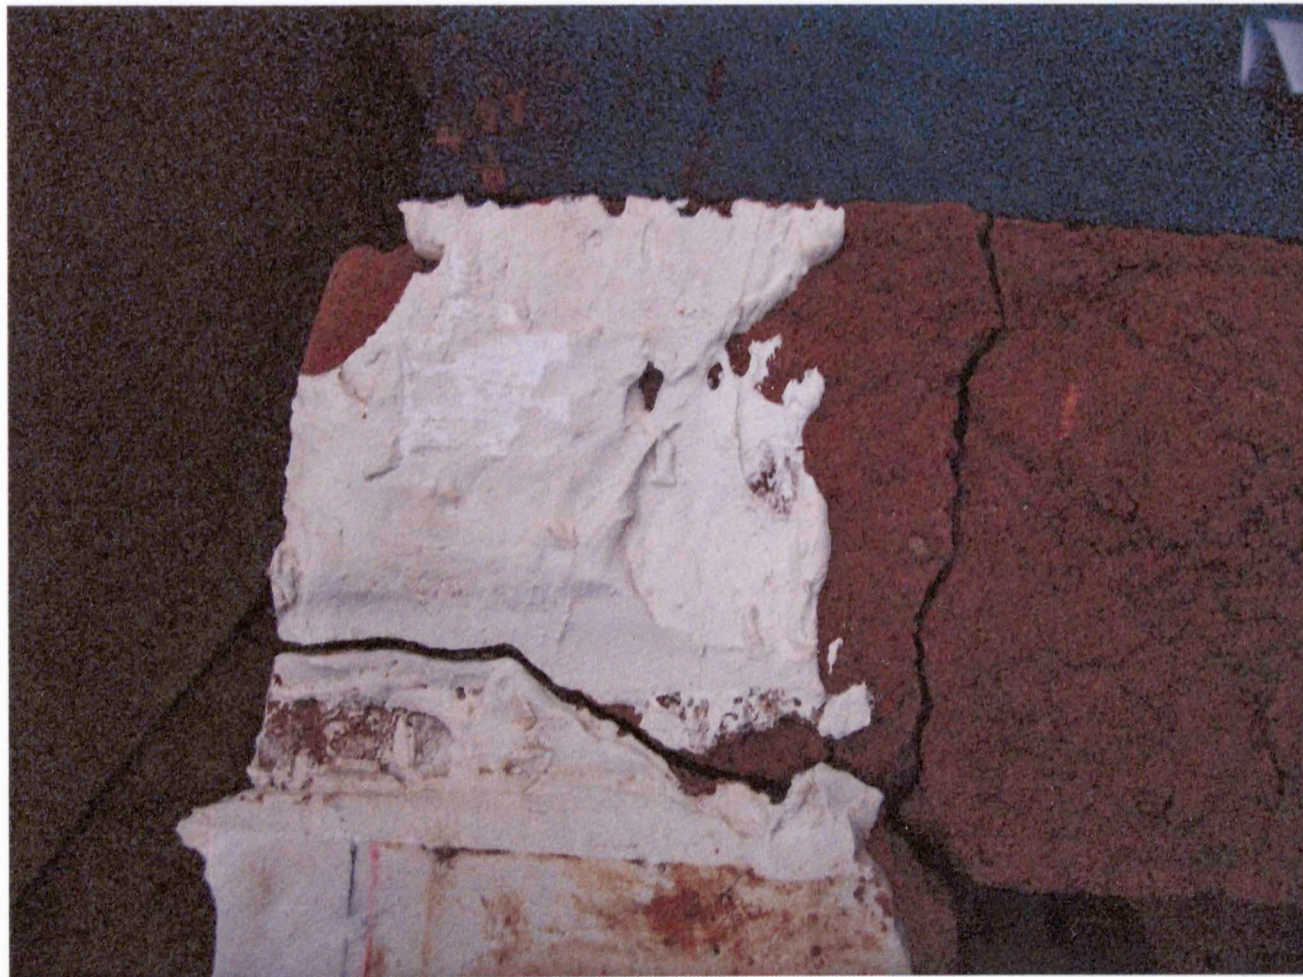
Figure 3.8: Test 1 plan view above cracked northwest corner of north wall

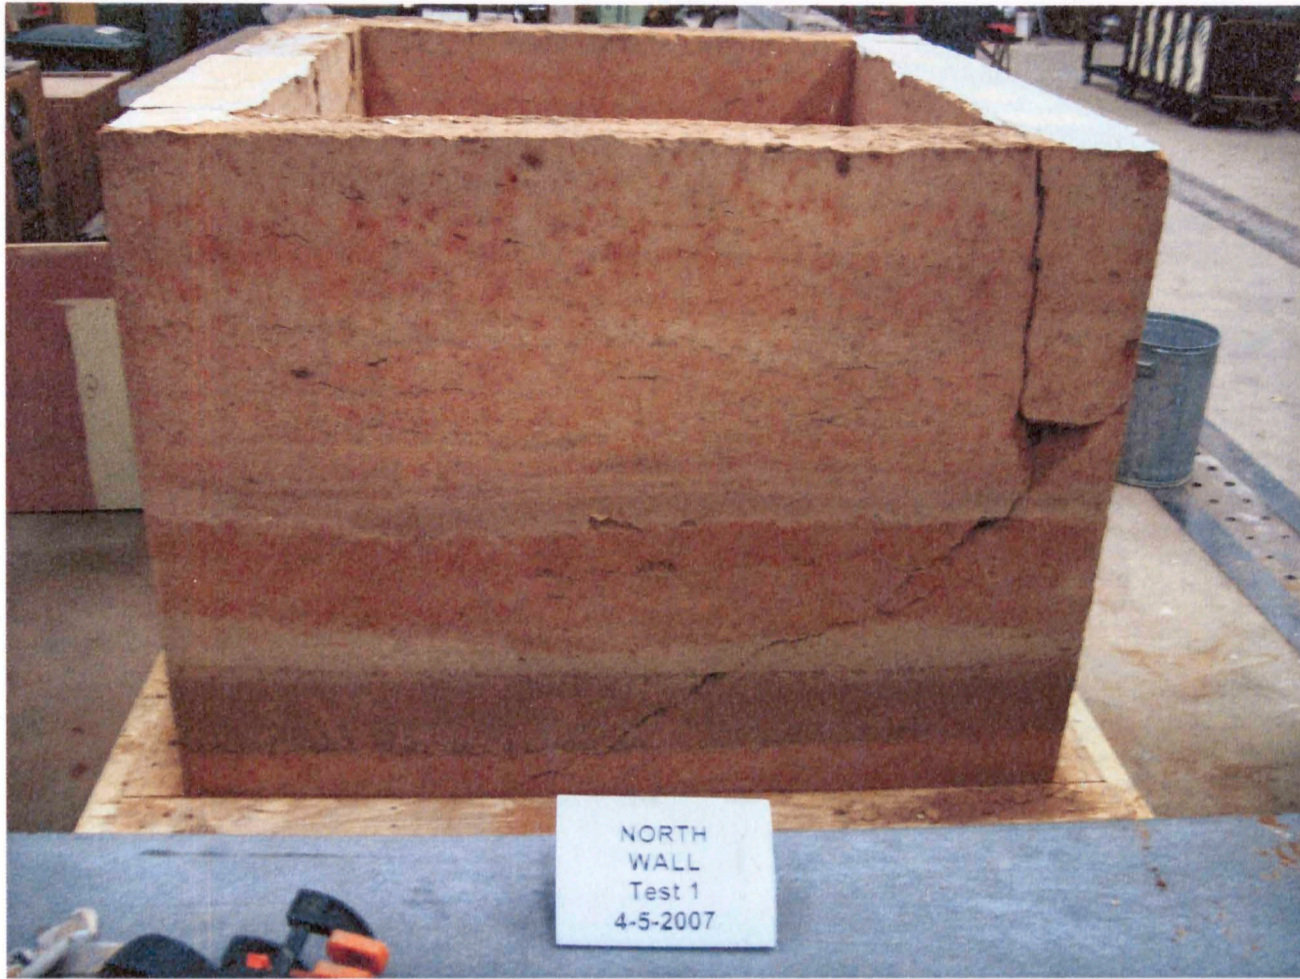
Figure 3.9: Test 1 diagonal crack on exterior north wall

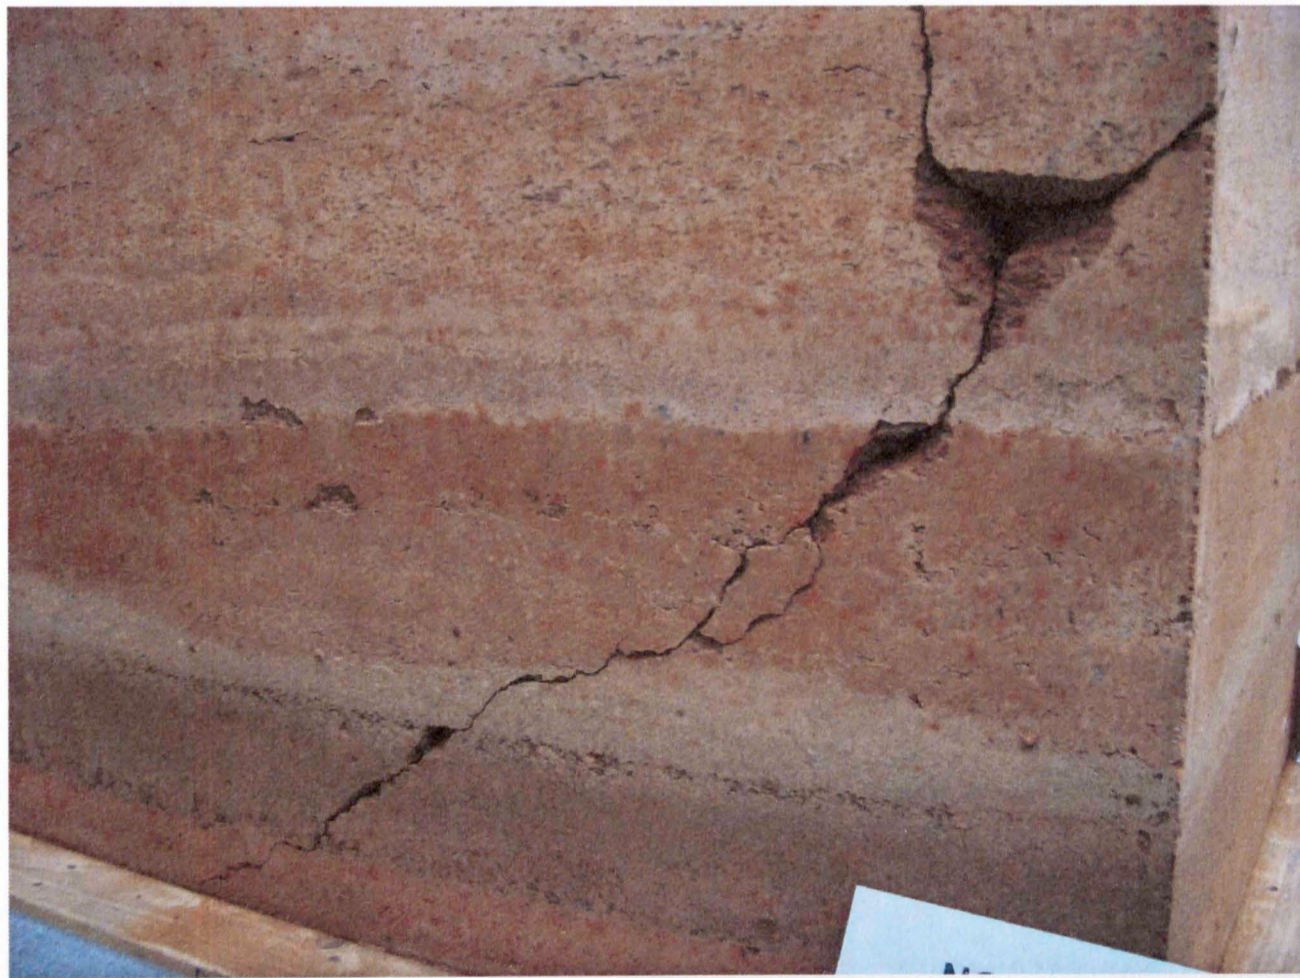
Figure 3.10: Test 1 close up of diagonal crack in lower half of north wall

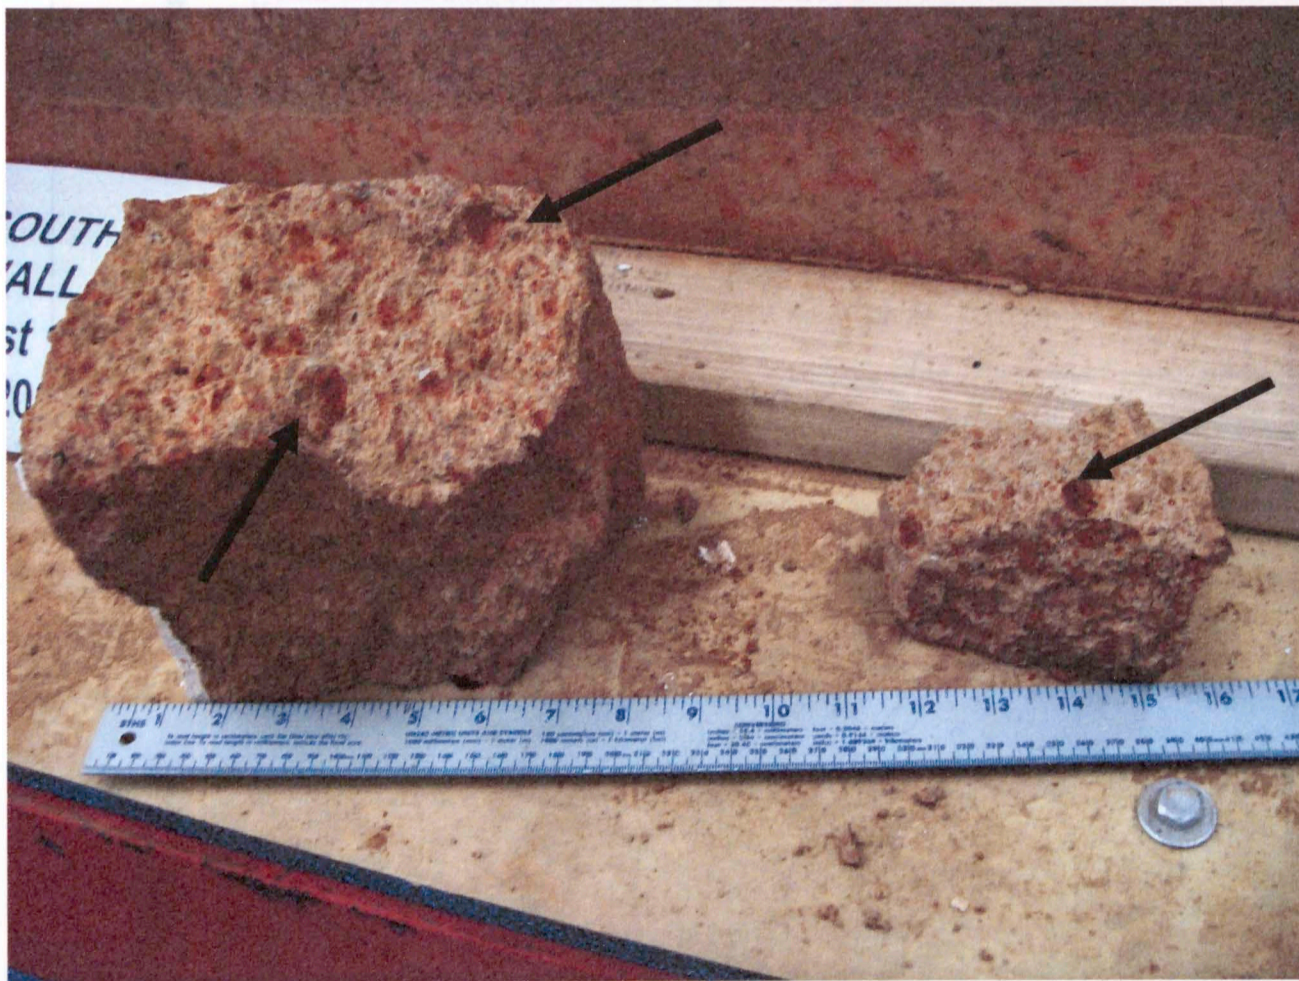
Figure 3.12: Test 1 post-test fragments with large clumps of red clay

During demolition, the model separated along two horizontal layers. The first separation was at midheight of the model—the location where the model was left to air-dry for 1-2 hours, and the second separation occurred between the first and second layers where there was an elapsed time of 30 minutes between compaction of layers. The bottom of the second layer was not well compacted and predominantly consisted of $\frac{1}{2}$ in. diameter balls of silt. Portions of rammed earth were collected and observed to contain large balls of the red clay and silt (**Figure 3.12**). Both the balls of clay and silt were soft and easily crushed between the fingers.

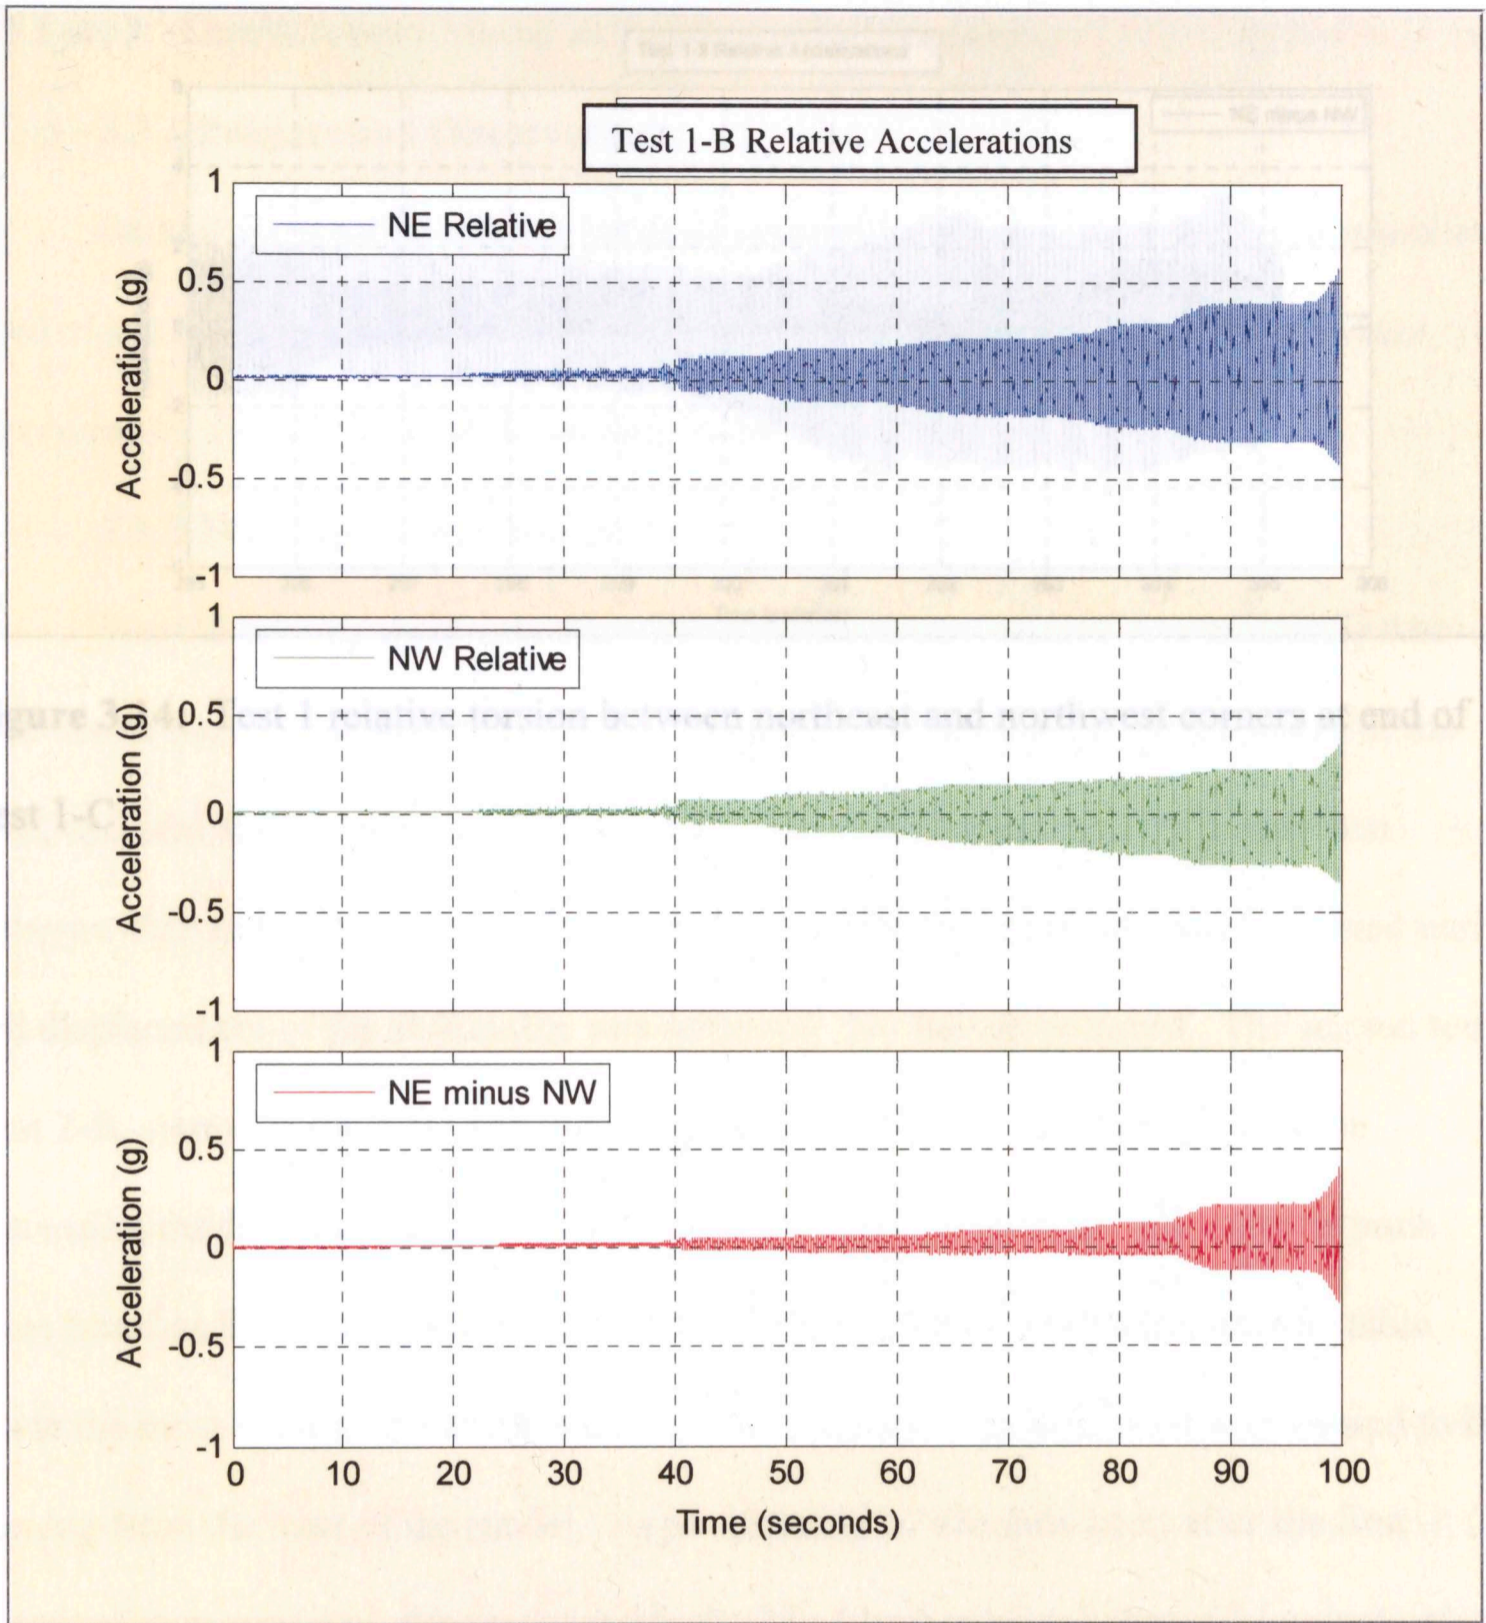
Figure 3.13: Test 1 accelerations at beginning of Test 1-B

In viewing the plotted data from the beginning of Test 1-B, the northeast corner reflected a higher acceleration during most of the test. When plotting the relative accelerations between the northeast and northwest corners, a disparity was visible starting at approximately 90 seconds (**Figures 3.13**). The collapse of the lintel was apparent at approximately 300 seconds where the accelerations at the northeast corner increased sharply from 2 g to 4 g. After the lintel fell at 300 seconds, the disparity between the northeast and the northwest corner increased even further. Because the accelerometer fell with the northwest corner, the signals to all accelerometers were lost. Correlating the video with the accelerometer data, the loss of signal was apparent at 305 seconds (**Figure 3.14**).

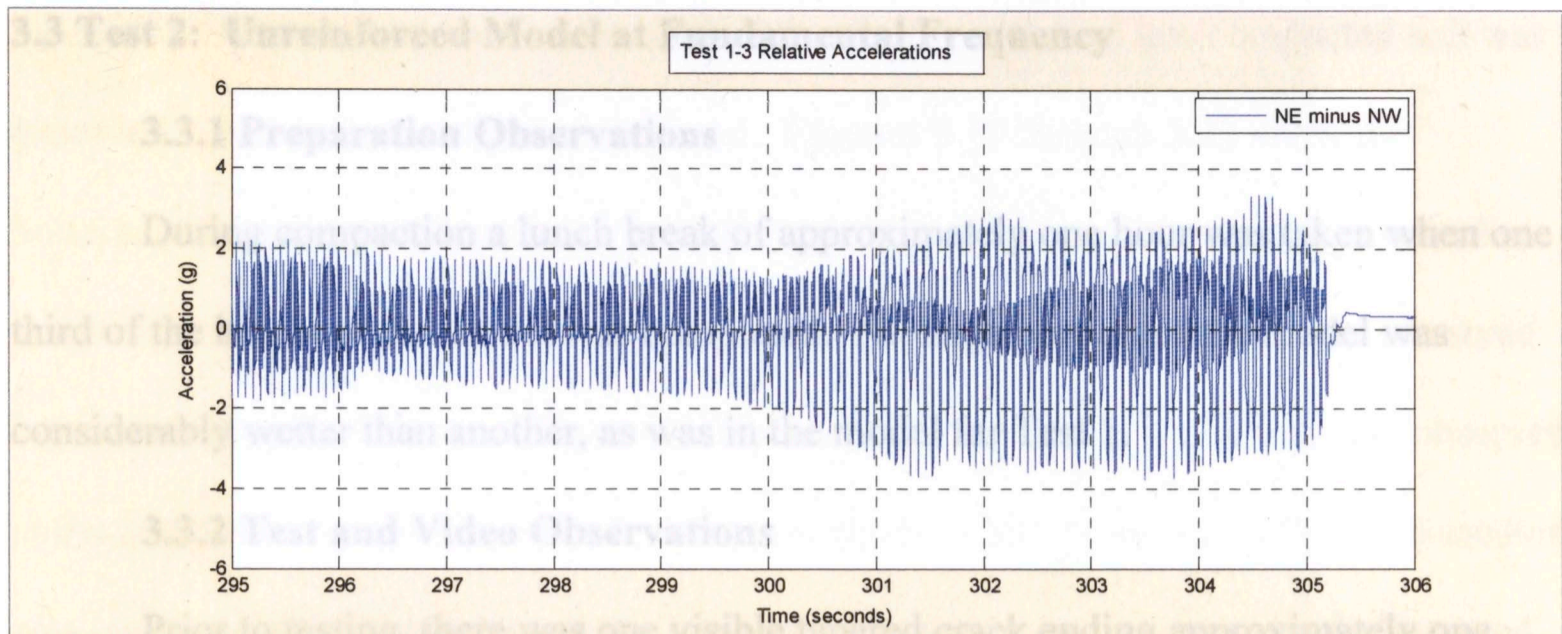
Figure 3.14: Test 1 relative torsion between northeast and northwest corners at end of Test 1-C

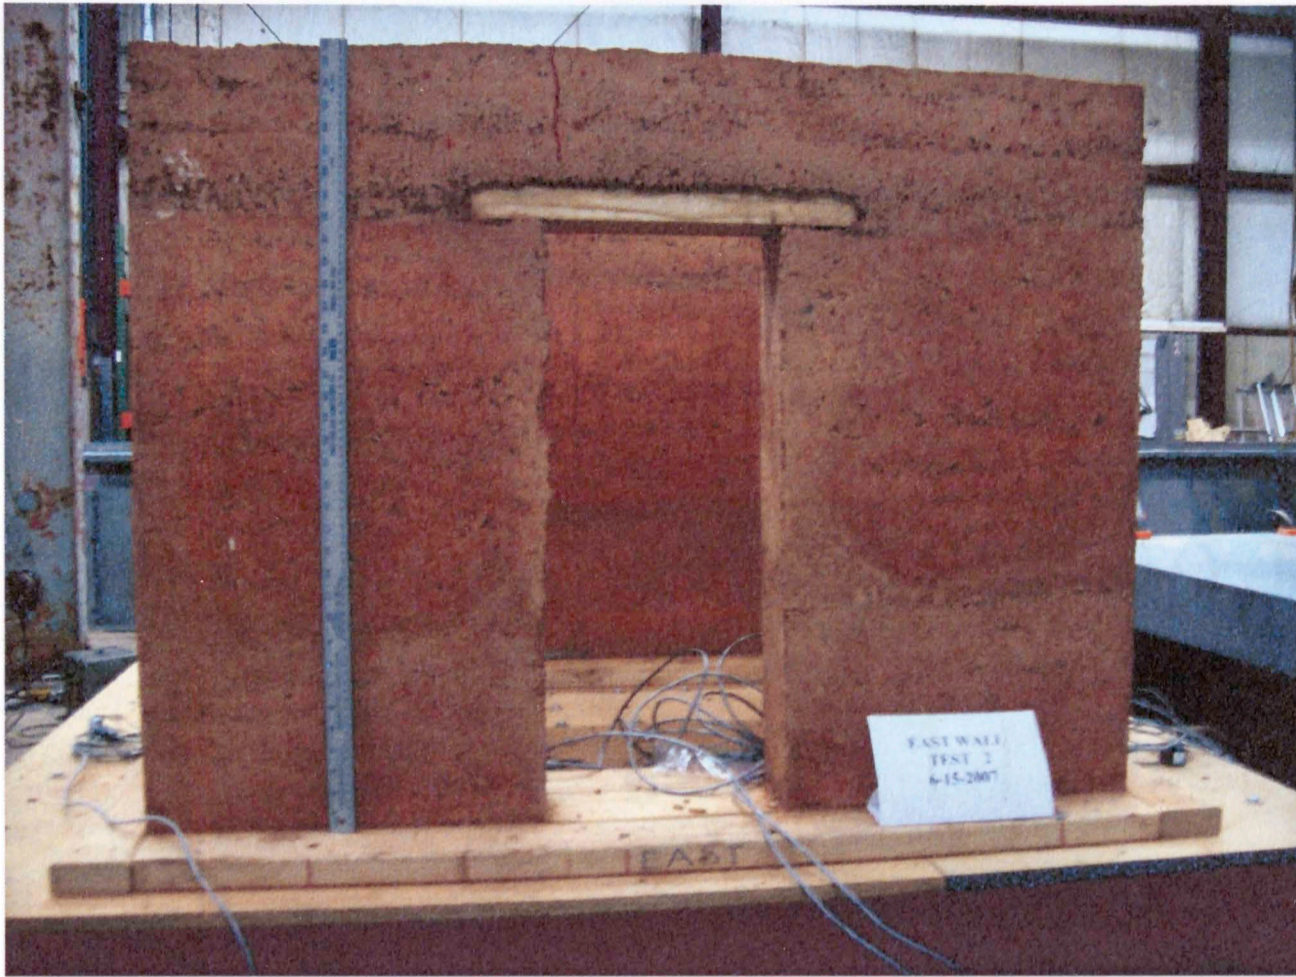
Figure 3.16: Test 2 Interior view of east wall with cracks above lintel and delamination

The tapered crack above the lintel prior to testing had fully propagated to the top of the lintel (**Figure 3.16**). In addition, a diagonal crack formed at the corner of the door opening towards the northeast corner of the model as seen in **Figures 3.17**. Unlike the

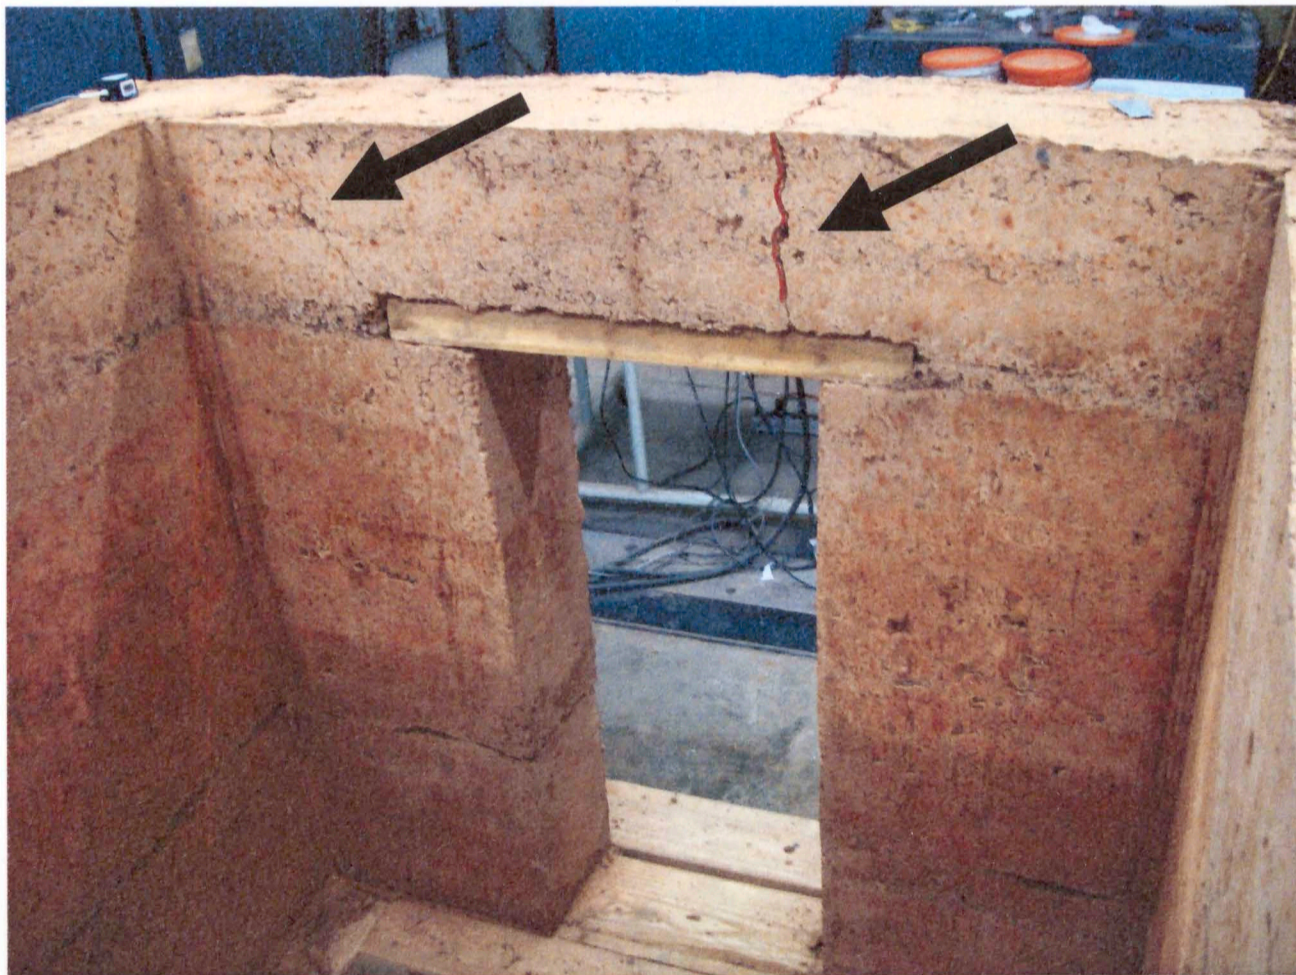
Figure 3.15: Test 2 east wall before test (initial crack above lintel outlined in red) *less compacted soil adjacent to edge of lintel*

Prior to testing, there was one visible tapered crack ending approximately one inch above the lintel (**Figure 3.15**). The crack penetrated through the thickness of the wall, and was slightly wider at the top. The measured fundamental frequency was between 4Hz and 6Hz. Test 2-A began at 4 Hz, while the amplitude was increased until full displacement of the shaketable was achieved. No failure occurred. The second test, Test 2-B, started at the 4 Hz and maximum displacement of the shaketable while increasing the frequency by 2 Hz approximately every 30 seconds. Changes in pitch were heard as the shaking transitioned from 8 Hz to 10 Hz. The model and the table made the most noise at the transition to 12 Hz. Ten seconds later, dust was viewed to be coming from the base of the model. Approximately 17 seconds later, after the first clouds of dust appeared, the model suddenly failed by horizontal shear (delamination) at all of the walls towards the lower third of the height of the model (at the cold joint).
