SHAKE TABLE TESTING OF SCALED RAMMED EARTH MODELS

A THESIS

A THESIS APPROVED FOR THE
SCHOOL OF CIVIL ENGINEERING AND ENVIRONMENTAL
SCIENCE

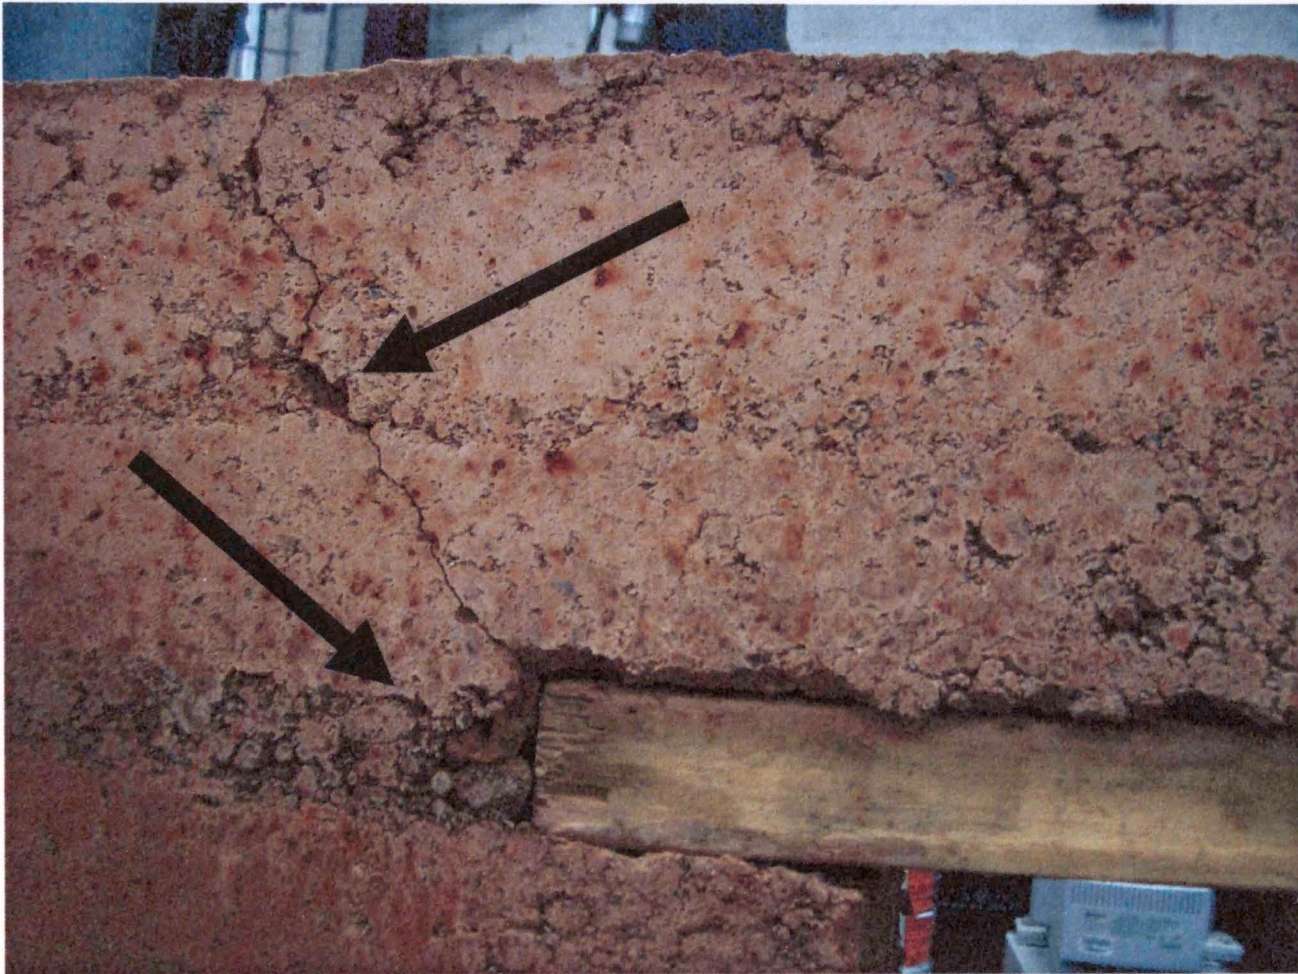
Figure 3.16: Test 2 Interior view of east wall with cracks above lintel and delamination

The tapered crack above the lintel prior to testing had fully propagated to the top of the lintel (**Figure 3.16**). In addition, a diagonal crack formed at the corner of the door opening towards the northeast corner of the model as seen in **Figures 3.17**. Unlike the

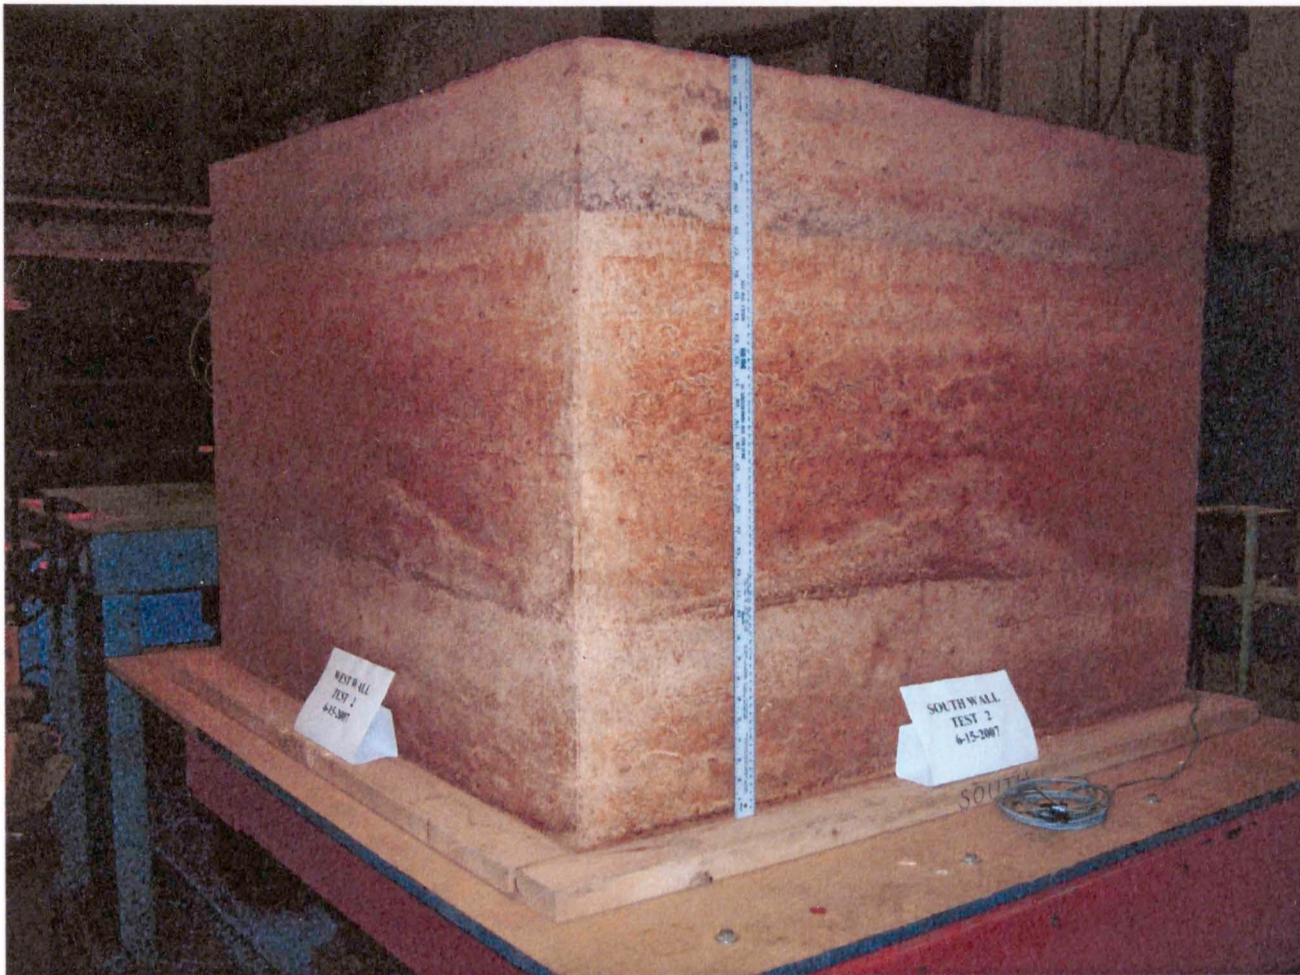
Figure 3.21: Test 2 delamination along south and east walls after test

model for Test 1, cracks were more vertical than horizontal, and less compacted soil was observed adjacent to the edges of the lintel. **Figures 3.19 through 3.23** show the horizontal delaminated layer at the same elevation on all sides of the model. Vertical cracks approximately 3 inches from each exterior corner of the west wall were observed below the delaminated layer (**Figures 3.24 and 3.25**). A vertical crack was also observed at the northwest reentrant corner. With the exception of the delaminated layer, no erosion was observed in the cracks above the lintel or along the base of the west wall. Rammed earth near the delaminated layer spalled near the outer surface of the wall. No other cracks were observed. During demolition, the rammed earth above the delaminated layer remained fully intact and was difficult to break. Later in the demolition process, the upper 12 inches separated from the southeast corner.

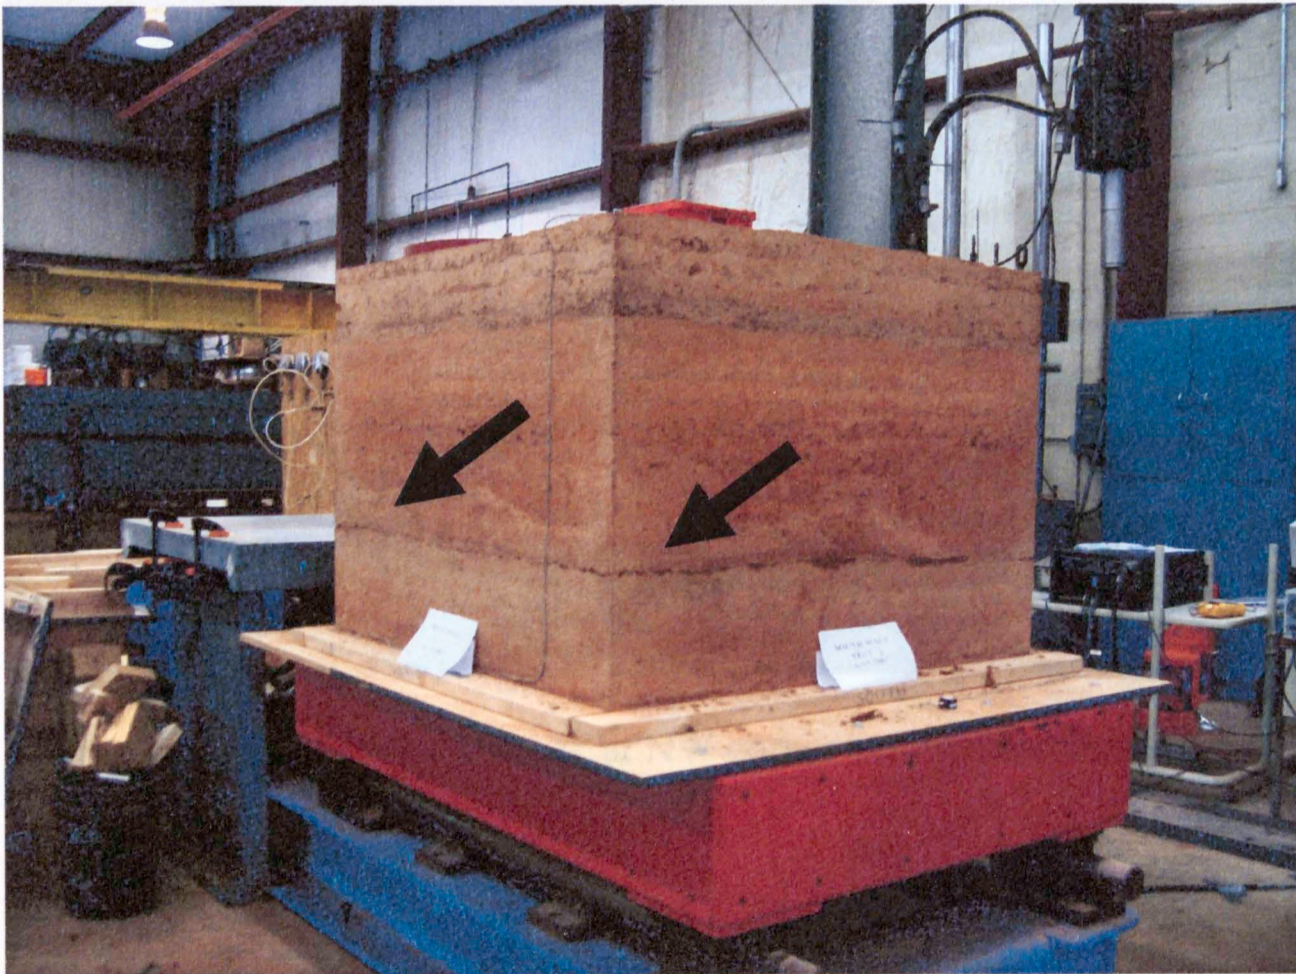
Figure 3.22: Test 2 view of west and south walls before test

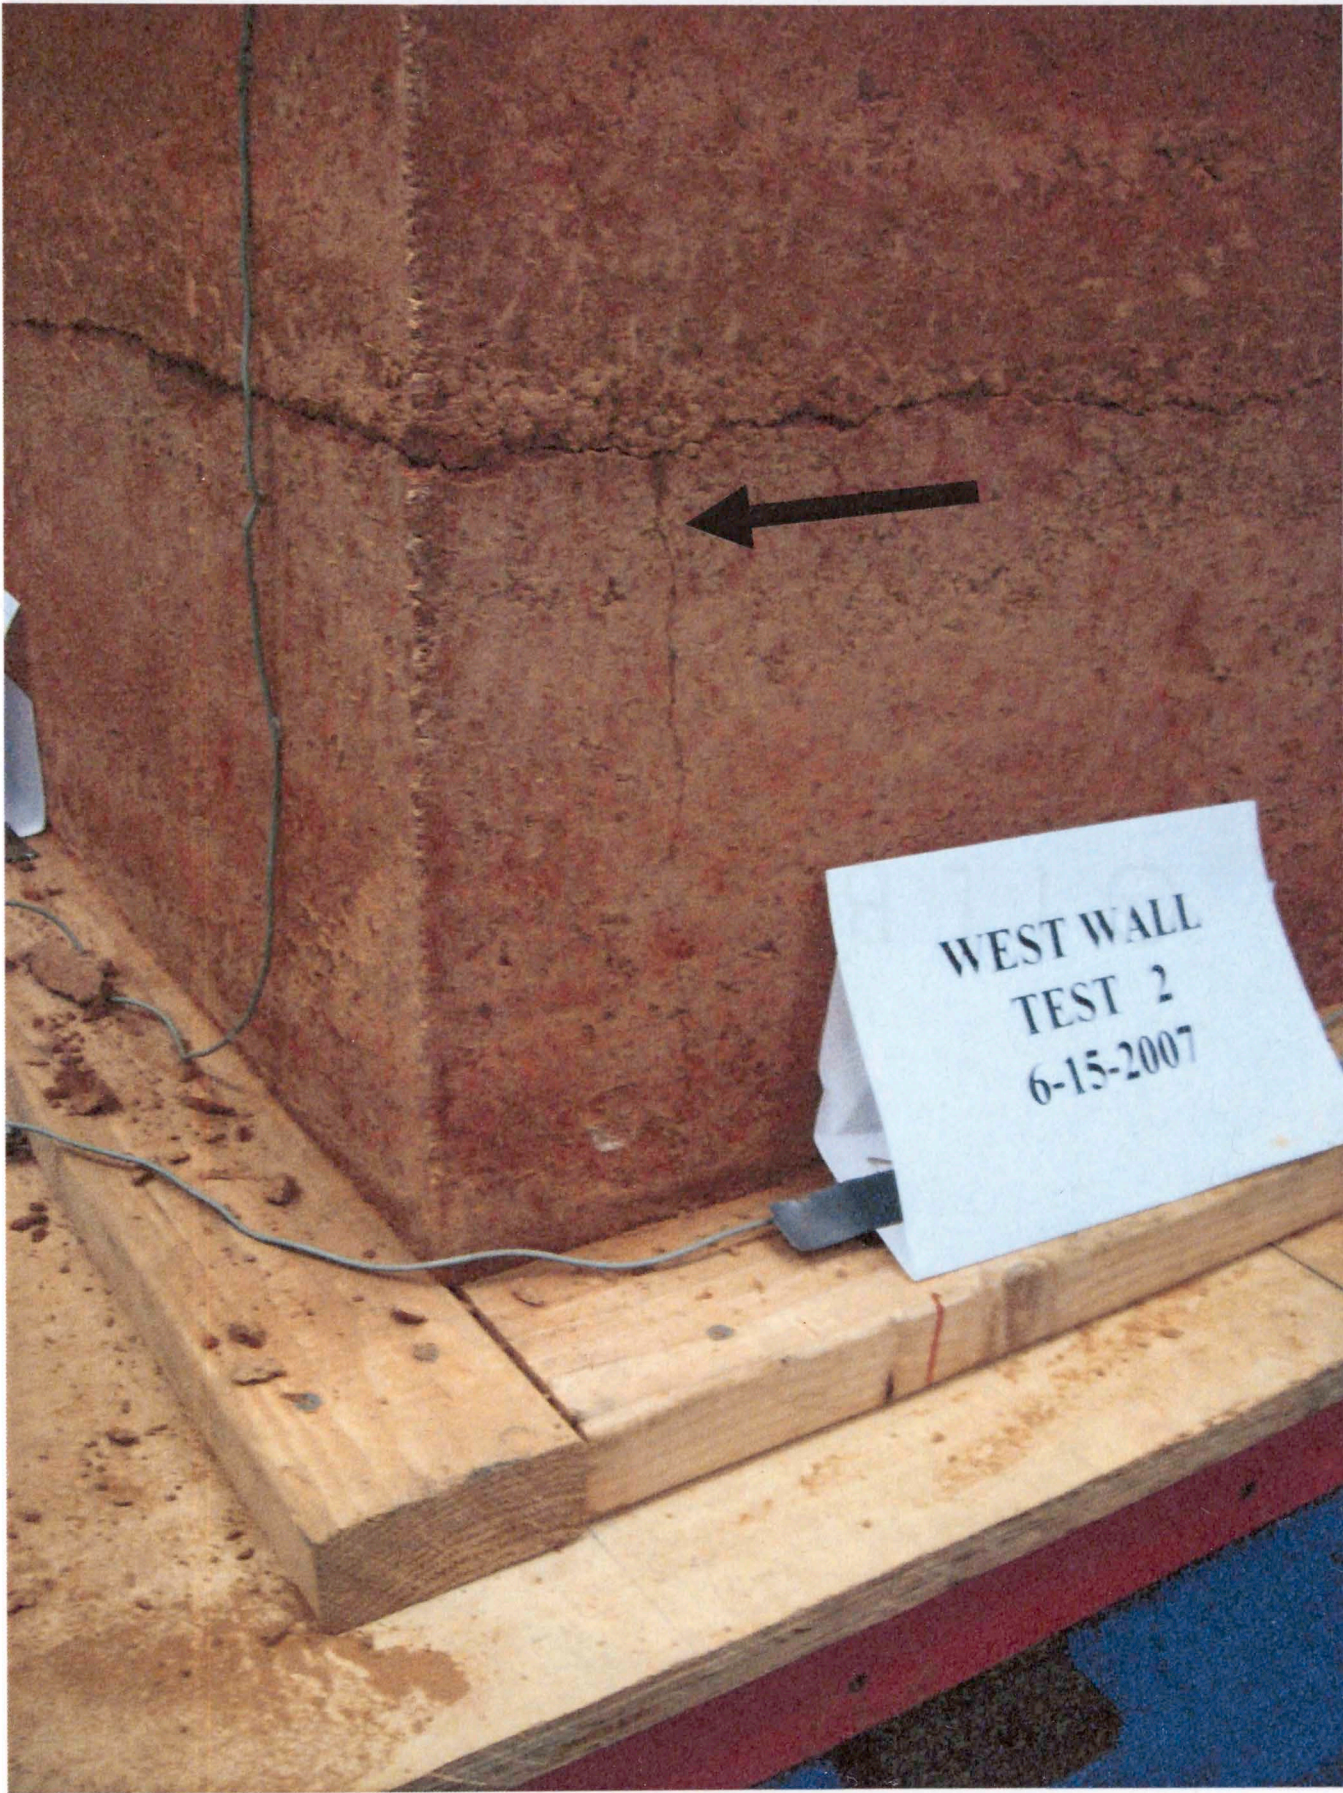
Figure 3.23: Test 2 delamination along west and south walls after test

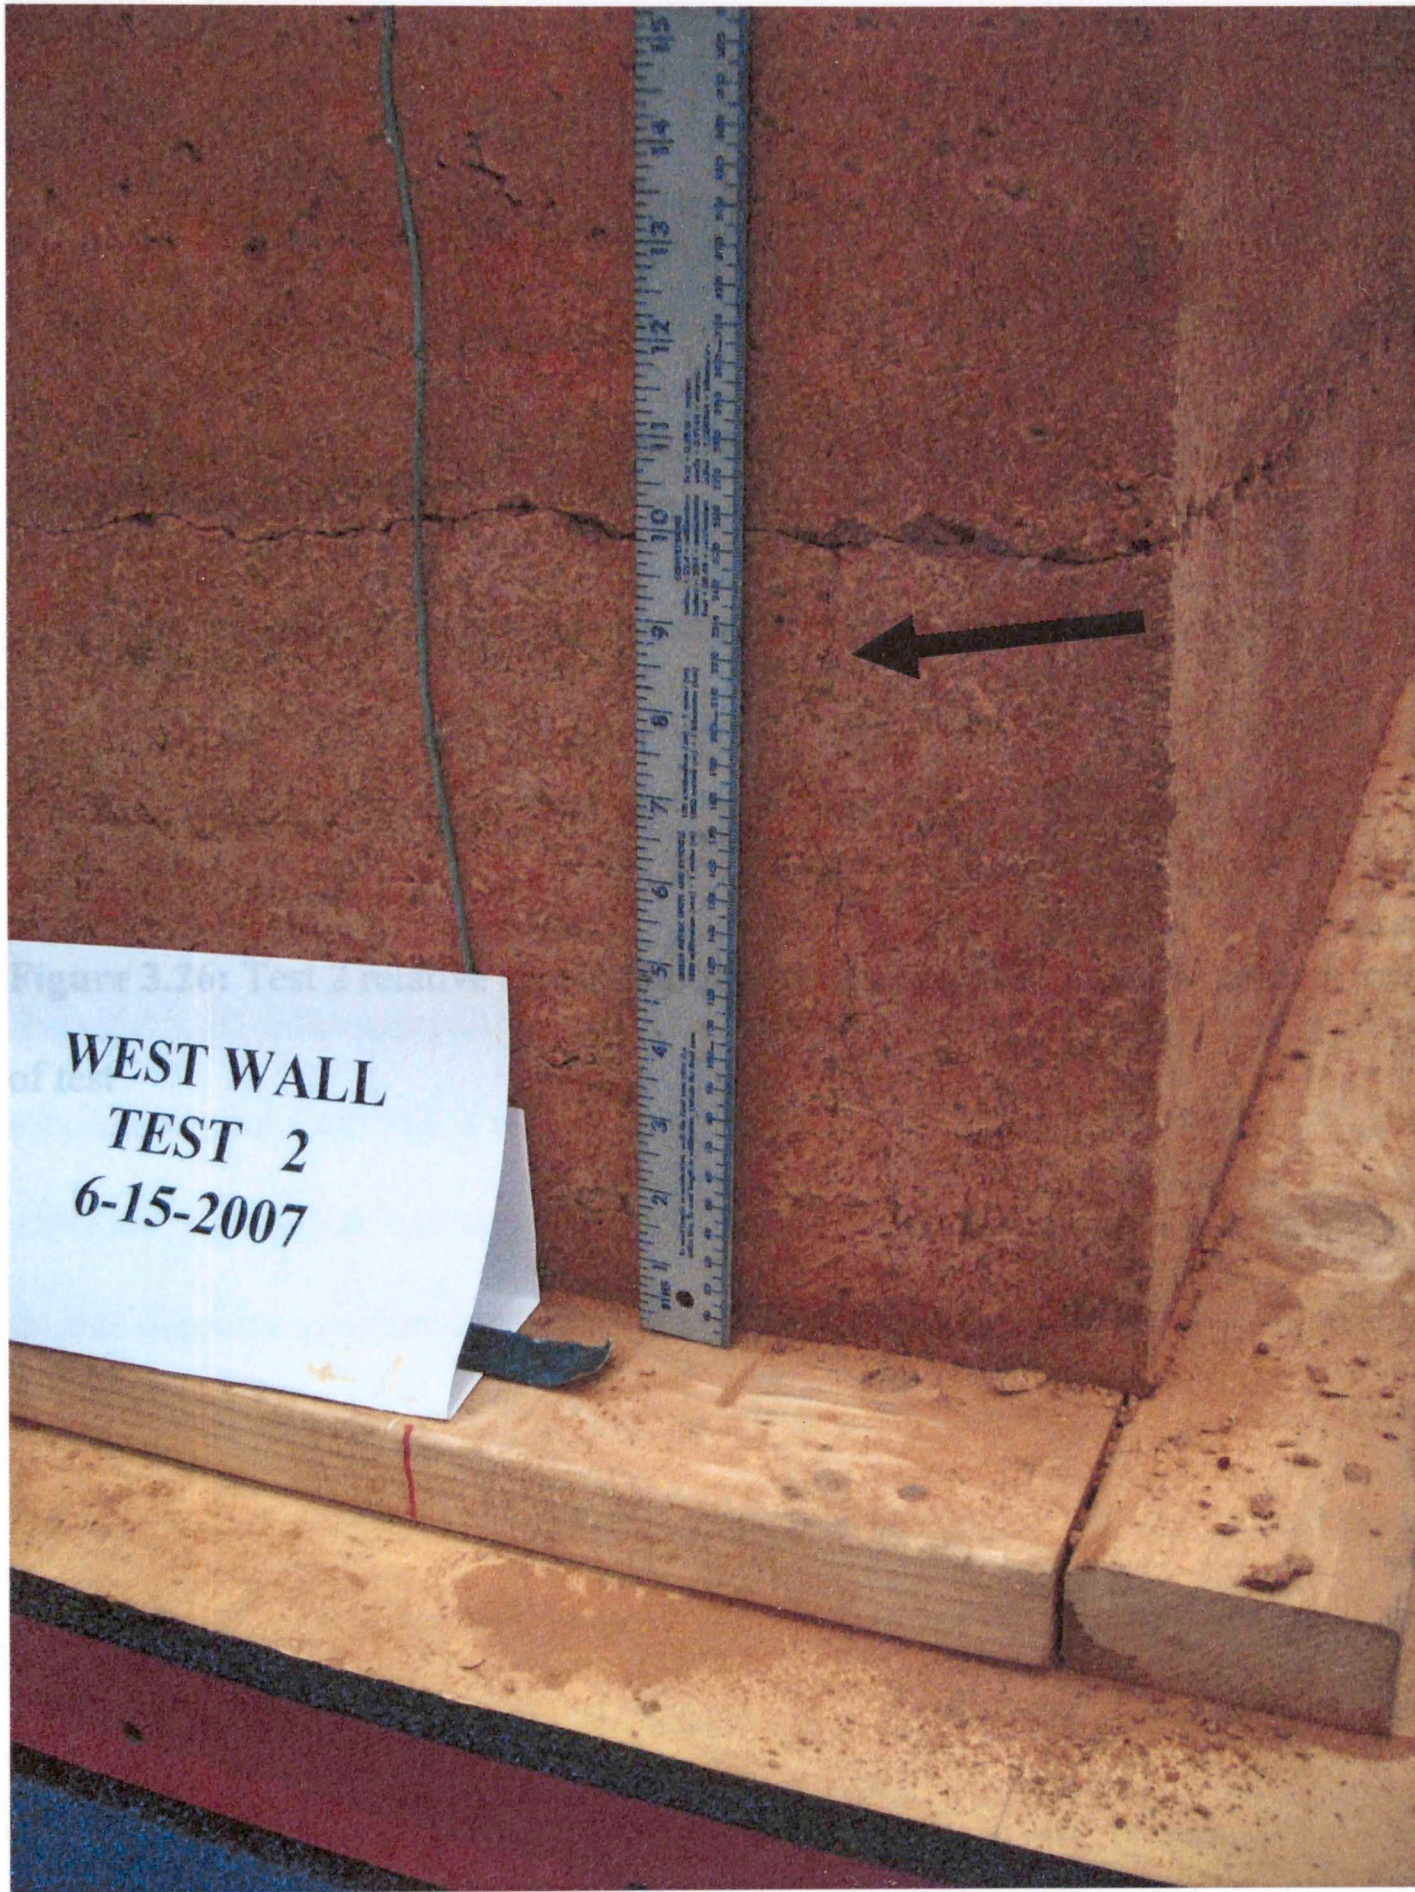
Figure 3.24: Test 2 vertical crack at NW corner below delaminated layer

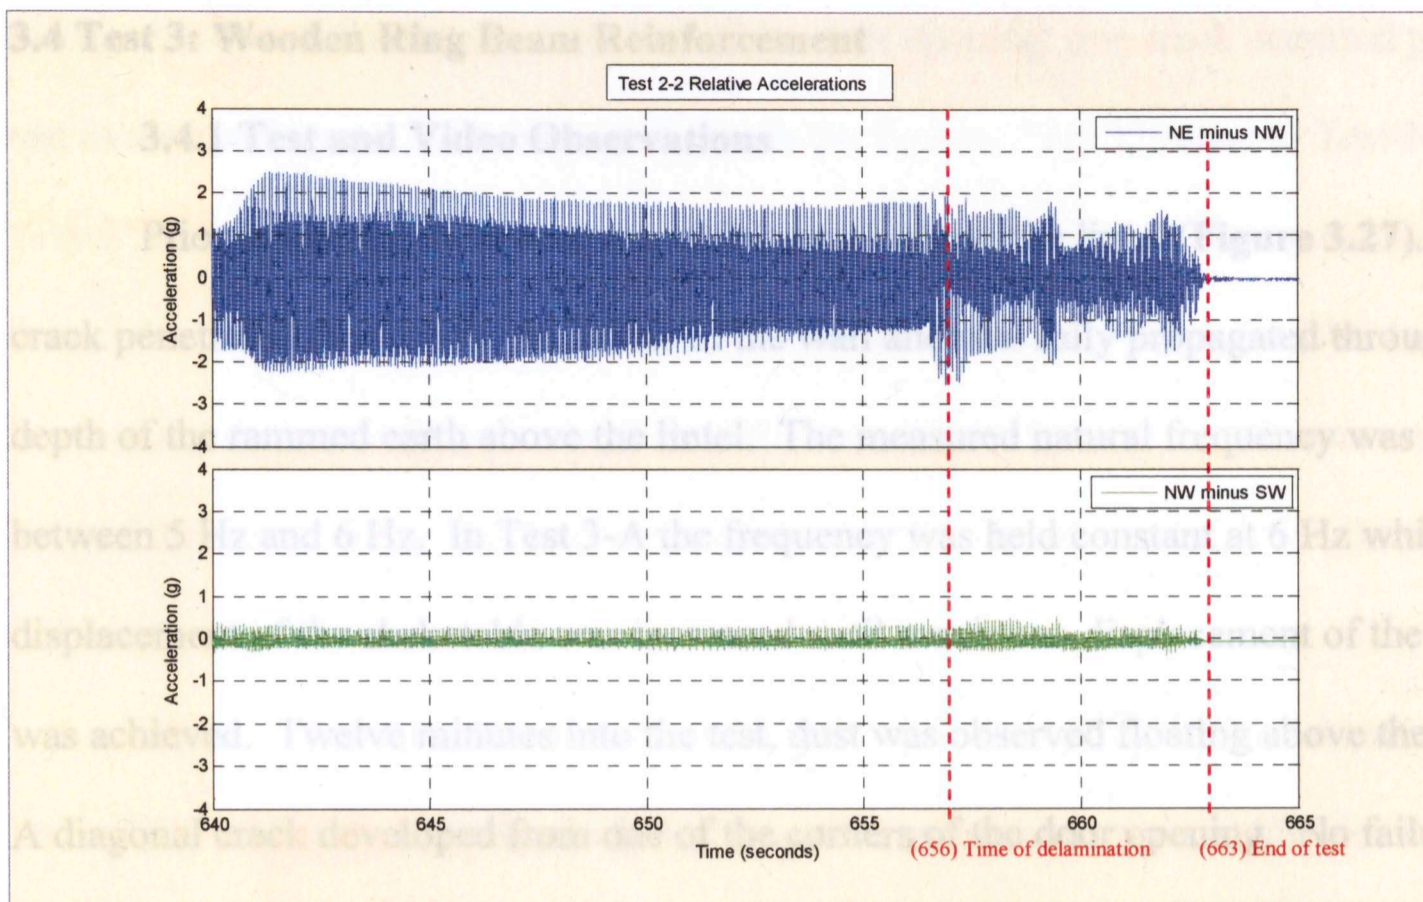
Figure 3.25: Test 2 vertical crack at SW corner below delaminated layer

Figure 3.26: Test 2 relative accelerations between NE, NW, and SW corners towards end of test

At approximately 640 seconds, the northeast corner exhibited an increase in relative acceleration at 10 Hz. Delamination of the model occurred at approximately 656 seconds while the model was at 12 Hz. In plotting the relative accelerations between the corners (**Figure 3.26**) the northeast and the northwest corners of the model were moving in opposite directions before and after failure, although after failure the accelerations appeared more erratic. The northwest and southwest corners remained synchronized throughout the test, and reflected a difference close to zero. Elapsed time between the delamination and the end of the shaketable movement was about 7 seconds.

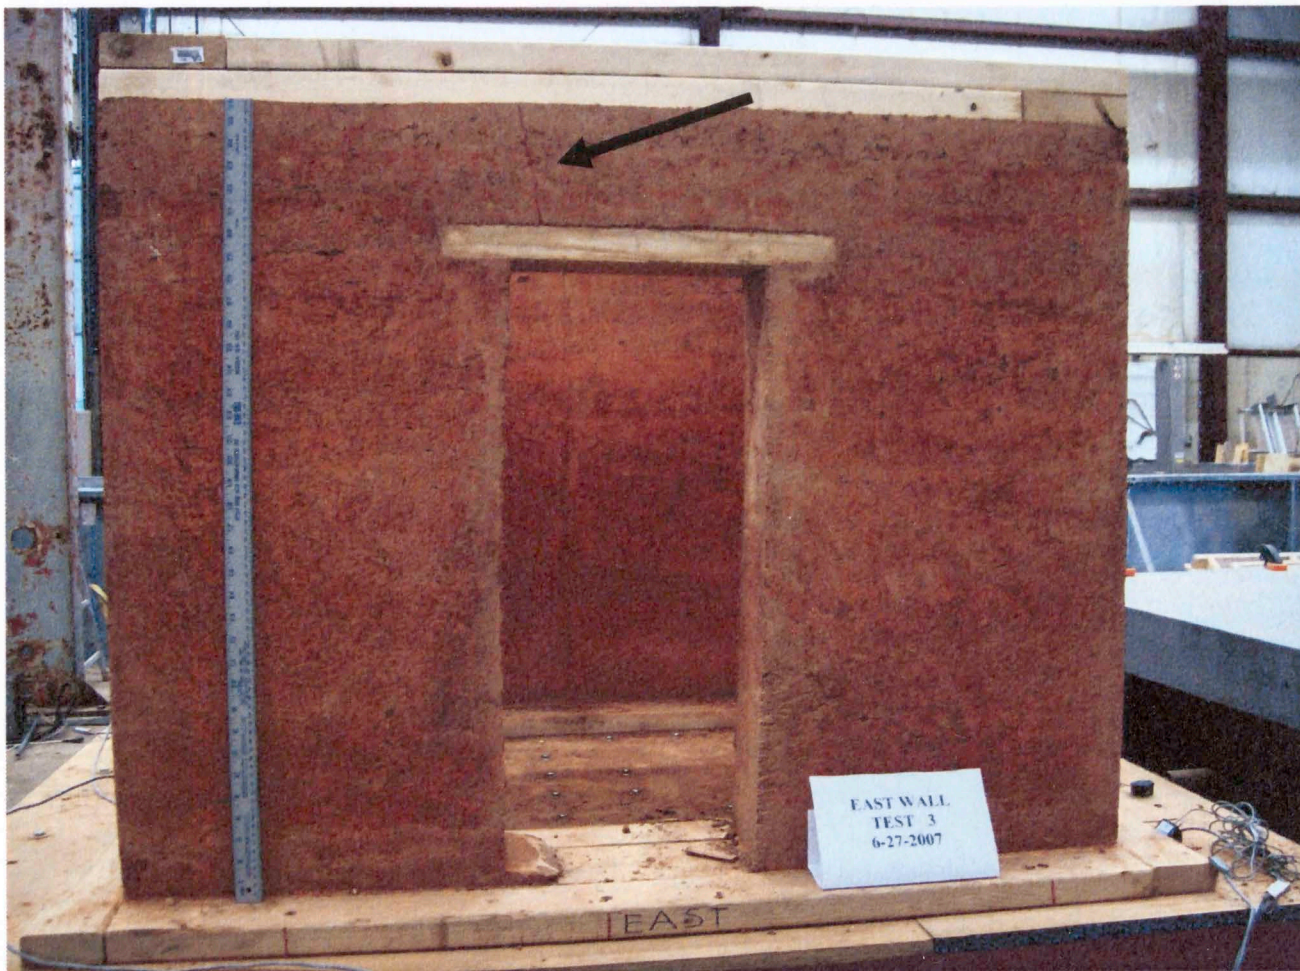
Figure 3.27: Test 3 view of east wall before test, note crack above door opening

Prior to testing, there was one visible crack above the lintel (**Figure 3.27**). The crack penetrated through the thickness of the wall and was fully propagated through the depth of the rammed earth above the lintel. The measured natural frequency was between 5 Hz and 6 Hz. In Test 3-A the frequency was held constant at 6 Hz while the displacement of the shaketable was increased until maximum displacement of the table was achieved. Twelve minutes into the test, dust was observed floating above the model. A diagonal crack developed from one of the corners of the door opening. No failure occurred. In Test 3-B, at full shaketable displacement the frequency was increased at increments of 2 Hz every 30 seconds. At 10 Hz there was visible overturning of the model and dust was visible all around the model. At 12 Hz the overturning and the dust subsided, but a crack was developing at the west wall of the model. At 14 Hz the 45-degree diagonal crack at the south wall was visible, and more dust came from the model, but there was no collapse. At 16 Hz there was visible dust coming from the model, and a second crack developed at the south wall at a steeper angle. Testing was continued to further increase the frequency up to 18 Hz. Still no collapse occurred and the test was ended. **Figure 27** through **Figure 39** show the walls of the model before and after testing.

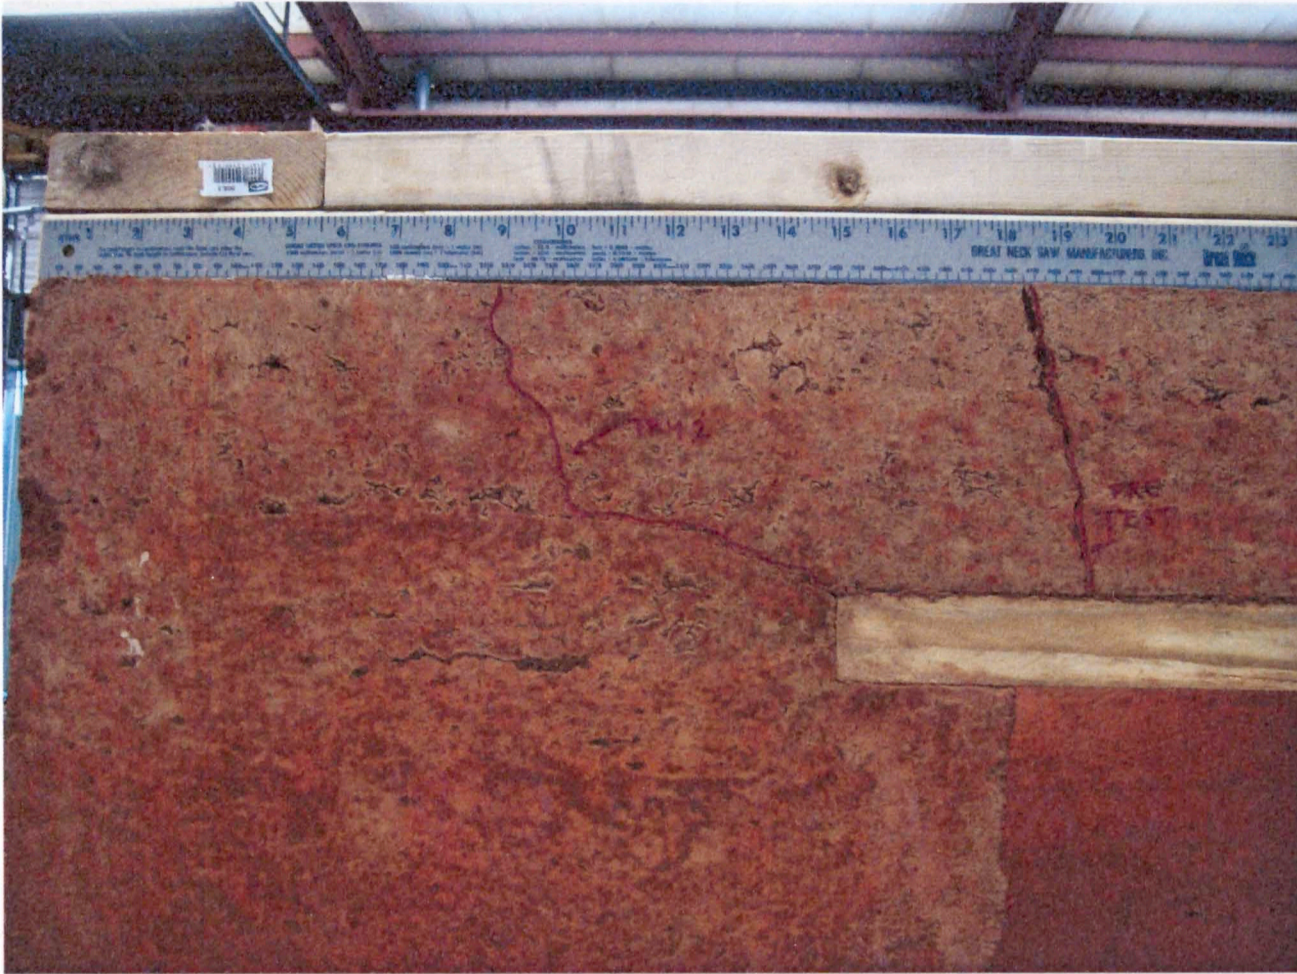
Figure 3.28: Test 3 cracks above lintel near SE corner of east wall

Three cracks total were located above the lintel at the east wall. The vertical crack near midspan of the lintel prior to testing had widened during testing, and the edges of the crack appeared eroded at the exterior wall (**Figures 3.28 and 3.29**). Two diagonal

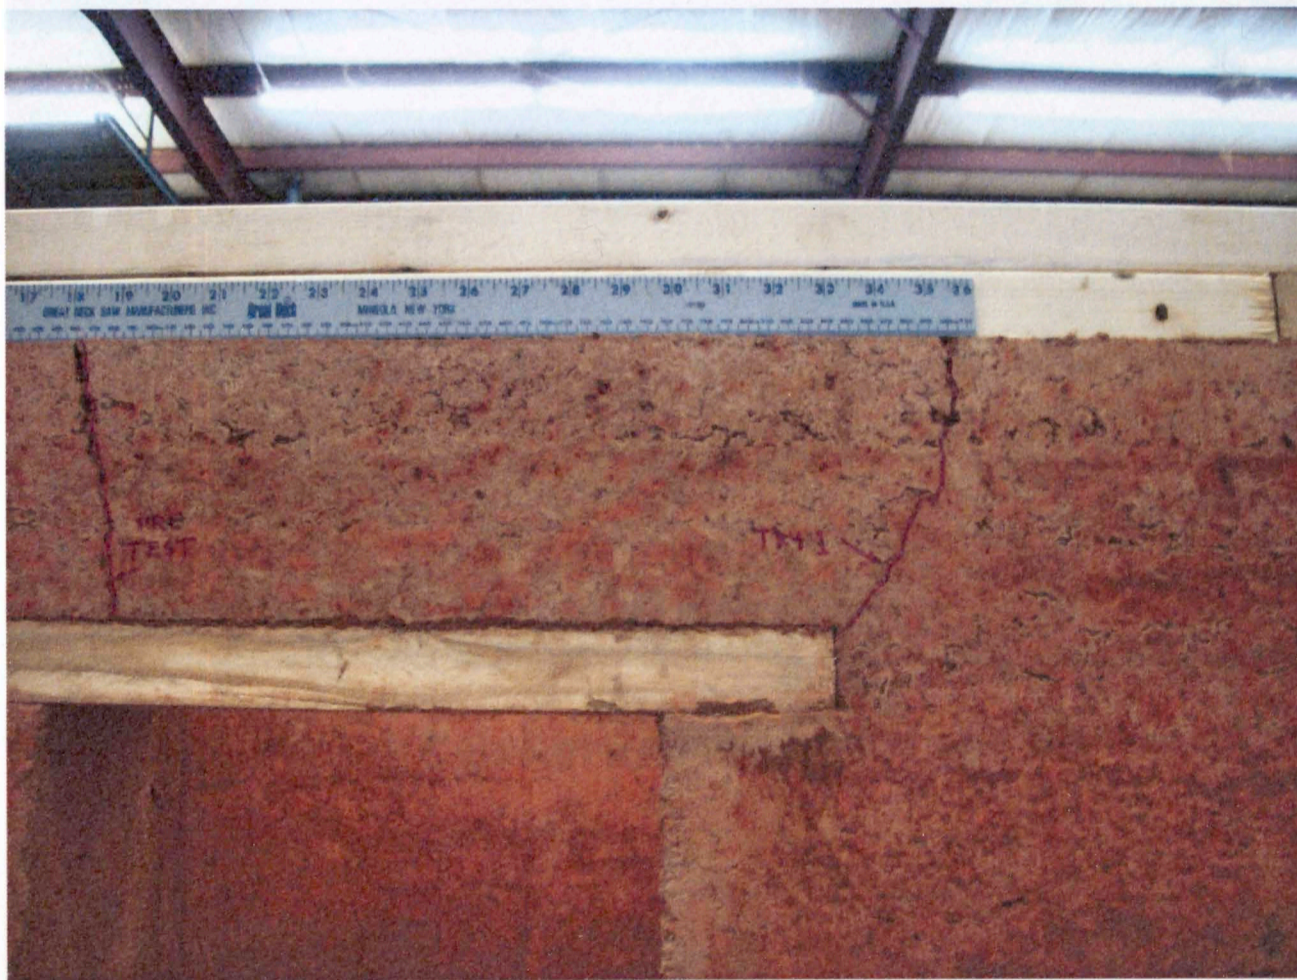
Figure 3.29: Test 3 cracks above lintel near NE corner of east wall

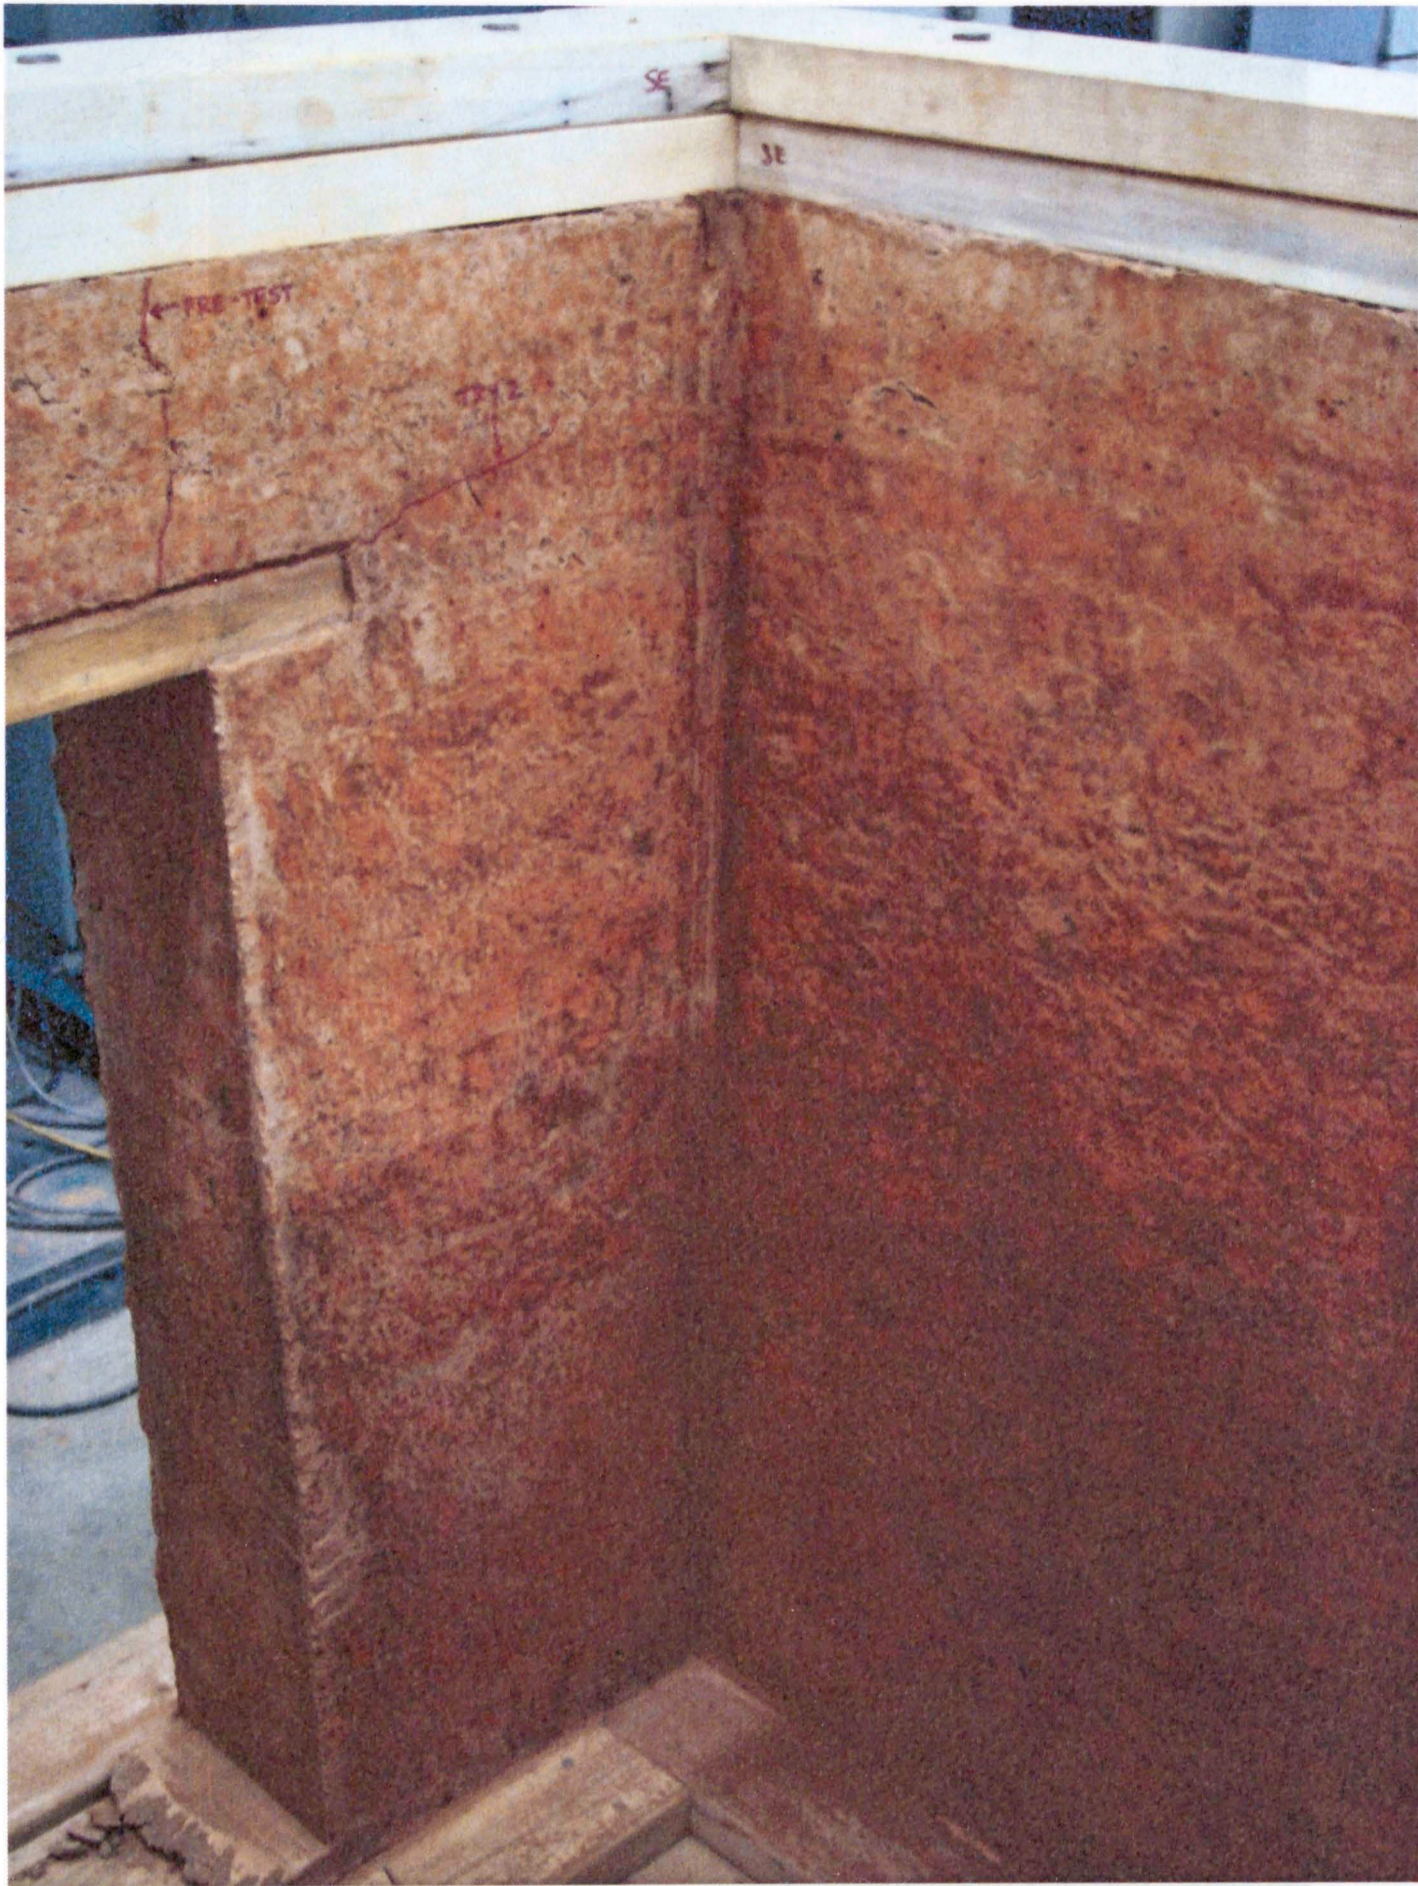
Figure 3.30: Test 3 view of interior southeast corner after test, note cracks outlined in red

cracks were located at the upper corners of the door opening: one crack occurred per sub-test as seen in **Figures 3.28 through 3.30**. In the figures, “Try 1” refers to Test 3-A and “Try 2” refers to Test 3-B. Spacing of the cracks above the lintel were approximately 9 in., 19 in., and 36 in. from the southeast corner of the model. The spikes for the ring beam along the east wall were also 9 in., 19 in., and 36 in. from the southeast corner. Two of the cracks above the lintel were at least within 1 in. of a spike, while the third crack was within 3 in. of a spike.

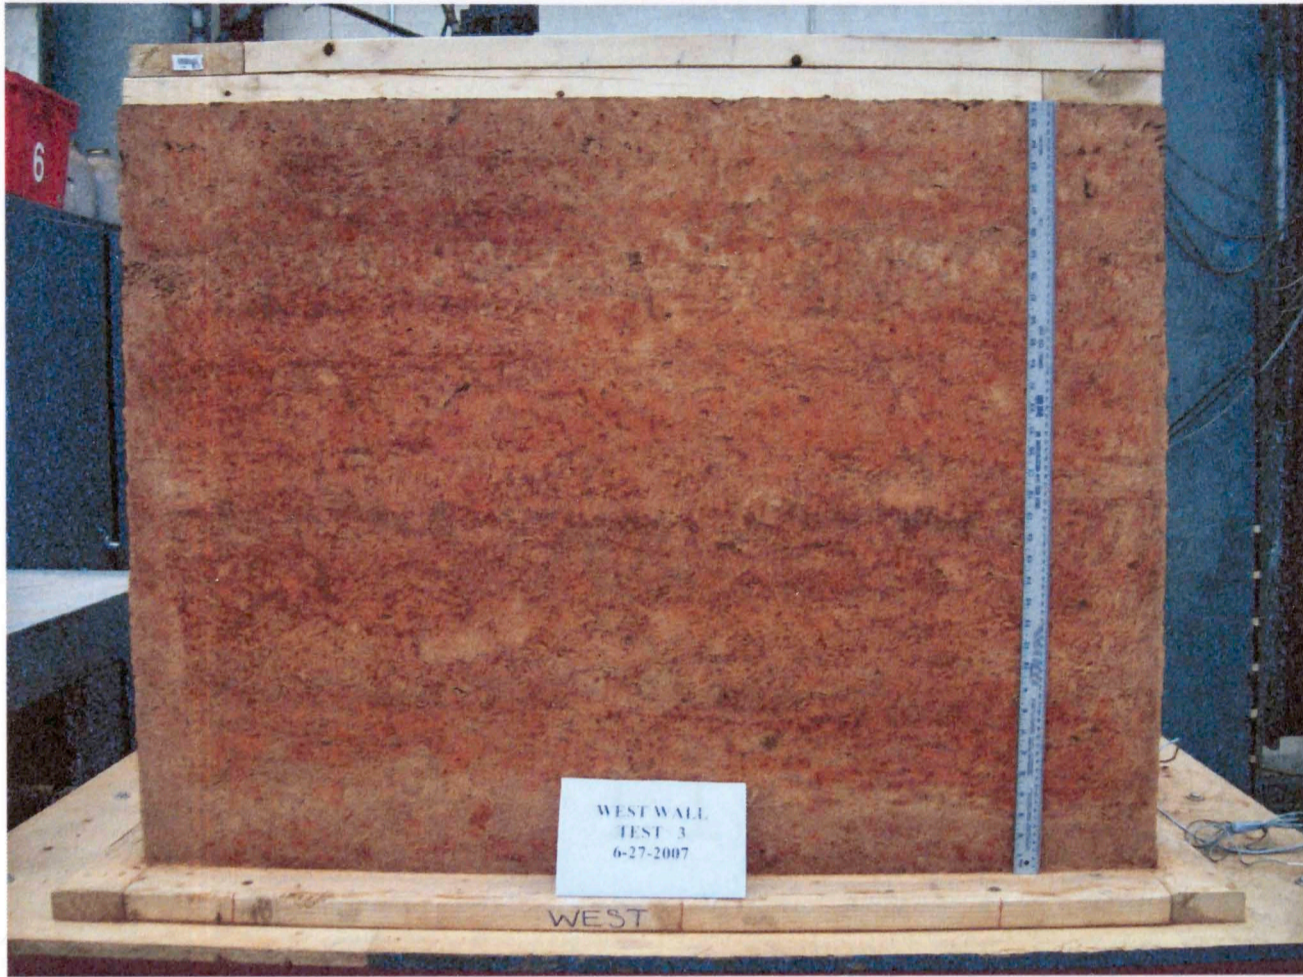
Figure 3.31: Test 3 view of west wall before test

At the exterior southwest corner, the near vertical crack of the model started at the base of the west wall, approximately 3 in. from the exterior corner, and traveled upwards 21 in. before wrapping around the corner to the south wall (**Figure 3.31 through Figure 3.35**). Of the two diagonal cracks at the south wall, one was at a 45-degree angle to the top of the south wall at 16 in. from the corner, and the second almost vertical to the top of the south wall at 5 in. from the corner (**Figure 3.37 and 3.38**). Similar to the east wall, the 45-degree diagonal crack was within 3 in. of the nearest spike. Inside the model a vertical crack was observed at the reentrant corner between the south and west walls. At approximately two thirds of the height of the model, the crack at the reentrant corner branched into the 45-degree angle crack on the south wall (**Figure 3.39**). Beyond the diagonal crack, the vertical crack at the reentrant corner continued to the top of the wall.

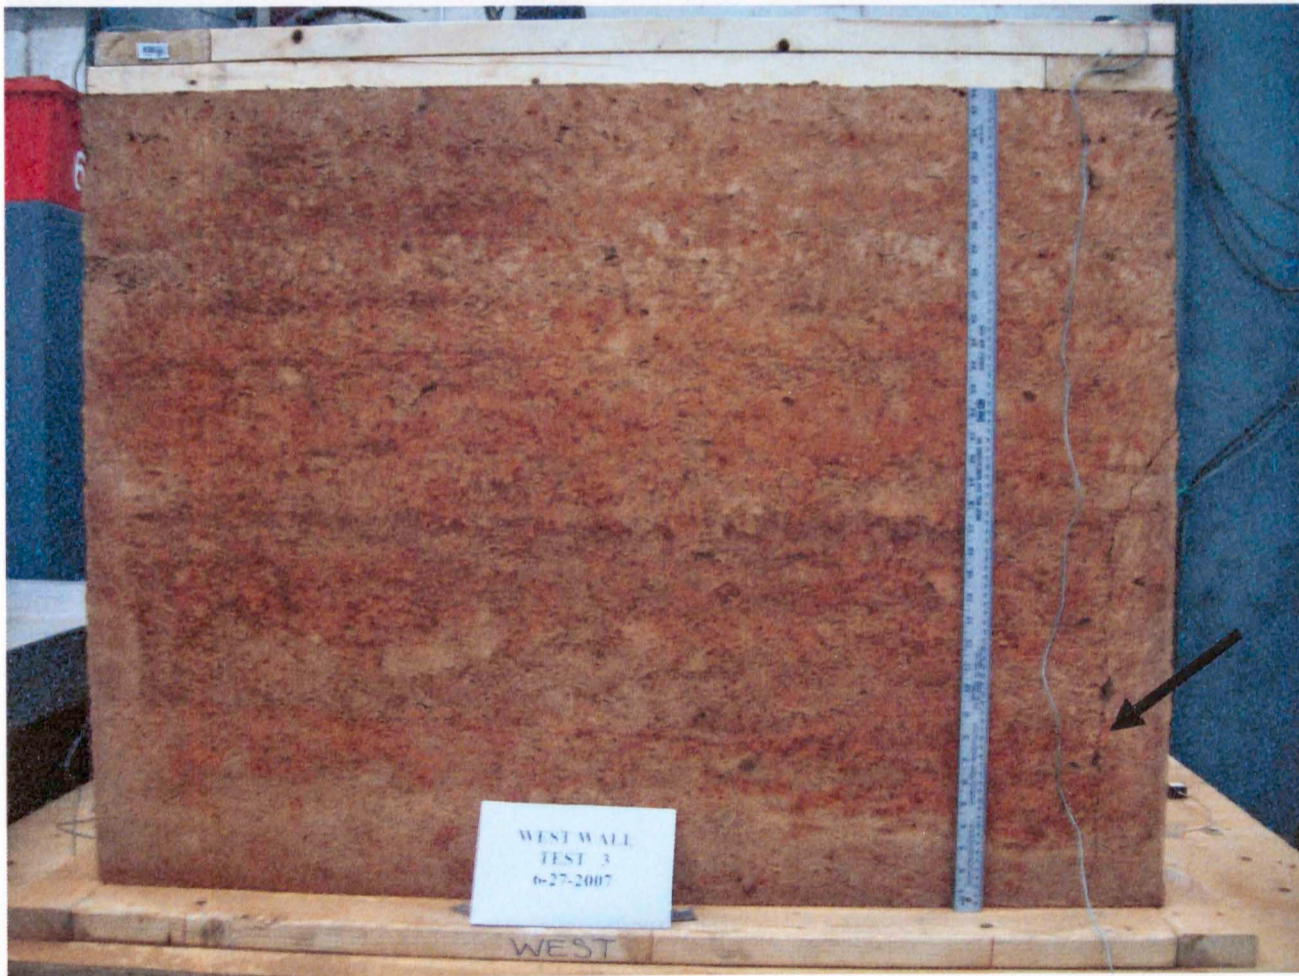
Figure 3.32: Test 3 view of west wall after test
