SHAKE TABLE TESTING OF SCALED RAMMED EARTH MODELS

A THESIS

A THESIS APPROVED FOR THE
SCHOOL OF CIVIL ENGINEERING AND ENVIRONMENTAL
SCIENCE

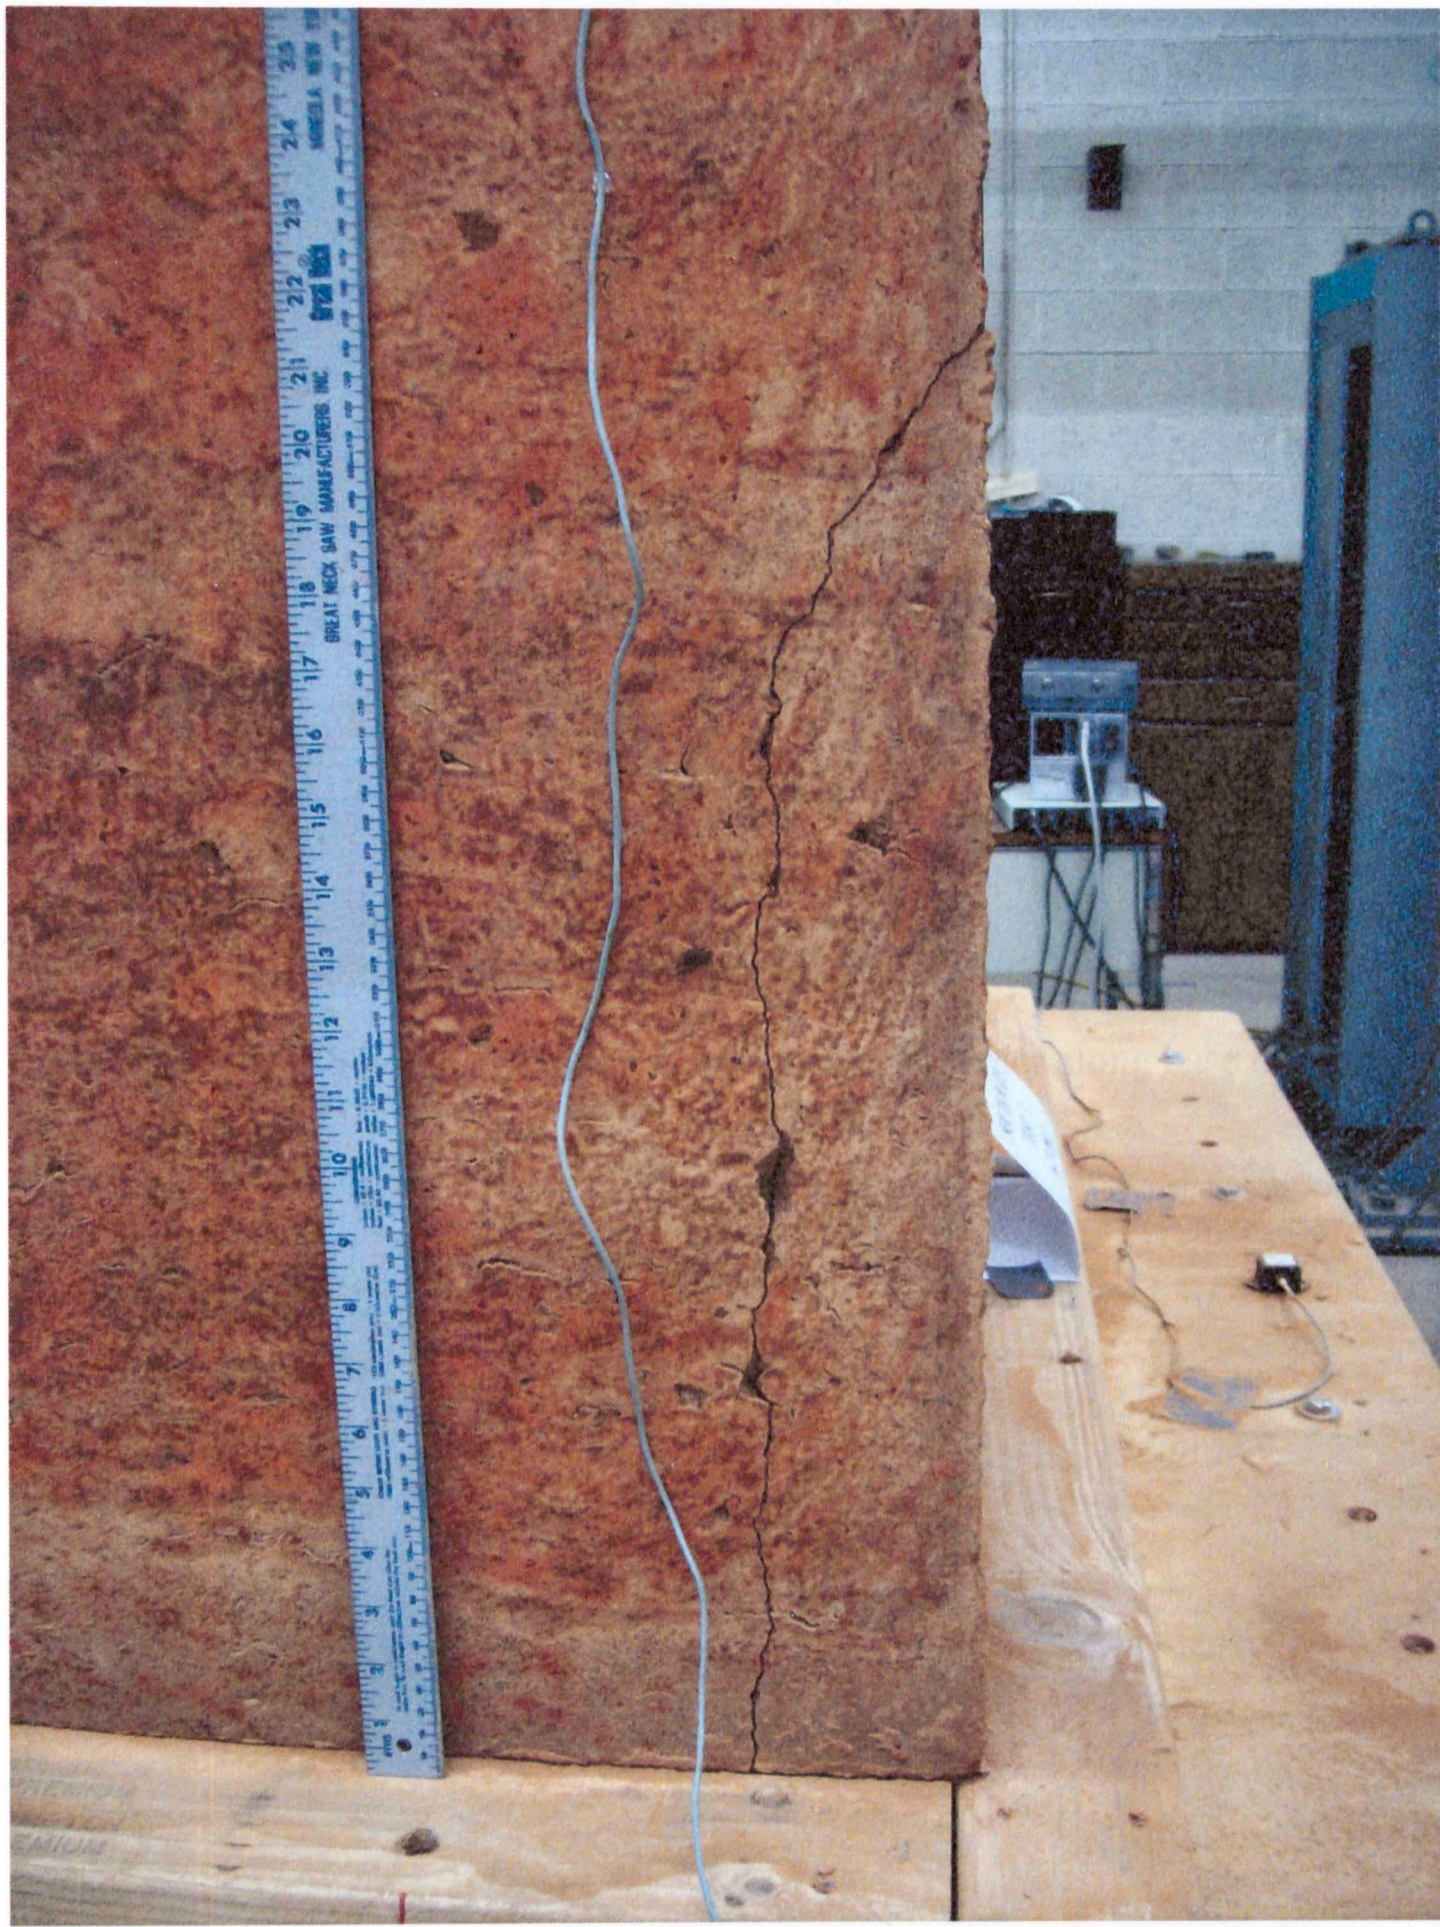
Figure 3.33: Test 3 view of crack near base of west wall at SW corner

At the exterior southwest corner, the near vertical crack of the model started at the base of the west wall, approximately 3 in. from the exterior corner, and traveled upwards 21 in. before wrapping around the corner to the south wall (**Figure 3.31 through Figure 3.35**). Of the two diagonal cracks at the south wall, one was at a 45-degree angle to the top of the south wall at 16 in. from the corner, and the second almost vertical to the top of the south wall at 5 in. from the corner (**Figure 3.37 and 3.38**). Similar to the east wall, the 45-degree diagonal crack was within 3 in. of the nearest spike. Inside the model a vertical crack was observed at the reentrant corner between the south and west walls. At approximately two thirds of the height of the model, the crack at the reentrant corner branched into the 45-degree angle crack on the south wall (**Figure 3.39**). Beyond the diagonal crack, the vertical crack at the reentrant corner continued to the top of the wall.

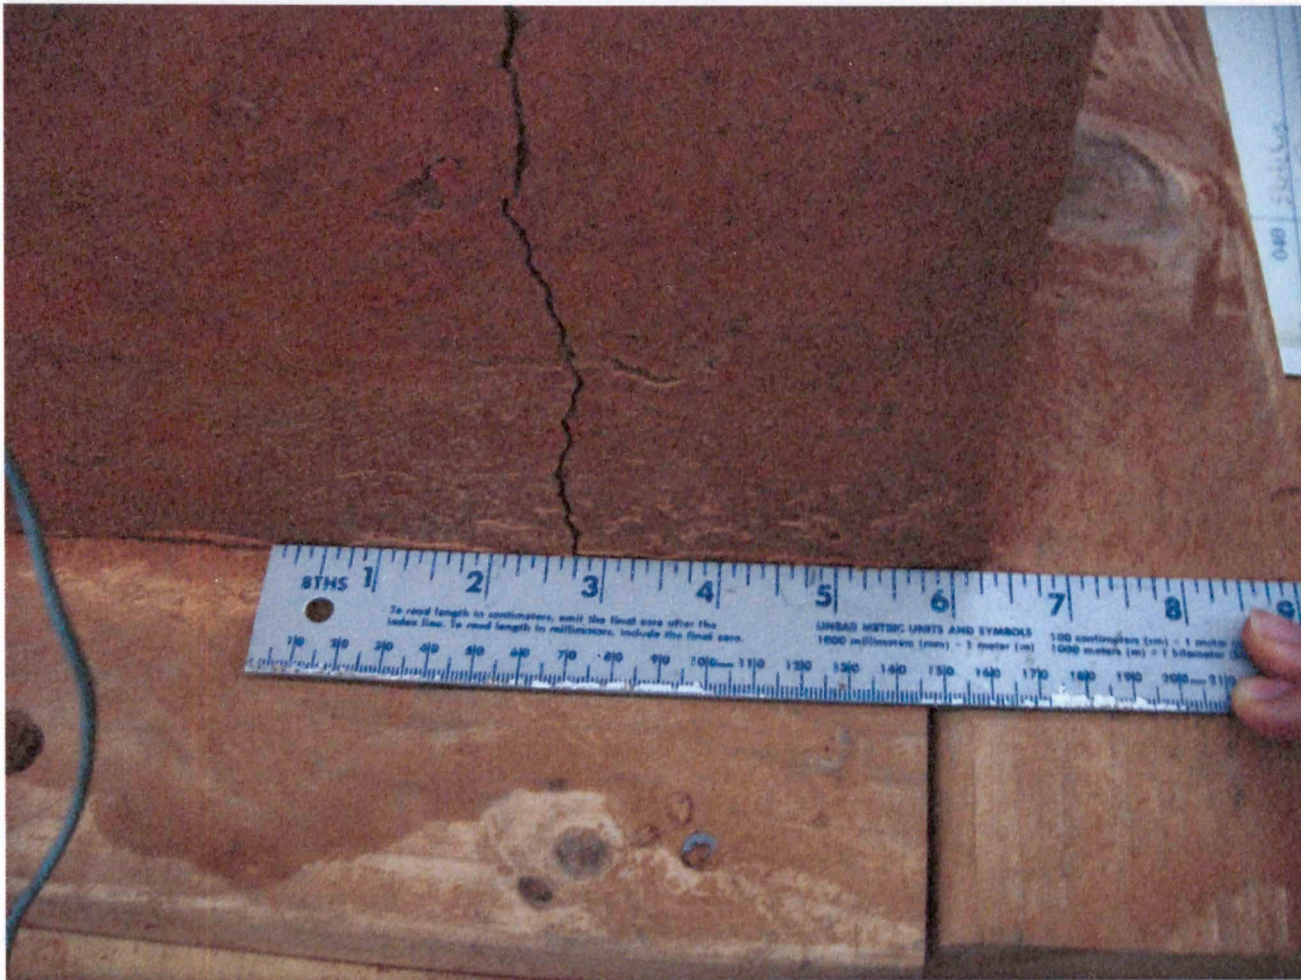
Figure 3.34: Test 3 width of fractured section at SW corner along base of west wall

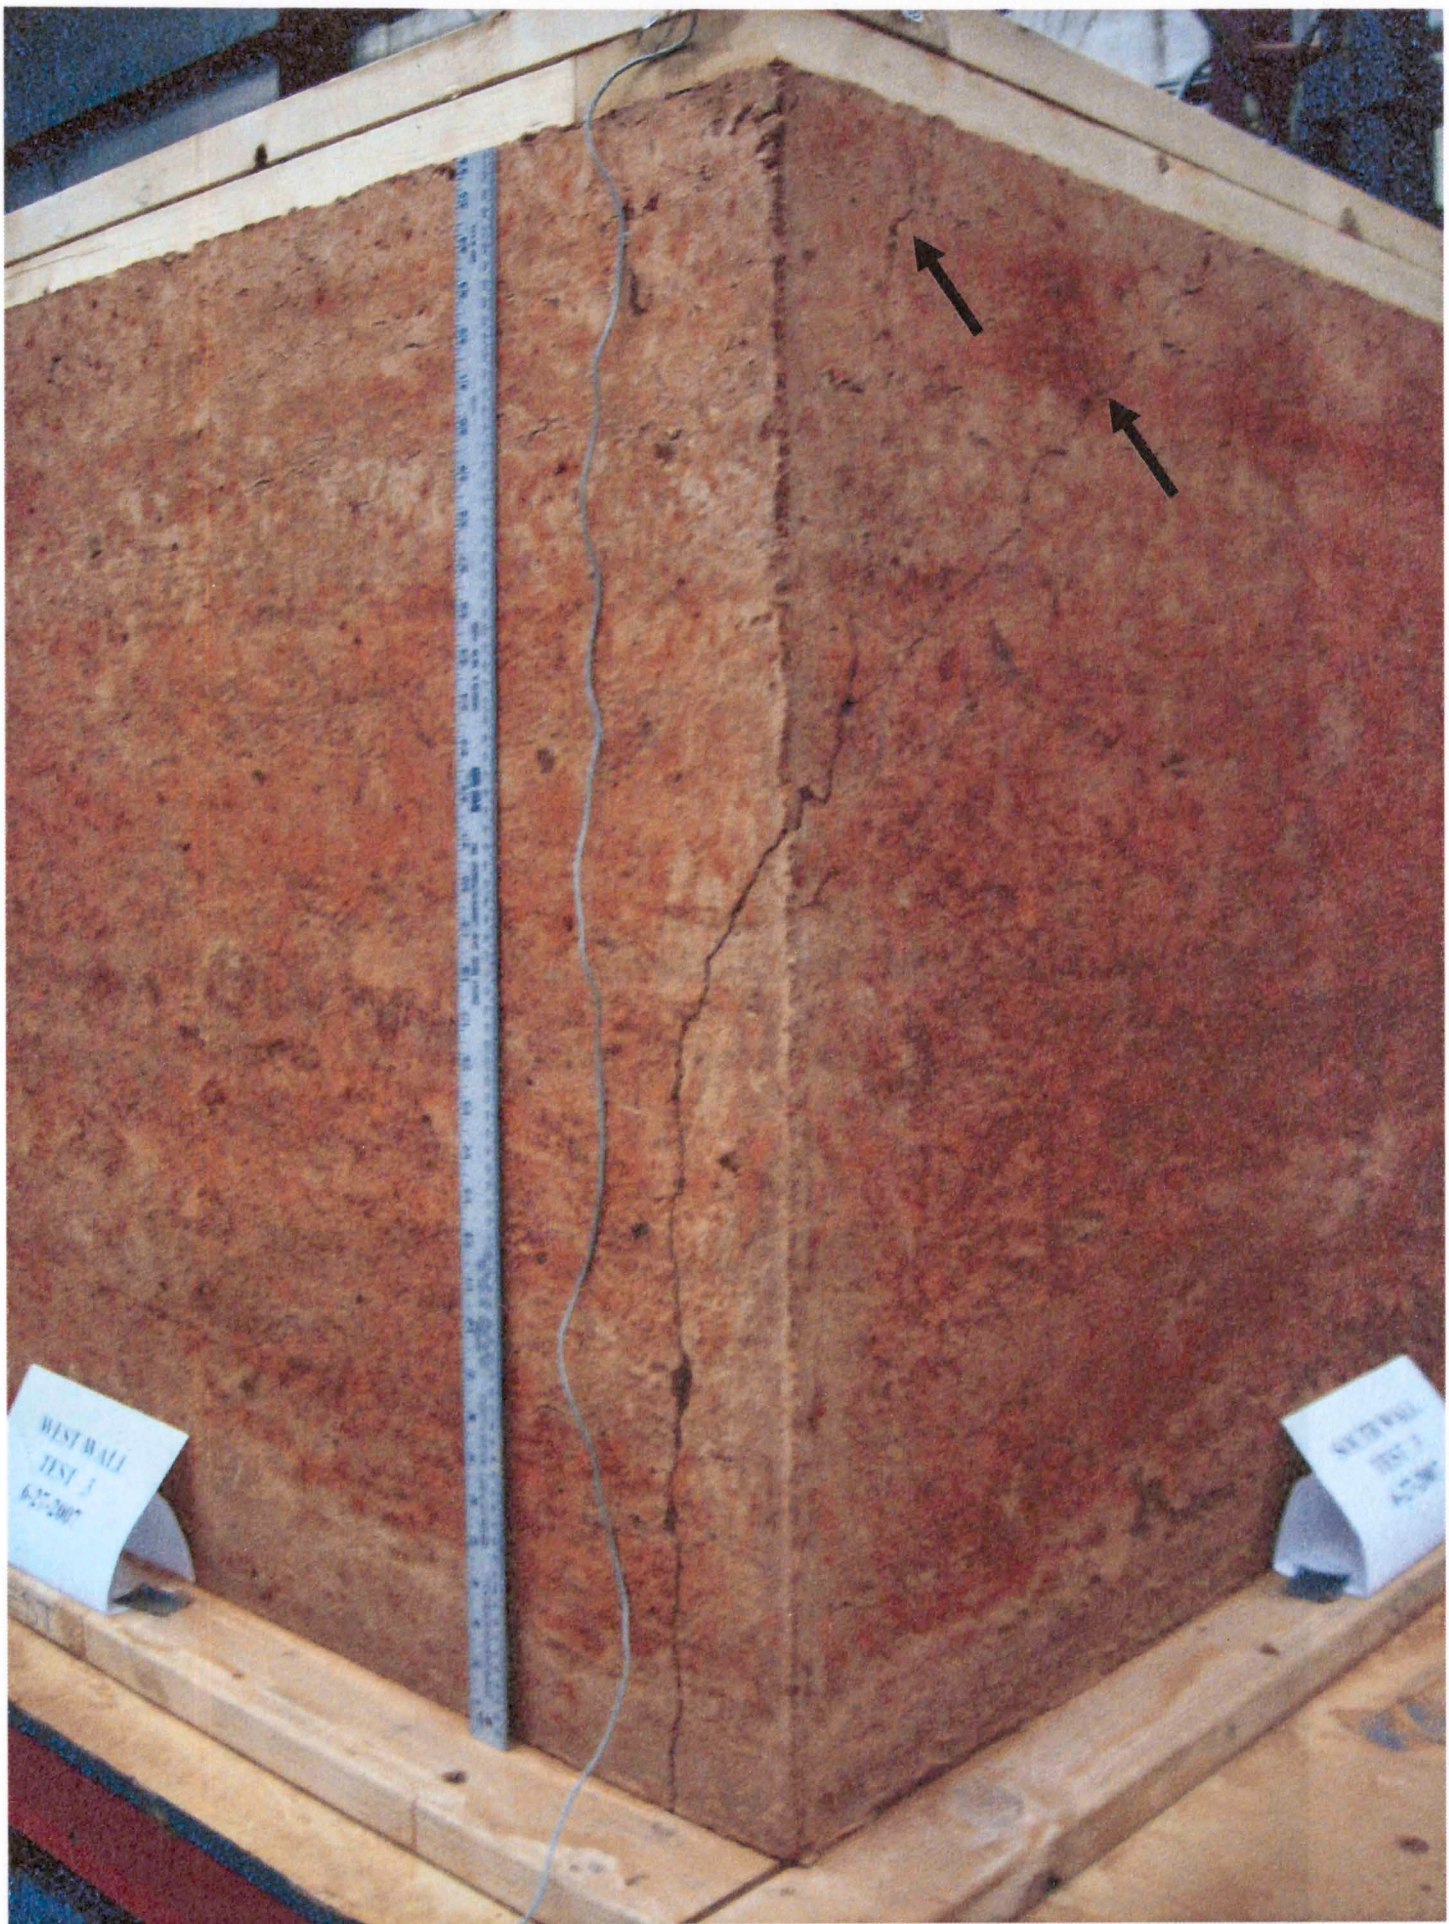
Figure 3.35: Test 3 view of cracks across SW corner

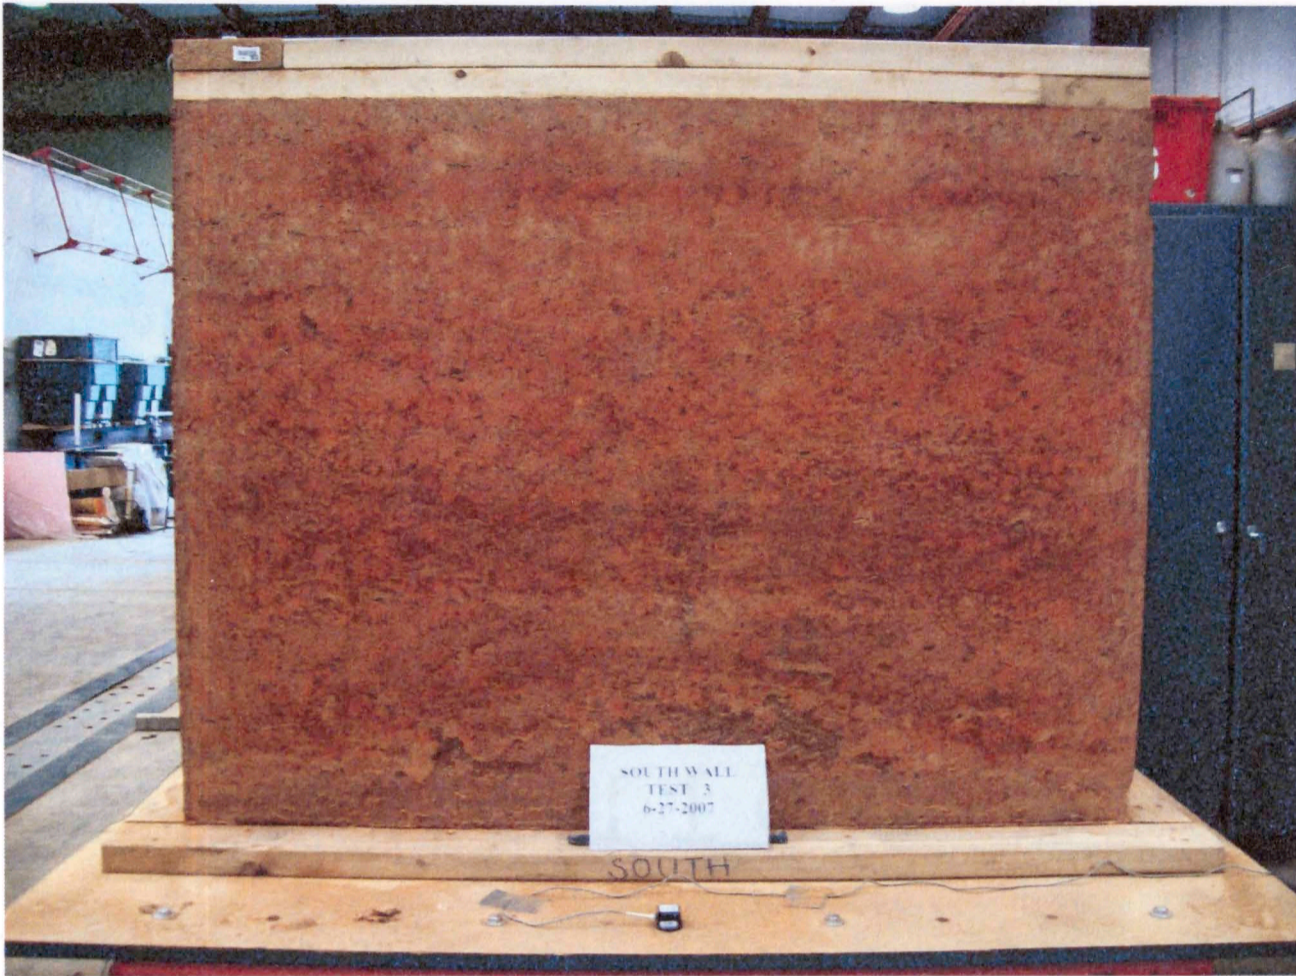
Figure 3.36: Test 3 view of south wall before test

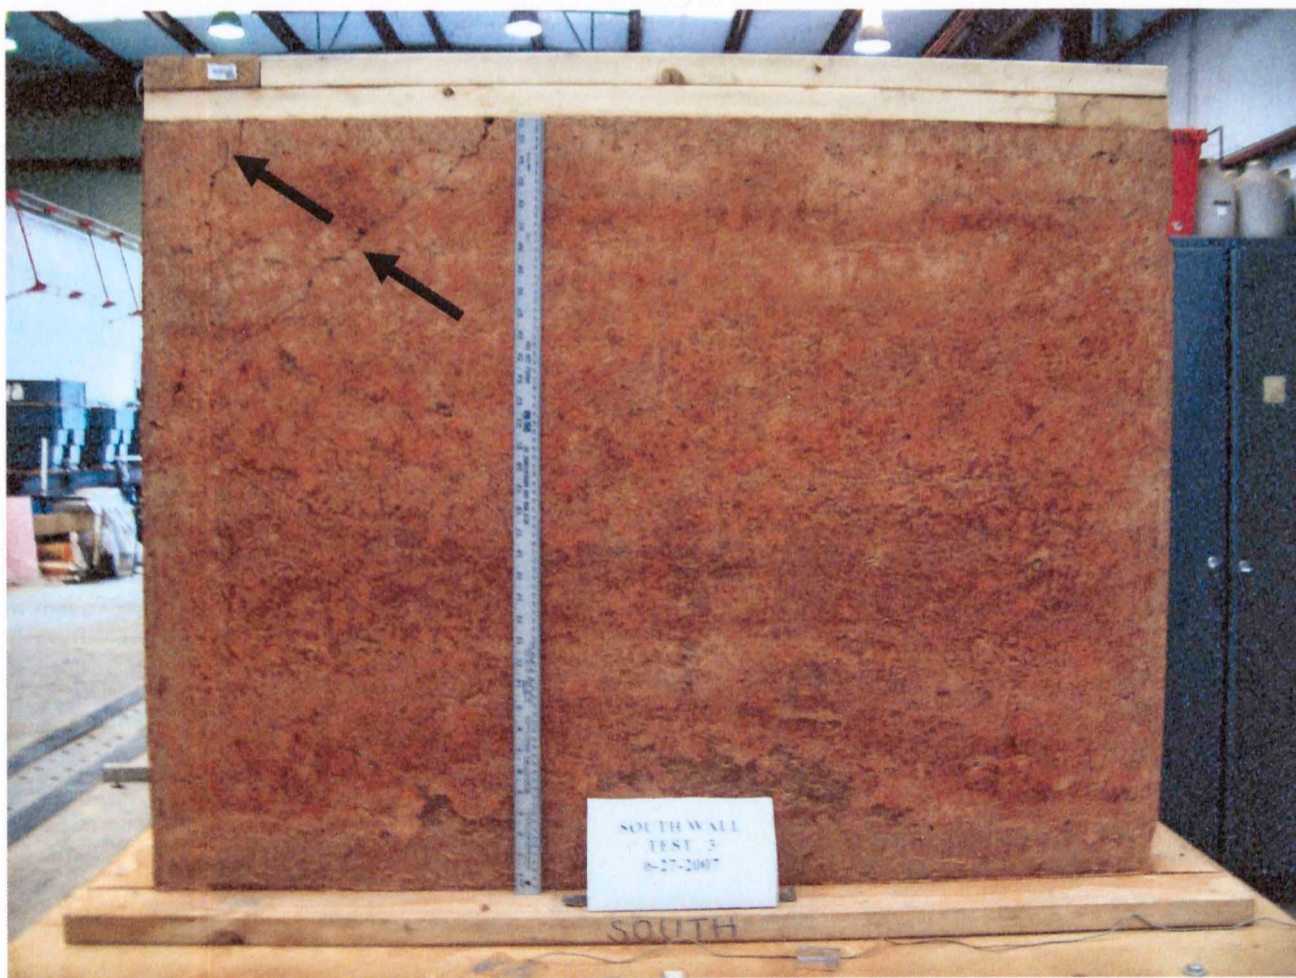
Figure 3.37: Test 3 view of south wall after test. Arrows point to fractures

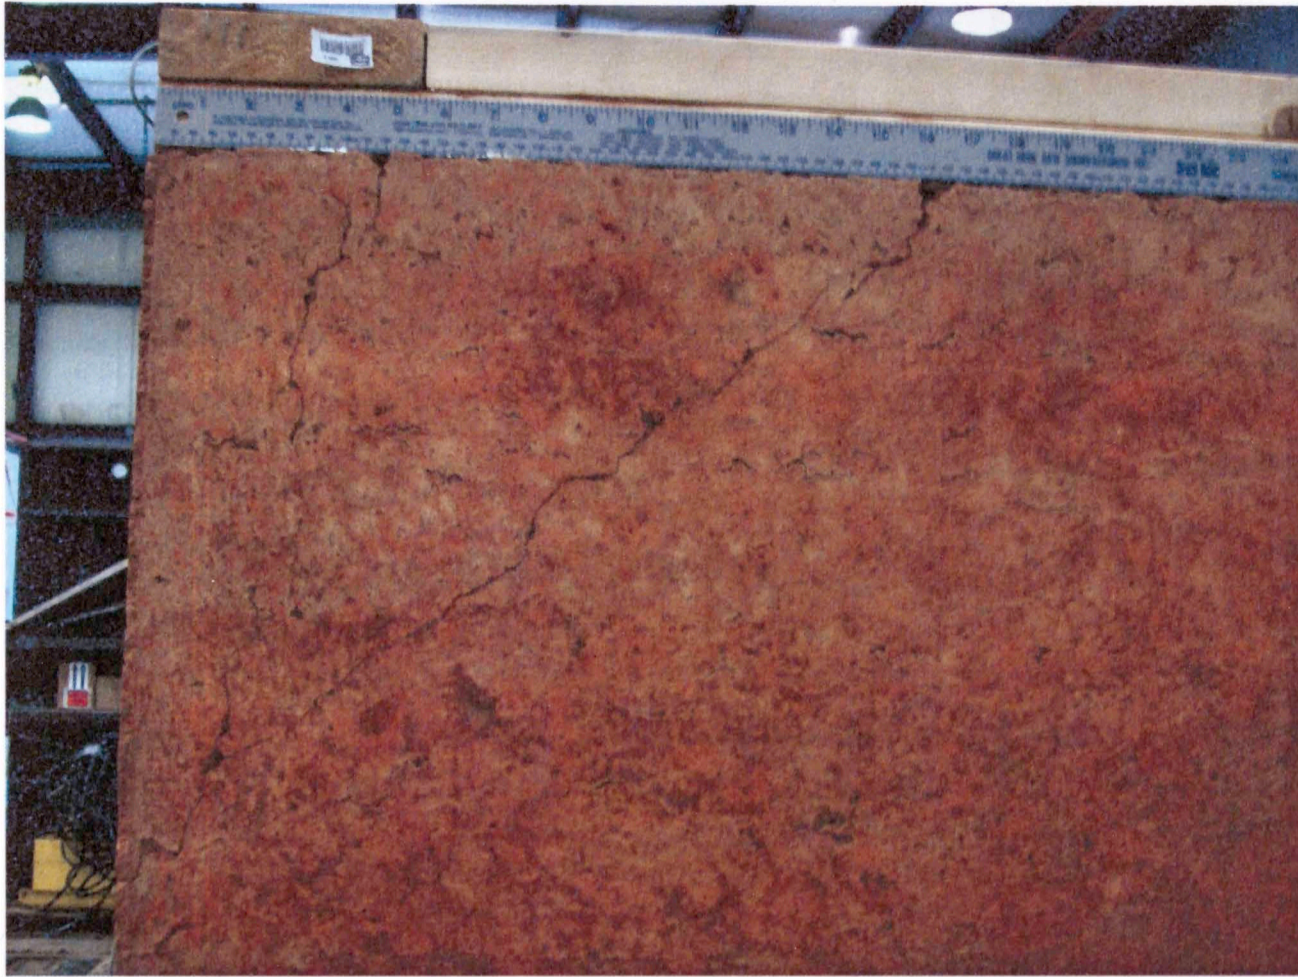
Figure 3.38: Test 3 close-up of previous photograph

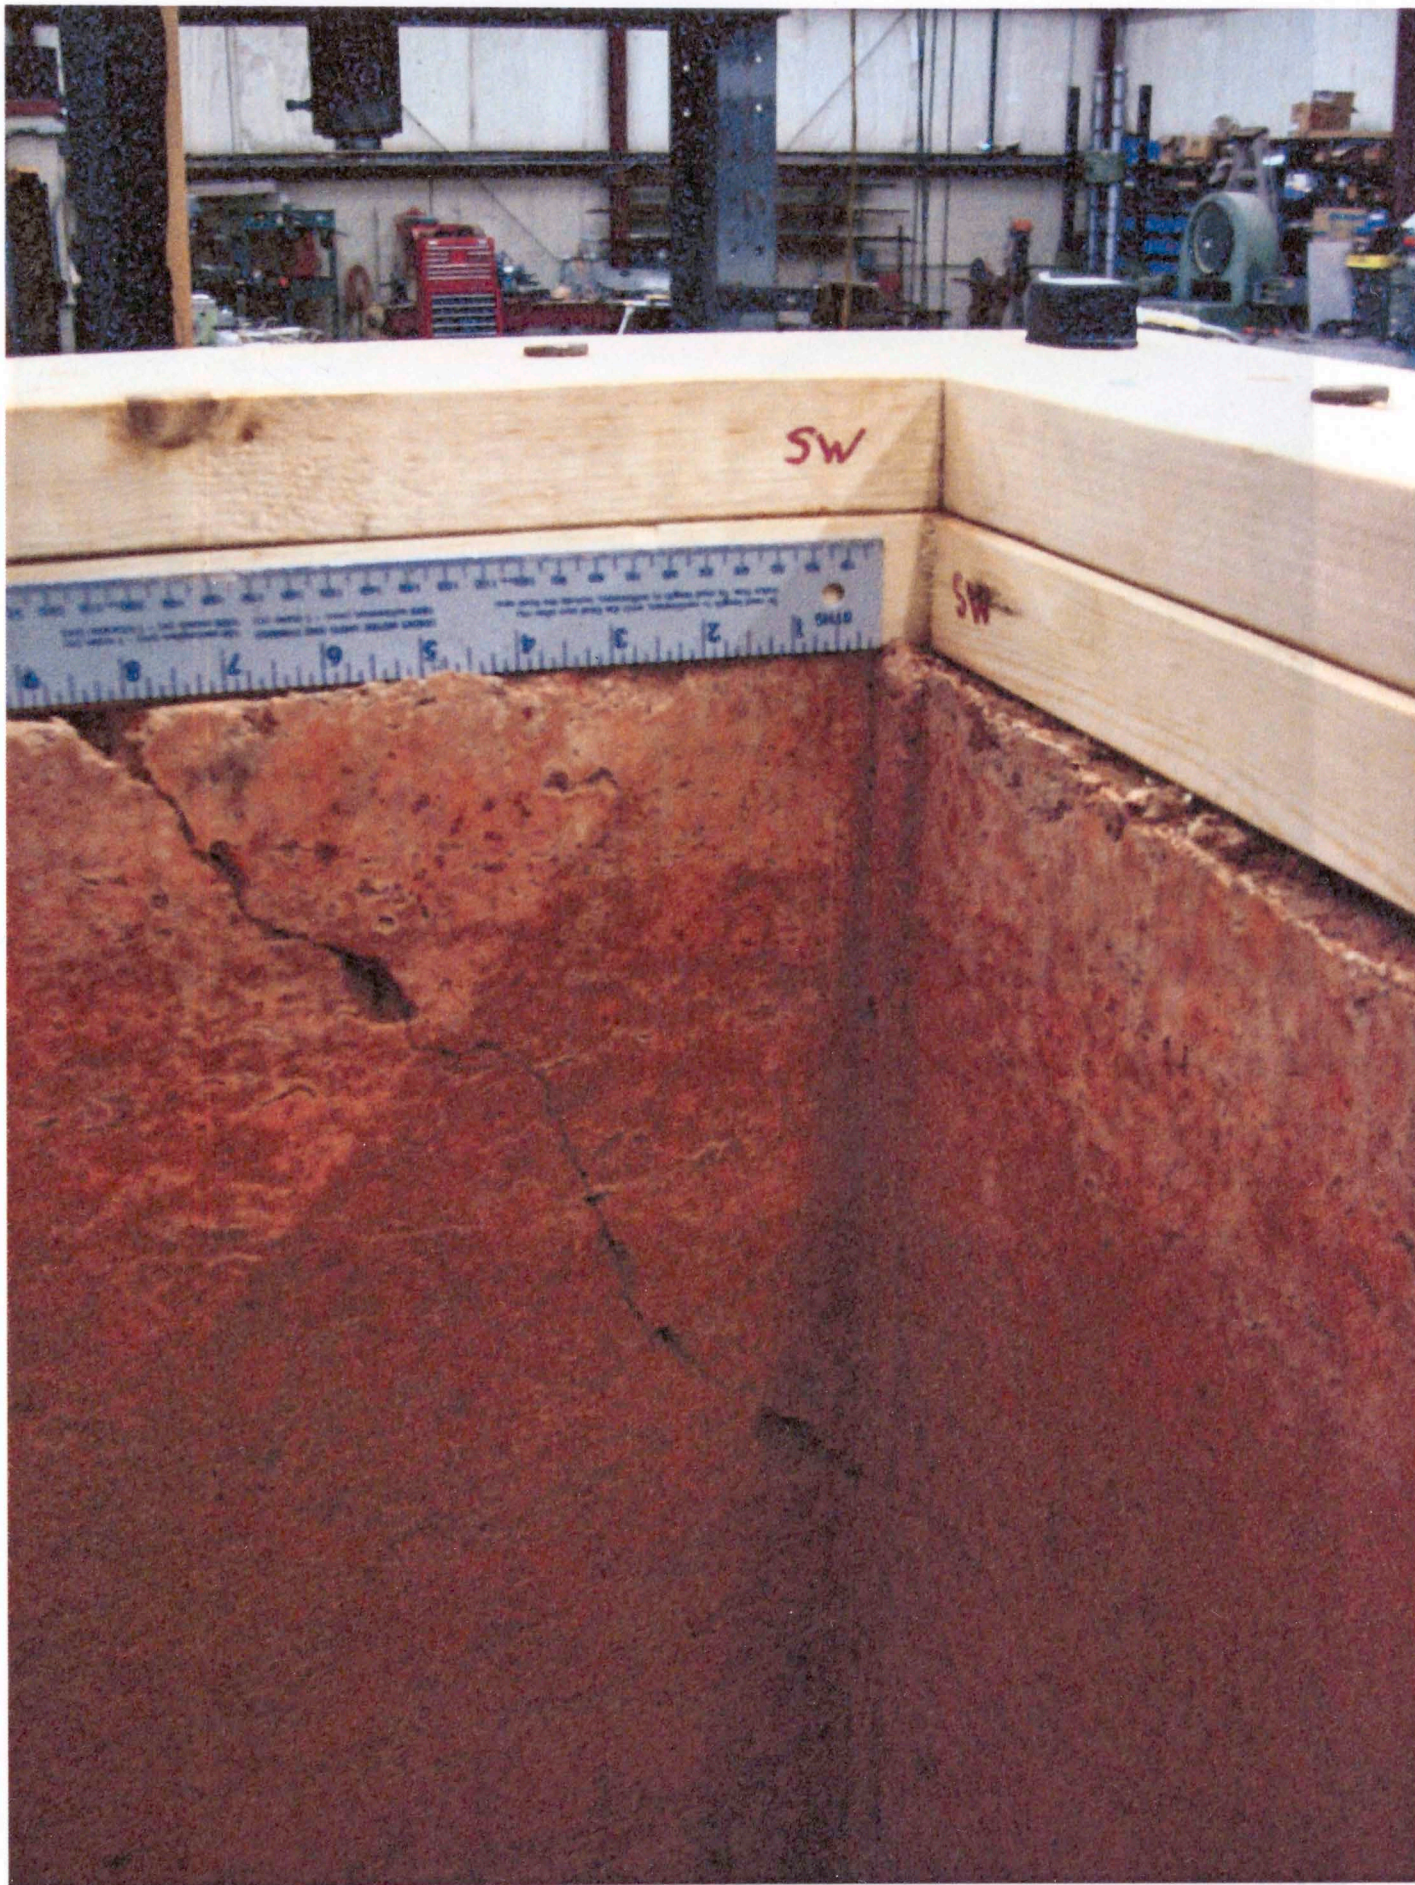
Figure 3.39: Test 3 measurement of diagonal crack at interior of SW corner

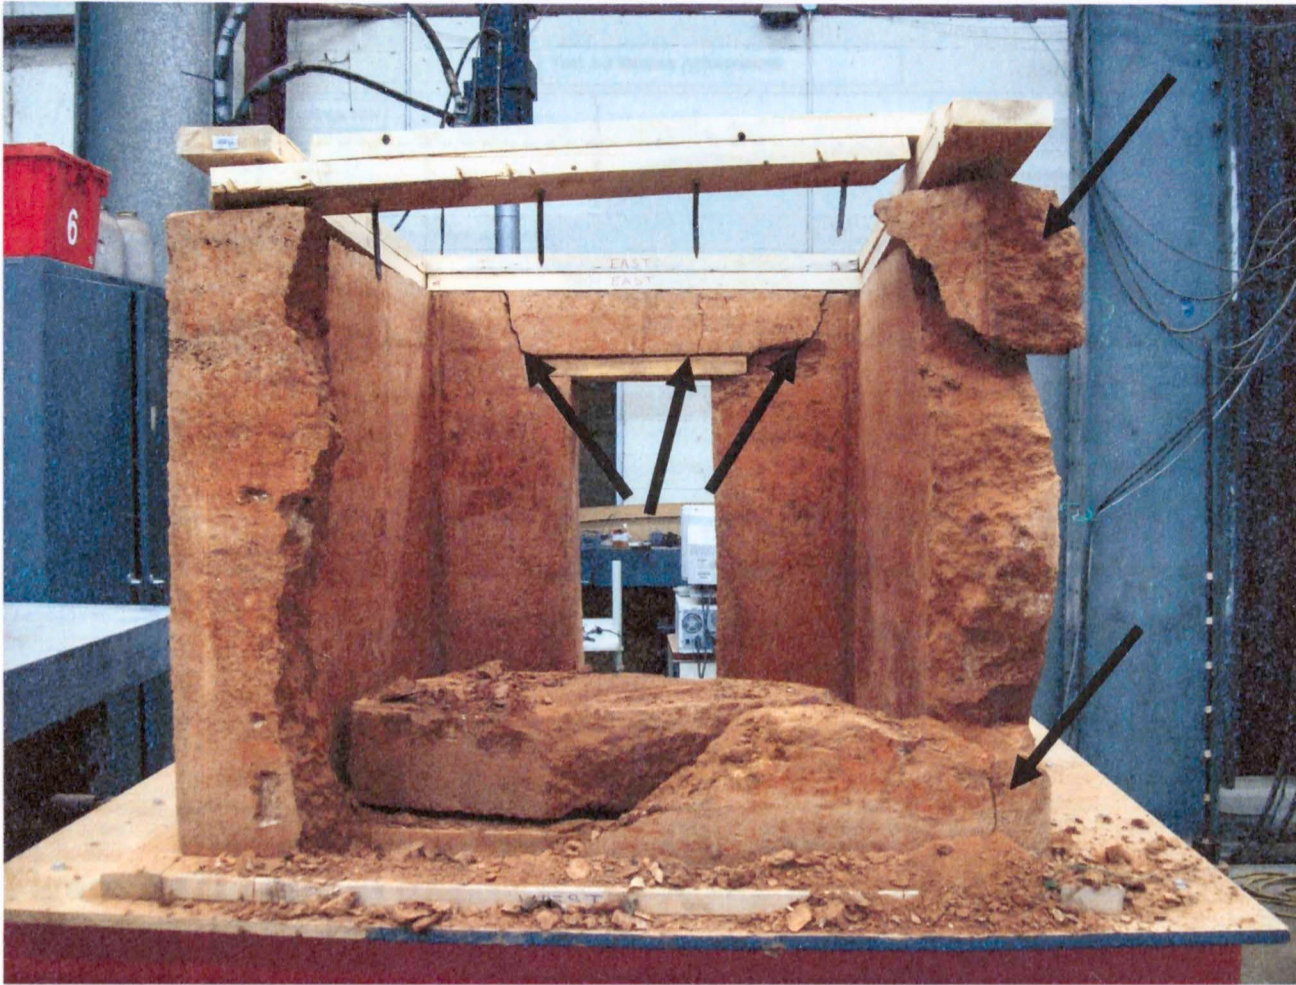
Figure 3.40: Test 3 model after demolition (arrows point to cracks from testing)

During demolition, most of the cracks from the test were still visible (**Figure 3.40**). The cracked section of rammed earth at the upper south wall remained attached to the spike and suspended in the air (**Figure 3.41**). The model was more difficult to demolish than previous models. The ring beam had to be forced off the model first, before the walls could collapse.

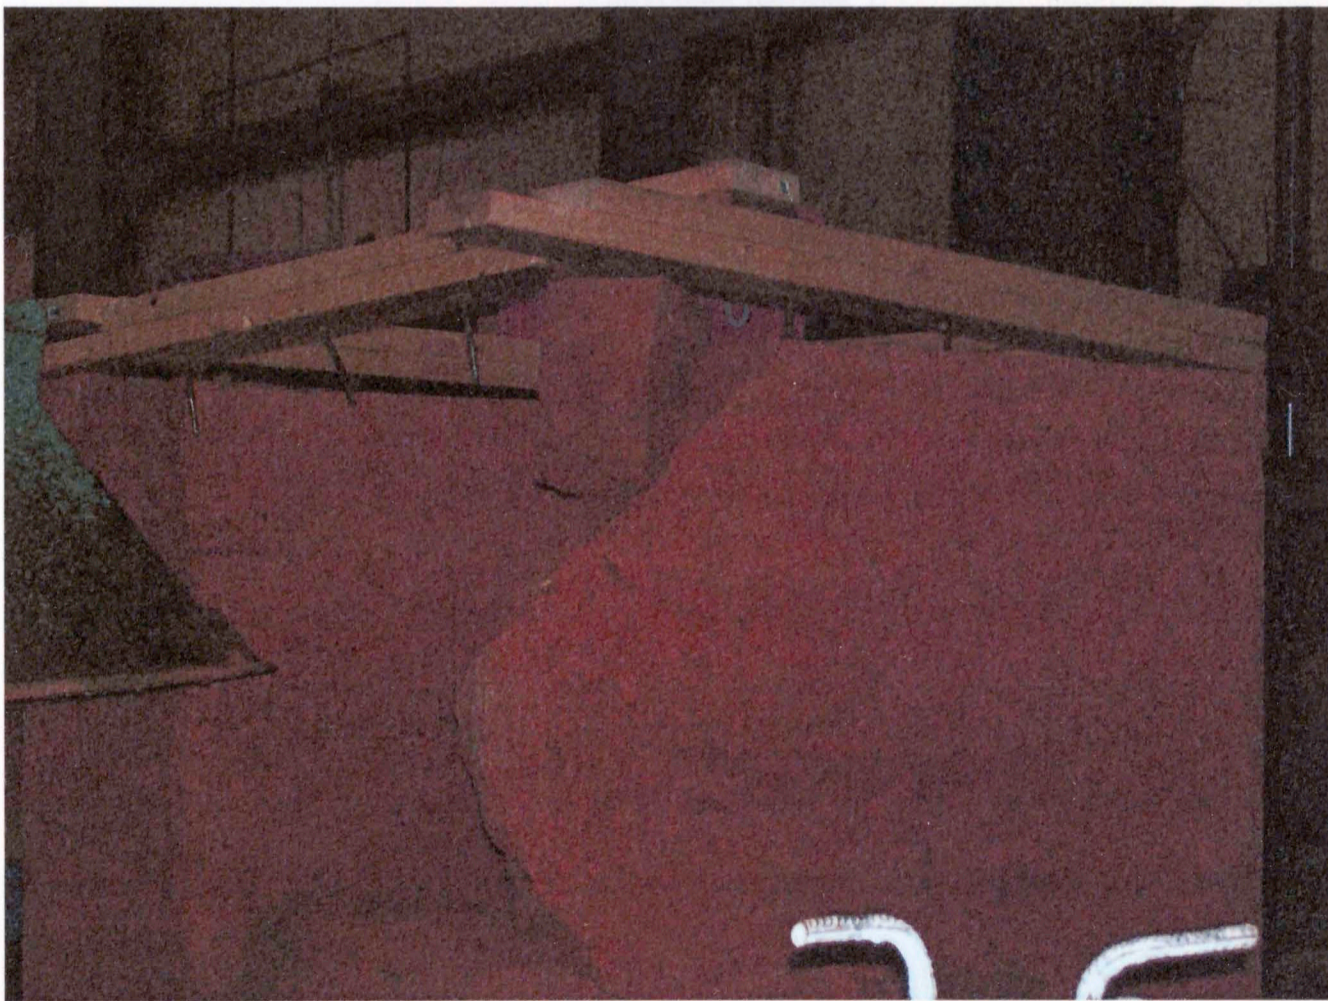
Figure 3.41: Test 3 view of suspended rammed earth at ring beam

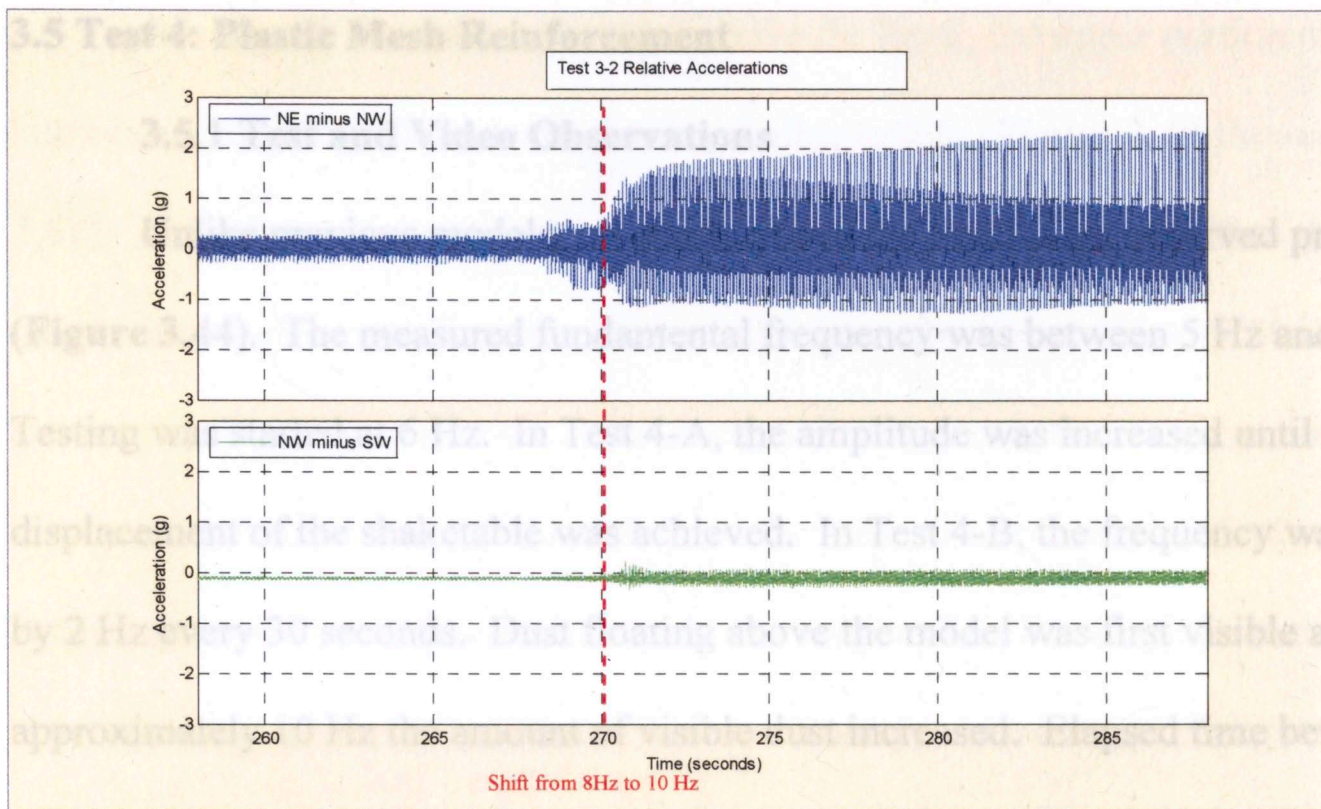
Figure 3.42: Test 3-B relative accelerations between corners from 8Hz to 10Hz, note increase in accelerations at approximately 270 seconds

In plotting the accelerometer data, there were no drastic changes in acceleration. Although the southwest corner cracked at 14 Hz, the accelerometers did not suddenly increase or decrease in acceleration as in previous tests. The greatest increase in acceleration reflected in the data was between the northeast and the northwest corners when the frequency was changed from 8 Hz to 10 Hz at approximately 270 seconds (**Figure 3.42**). Relative accelerations between the northwest and the southwest corners reflected a slight increase in acceleration at the same time, but the magnitude remained close to zero. By the end of the test all three corners were relatively uniform in their response and had similar accelerations (**Figure 3.43**).

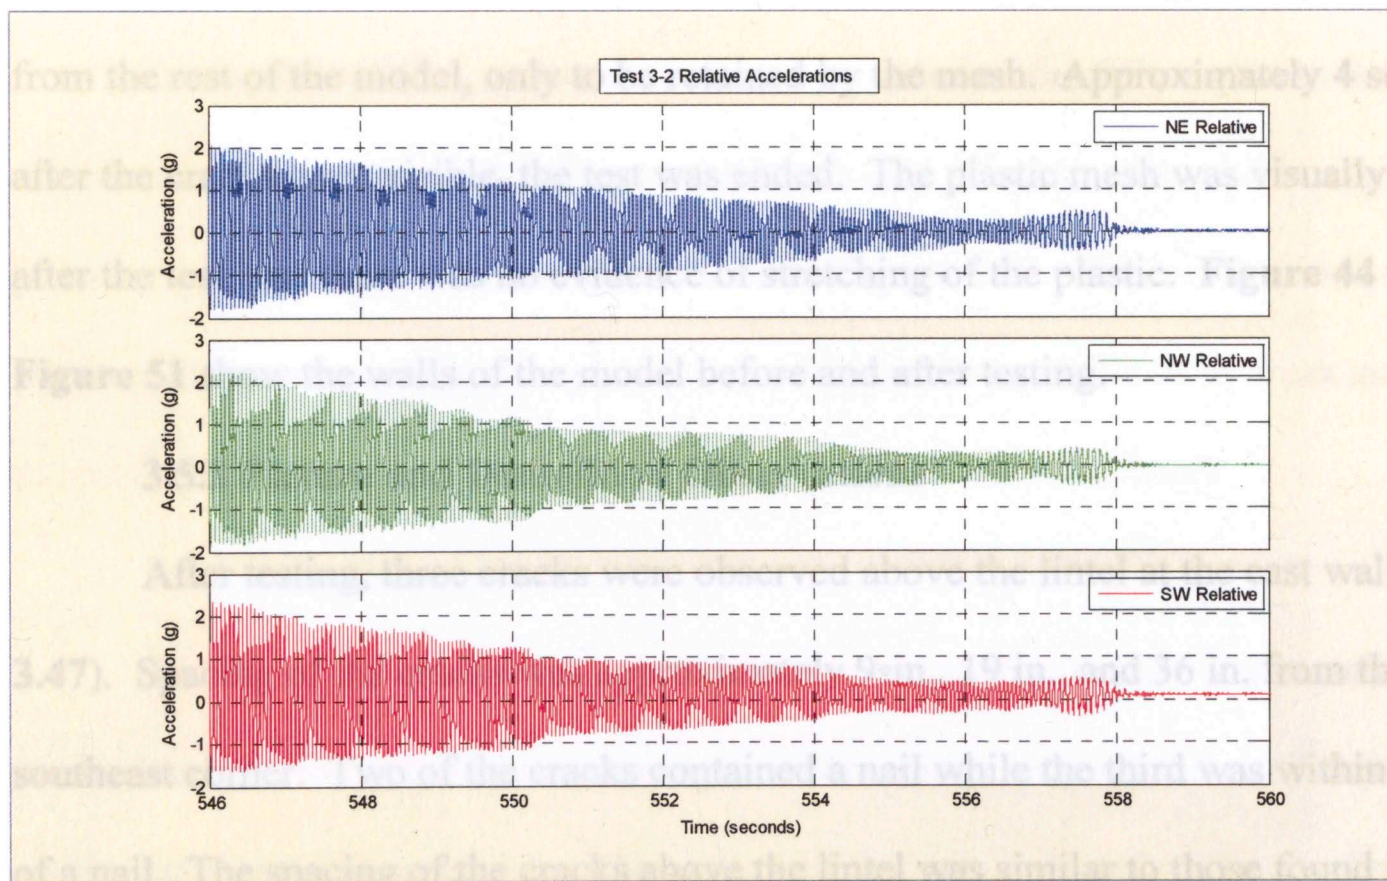
Figure 3.43: Test 3-B relative accelerations, note uniform accelerations between corners

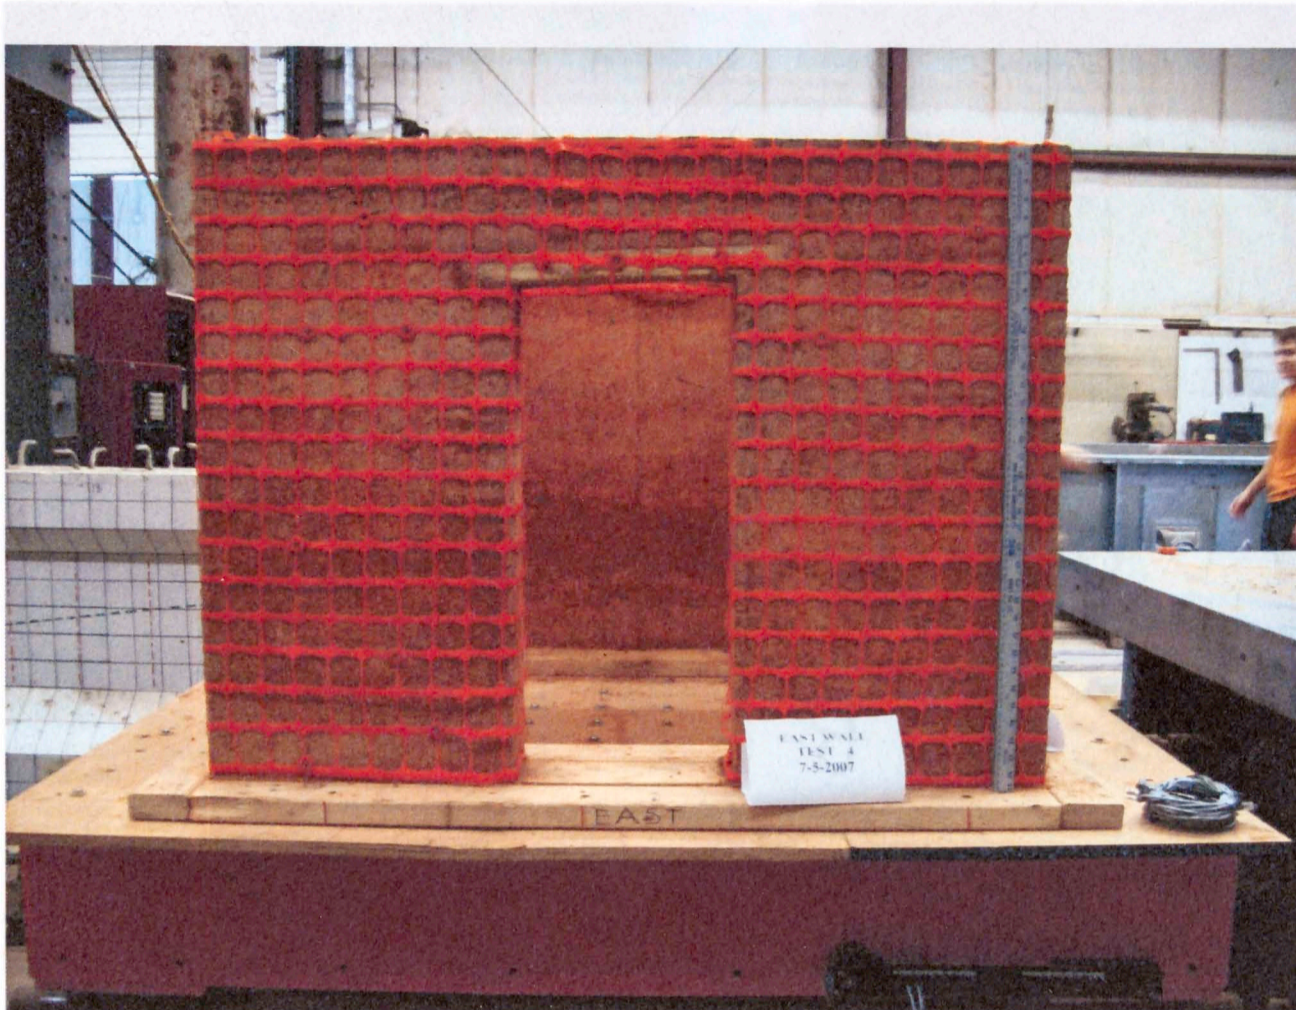
Figure 3.44: Test 4 view of east wall before testing

Unlike previous models, no cracks above the lintel were observed prior to testing (**Figure 3.44**). The measured fundamental frequency was between 5 Hz and 6 Hz. Testing was started at 6 Hz. In Test 4-A, the amplitude was increased until full displacement of the shaketable was achieved. In Test 4-B, the frequency was increased by 2 Hz every 30 seconds. Dust floating above the model was first visible at 8 Hz. At approximately 10 Hz the amount of visible dust increased. Elapsed time between 10 Hz and 12 Hz was approximately 36 seconds. At 12 Hz a crack above the door opening was visible at the east wall. Simultaneously, the northwest corner fully cracked along the north and west walls. There was visible separation between the fractured portion of the northwest corner and the remainder of the west wall. The corner appeared to fall away from the rest of the model, only to be retained by the mesh. Approximately 4 seconds after the cracks were visible, the test was ended. The plastic mesh was visually evaluated after the test, and there was no evidence of stretching of the plastic. **Figure 44** through **Figure 51** show the walls of the model before and after testing.

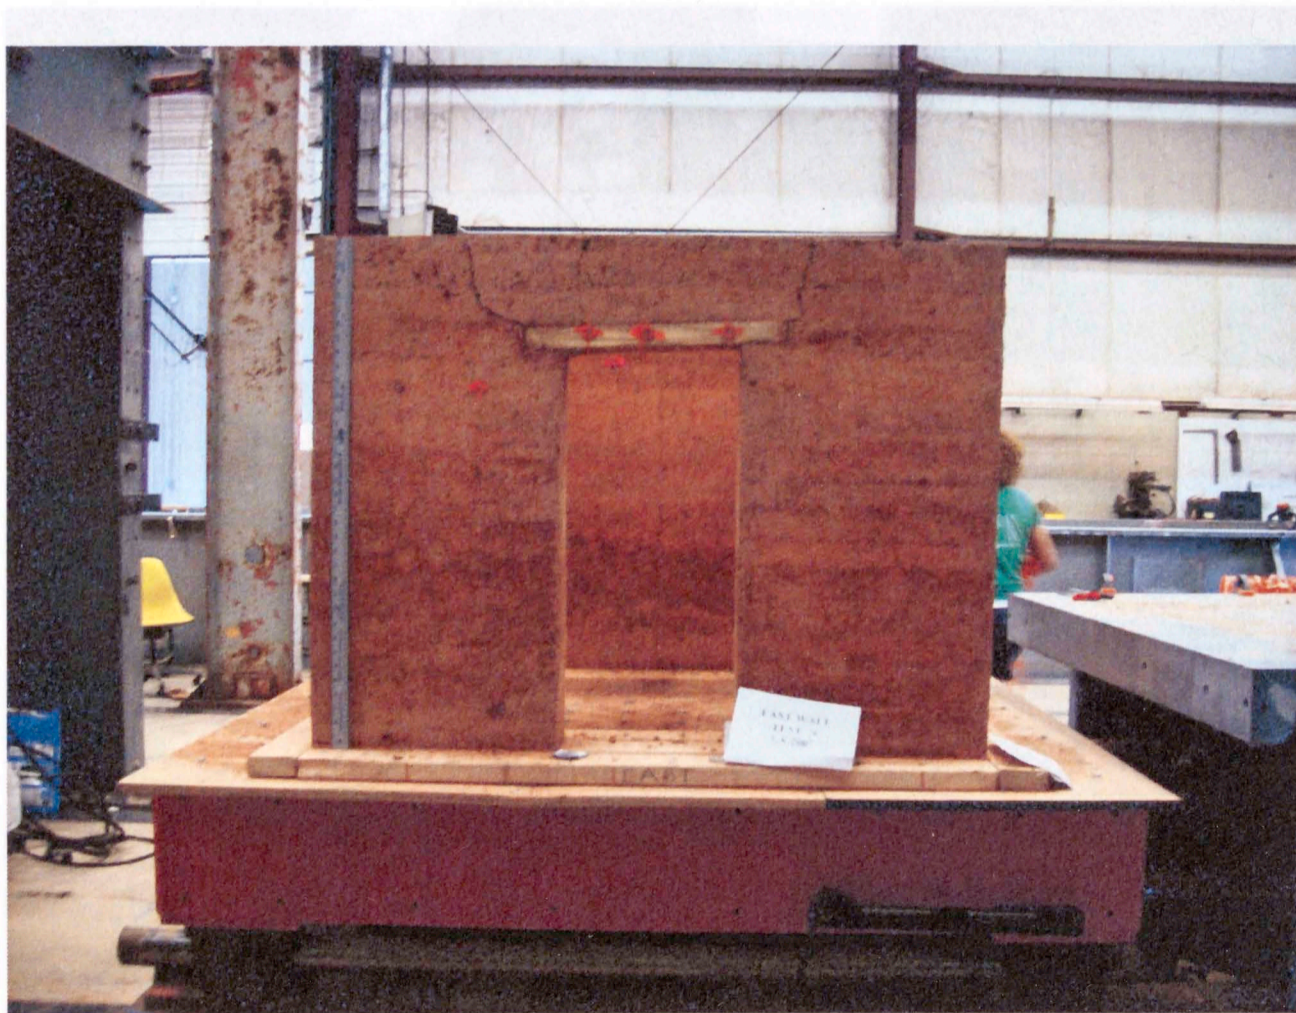
Figure 3.45: Test 4 view of east wall after test with the mesh removed

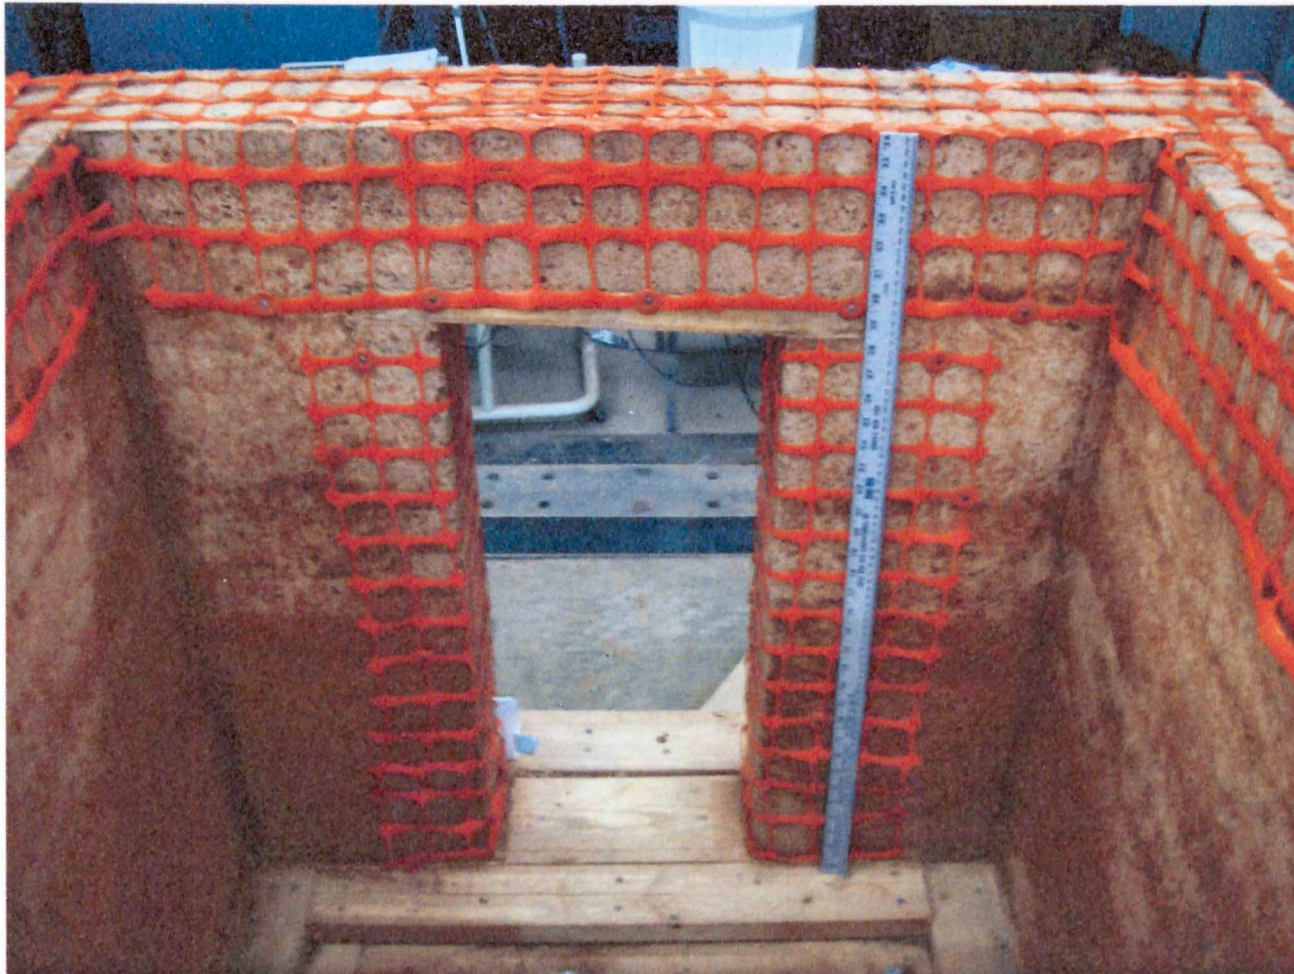
Figure 3.46: Test 4 interior of east wall before testing
