SHAKE TABLE TESTING OF SCALED RAMMED EARTH MODELS

A THESIS

A THESIS APPROVED FOR THE
SCHOOL OF CIVIL ENGINEERING AND ENVIRONMENTAL
SCIENCE

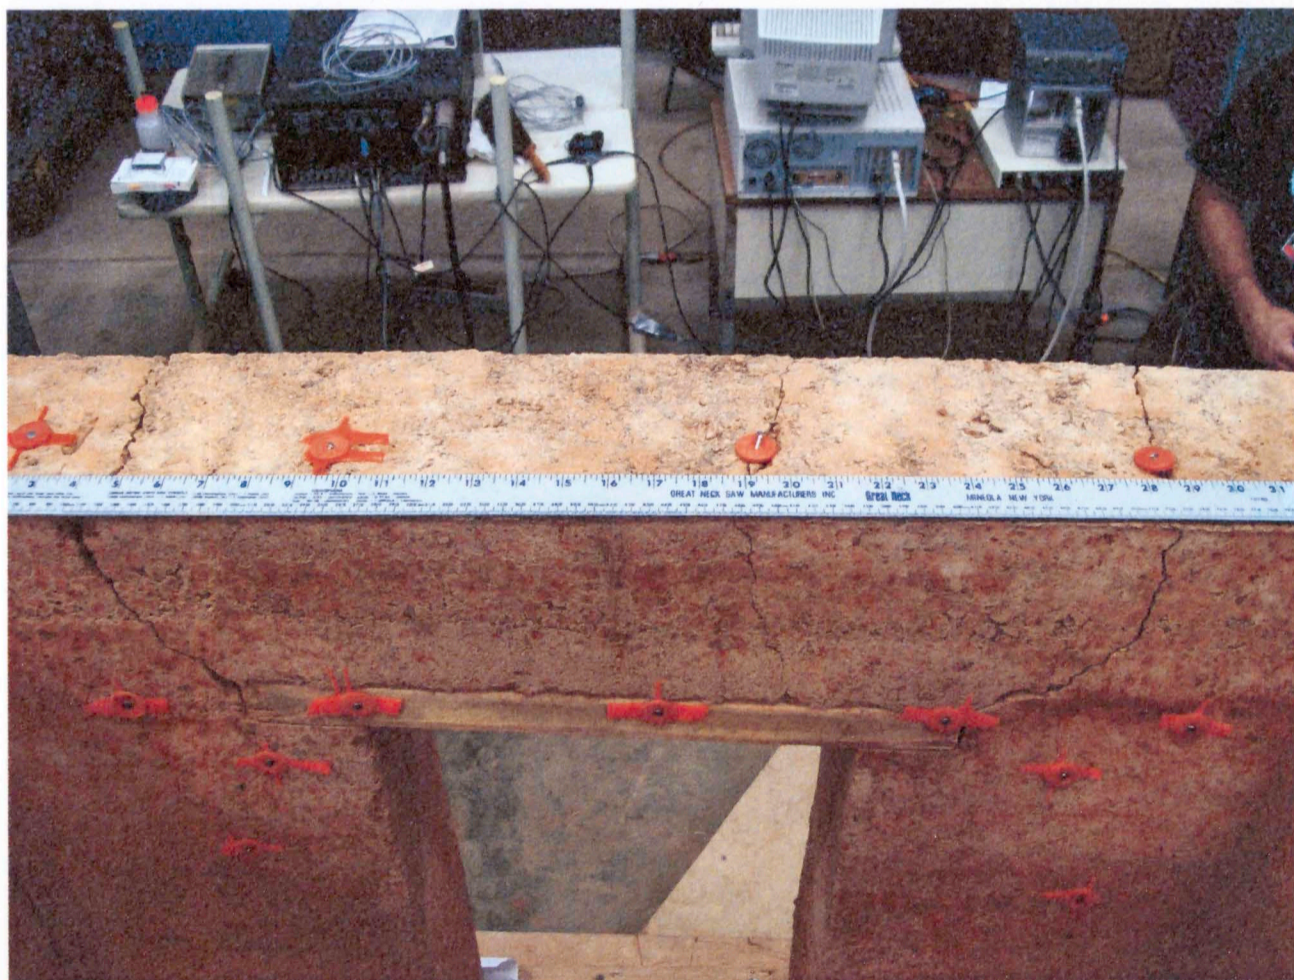
Figure 3.47: Test 4 view of cracks with nails above lintel in east wall after test

After testing, three cracks were observed above the lintel at the east wall (**Figure 3.47**). Spacing of the cracks was approximately 9 in., 19 in., and 36 in. from the southeast corner. Two of the cracks contained a nail while the third was within 3 inches of a nail. The spacing of the cracks above the lintel was similar to those found in the model for Test 3.

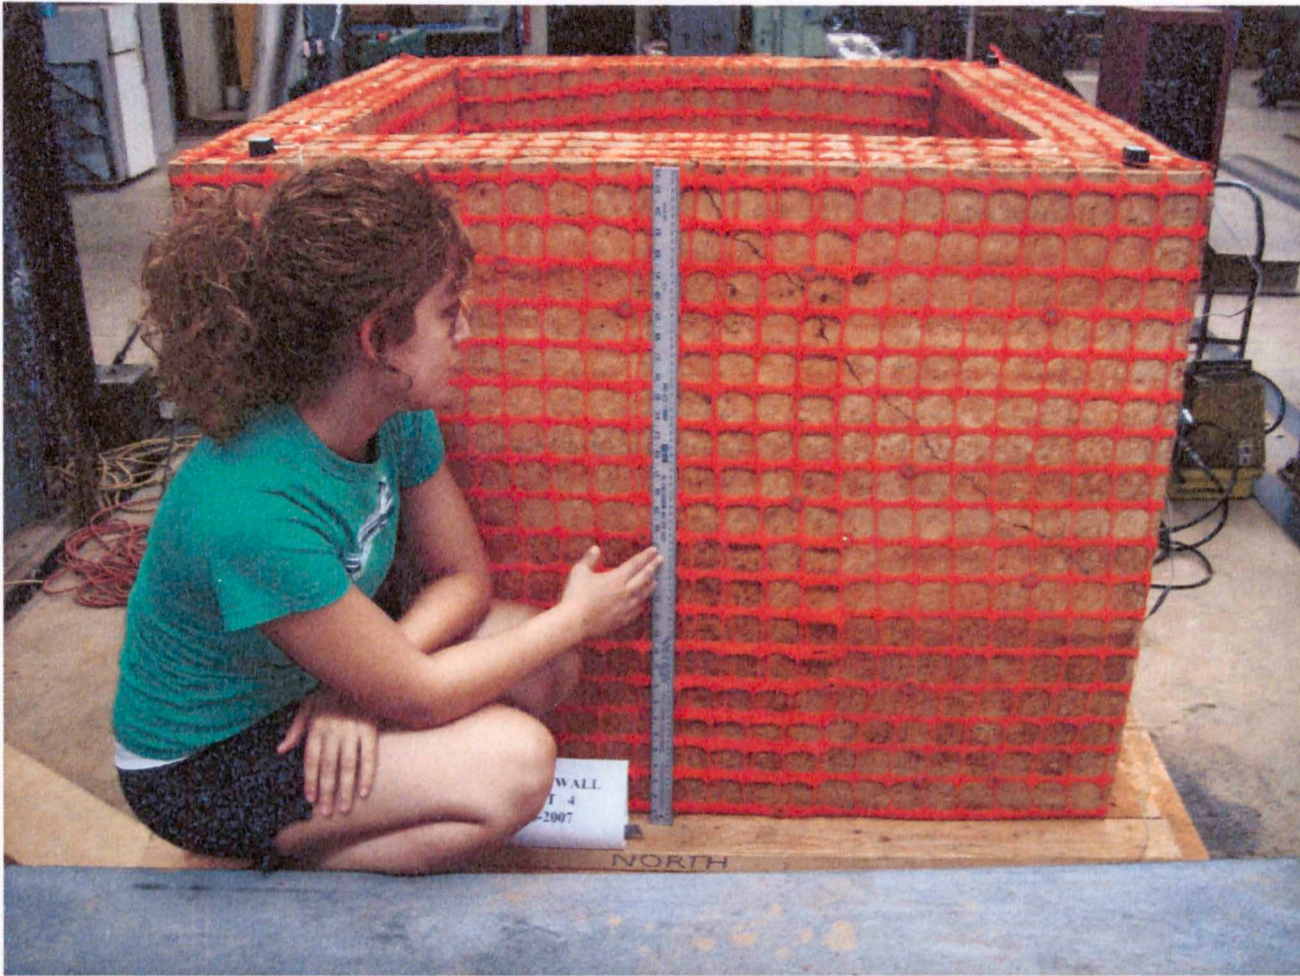
Figure 3.48: Test 4 view of diagonal crack along north wall with mesh after test

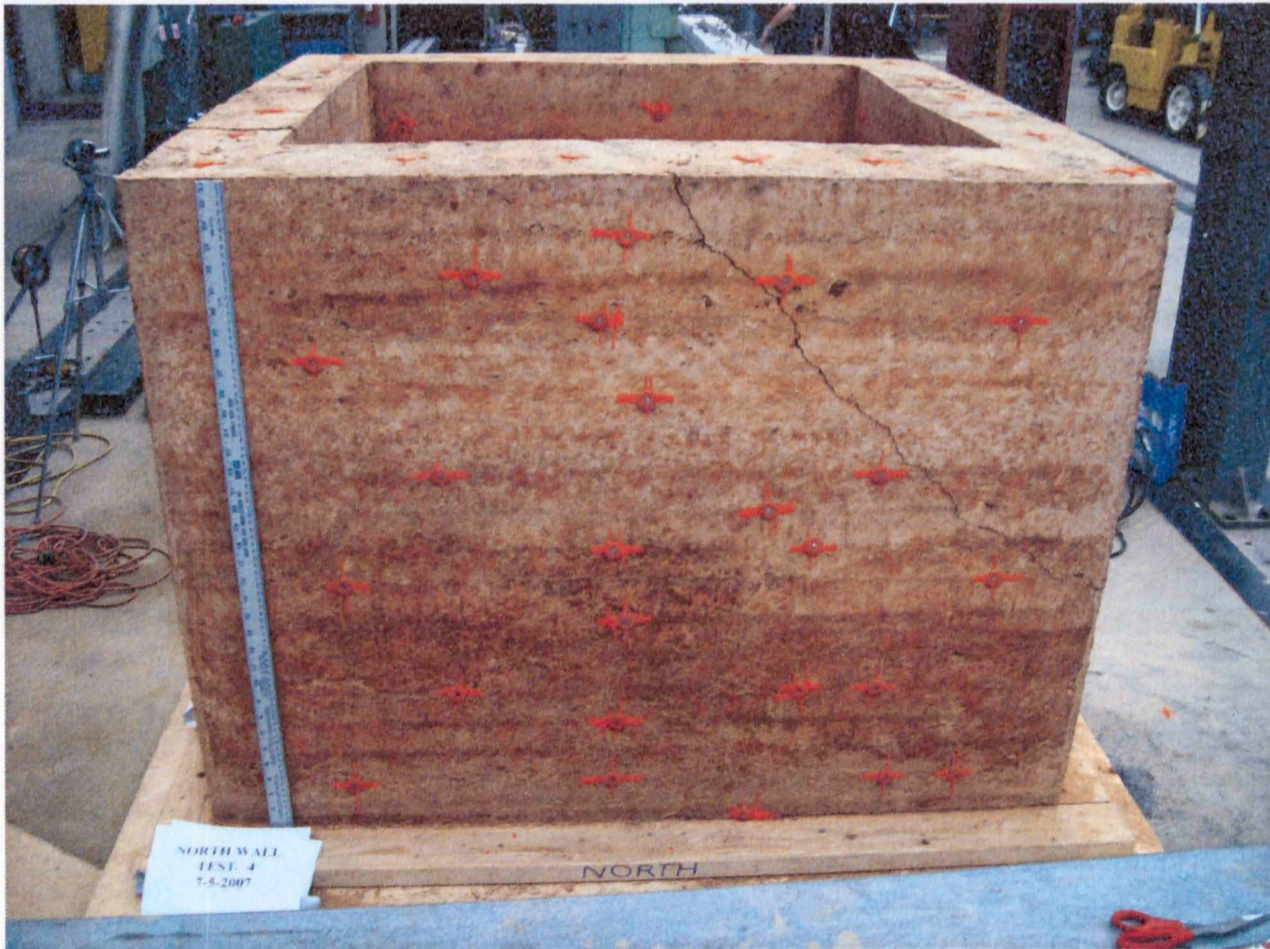
Figure 3.49: Test 4 view of diagonal crack along north wall after test

Along with the cracks observed above the lintel, the upper portion of the northwest corner was completely fractured after testing (**Figure 3.49 through Figure 3.51**). A crack approximately 45 degrees was located in the upper half of the north wall was of the model, extending from the exterior corner to approximately 24 inches on the north wall. The diagonal crack at the north wall intersected the diagonal cracks long the west wall at approximately 14 inches from the base. There was a vertical crack observed at the reentrant corner between the north and west walls. The vertical crack intersected the diagonal cracks at the north and west walls at approximately midheight of the model (18 inches from the base) (**Figure 3.50**). The cracked section along the upper half of the west wall extended approximately 18 inches from the exterior northwest corner. One nail was located within the crack at the base of the west wall. In total, only four of the 131 nails used in the model appeared within a crack.

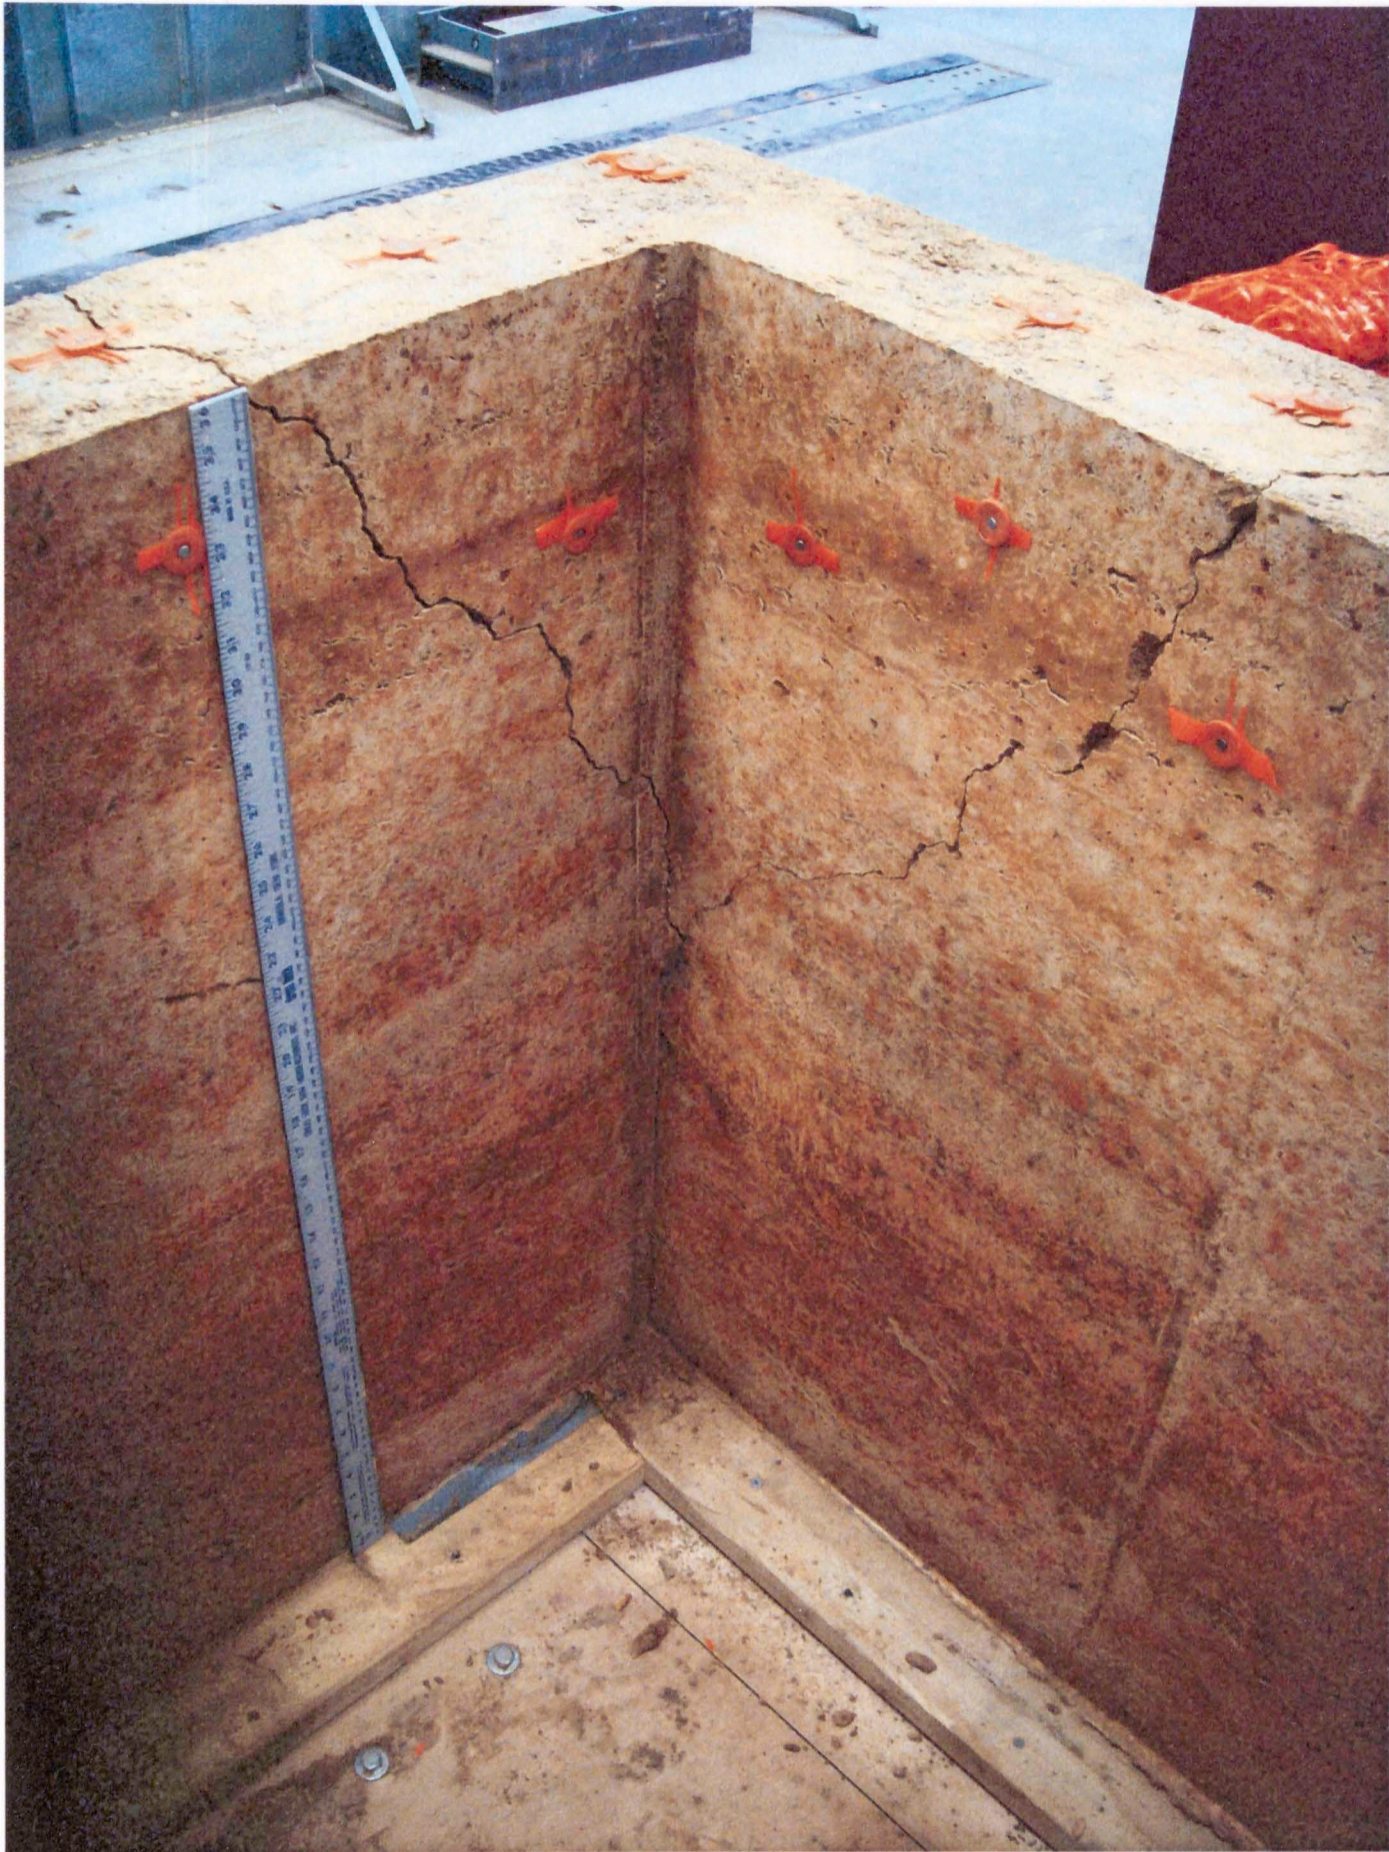
Figure 3.50: Test 4 interior view of NW corner after test

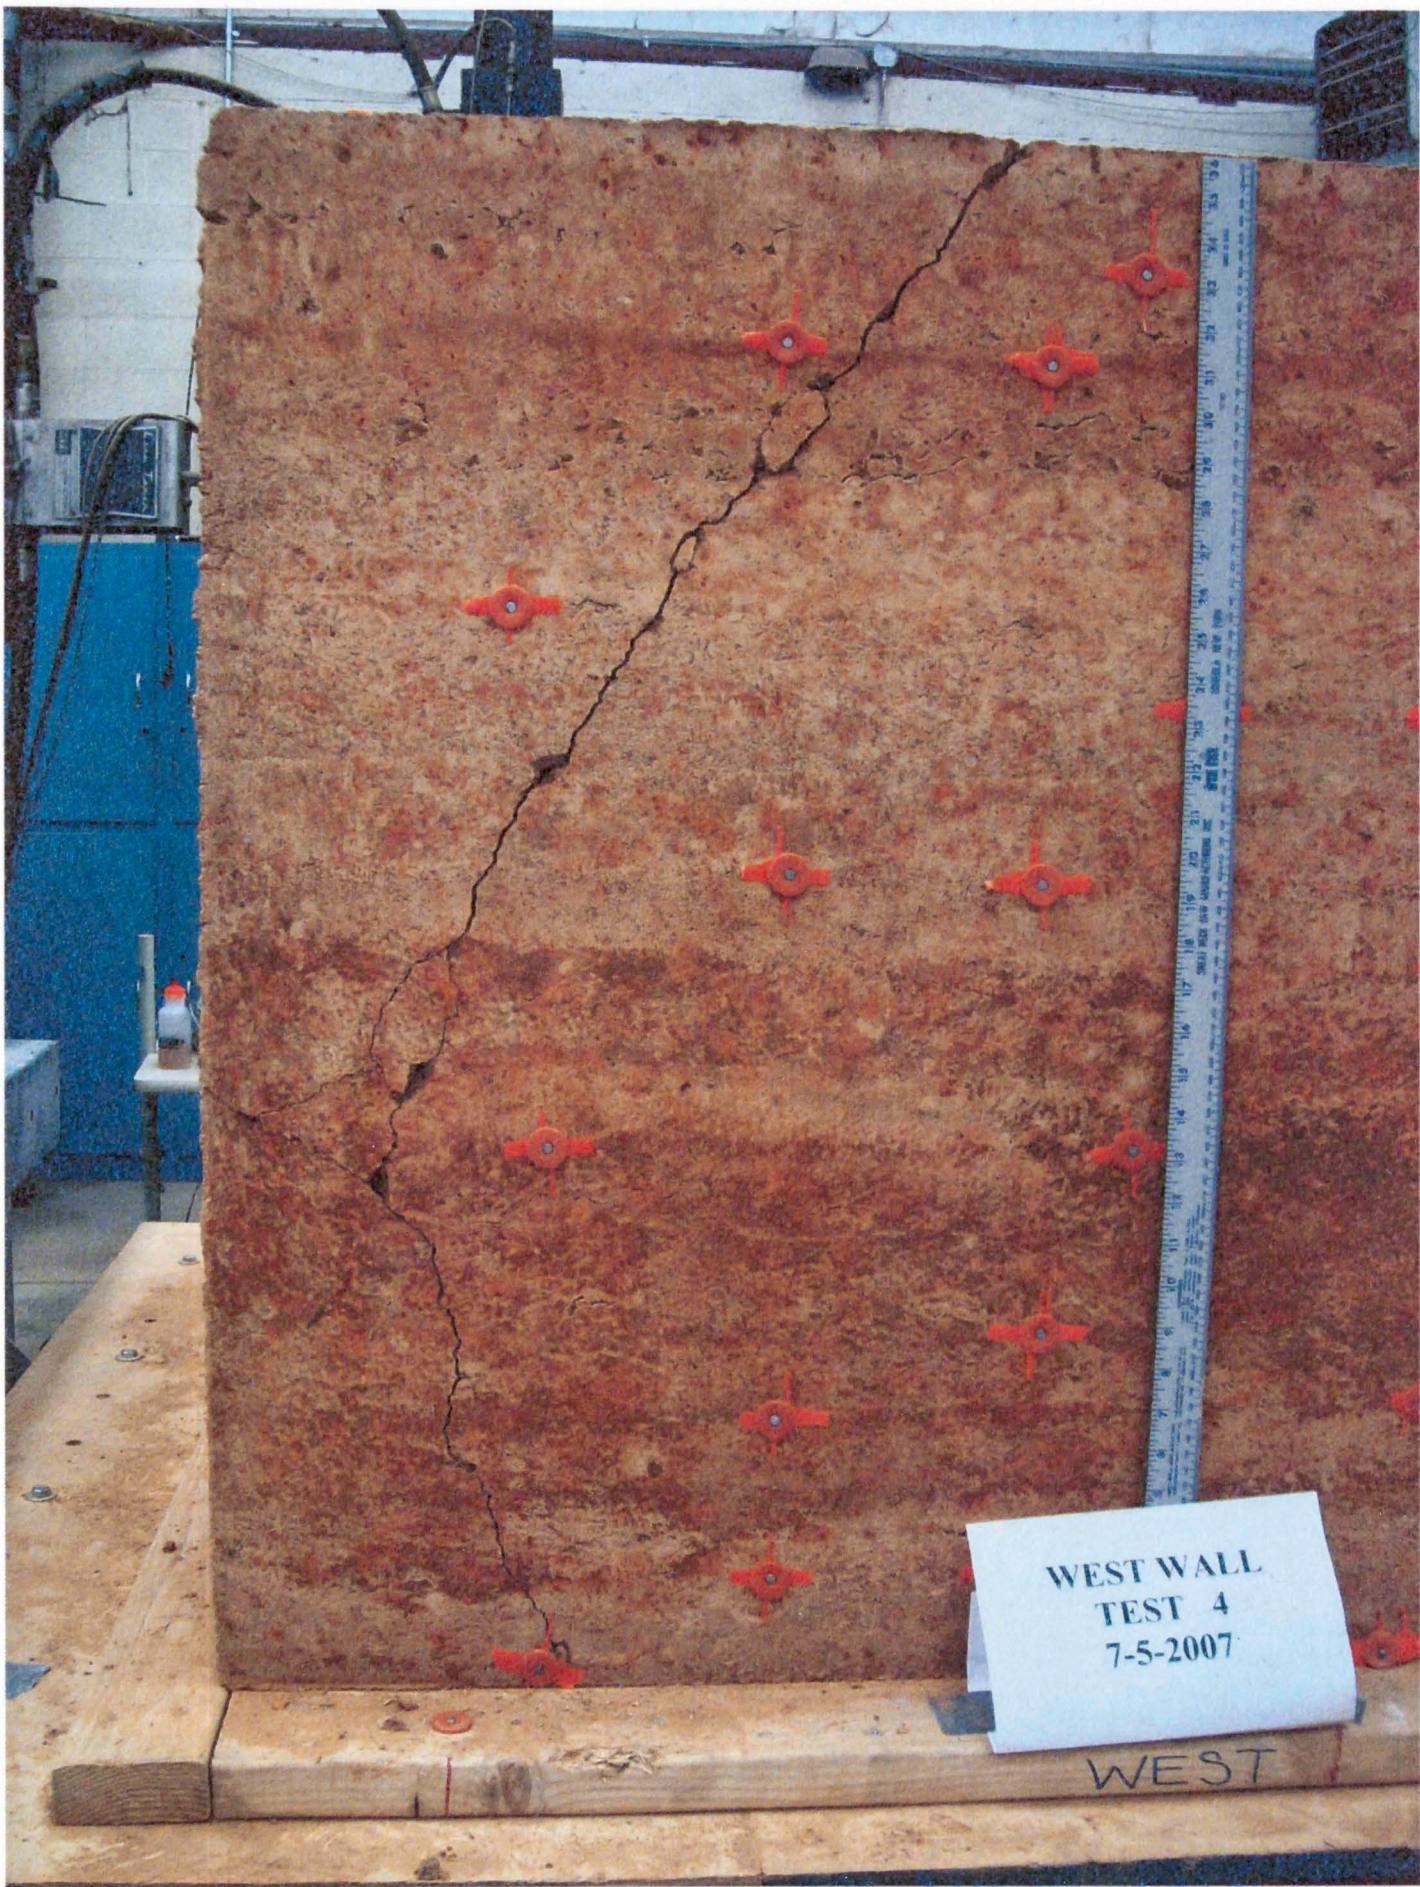
Figure 3.51: Test 4 view of diagonal crack at northwest corner of west wall after test

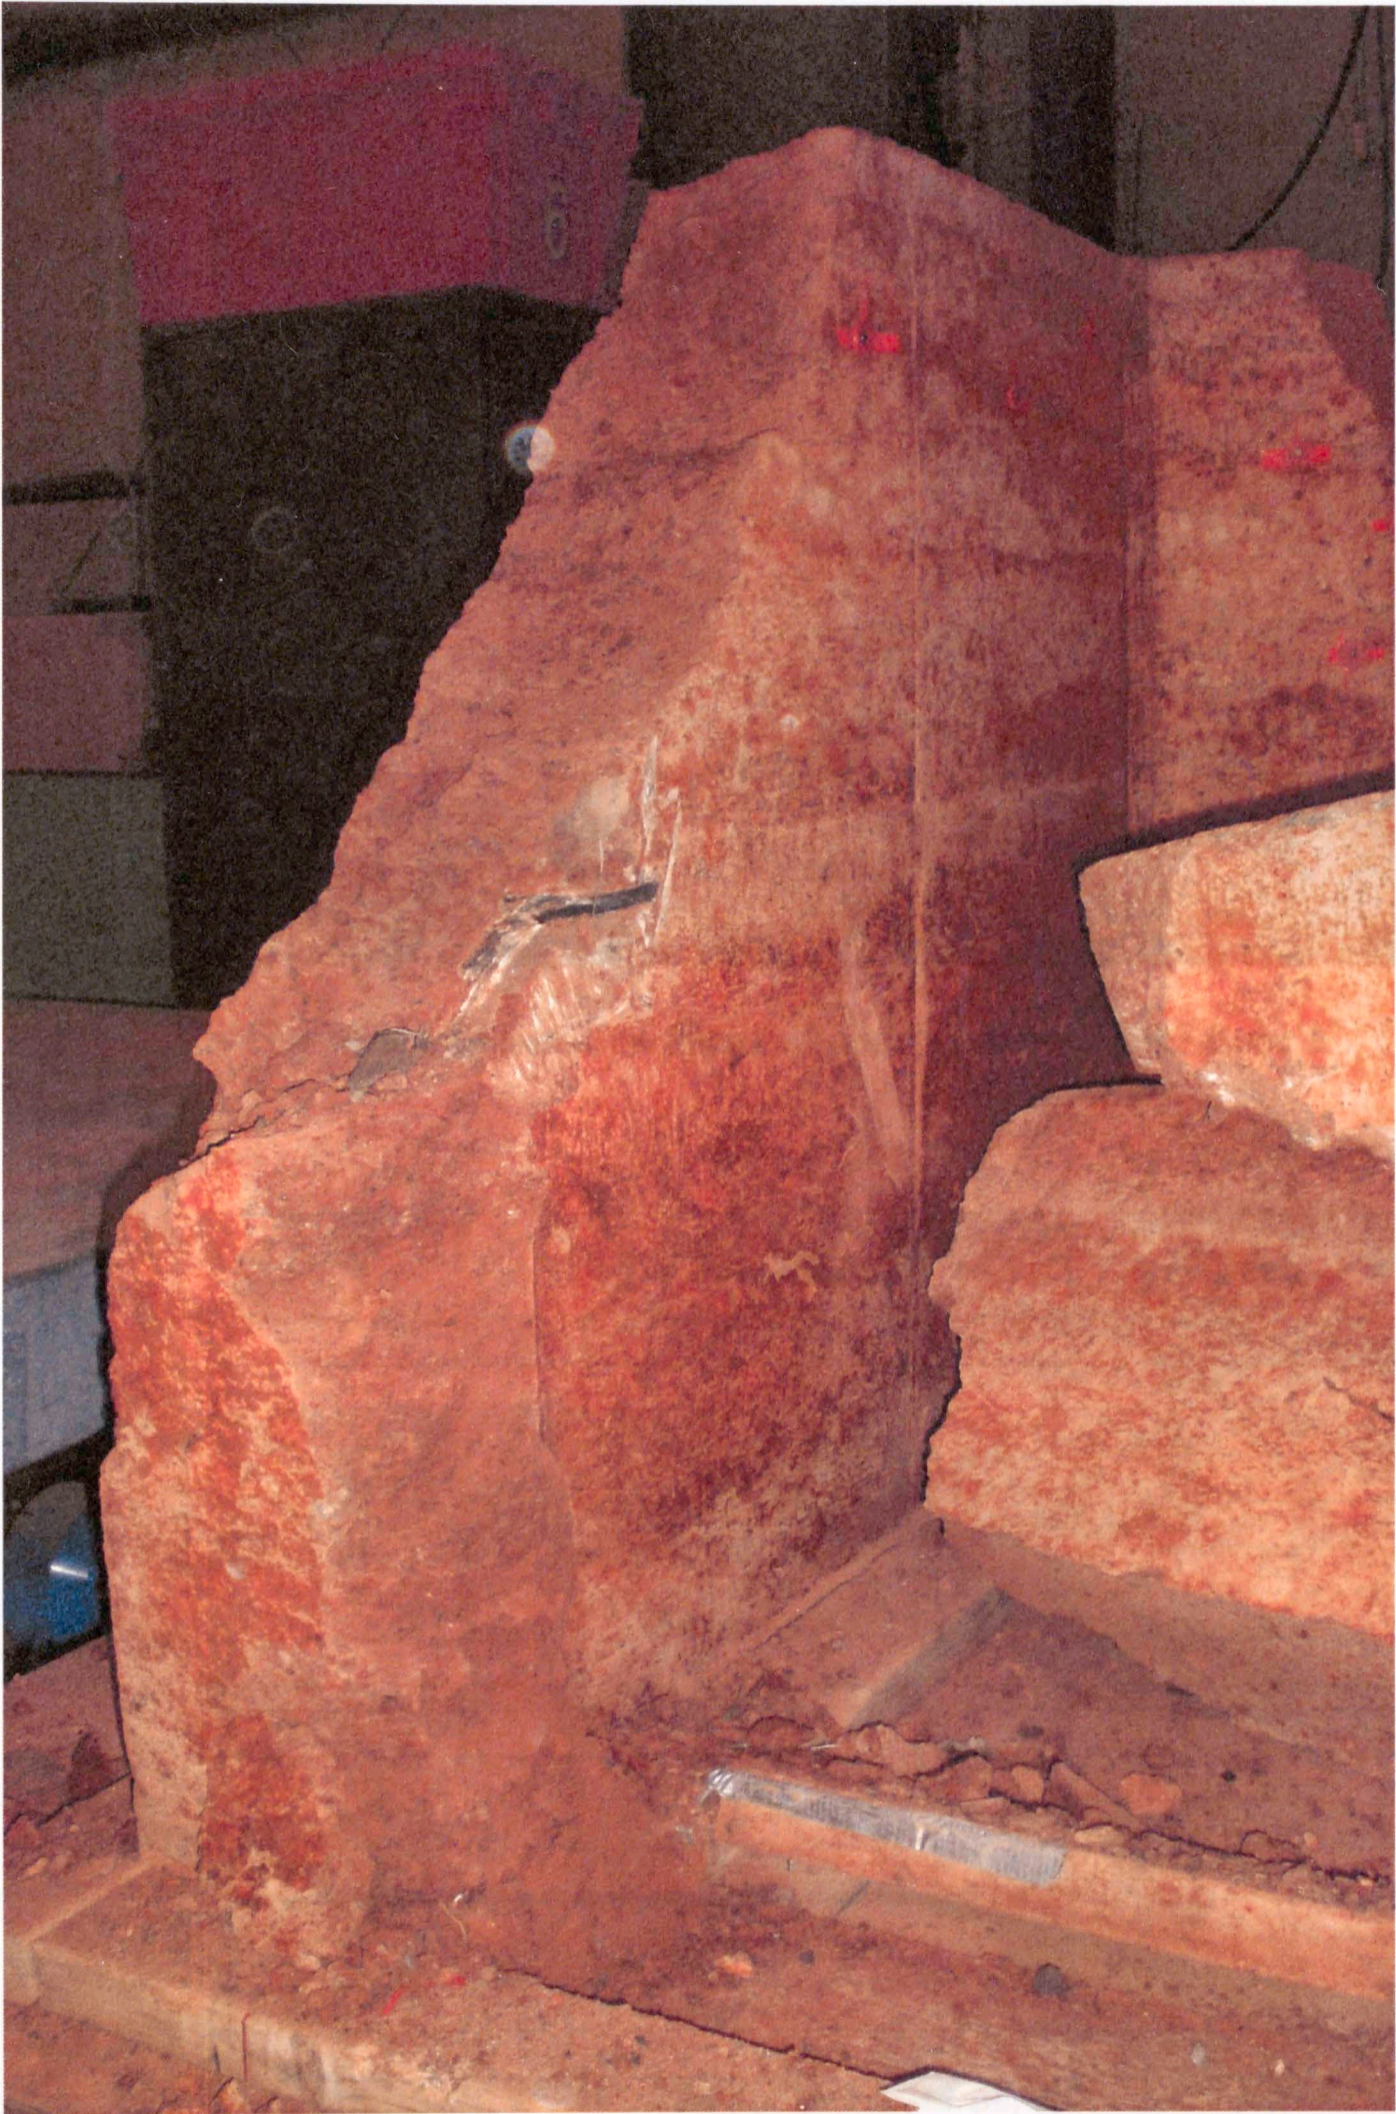
Figure 3.52: Test 4 view of exposed failure planes at north and west walls during demolition

During demolition, a clearer view was provided of the failure planes in the northwest corner of the model (**Figure 3.52**). One of the walls fractured into several pieces upon impact with the ground, as seen in **Figure 3.53**. This was unusual since portions of the rammed earth in previous models were very difficult to break and tended to remain in portions larger than 2 ft², even if they fell onto the floor.

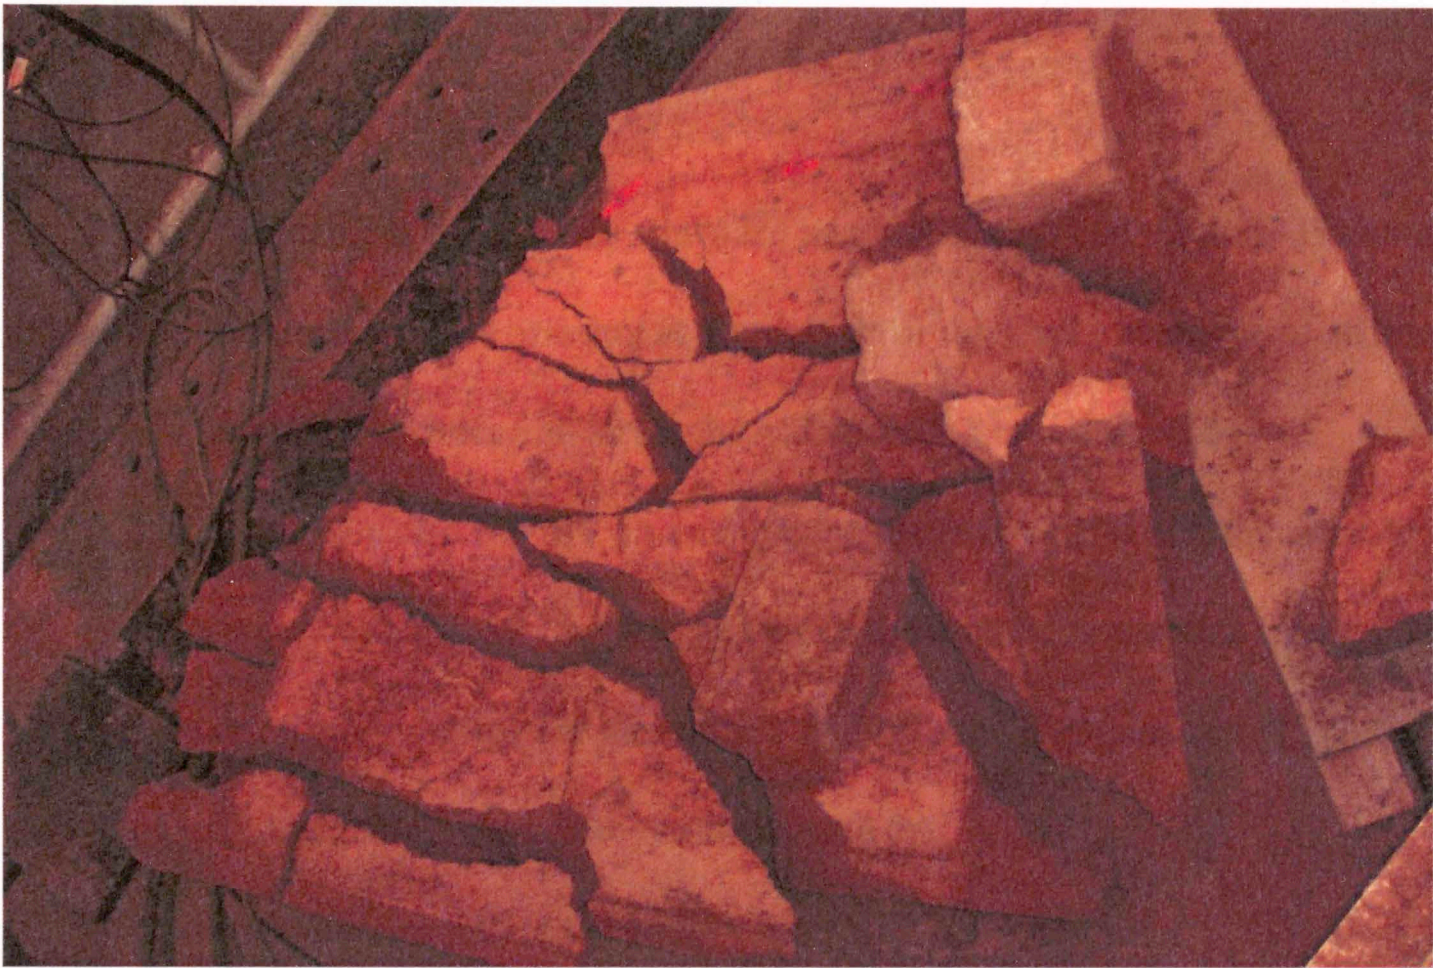
Figure 3.53: Test 4 view of wall that fractured upon impact with the floor

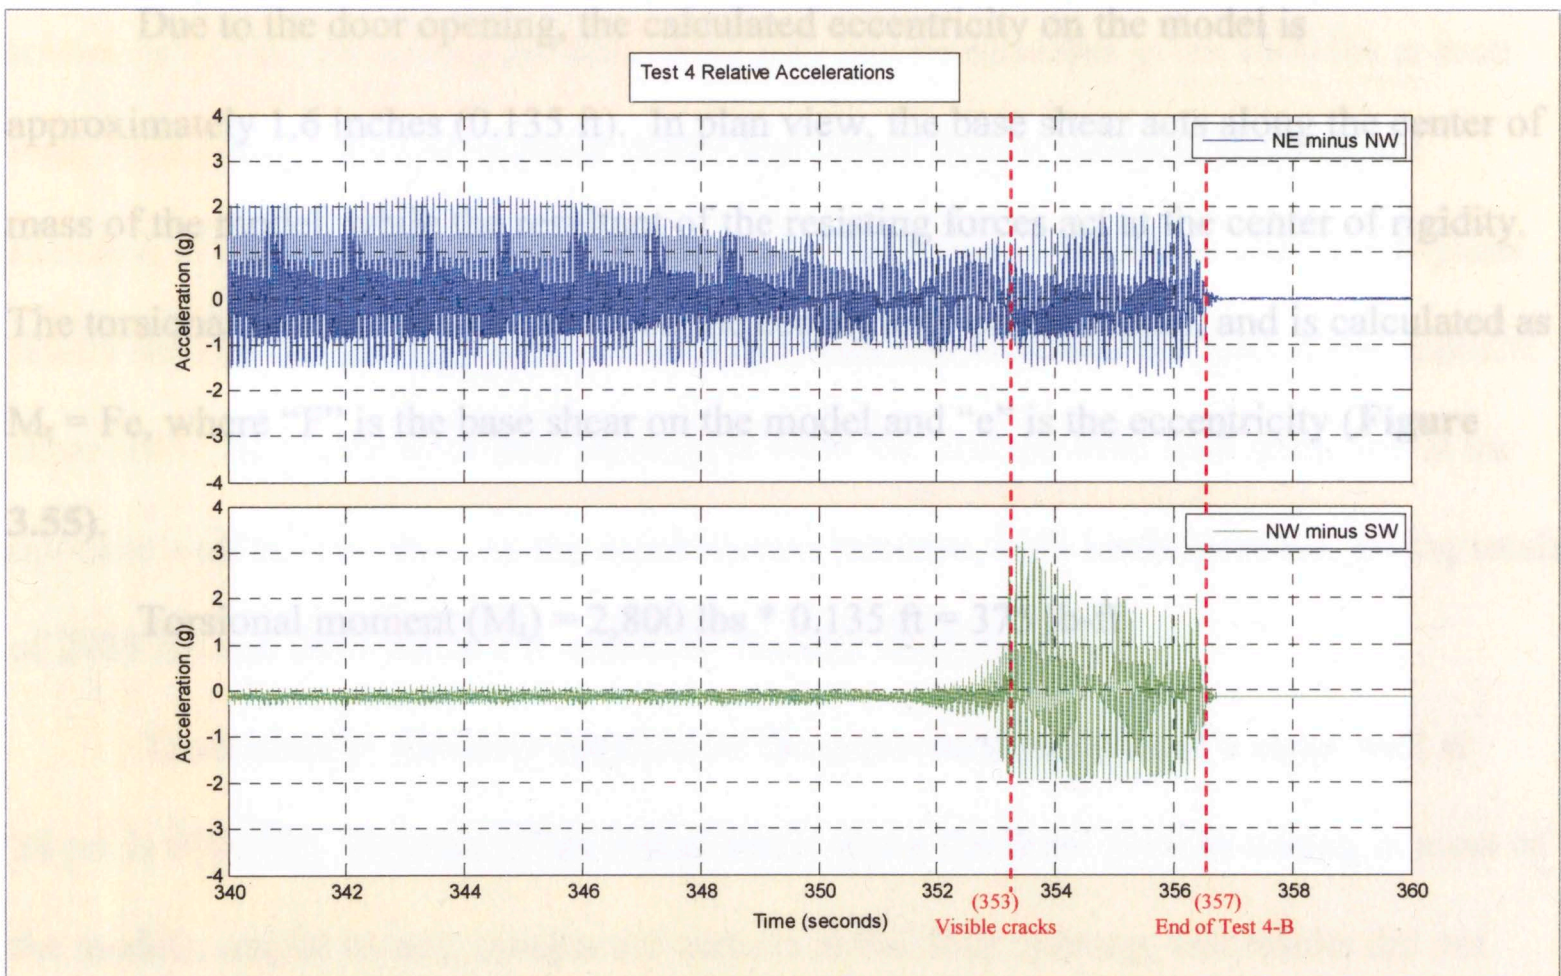
Figure 3.54: Test 4 relative accelerations between corners at failure

The crack at the northwest corner occurred at approximately 353 seconds, and was reflected in the graph as an increase in accelerations between the northwest and the southwest corner (**Figure 3.54**). The end of the test was reflected in the accelerometer data as a sharp decline at approximately 357 seconds.

Data observations were limited to observing the envelope of each graph to view gross changes in acceleration between corners of each model. Due to the weak shear strength of rammed earth, stress-concentrations at the door opening, and pre-existing cracks above the lintel prior to testing, differences in acceleration between the northeast and northwest corners are likely due to cracking in the east wall. Differences in accelerations between the northeast and the northwest corners were reflected prior to cracking of the other corners, which correlated with the visual observations. Results from Test 4 showed that rammed earth can potentially open and close at cracks during cyclic loading. Towards the end of Test 4, the relative difference between northwest and southwest corners increased approximately at the time the crack was observed at the northwest corner.

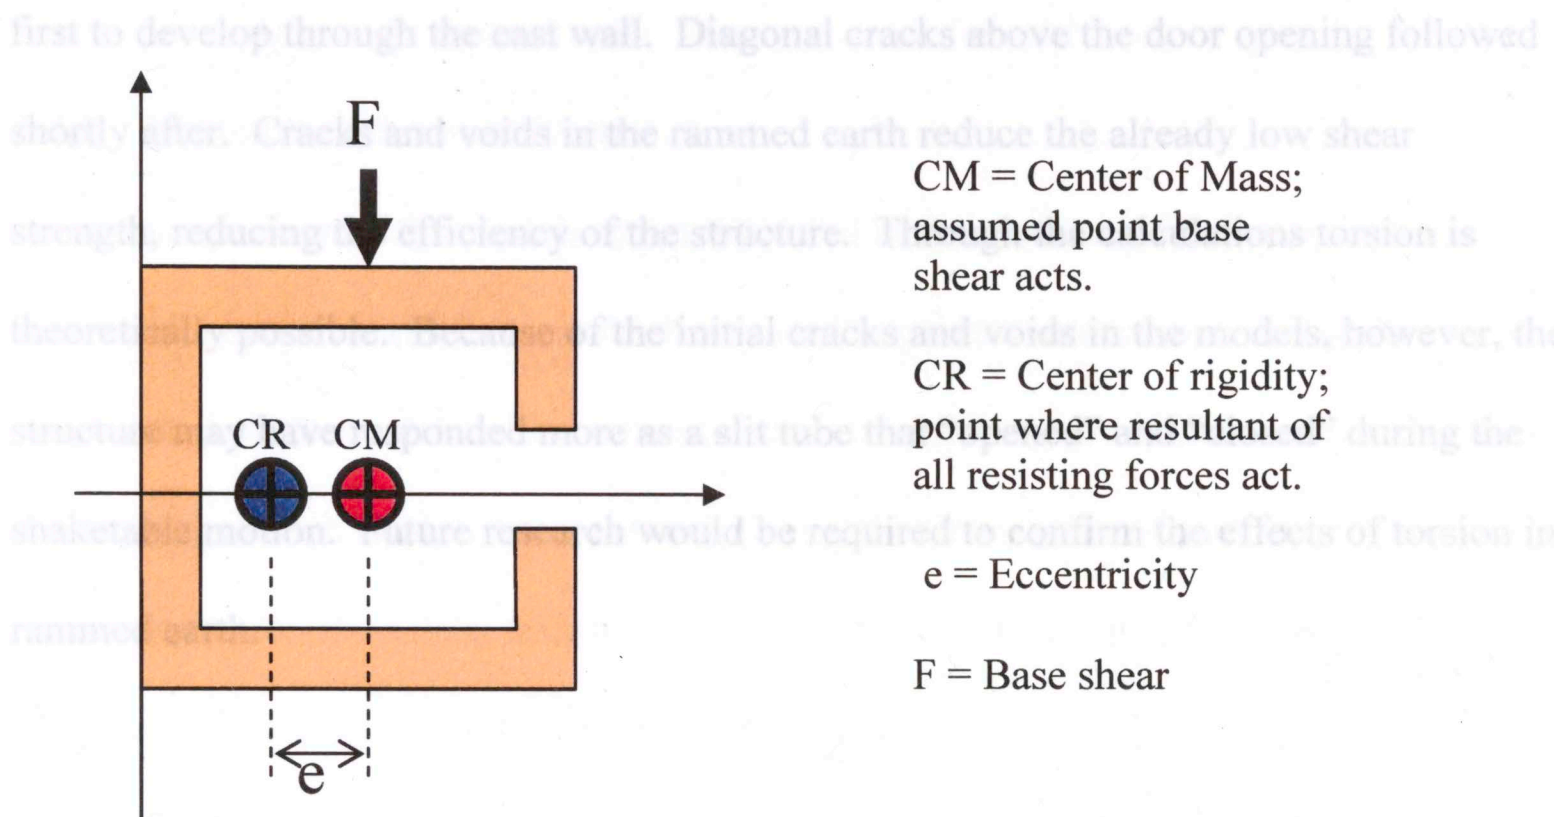
Figure 3.55: Sketch of location of base shear and eccentricity

Due to the door opening, the calculated eccentricity on the model is approximately 1.6 inches (0.135 ft). In plan view, the base shear acts along the center of mass of the model, while the resultant of the resisting forces act at the center of rigidity. The torsional moment (M_t) depends on the eccentricity on the model, and is calculated as $M_t = Fe$, where “F” is the base shear on the model and “e” is the eccentricity (**Figure 3.55**).

$$\text{Torsional moment } (M_t) = 2,800 \text{ lbs} * 0.135 \text{ ft} = 375 \text{ lb-ft}$$

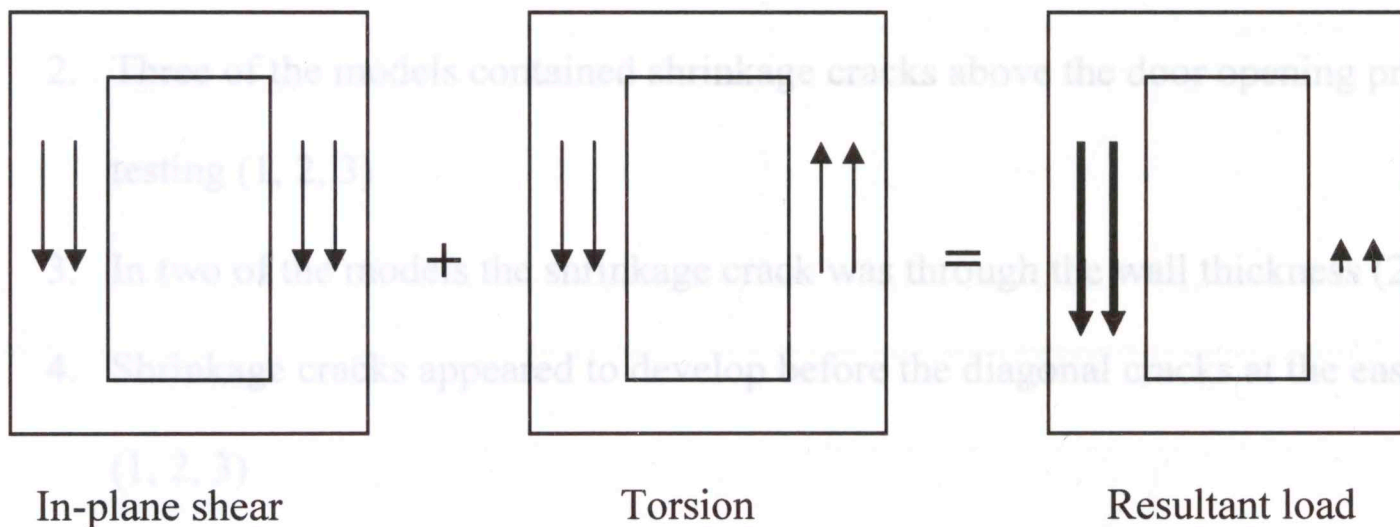
Figure 3.56: Sketch of resultant forces on model

Resolving the moment to an equivalent couple, the forces along each shear wall due to torsion is 94 lbs. Resolving the base shear into two components gives 1400 lbs at each wall. The combination of in-plane shears and forces from a torsional moment are sketched in **Figure 3.56**. As seen in the figure, the addition of torsion with the in-plane shears reduces the resultant load at one shear wall, and increases the load at the opposite shear wall. At 1 g the total load increase is 1494 lbs, and the total load reduction at the opposite wall is 1306 lbs. As the accelerations increase, both loads increase, giving totals of 2989 lbs and 2611 lbs at 2 g, and 4767 lbs and 3633 lbs at 3 g.
