EFFECT OF SPACE RADIATION ON COMPOSITE  
MATERIAL THAT WAS INTERNAL AND EXTERNAL OF  
THE PRESSURIZED VOLUME ON THE INTERNATIONAL  
SPACE STATION (ISS)

Submitted to the Faculty of the Graduate College of the Oklahoma  
State University in partial fulfillment of the requirements for the  
Degree of MASTER OF SCIENCE  
JULY, 2022

Major Field: MATERIALS SCIENCE AND ENGINEERING

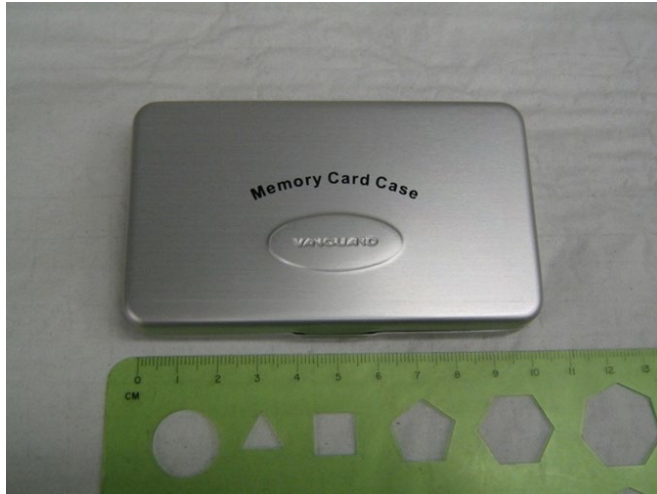
**Figure 7: Exterior Image of the Passive Detector Carriers**

These boxes were procured from Vanguard World and the original design of the box was to hold 8 RAM memory cards (figure 7). The boxes came with molded silicon liners that were removed and retro fitted with holders that fit the composite coupons. The boxes could carry up to 16 flat composite coupons in each box. The dimensions of the box are 6.2 x 10.2 x 1.5 centimeters, and the weight is 70 grams empty. The part number assigned to the box (SEY15550432-316) was used to track exposure of the specimens to radiation damage. Figure 8 shows the inside of the boxes prior to the removal of the silicone liner.

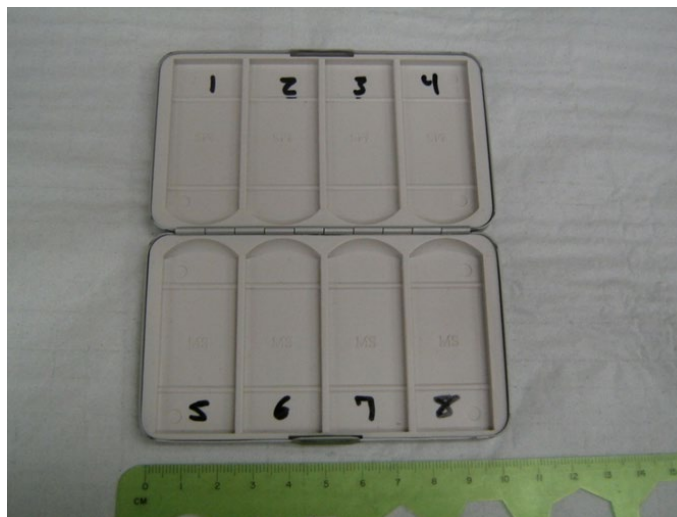
**Figure 8: Interior Image of the Passive Detector Carriers**

The composite coupons and metal foils were cut to the required dimensions to fit into the aluminum passive detector carrier boxes. The coupons were placed into four stacks consistent with prior experiments that had flown on the ISS. The first of the stack was A-CFCDET-1, which contained the control coupons that had no metallic foil inserted between the composite samples. The second stack was A-CFCDET-2, with the Niobium foil placed between each composite coupon, the third stack was A-CFCDET-3, with the Tungsten foil placed between each composite coupon, while the final stack was A-CFCDET-4 coupons with the lead foil. Table 3 lists all the composite coupons of the assembled stacks. Figure 9 displays the stacking sequence used in every stack. The stacks were individually wrapped in a Permacel P-221 Kapton tape with acrylic adhesive. The thickness of the Kapton tape was 2.5 x 3 x 0.006 cm. The location of the aluminum passive detector carrier boxes with specimens was shown in Figure 8.

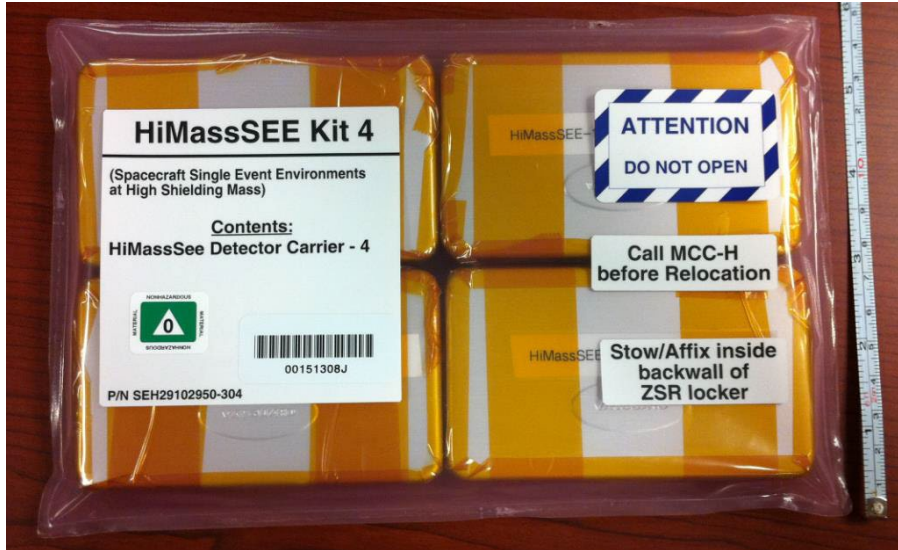
Figure 10: Packaging Group SEH29102950-304 which contains SEY15550432-316

After the stacks were placed in the mapped slots inside the aluminum passive detector carrier boxes, the boxes were shut and taped closed with Permacel P-221 Kapton Tape to ensure they would not open during launch or while on board ISS. SEY15550432-316 was packaged with group SEH29102950-304 and sealed in a flight poly bag. Flight was recorded before and after packaging. The weight of SEH29102950-304 prior to packaging was 307.0 grams and post packaging were 320.0grams. NASA JSC Materials and Processes lab (B13/RM258/260) balance (ID#M56489: 12Kg max) was used to measure the weights of each package. Figure 10 below shows the package group prior to being placed in the Nomex zero gravity storage locker. Figure 11 is an image of the SEH29102950-304 packaging placed in the Nomex zero gravity storage locker prior to close out.

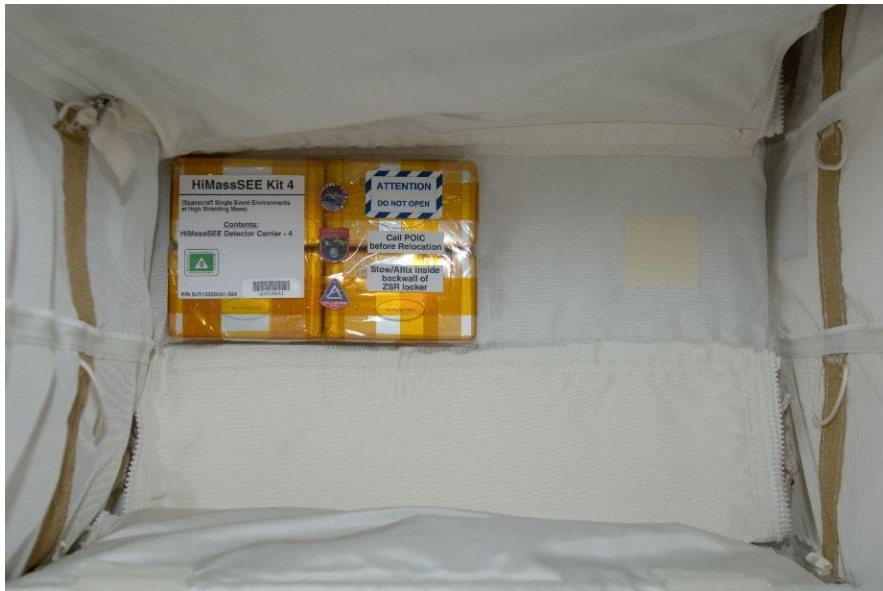
Figure 11: Packaging Group SEH29102950-304 prior to close out

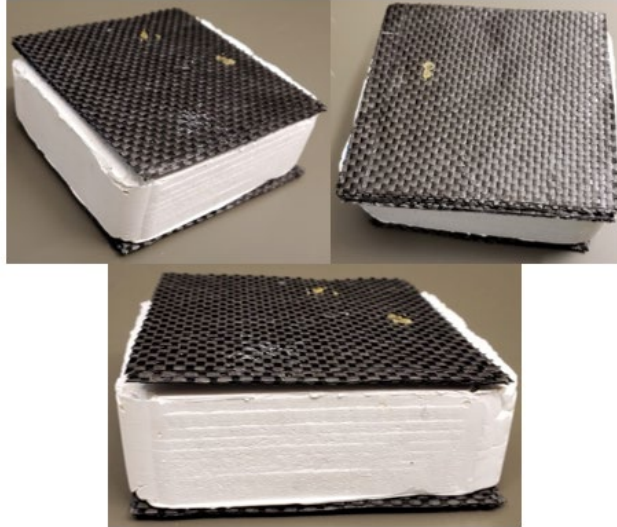
**Figure 12: SC2020 Coupons Sandwiched with Carbon Fiber Coupons**

To maintain the structural integrity required, the SC2020 coupons were sandwiched between two carbon fiber/epoxy panels of 3mm thick and 76.2mm x 76.2mm length and width. The SC2020 coupons and carbon fiber face sheets are shown in figure 12 below.

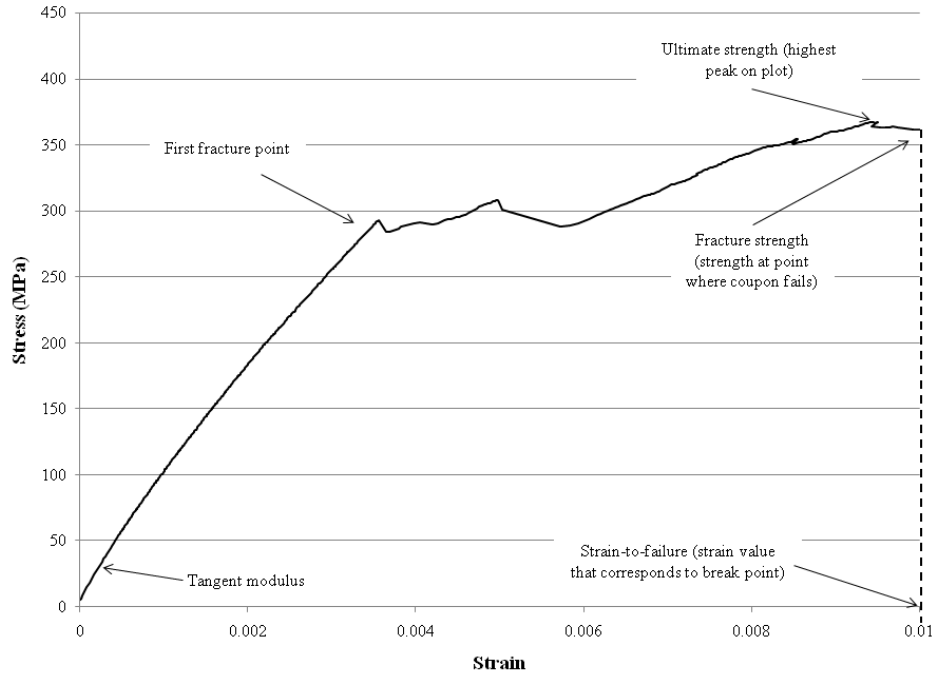
**Figure 15: The graph above is representative of the stress-strain curve of a coupon that has been exposed to radiation and tensile tested**

The tensile testing of the ground samples and radiation exposed were to follow the procedures outlined in ASTM D2343. The crosshead speed was selected at 1.27mm/min which has been used in previous tensile tests that involved radiation exposed coupons [6,7]. The area of radiation exposure was across the entire coupon which was equivalent to 940 mm<sup>2</sup>. The area was calculated at 20 mm in width and 47 mm in length. The coupons were pre-cut, and the dimensions were controlled by the aluminum passive detector carrier boxes. Stress-strain data curves were to be generated from the data via an axial strain gauge that was attached the coupon. The following data was collected from the tensile pulls of the coupons: Modulus, ultimate strength, fracture strength, strain-to-failure, fracture energy, and first fracture point. Figure 15 below demonstrates graphically the collection of this data [6,7]

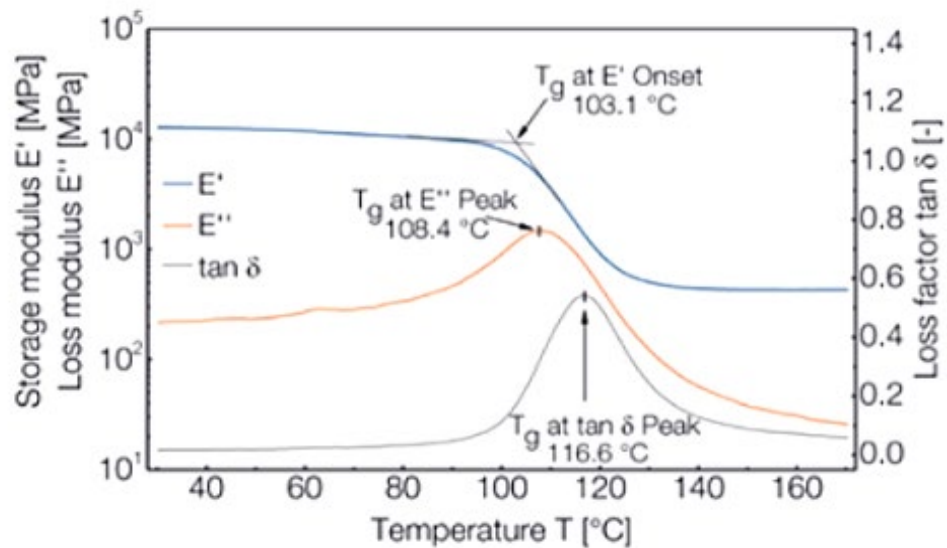
Figure 16: Example of a DMA data plotted on a Multiple Y plot

cantilever clamp with a span length of 35mm. Three-point bend tests were carried out by first equilibrating the coupons to 25°C and then heating the coupons from 30°C to 150°C at a ramp rate of 3°C/min and applying a constant stress load of 1N with 1 Hz frequency. The three-point bend test provides the storage modulus and the loss modulus. The dampening coefficient ( $\tan \delta$ ) of the sample was measured using a Origin Pro 2022B analysis software. Figure 16 below demonstrates an example graphically the collection of DMA data results.

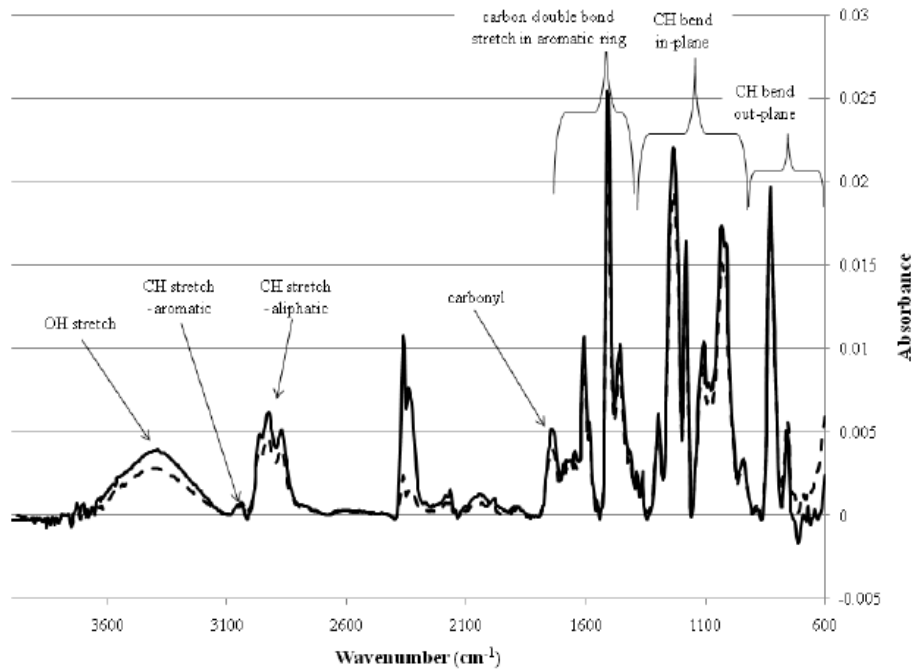
**Figure 17: Carbon Fiber/Epoxy irradiated coupons tested by FTIR (ATC)**

The HiMassSEE carbon coupons were examined using Fourier transform Infrared Spectroscopy (FTIR) to better understand the material from a molecular level and to better investigate which chemical bonds have changed with the irradiation. The FTIR experiments were run using the Attenuated Total Reflectance (ATR) method. A Shimadzu IRSpirit with QATR-S having diamond prism was used for attenuated total reflection FTIR (ATR-FTIR). The spectra were collected by acquiring 16 scans at a resolution of 2 cm<sup>-1</sup> in absorbance mode ranging from 500 to 4000 cm<sup>-1</sup>. The ATR method allows for investigation of the surface. Prior to characterizing any panels, a background spectrum was obtained and subtracted from the subsequent sample spectra. This process enabled the removal of any background noise, such as water, from the signal so that weaker signals could be more easily observed. Pressure was applied during data collection to ensure that there was adequate contact between the sample and the ATR crystal. Figure 17 is a sample FTIR (ATR) of an irradiated carbon fiber/epoxy composite sample.

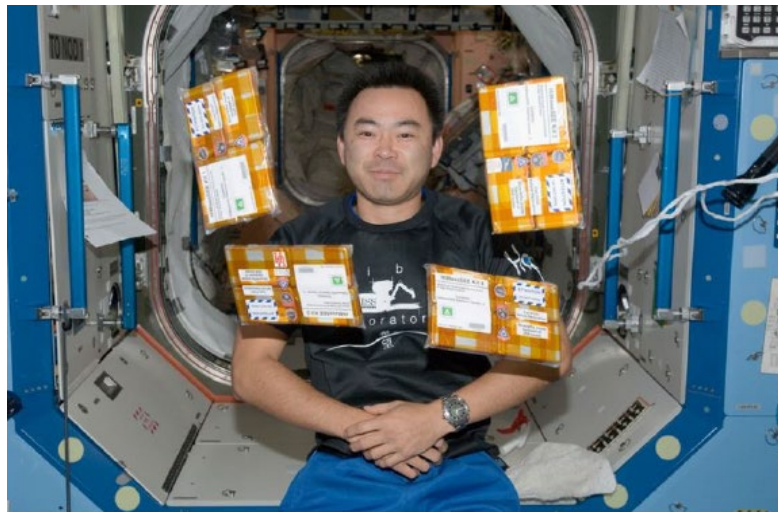
**Figure 19: Composite Coupons onboard ISS Materials on the International Space Station (ISS) MISSE-11 Experiment**

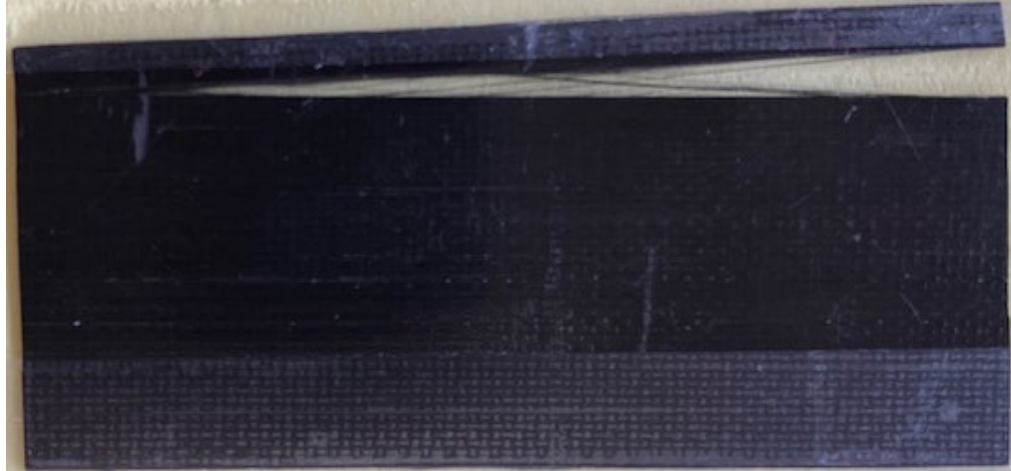
**Figure 21: Composite Coupon that was separated from group of tows. Signs of fiber tearing occurring from the separation**

The mechanical testing that was selected for determining the impact of the radiation had on the composite coupon specimens was tensile testing. The tests were to be used to characterize the material properties and compare them to each other. Once the composite coupons were delivered to JSC for processing and pretesting setup it was determined that there was an issue with the test coupons that was not originally considered. Due to the manufacturing and peel ply applied to the fiber, the individual tows cured together. This provided immediate concerns that when separating the tows apart there would be damage that occurred to the edge of the tow that would more greatly impact the material properties that would result in a false testing showing degradation of strength when in fact it was the processing error that would have created this degradation. Figure 21 demonstrate the issues that arose when trying to separate the fiber tows from each other.

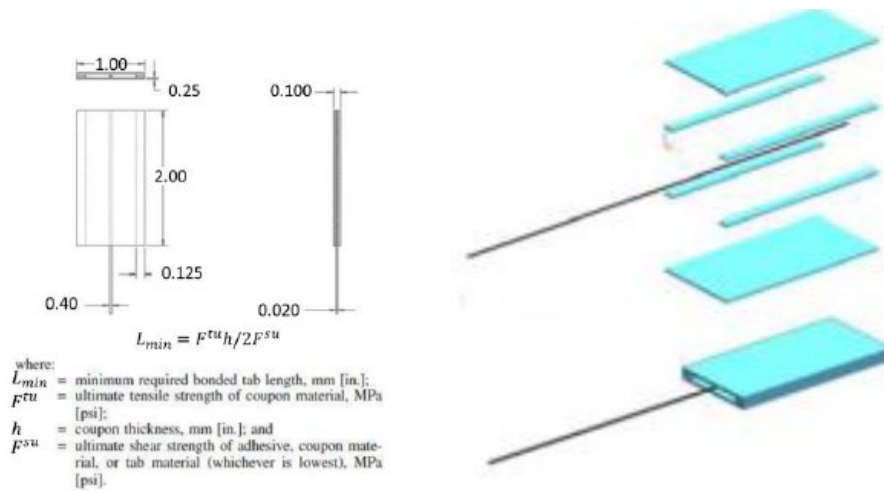
**Figure 22: Cardboard tabbing of carbon fiber strands**

The next issues that arose from the review was that the composite coupons themselves were way too small to fit into standard load frames. Alternative methods of tensile testing have been developed by NASA White Sands Test Facility in Los Cruses, New Mexico for small strand testing. The process involved tabbing the strands with cardboard strands as shown in Figure 22 and testing the strands in a micro-load frame that was developed previously for testing Kevlar 49 roving in the SEM. Figure 23 is a picture of the micro-load frame. Unfortunately, constraints on the size of the specimens meant that ASTM D2343 could not be used to generate tabbed strand specimens as had been done in the work of [17, 18]. Collaboration with NASA White Sands Test Facility into the possibility of using a micro-load frame also turned out to be problematic due to the short gauge length of the specimen and the fact that the strands were joined to each other and would not fit the width constraint of the instrument.

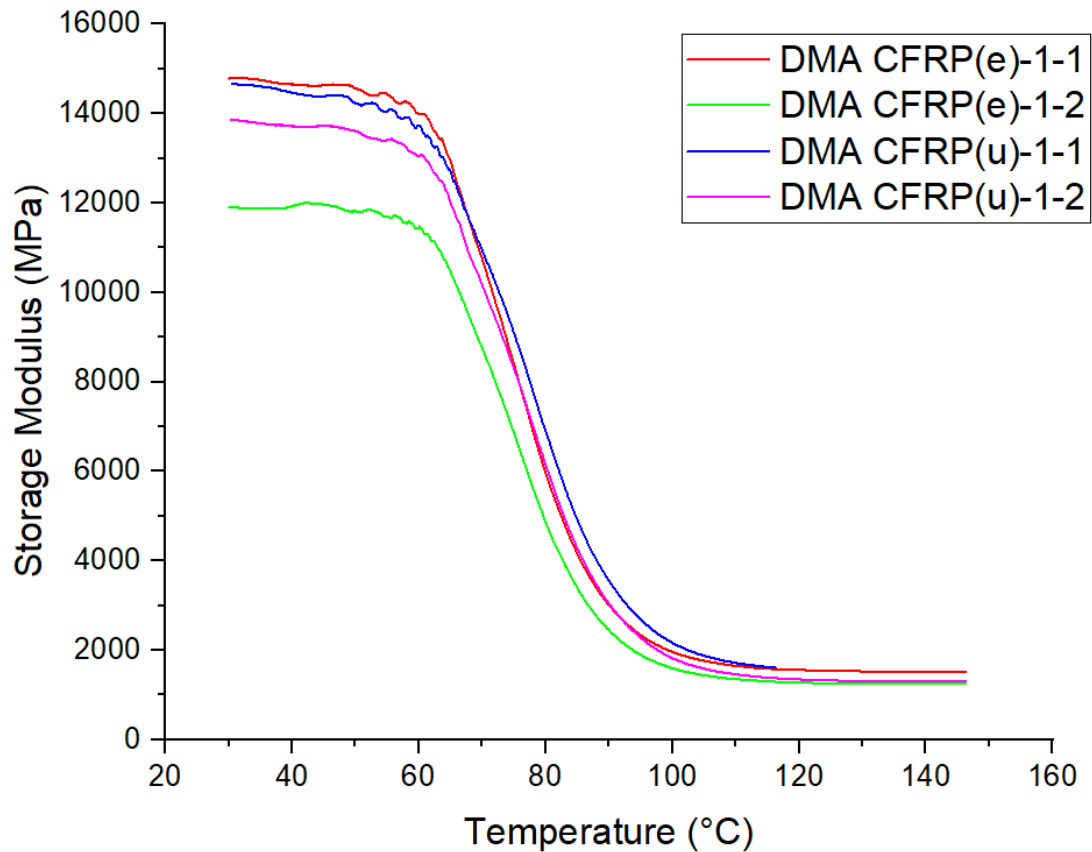
**Figure 25: Plot of the Storage Modulus vs. Temperature comparison of flight vs. ground control**

Figure 25 above shows that there are minor changes in the storage modulus between CFRP(e)-1-1, CFRP (u)-1-1 and CFRP (u)-1-2. The DMA data for CFRP (e)-1-2 however shows that there is a reduction in the storage modulus. The difference between DMA CFRP (e)-1-1 and DMA CFRP (e)-1-2 is 2883 MPA. Both these coupons were irradiated outside the ISS , but only one of the coupons (CFRP (e)-1-1) showed no change from the ground controls. The reduction of storage modulus could be attributed to CFRP (e)-1-2 receiving higher doses of atomic oxygen due to its orientation.

It was observed that as the temperature increased, the storage modulus decreased around 50°C. Figure 24 shows that the storage modulus of all the 4 samples decreased as the temperature increased. Figure 25 is a comparison of the irradiated and the ground specimens. It can be observed that no significant change between the irradiated and ground specimens. Figure 26 displays the loss modulus as temperature increased individually plotted for all coupons, while Figure 27 is the comparison of the loss modulus for all the samples. Damping factor, or  $\tan\delta$  was also recorded to see if there was a difference between the ground controls and the flight coupons. Figure 28 and Figure 29 display the individual coupons results and the comparative results.

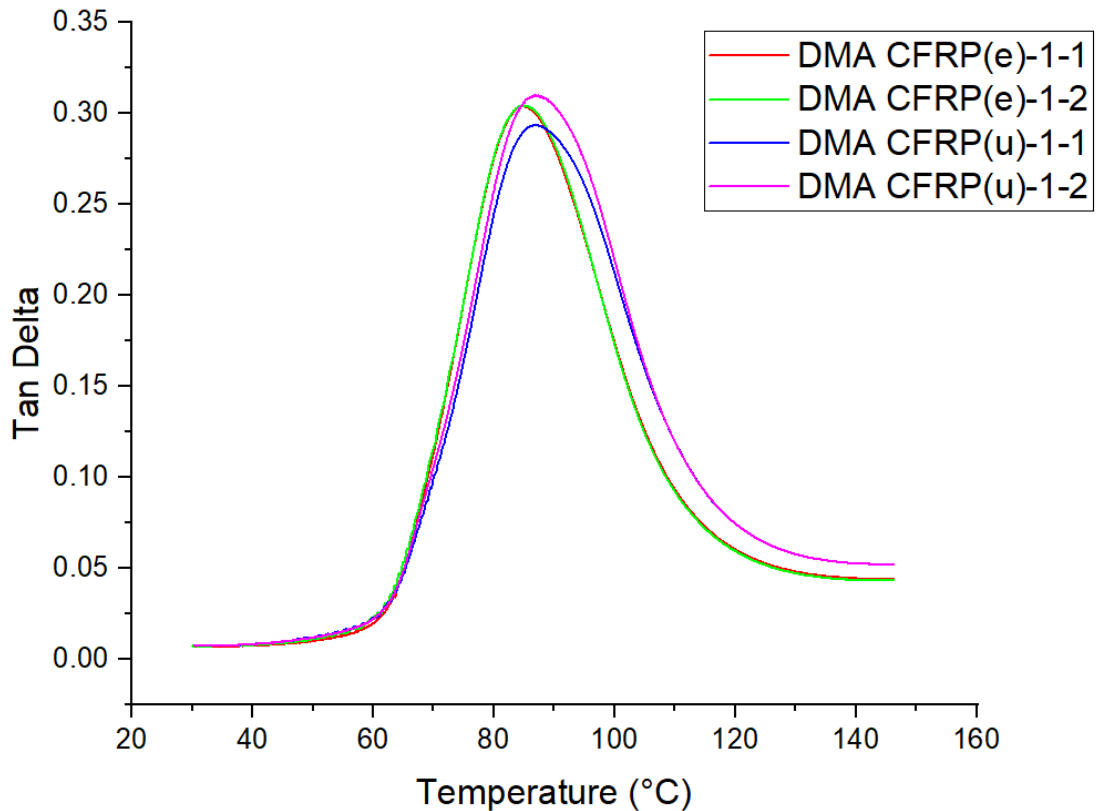
**Figure 29: Comparative plot of Delta Tan on MISSE-11 coupons**

The damping factor or Tan Delta data demonstrated that the molecular structure and mechanical properties were affected as the temperature was increased. Both the irradiated samples showed a slightly higher tan delta, which is indicative of an increased molecular weight versus a broader peak of the ground controls which could be attributed to a larger distribution of molecular weights.

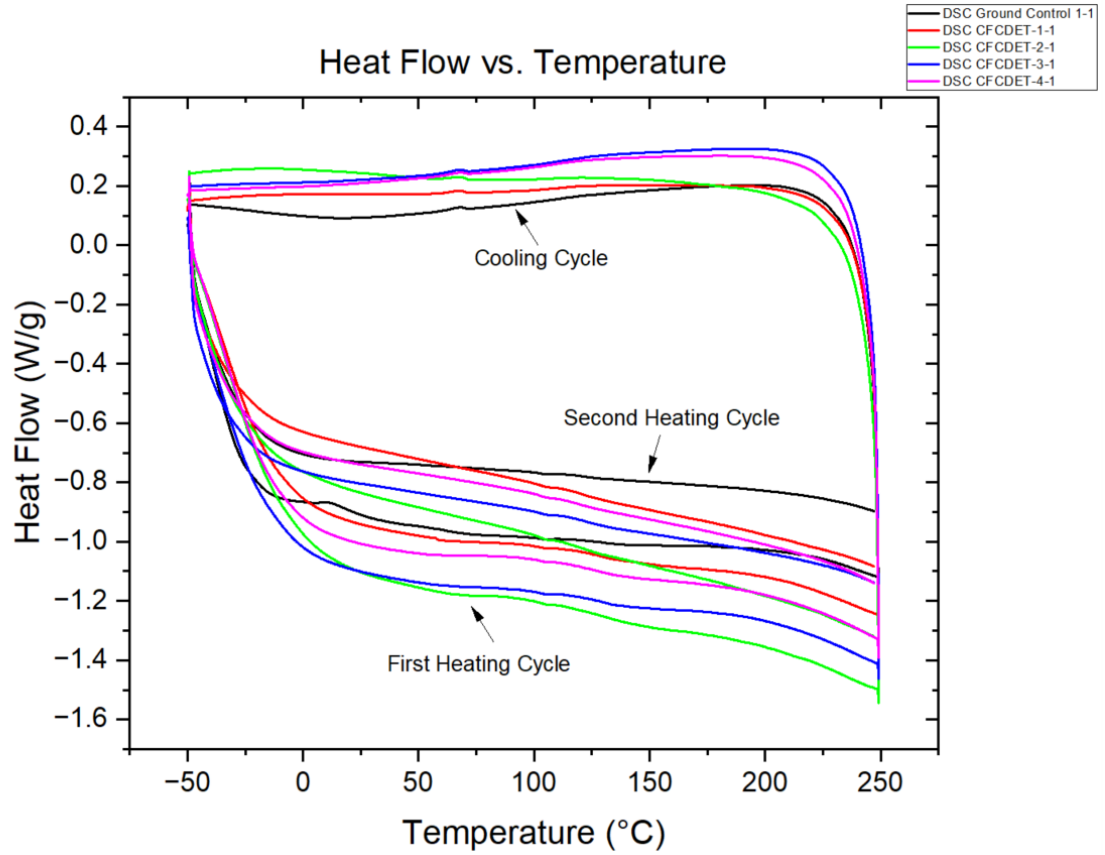
**Figure 31: Comparison data plots of HiMassSEE coupons (ground controls and Flight coupons)**

The plotted data shown in Figure 32, shows that there are no cure peaks that occur in the coupons in the first heat cycle, which could demonstrate that all the coupons were fully cross linked prior to being irradiated as there is not a major difference shown between the ground controls and the flight coupons. Figure 31 is the comparison of the all the coupons, while once again there is no noticeable curing peaks found. There is a difference in slope from that of the ground control coupons which does suggest that the irradiated coupons could be undergoing chain scission.

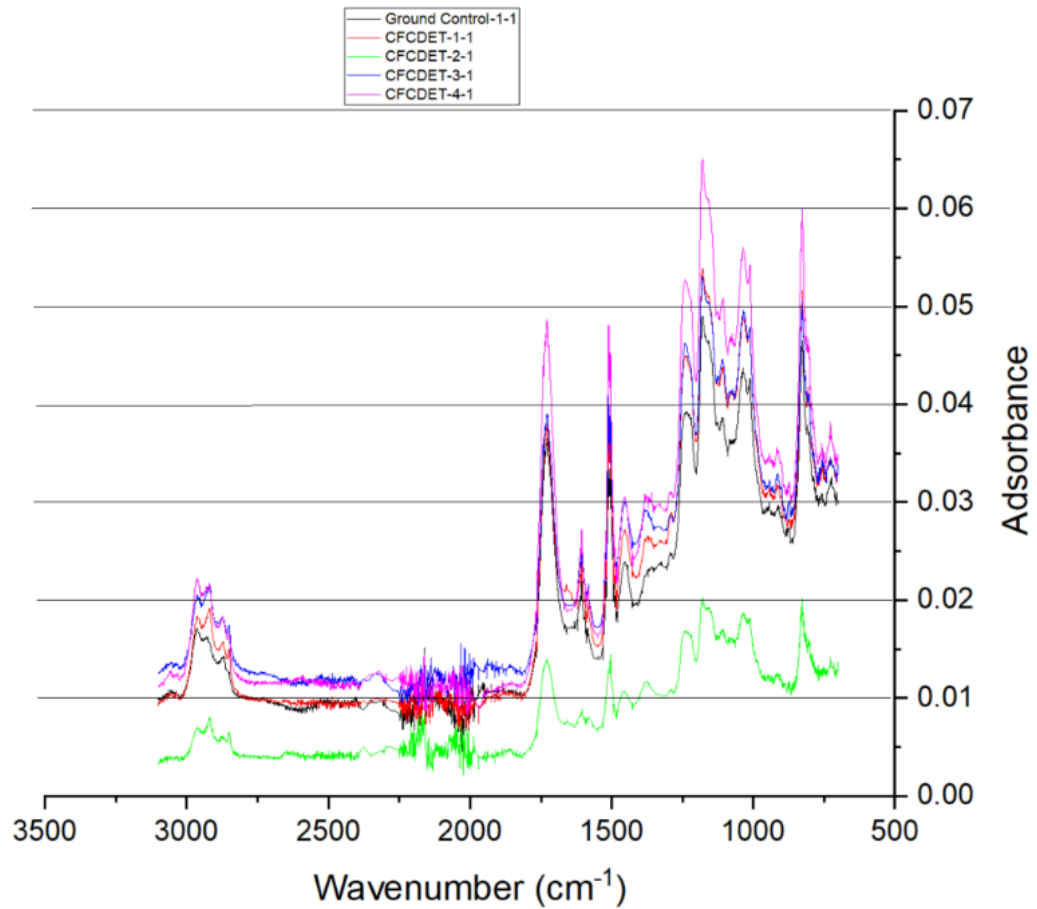
**Figure 33: FTIR Comparison data plots for the HiMassSEE Coupons**

values. However, one of the flight coupons (CFCDET-2-1), experienced less absorbance than ground control coupons which was not exposed to any radiation. In the region of 1750  $\text{cm}^{-1}$  to 2250  $\text{cm}^{-1}$  there are peaks with lower absorbance peaks in the data (Figure 33), which could be representative of oxidation. Figure 34 is the FTIR test results of all the samples.

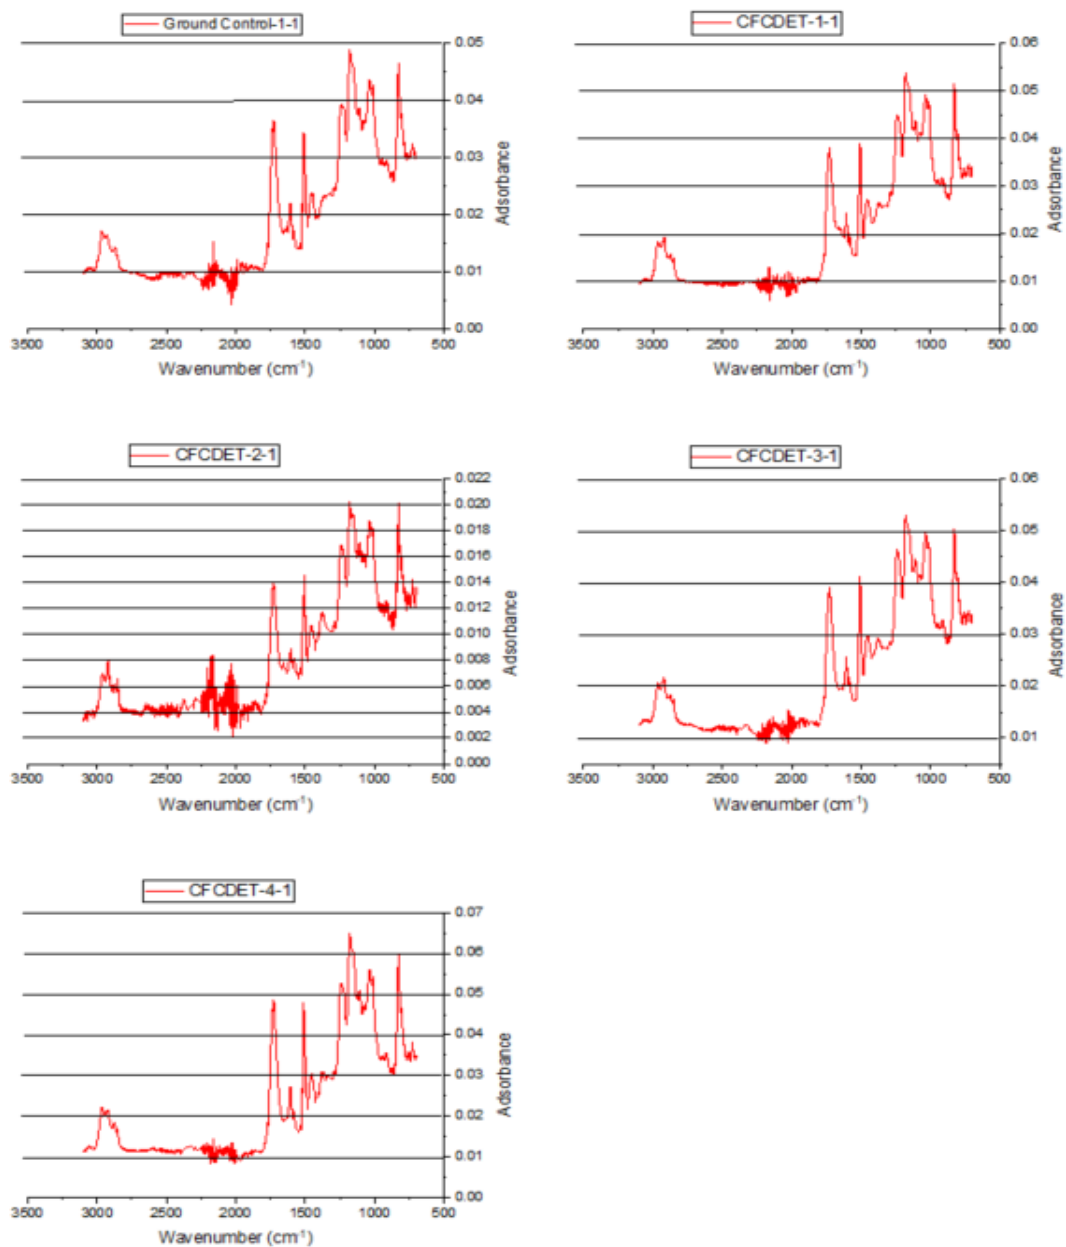
**Figure 34: FTIR Test Data Plots of the HiMassSEE Coupons**

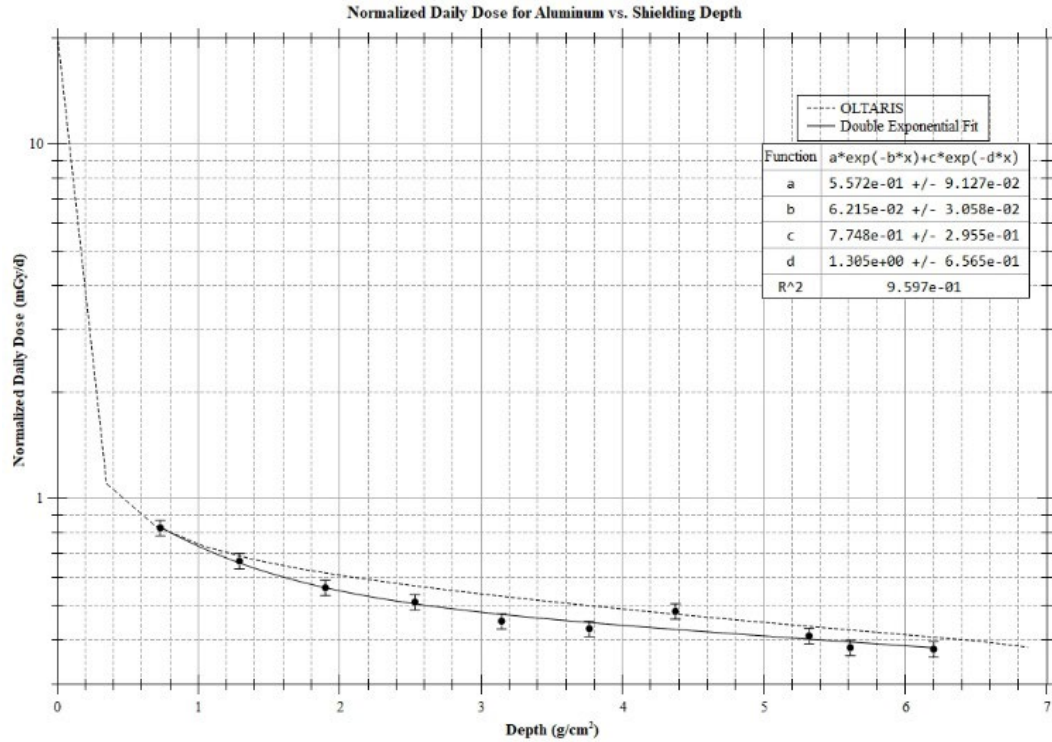
Figure 51 below shows models that were run to depict the normalized daily dose for aluminum versus the shielding depth in semi-log scale. Once again, the left end of the OLTARIS curve shoots up exponentially since most of the low energy protons from the trapped belt is stopped by the outer layer of the sample. As a result, most of the energy is deposited into the shallower depth part of the material.

**Figure 51: Normalized daily dose for aluminum versus the shielding depth in semi-log scale**

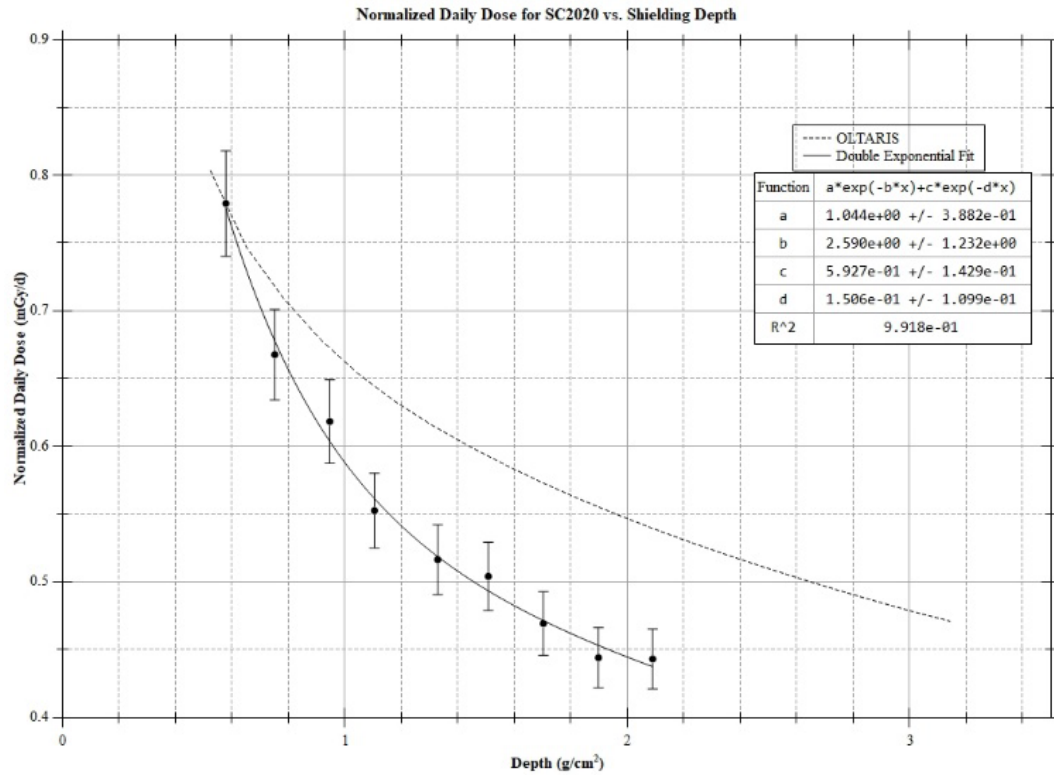
Figure 52 below demonstrates the normalized daily dose for SC2020 versus the shielding depth on a linear scale. The drastic exponential decay is not observed in this plot since SC2020 was covered by rather thick carbon composite face plates, which stopped all low energy protons from entering SC2020.

**Figure 52: Normalized daily dose for SC2020 versus the shielding depth in linear scale**

In each of the above model runs, there is a common characteristic in all of them, which is that the impact depth is shallow. For the aluminum face sheets there is similarity to the curves from the polyethylene, however the composite face sheets appeared to provide better radiation absorption, which was able to stop a considerable amount of the low energy protons.
