THE IMPACT OF AIRLINE PILOT AGE AND FLIGHT
EXPERIENCE FACTORS ON THE INCIDENCE OF
COMMERCIAL AIR CARRIER ACCIDENTS
ATTRIBUTED TO PILOT ERROR

Submitted to the Faculty of the
Graduate College of the
Oklahoma State University
in partial fulfillment of
the requirements for
the Degree of
DOCTOR OF EDUCATION
May 1999

Thesis
1999D
S357i

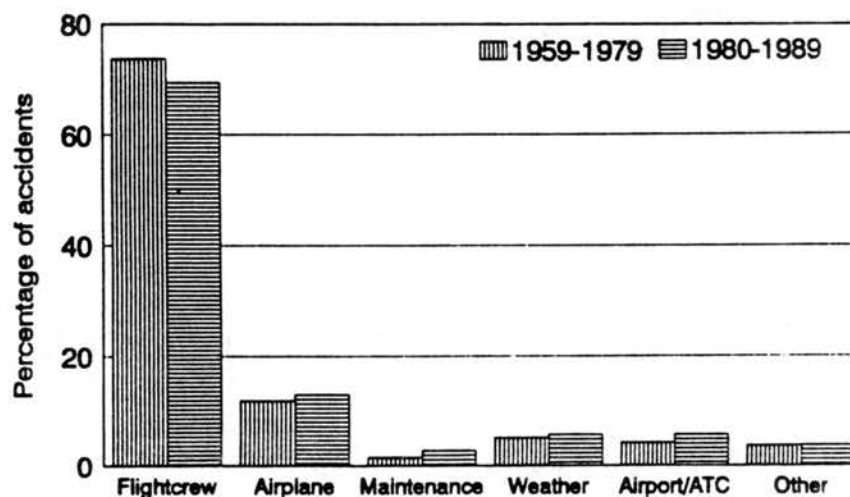
Figure 1. Primary Causes of Hull Loss Accidents (Excluding Military and Sabotage): Worldwide Commercial Jet Fleet, 1959-1989. Data From Boeing Aircraft Company. (From Wiener, Kanki, and Helmreich, 1993, p. 5)

Since the 1950s, when the airline industry introduced safer and more reliable turbojet aircraft, the focus of commercial aviation accidents has shifted from failures of airframes and engines to the question of flightcrew, or “pilot” error. As shown in Figure 1, between 1959 and 1989 “. . . flightcrew actions were causal in more than 70% of worldwide accidents involving aircraft damage beyond economical repair.” (Wiener, Kanki, and Helmreich, 1993, p. 5).
