INVESTIGATION OF COMPUTATIONAL PROBLEM AREA
DETECTION ON EARTHEN SPILLWAYS ACROSS
VARYING IMAGE RESOLUTIONS

Submitted to the Faculty of the
Graduate College of the
Oklahoma State University
in partial fulfillment of
the requirements for
the Degree of
MASTER OF SCIENCE
July, 2010

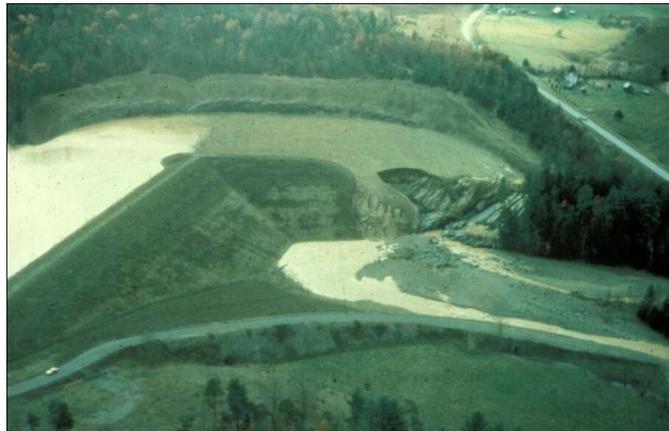
Figure 2.1 below is an example of a spillway flowing. You can see a gully near the end of the spillway. A gully like this can erode upstream into the reservoir and cause the draining of the entire reservoir.

Figure 2.1 Vegetated spillway being eroded. *Photo courtesy USDA-ARS HERU*

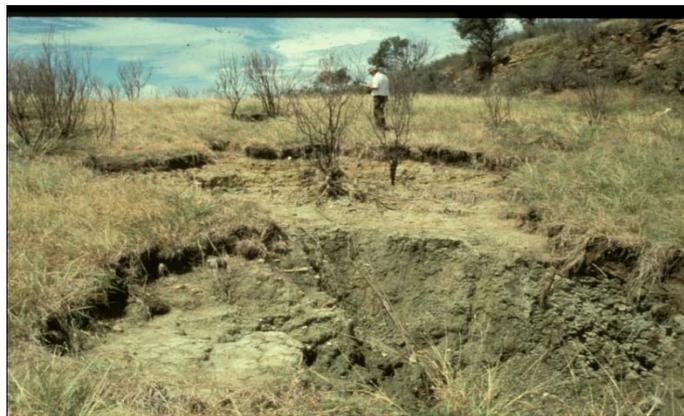
Any section of vegetation that is of low quality is a problem for the spillway. In order to function properly the vegetal cover must be uniform and in good condition. Areas of vegetation that are considered of low quality are described as *discontinuities* in spillway literature, but for clarity are referred to as *problem areas* in this work. Problem areas may be areas of unhealthy vegetation, no vegetation, or unwanted vegetation and are classified into two categories: major and minor. A major problem area is one that has dimension parallel to flow that is greater than the height of the vegetation. Minor problem areas are recognizable problems that are not large enough to be classified as major problem areas [22][23][24][25][28]. Figure 2.2 below illustrates one type of problem area; a small mesquite tree that has caused erosion in the immediate area.

Figure 2.2 Example of a major problem area. *Photo courtesy USDA-ARS HERU*

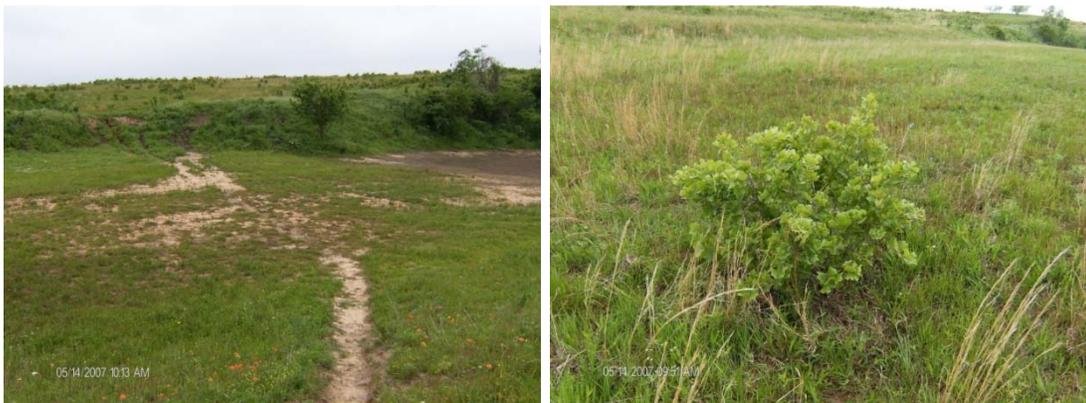
Areas of bare soil were distinguished in the groundtruth maps from trees and undesirable plants because of the differences in shape and color between the two types of areas. Throughout the rest of this work, problem areas of bare soil are referred to as Type 1 problem areas. Similarly, problem areas consisting of trees or undesirable plants are referred to as Type 2 problem areas. Segmentation results in Chapter 4 are presented separately, in some cases, for these two types in order to compare how well the algorithms are performing on each type. Figure 3.3 below shows the difference between the two types of problem areas.

Figure 3.3 Example of a Type 1 problem area consisting of a bare soil path (left). Example of a Type 2 problem area consisting of a small tree (right).

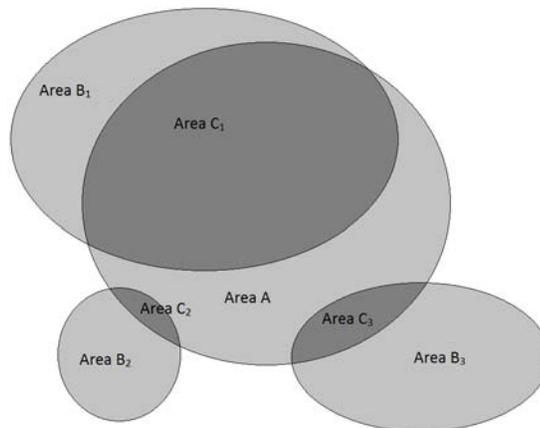
Multiple segment areas often intersect a single groundtruth problem area, but only one intersection is considered. Figure 3.7 below illustrates the selection of the *best match segment*. In the figure, Area A is intersected by several areas (B_1, B_2, B_3). Area B_1 has the largest intersection(Area C_1), so in the Figure 3.7, B_1 represents the best match for Area A.

Figure 3.7 Venn Diagram illustrating a best match segment.

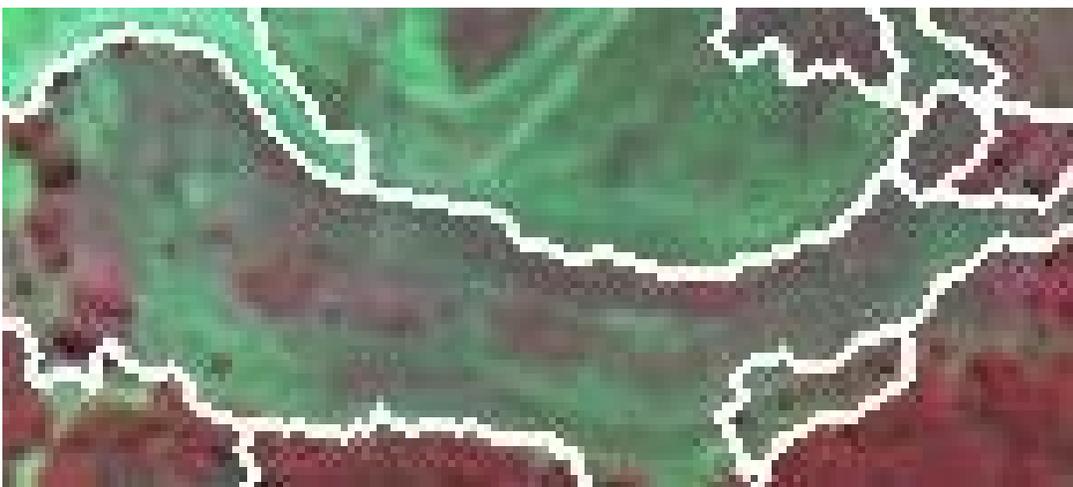
In comparing Figure 4.6 and 4.7 below, the degradation of segmentation with decreasing resolution is illustrated. Comparing the segment sizes in Figures 4.6 and 4.7, it can be easily seen how the *Percent In* metric is reported at such a high rate for the JSEG algorithm. Groundtruth problem areas are relatively small compared to the segments produced by JSEG at lower resolutions.

Figure 4.7. JSEG segmentation of Salt Camp Creek Site 6 at 150cm resolution. This image has been enlarged for viewing purposes.
