DESIGN OF CONTINUITY CONNECTIONS FOR PRECAST,  
PRETENSIONED GIRDERS USING ULTRA-HIGH PERFORMANCE  
CONCRETE

A THESIS

A THESIS APPROVED FOR THE  
SCHOOL OF CIVIL ENGINEERING AND ENVIRONMENTAL SCIENCE

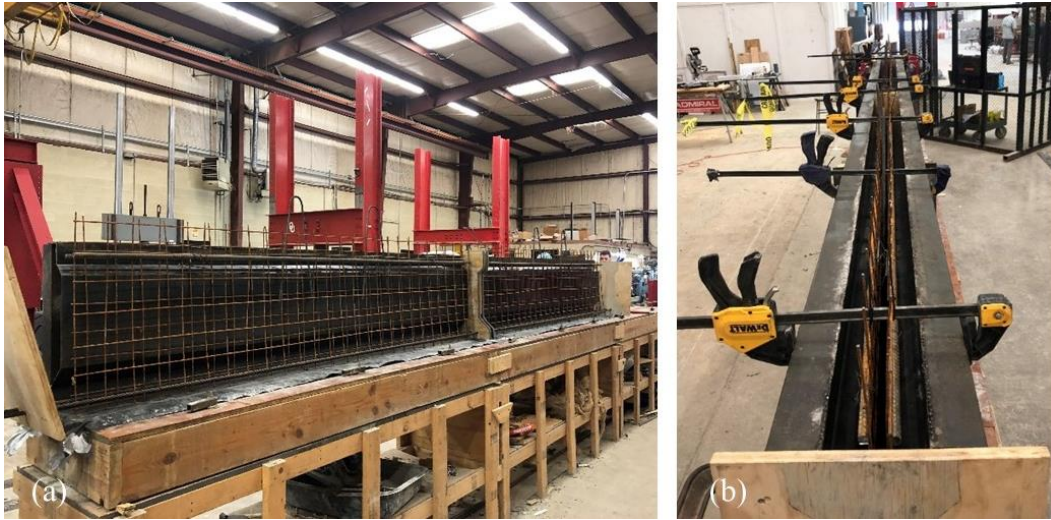
*Figure 9: Elevation view (a) and plan view (b) of steel cage before casting*

On the day of casting, the strands were tensioned at the same time to approximately 76.3% of the strands' ultimate capacity, which was roughly 206 ksi. Two hydraulic rams inside the live end abutment were used to incrementally apply load. The load was monitored using a 50 kip capacity through hole donut load cell and load was double-checked against manual displacement measurements compared to the calculated elongation. Once the required amount of stress was applied to the strands, the moving plate inside the abutment was secured in place using the large blue nuts shown in Figure 7 and the load was removed from the rams. The steel cages were then set into place and tied to the strands. The final piece of formwork was added and adjusted such that the center of strand was 3.5 in. from each edge of the bottom bell. Clamps were used to hold the top of the formwork and endplates in the correct position. The shear steel was tied to the clamps as needed to center them during casting. The formwork and steel reinforcement prior to casting can be seen in Figure 9.

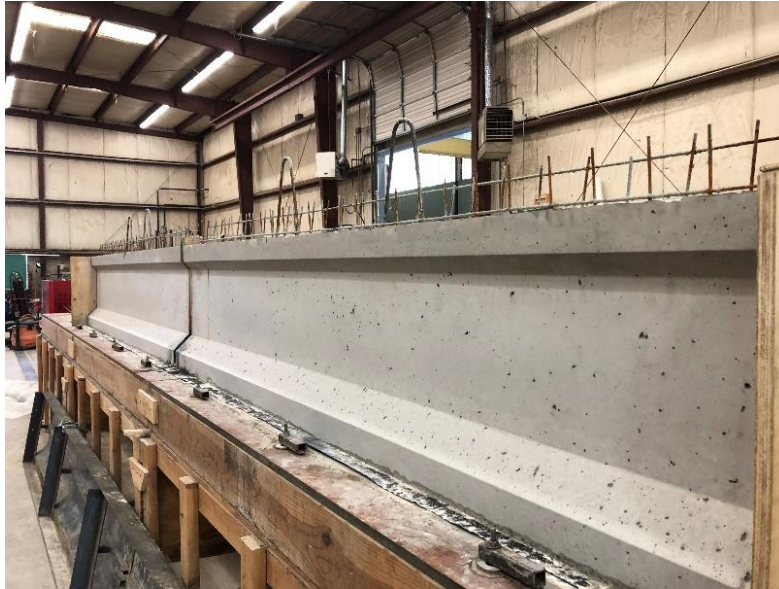
*Figure 10: Two prestressed girders simultaneously cast on the prestressing bed*

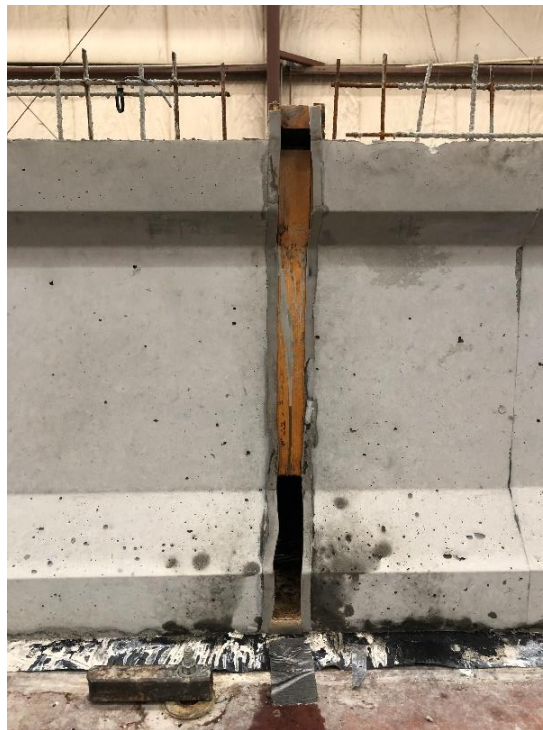
*Figure 11: Wooden divider between adjacent girders*

a wooden divider cut to match the shape of the girders was placed in the middle of the form. The divider had to be as thin as possible, yet thick enough to allow the prestressing strand between each girder to be cut during detensioning. Next, the prestressing strand was pulled through the dead abutment, an end plate, the wooden spacer, another end plate, the live end abutment, the load cell, and finally secured in place using strand chucks. Figure 8 shows the donut load cell used to measure the force applied to one of the strands during tensioning and anchorage chucks prior to stressing. The final step before tensioning was to secure one piece of the metal formwork roughly in place on the table.

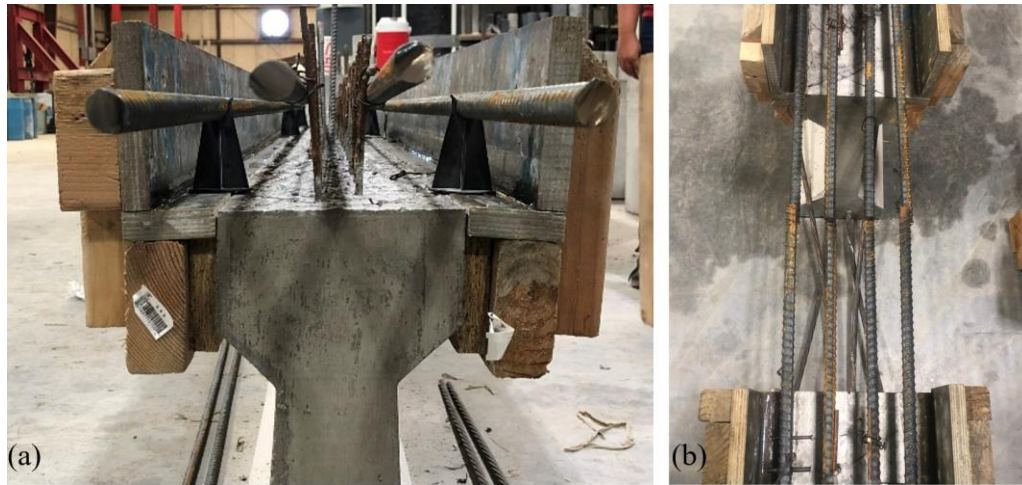
*Figure 13: Deck reinforcement vertical offset (a) and adjacent lap splice alignment (b)*

plastic chairs. All rebar was tied together to prevent lateral movement during casting. The final placement of rebar and trial fitting of the lap splice in the deck can be seen in Figures 13 and 14. Foam board insulation was used as end plates around the lap splices and plywood end plates were used on the other end.

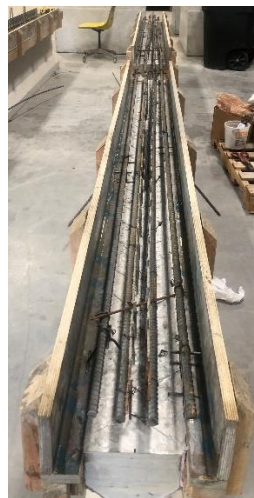
*Figure 14: Deck reinforcement placed in formwork*

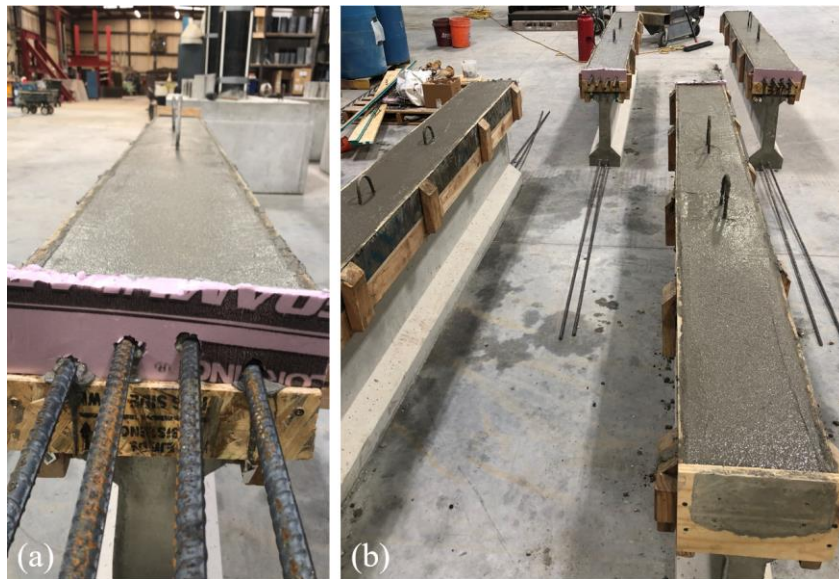
*Figure 15: Freshly placed deck concrete showing a close-up of the forms around the lap splice (a) and an entire set of specimens (b)*

6000 psi and a slump of 8 in. Once the concrete was removed from the mixer a slump test was performed in accordance with ASTM C1611. Additionally, a total of twelve 4 in. by 8 in. cylinders were made for each set of girders. The rest of the concrete was transported from the mixer and placed into the formwork using a hopper suspended by the overhead crane. A mallet was used to tap the sides of the forms to help the concrete flow into the forms. The decks were cured for 7 days covered in wet burlap. The formwork was not removed at a specific time, but the compressive strength was checked to ensure the concrete had reached 4000 psi before the forms were removed. Various stages of the casting process can be seen in the following Figures 15 and 16.

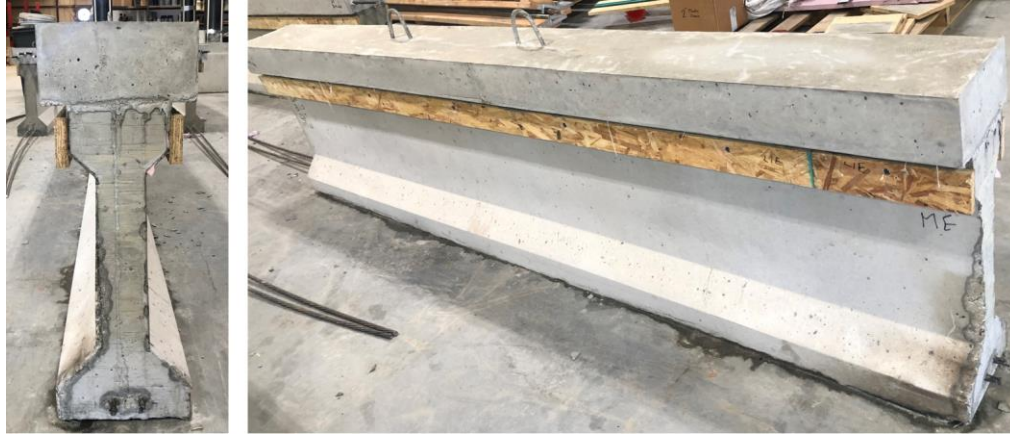
Figure 16: Finished concrete decks after form removal

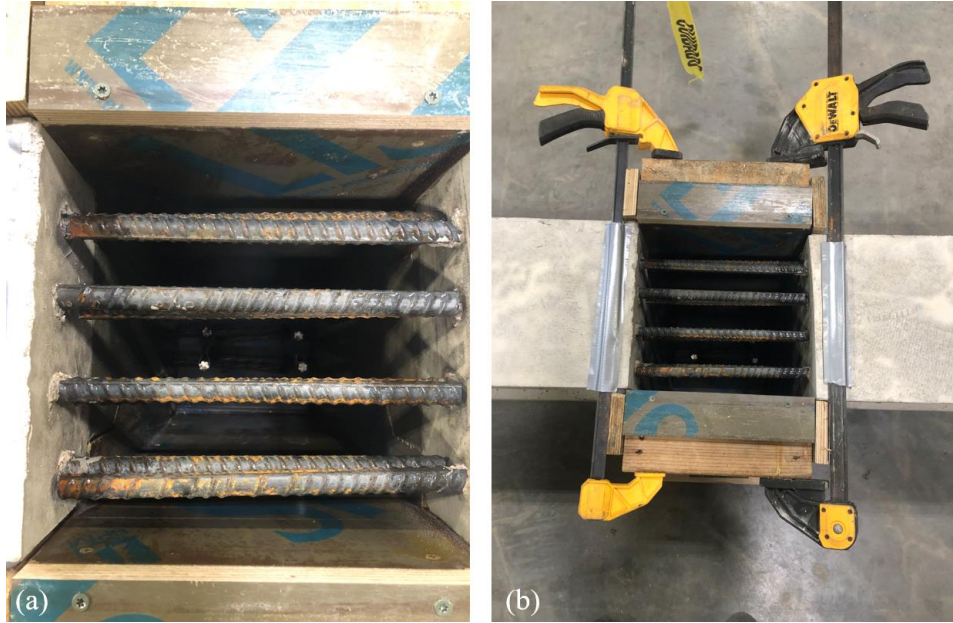
Once the girders were aligned and the steel reinforcement was set, formwork that followed the contour of the beam could be set perpendicular to the girders to form a rectangular joint. Due to slight variations in the shape of the girders, each piece was trial fit to determine its final placement. The forms were secured in place such that the joint corners were roughly 90 degrees. Next, these form pieces were secured in place on the bottom and the top was held in place with a bar clamp. At this point, the joint formwork was complete, and the edges were sealed using silicone. The completed formwork can be seen in Figure 22.

Figure 22: Plan views of joint formwork secured in place showing a close-up of the reinforcement (a) and zoomed-out view of the restraints (b)

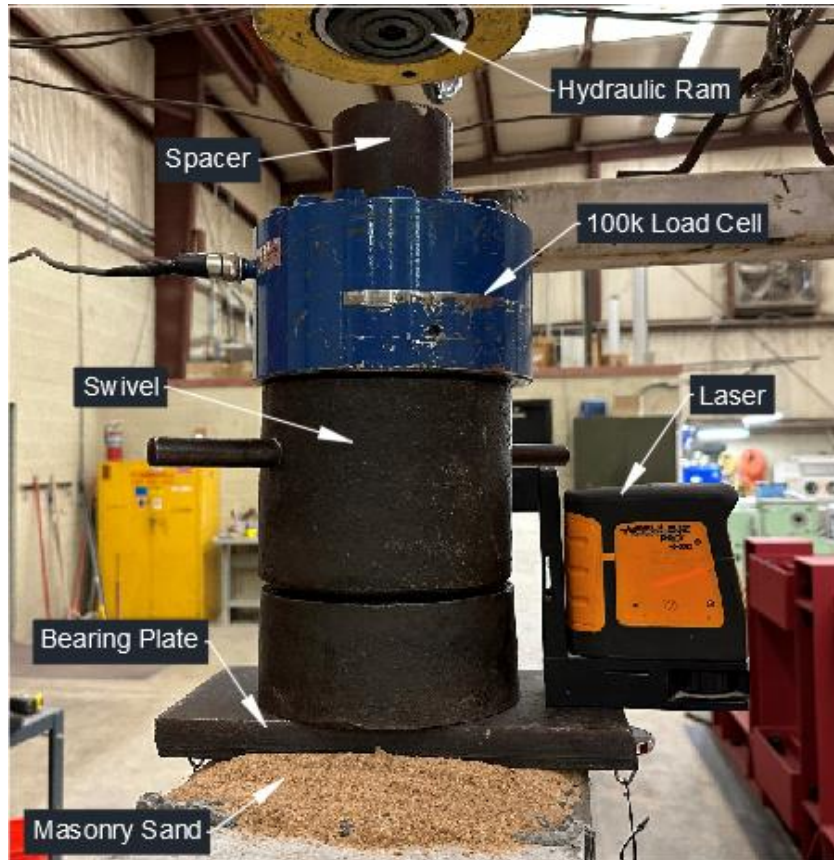
known amount and comparing the readout of the instrument. The apparatus used to apply the load to the joint can be seen in Figure 25.

*Figure 25: Detailed view of components for joint testing apparatus*

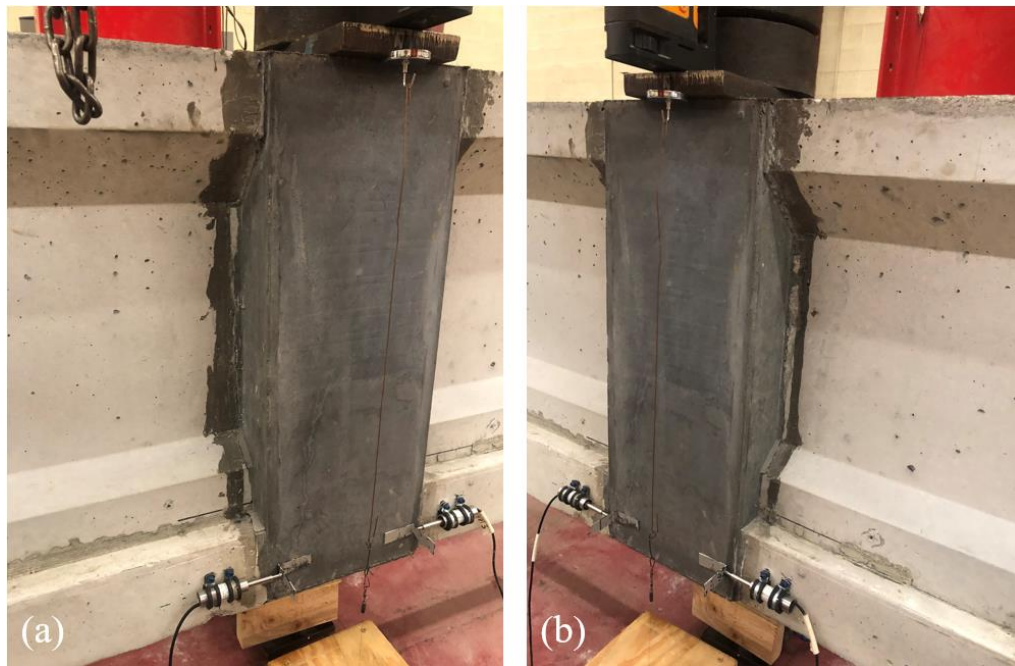
Specimen HSJ3-1 was first tested in the negative moment orientation. The joint interface before testing is shown in Figure 26. A thin layer of UHPC and silicone can be seen on the surface of the girder near the joint in Figure 26. This was an artifact on all specimens from the joint casting process and did not affect structural testing results.

*Figure 26: Northwest (a) and southwest (b) side of the joint HSJ3-1 before testing*

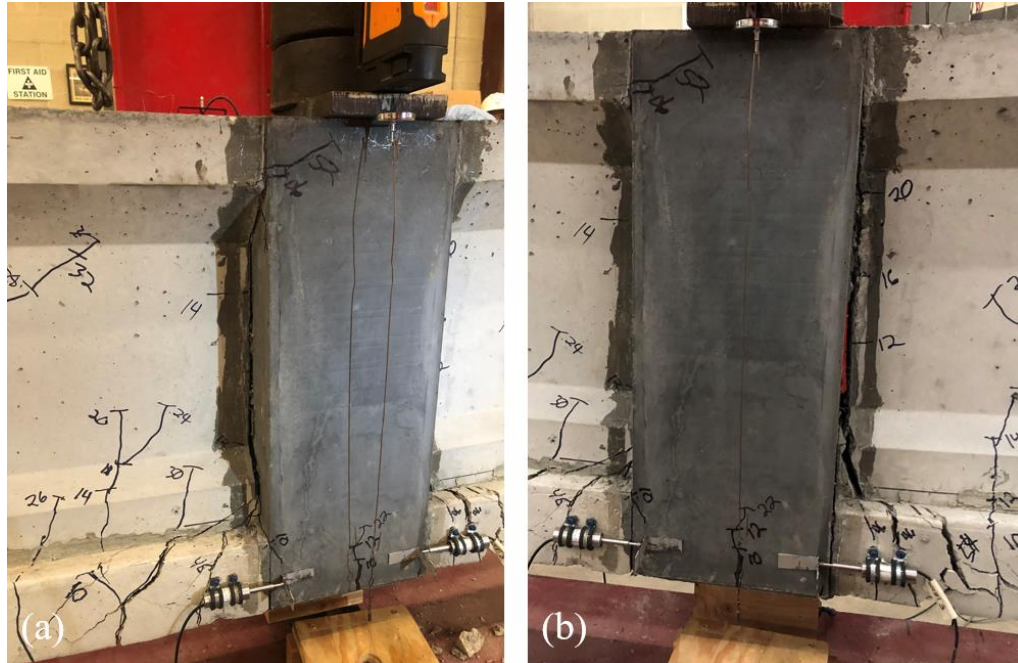
from the point of initial cracking in the deck, into the girder, and then along the joint-girder interface to approximately half the depth of the girder. From 12 to 20 kips, the joint-girder interface opened, and cracking along the interface propagated to approximately the location of the prestressing strands. From 20 to 46 kips, the flexural cracks that started in the deck gradually extended toward the load point. Up to a loading of approximately 30 kips, new flexural cracks were detected in the deck and girder farther out from the joint along the length of the specimen. The farthest started approximately 7 ft away from the joint. Cracks would generally converge at some point in the web of the girder on their way to the load point. As loading increased the growth of flexural cracks generally slowed, and only additional separation at the joint-girder interface was observed. At 46 kips, the vertical crack along the joint-girder interface reached the as-cast bottom flange and turned toward the load point, causing horizontal cracks to form in the joint. No additional flexural cracks were detected in the girder beyond this point. Beyond 50 kips, the magnitude of deflection between loading increments increased significantly. At 52 kips, additional horizontal cracking started to occur in the joint around a location assumed to coincide with the strand location. Cracks were not marked beyond this point and any additional deflection was the result of the crack from the deck into the joint-girder interface opening. At this point, the separation at the joint was so significant it was possible to clearly see through to the other side. The test was stopped when the specimen reached a loading of 56 kips but failed to go any higher with additional deflection. The manually measured deflection was 2-3/4 in. under final loading and 2-1/8 in. after the load

was removed. The state of the specimen before the load was removed can be seen in Figures 27 and 28 including the cracks marked throughout testing.

Figure 27: Northwest (a) and southwest (b) side of the joint HSJ3-1 under final loading

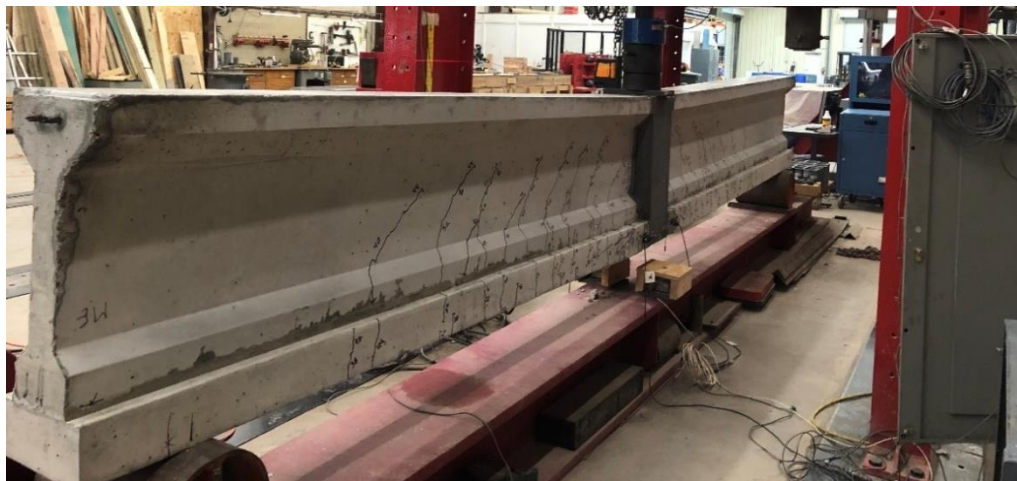
Figure 28: HSJ3-1 entire specimen showing deflection under final loading

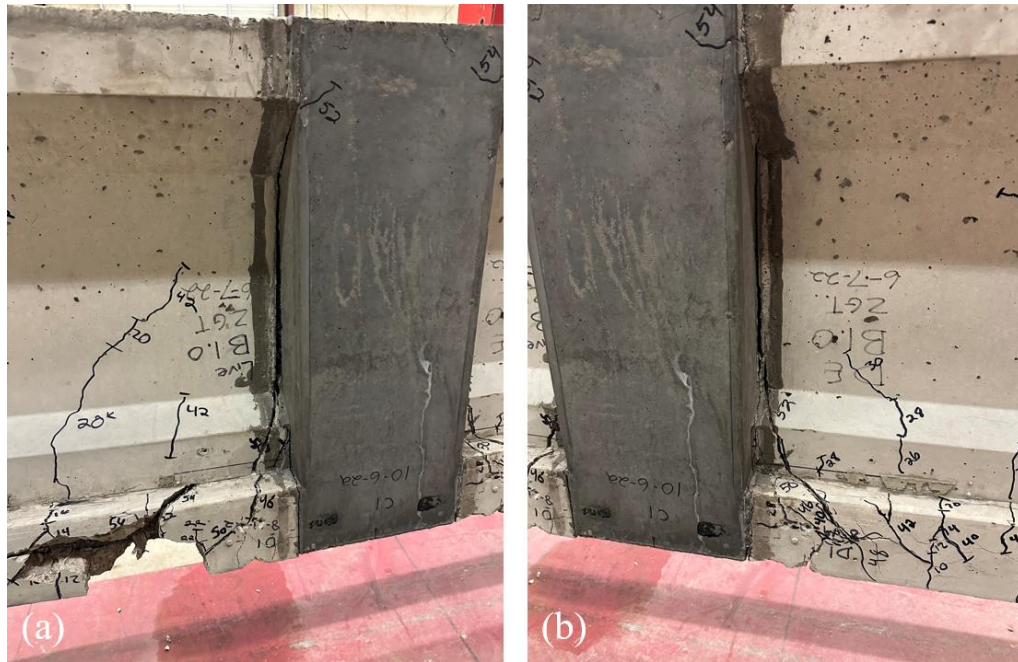
Just after the test was stopped large chunks of concrete fell out of the deck and exposed the deck reinforcement, shown in Figures 29 and 30. The specimen suffered significant damage and was deemed unfit for testing in the positive moment orientation.

Figure 29: Southeast (a) and northeast (b) side of joint HSJ3-1 after final loading

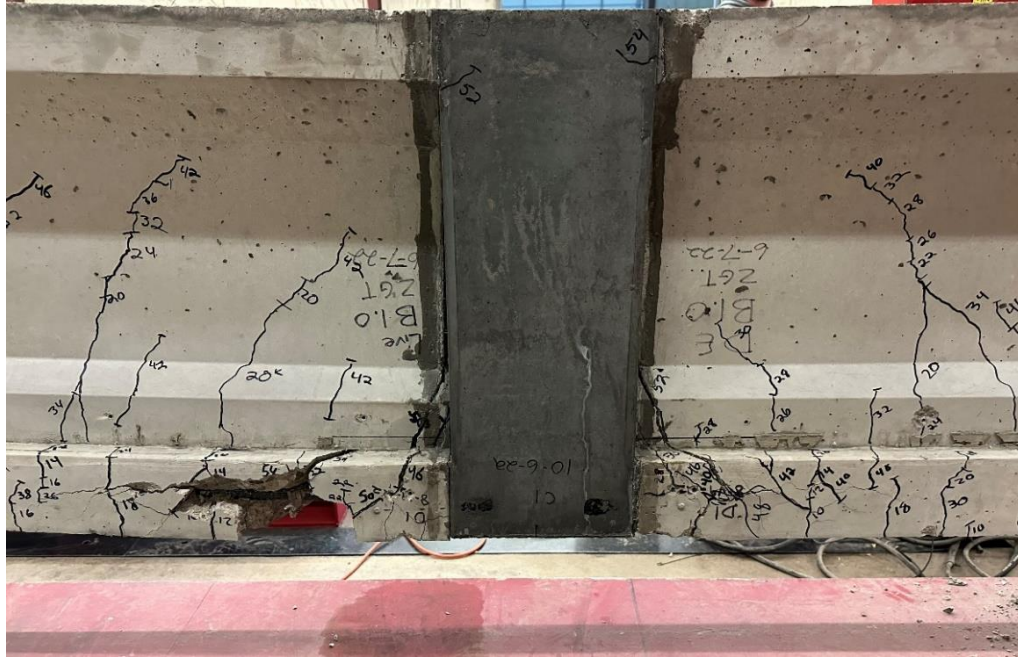
*Figure 30: East side of HSJ3-1 joint after final loading showing locations of significant concrete spalling*

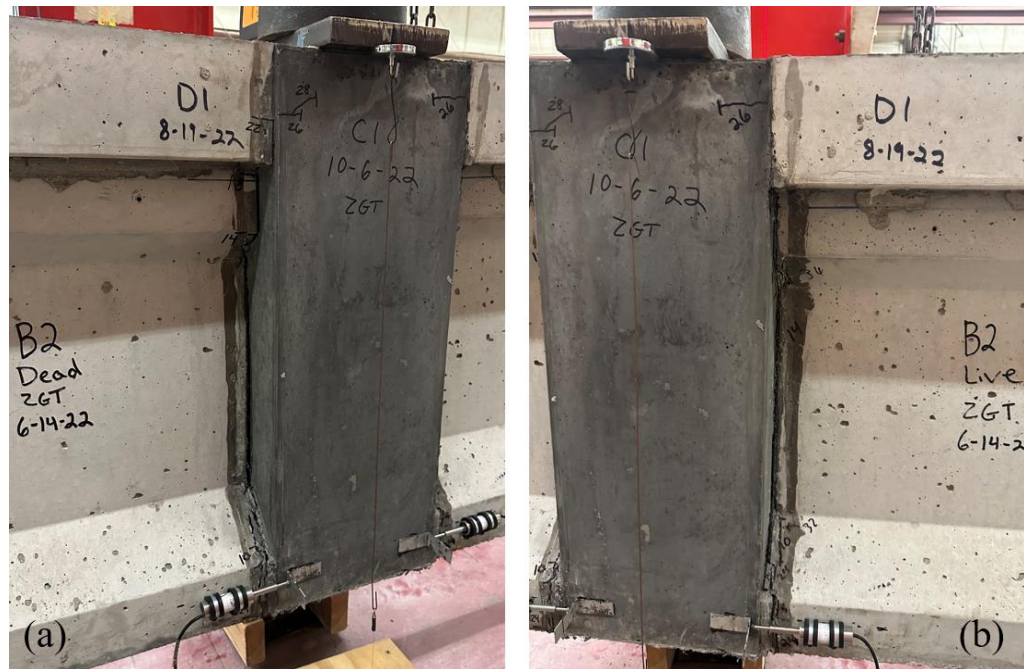
Initial cracking was observed at a load of 5 kips and was present on both sides of the joint-girder interface along the as-cast bottom flange. The initial cracks propagated up the joint-girder interface as loading increased and were the only locations where cracks started throughout the duration of the test. From 5 to 10 kips, the initial cracks grew to the bottom of the as-cast top flange. At a loading of 12 kips, the cracks reached the bottom of the deck. At 14 kips, the crack opened halfway up the deck, to the approximate location of the mild steel lap splice. At 26 kips, the cracks turned toward the load point and caused horizontal cracks to form in the UHPC joint. For the remaining duration of the test, small cracks were observed around the existing crack at the joint-girder interface and large openings

at the joint-girder interface were observed. The state of the specimen before the load was removed can be seen in Figures 34-36 including the cracks marked throughout testing.

Figure 34: Southeast (a) and northeast (b) side of the joint HSJ3-2 after testing

Specimen HSJ3-2 was removed from the load frame, flipped upside down, and placed back in the load frame to be tested in the negative moment orientation. No damage was observed while flipping the specimen. The state of the joint interface after positive moment testing, but before negative moment testing is identical to

that shown in Figures 34 and 35 in Section 4.3.2. Initial cracking was observed as flexural cracks in the as-cast top face of the deck at a load of 8 kips. Initial cracks started small and were dispersed within approximately 2 ft of the joint. Between 8 and 14 kips, the initial cracks started to propagate up through the deck toward the load point. From 14 to 20 kips, new flexural cracks beyond the initial cracks formed and extended from the as-cast top face of the deck to approximately the middle of the girder web. From 20 to 34 kips, small new cracks propagated intermittently out of existing cracks and connected to other existing cracks. From 36 to 48 kips, existing flexural cracks propagated up toward the load point and stopped at the as-cast bottom flange of the girder. The extent of flexural cracks in the girder due to negative moment loading is shown in Figure 39.

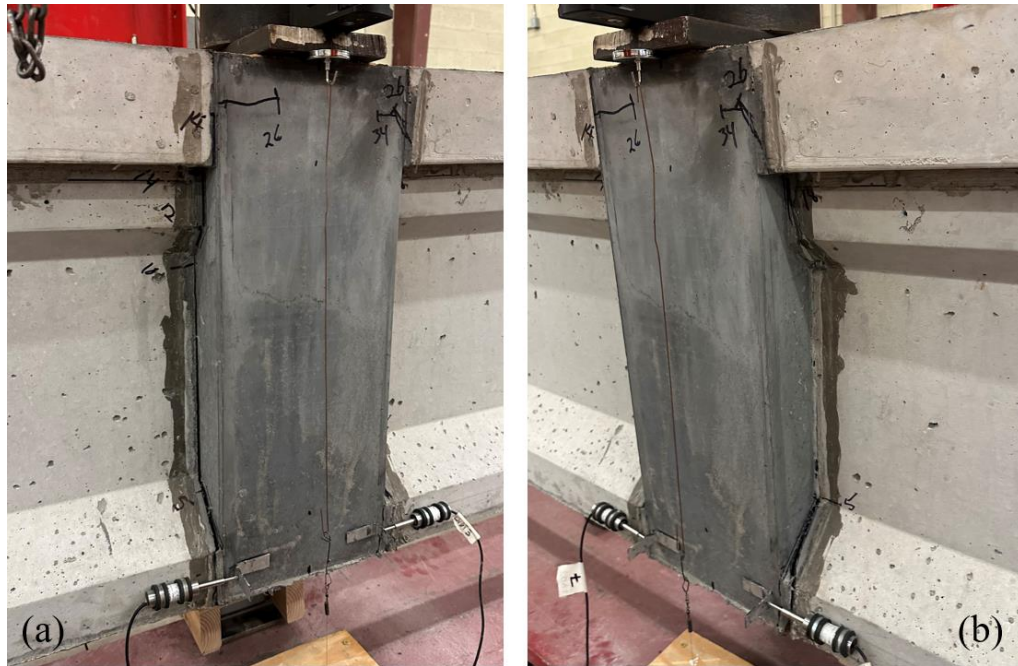
Figure 35: Northwest (a) and southwest (b) side of the joint HSJ3-2 after testing

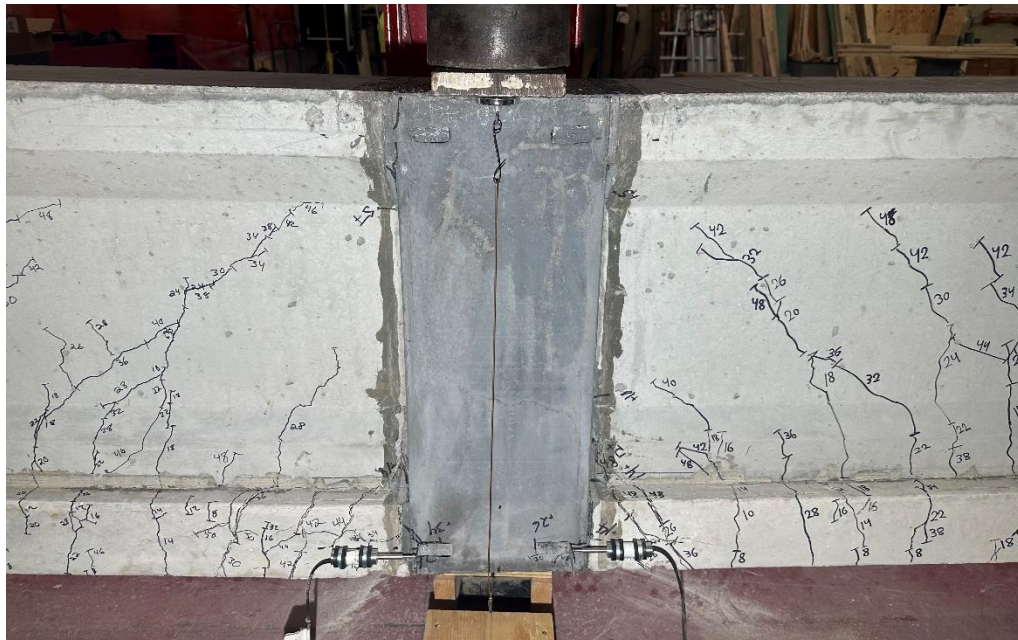
*Figure 39: Flexural cracking at east side of the joint for HSJ3-2 under final loading*

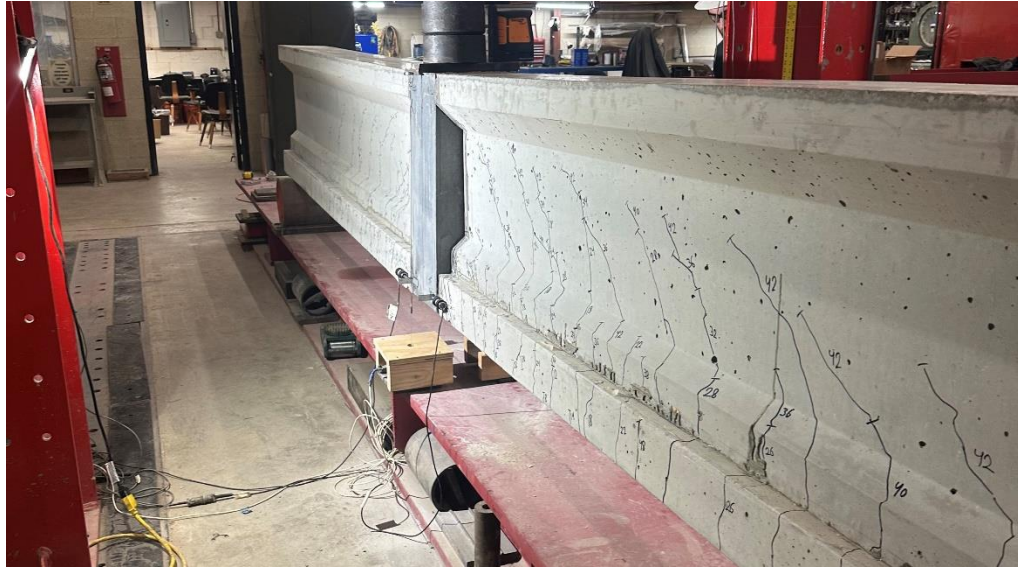
shown in Figure 40. Cracks were not documented after this point and significant deflection occurred with increased loading. The test was stopped after the specimen failed to reach a load of 52 kips. The final deflection of the specimen is shown in Figure 41. The manually measured deflection was 2-1/8 in. under final loading and 1-1/2 in. after the load was removed.

*Figure 41: Visible deflection and additional flexural cracking of HSJ3-2 under final loading*

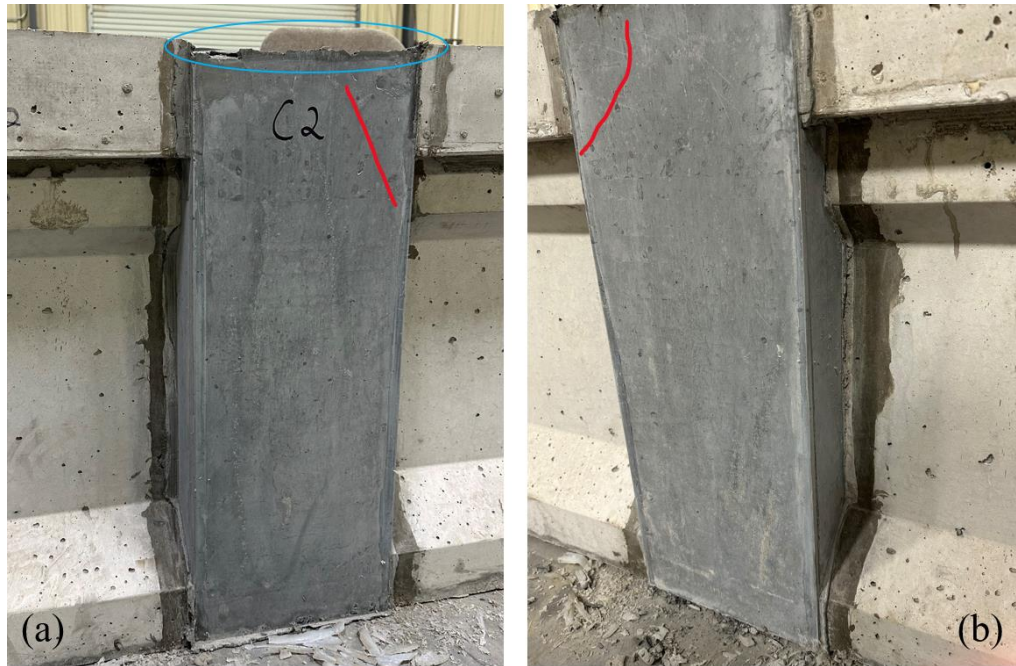
Before testing, it was discovered that the as-cast top surface of the joint material for HSDU-1 had experienced approximately 3/4 in. of settlement. The magnitude of the settlement could be distinguished from above the specimen as well as due to a noticeable change in color along the depth. Additionally, a single preexisting crack was marked near the top of the joint. Figure 44 shows the joint before testing and includes the settlement circled in blue and the extent of preexisting cracking highlighted in red. Figure 45 shows the surface of the UHPC joint material before and after being prepped for testing in the positive moment orientation. A layer of sand was used to prepare the rough surface left by the settlement to evenly distribute the load from the bearing plate to the joint.

Figure 44: Preexisting settlement is indicated by a blue oval and preexisting cracking is indicated by a red line on the southeast (a) and northeast (b) side of the joint HSJ3-2 before testing.

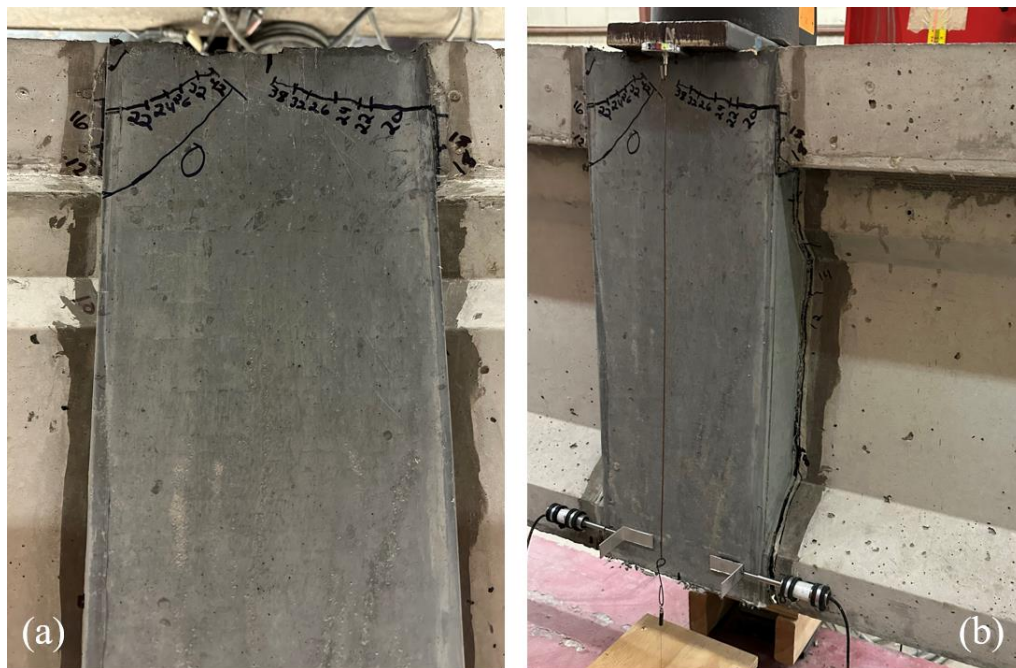
Figure 45: As-cast top of joint before (a) and after (b) masonry sand surface prep  
Note: This figure shows SSDU-1 which experienced very similar settlement to HSDU-1

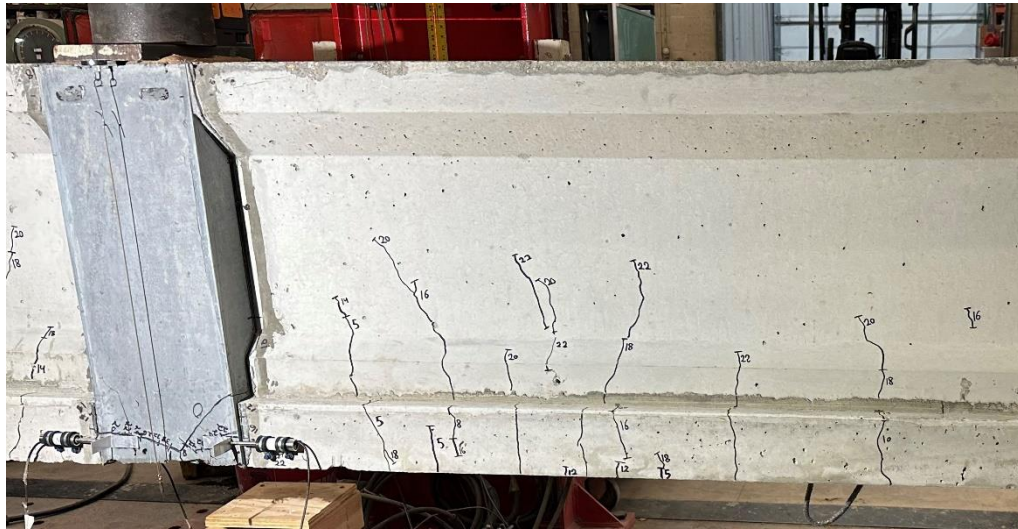
*Figure 50: East side of the joint (a) and northeast side of the interface (b) of HSDU-1 before negative moment test*

Specimen HSDU-1 was removed from the load frame, flipped upside down, and placed back in the load frame to be tested in the negative moment orientation. No damage was observed while flipping the specimen. The east side of the joint and the northeast side of the interface before testing is shown in Figure 50.

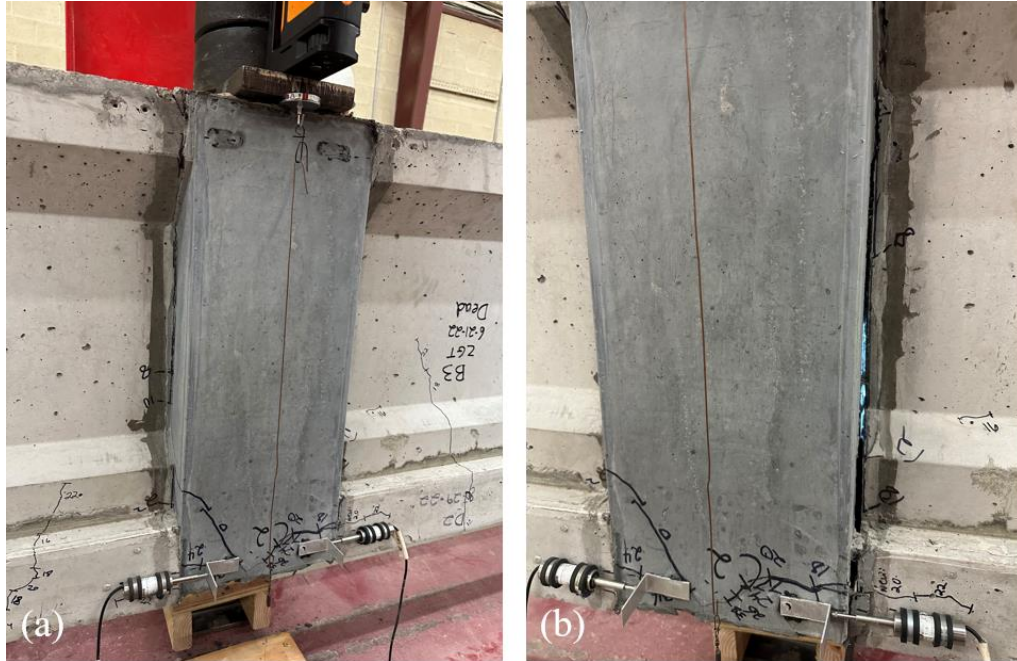
*Figure 51: Flexural cracking on northeast side of specimen HSDU-1 under final negative moment test loading*

the as-cast top of the deck into the girder. From 18 to 22 kips, flexural cracks reached approximately halfway up the web of the girder and bent toward the load point. Additionally, new horizontal cracks formed on the south side of the joint in the center of the deck and extended approximately 5 in. away from the joint. Flexural cracking on the east side of the north girder is shown in Figure 51.

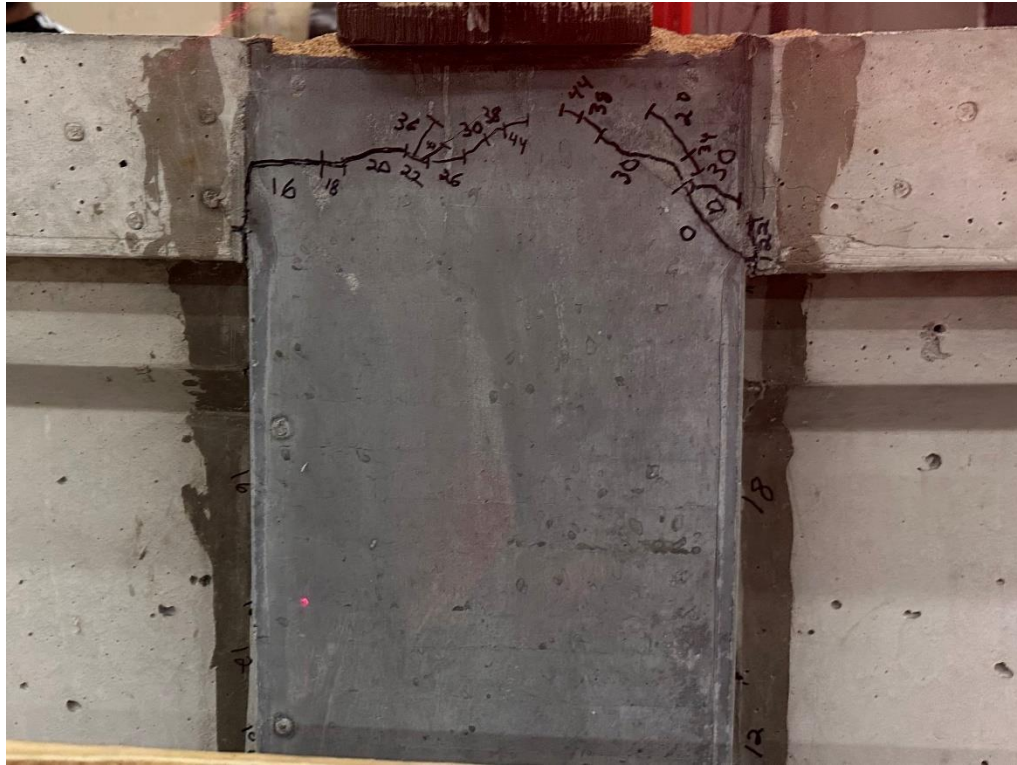
*Figure 57: Separation at the interface of HSDU-2 from the east (a) and west (b) side under final positive moment test loading*

Specimen HSDU-2 was first tested in the positive moment orientation. Initial cracking was observed at a load of 5 kips on both sides of the joint-girder interface along the as-cast bottom flange. As shown in Figure 57, the initial cracks propagated up the joint-girder interface as loading increased.

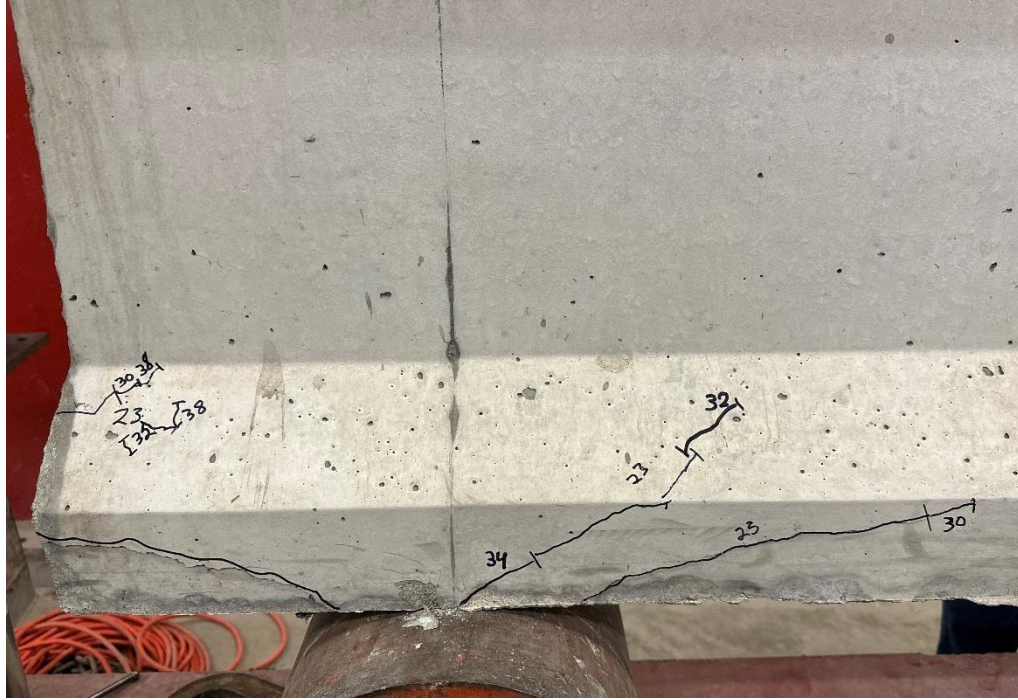
*Figure 58: Cracking on the west side of HSDU-2 near the as-cast top surface of the joint*

than 1 in. Final horizontal cracking near the as-cast top surface of the joint, which propagated from both the north and south interfaces, is shown in Figure 58.

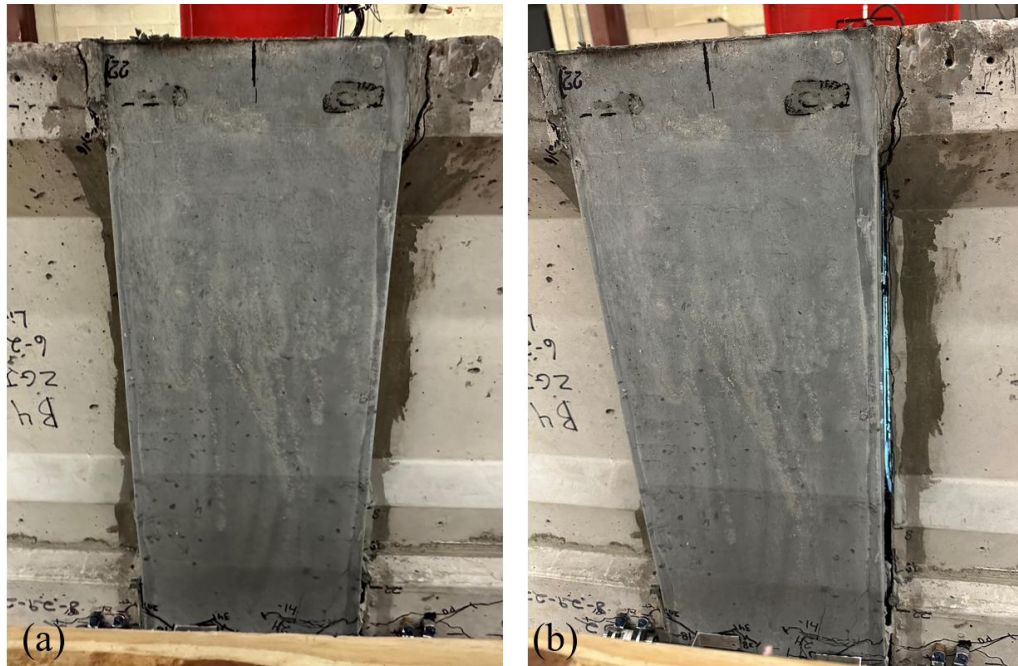
Figure 63: East side of HSDU-2 showing cracks near the as-cast top face of the joint before negative moment testing

Specimen HSDU-2 was removed from the load frame, flipped upside-down, and placed back in the load frame to be tested in the negative moment orientation. No damage was observed while flipping the specimen. Cracking near the as-cast bottom and as-cast top of the specimen before negative moment testing are shown in Figures 62 and 63, respectively.

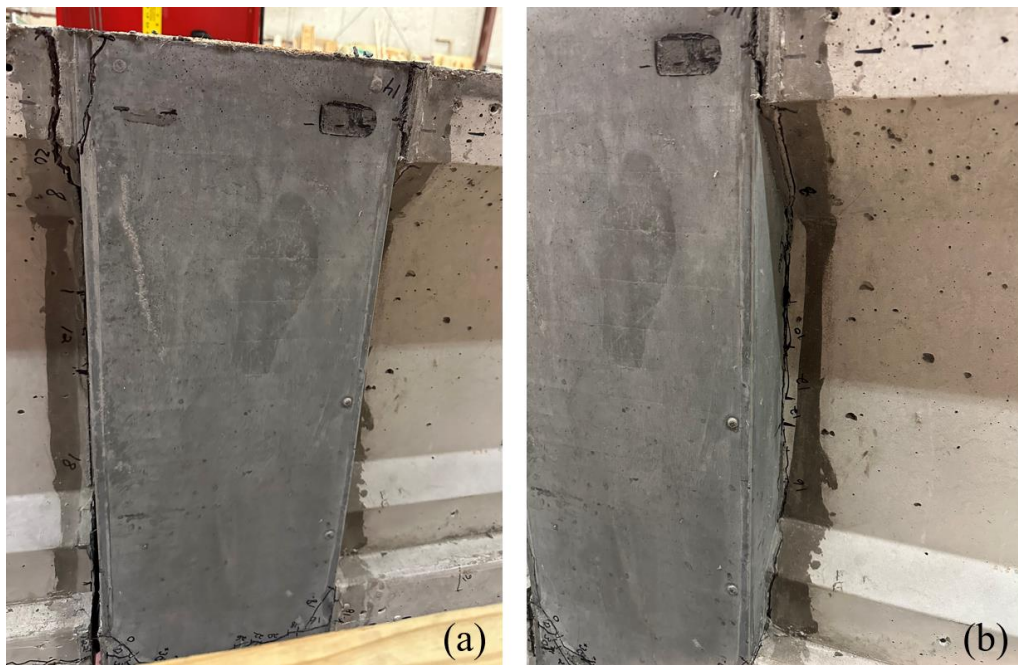
Figure 64: West (a) and southwest (b) side of HSDU-2 showing separation at the interface after negative moment testing

It is likely that cracks caused by positive moment testing opened further during the duration of negative moment testing but were indistinguishable from previous cracks and therefore not marked. At 5 kips, initial cracks were observed in the south girder as a series of cracks near the joint. One of these cracks was a horizontal crack starting from the mid-depth of the deck at the joint-deck interface that propagated toward the supports for approximately 1 ft. Two flexural cracks with lengths of approximately 1 in. started 2 ft away from the joint in the as-cast top face of the deck. From 8 to 10 kips, additional flexural cracks formed along the length of the south girder. Additionally, cracks caused by positive moment testing started opening from the as-cast top of the interface and continued to do so throughout the duration of the test. At 12 kips, the first cracks were observed in the north girder and followed the same pattern as the initial cracking in the south girder. At 14 kips, small, isolated cracks occurred in the center of the web in both girders and this cracking in both girders was identical in magnitude. Flexural cracks reached the as-cast bottom of the deck and propagated toward the load point. From 16 to 18 kips, flexural cracks continued through the as-cast top flange and to approximately the middle of the web. The test was stopped when the specimen could not resist additional load. Significant separation along the entire south interface was clearly visible at the conclusion of the test and is shown in Figures 64 and 65.

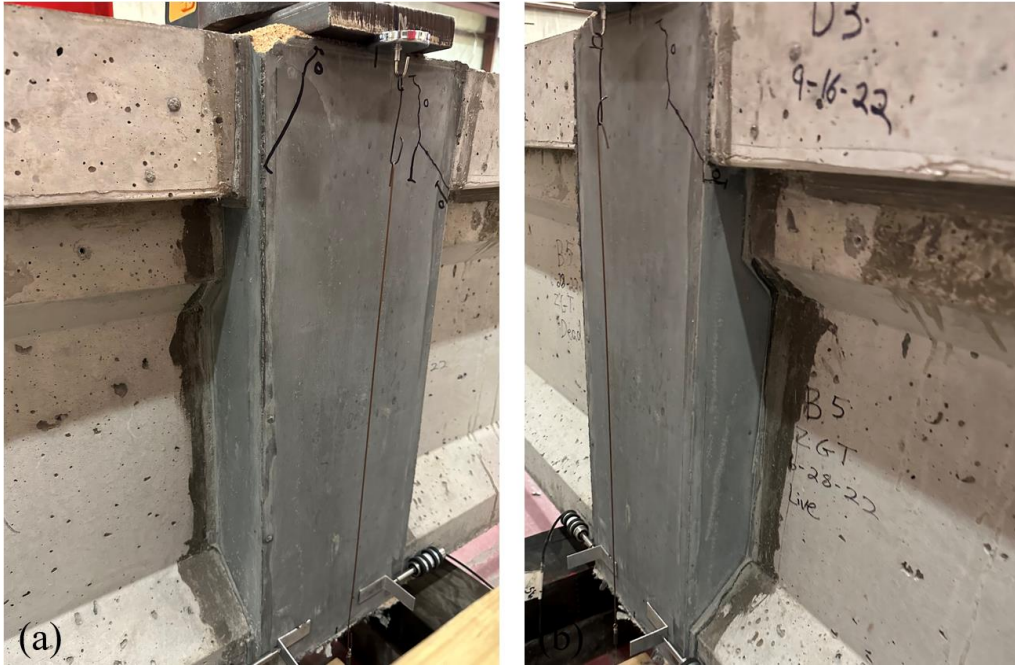
*Figure 72: Southeast (a) and northeast (b) side of joint SSDU-1 showing the joint interface before positive moment testing*

that started from the as-cast bottom of the deck on both sides of the joint up to the center of the as-cast top face of the joint. Additional cracks were detected on the as-cast top face of the joint but could not be seen from the sides to determine their severity. The joint-girder interfaces were uncracked before testing and are shown in Figures 72 and 73.

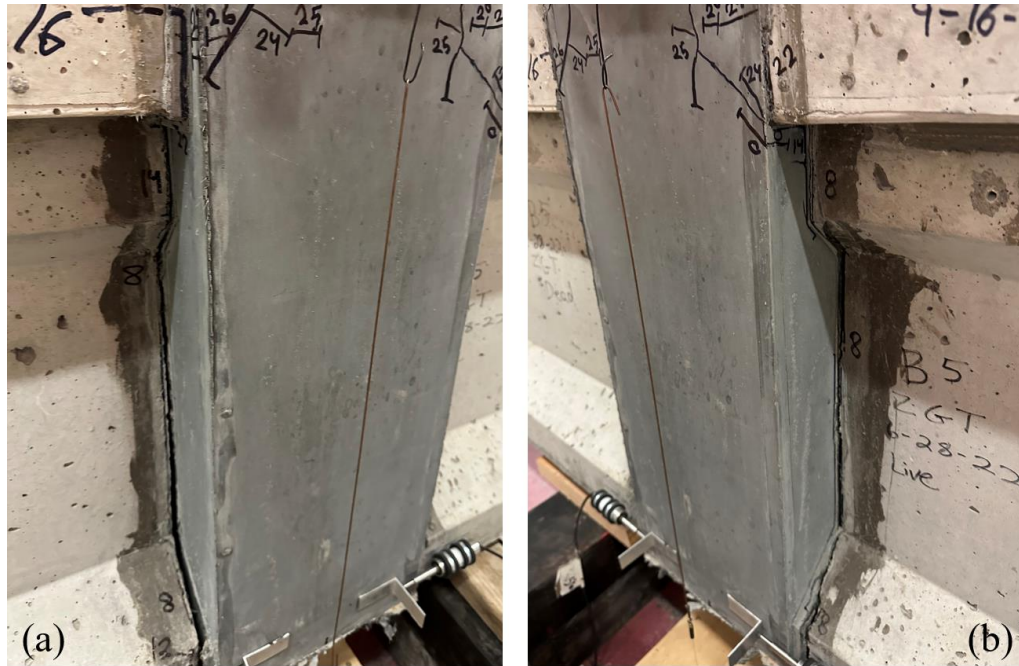
Figure 74: Southeast (a) and northeast (b) side of joint SSDU-1 showing cracking along the interfaces under final positive moment test loading

Specimen SSDU-1 was first tested in the positive moment orientation. Initial cracking was observed at a load of 8 kips, which is shown in Figures 72 and 73. Cracking occurred on both sides of the joint-girder interface and started from the as-cast bottom flange to the as-cast top flange. The joint separation started along the bottom of both interfaces and separation increased as the test continued. At 14 kips, the cracks followed along the interface up to the as-cast bottom of the deck. At 16 kips, the crack along the south interface reached the approximate location of the mild steel lap splice and stopped propagating upward. At 22 kips, the crack along the north interface reached the approximate location of the mild steel lap splice and stopped propagating upward. At 24 kips, new cracks in the joint started from the preexisting cracks and generally propagated toward the load point. The test was stopped at 26 kips due to the specimen experiencing increasingly larger deflections between load increments. Figures 74 and 75 show significant cracking along both interface locations, where signs of strand pullout could be seen under final loading. Cracking near the as-cast top face of the joint is shown in Figure 76.

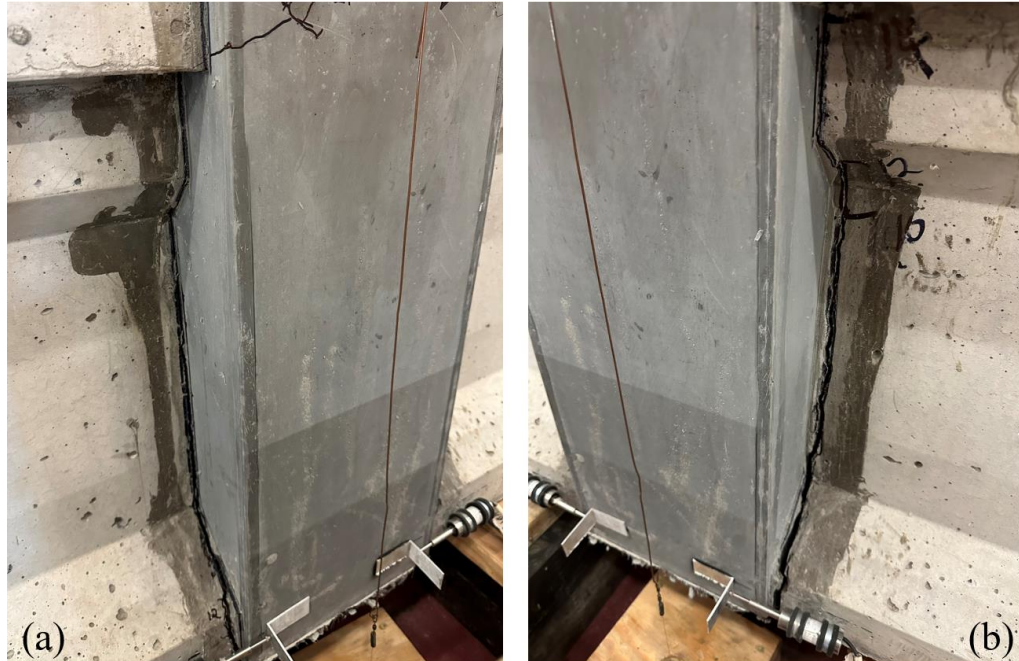
Figure 75: Northwest (a) and southwest (b) side of joint SSDU-1 showing cracking along the interfaces under final positive moment test loading
