DESIGN OF CONTINUITY CONNECTIONS FOR PRECAST,  
PRETENSIONED GIRDERS USING ULTRA-HIGH PERFORMANCE  
CONCRETE

A THESIS

A THESIS APPROVED FOR THE  
SCHOOL OF CIVIL ENGINEERING AND ENVIRONMENTAL SCIENCE

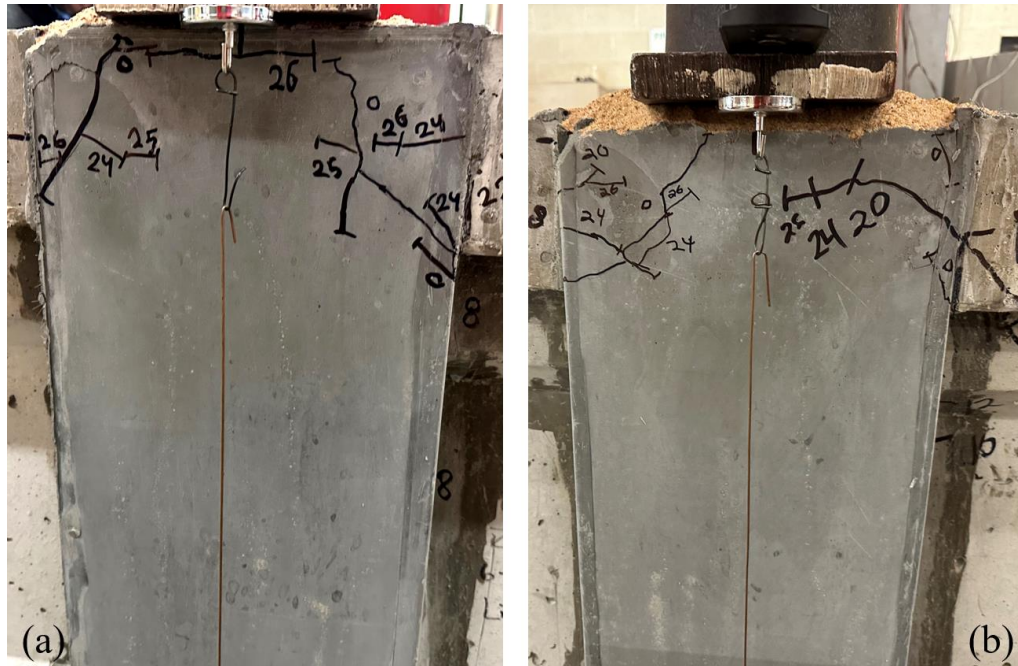
*Figure 76: East (a) and west (b) side of joint SSDU-1 showing cracks near as-cast top face under final positive moment test loading*

Specimen SSDU-1 was first tested in the positive moment orientation. Initial cracking was observed at a load of 8 kips, which is shown in Figures 72 and 73. Cracking occurred on both sides of the joint-girder interface and started from the as-cast bottom flange to the as-cast top flange. The joint separation started along the bottom of both interfaces and separation increased as the test continued. At 14 kips, the cracks followed along the interface up to the as-cast bottom of the deck. At 16 kips, the crack along the south interface reached the approximate location of the mild steel lap splice and stopped propagating upward. At 22 kips, the crack along the north interface reached the approximate location of the mild steel lap splice and stopped propagating upward. At 24 kips, new cracks in the joint started from the preexisting cracks and generally propagated toward the load point. The test was stopped at 26 kips due to the specimen experiencing increasingly larger deflections between load increments. Figures 74 and 75 show significant cracking along both interface locations, where signs of strand pullout could be seen under final loading. Cracking near the as-cast top face of the joint is shown in Figure 76.

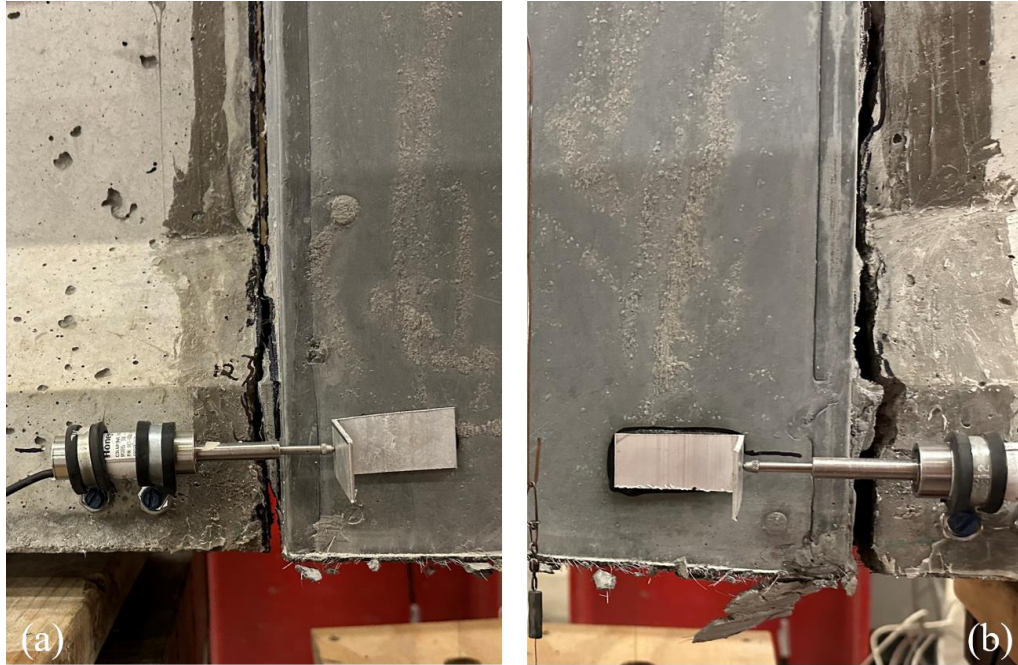
Figure 77: Northwest (a) and southwest (b) side of joint SSDU-1 showing separation at the interface near the as-cast bottom face under final positive moment test loading

The manually measured deflection was  $1\frac{5}{16}$  in. under final loading and  $\frac{15}{16}$  in. after the load was removed. Figures 77 and 78 show joint separation on both sides of the specimen under final loading.

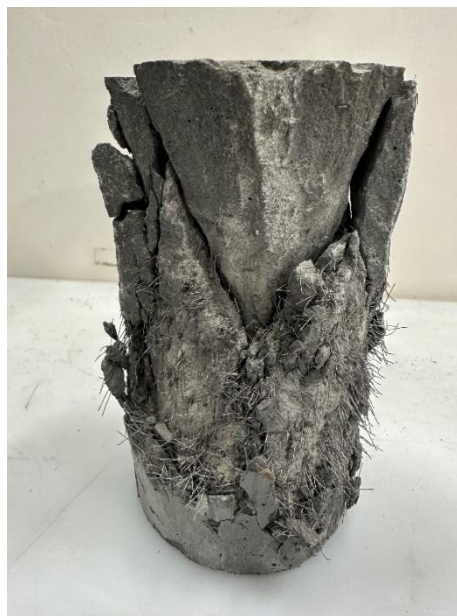
*Figure 79: Compressive cylinder showing significant fiber settlement in the Ductal® UHPC used for joints SSDU-1 and SSDU-2*

Since the as-cast top surface of all the joints constructed with Ductal® UHPC looked identical, the decision was made to split open compression testing cylinders from all batches. Figure 79 shows a cylinder from the batch of Ductal® UHPC that was used in joints SSDU-1 and SSDU-2, which confirms that fibers were only present in the bottom half of the specimen. This type of fiber distribution was not noticed while using Ductal® for previous projects.

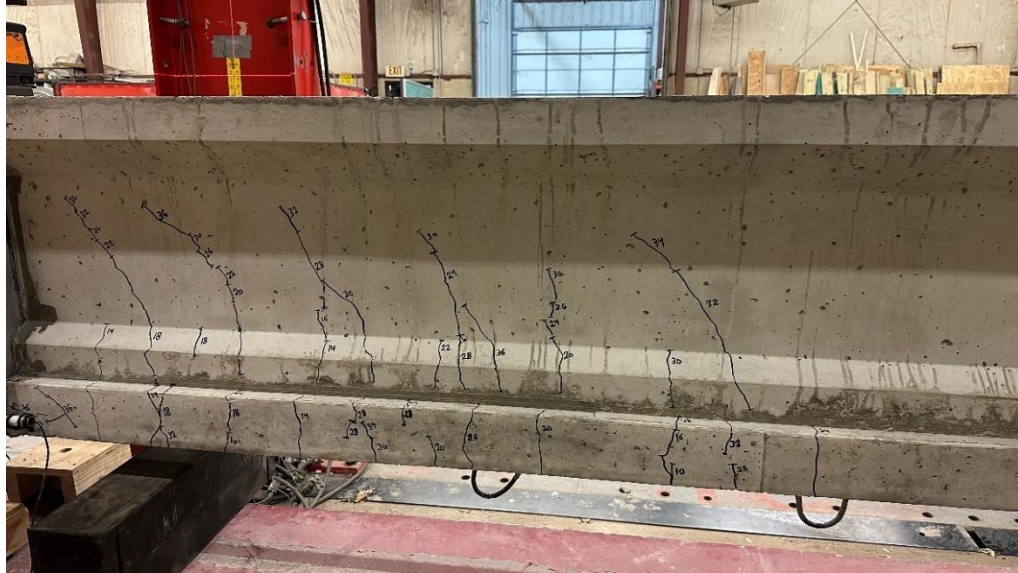
*Figure 82: East side of north girder SSDU-1 showing flexural cracks after negative moment test*

Specimen SSDU-1 was removed from the load frame, flipped upside down, and placed back in the load frame to be tested in the negative moment orientation. No damage was observed while flipping the specimen. At 5 kips, small initial flexural cracks were observed in the as-cast top face of both girder decks approximately 3 ft away from the joint. From 5 to 8 kips, additional flexural cracks started intermittently along the length of the girder from the as-cast top face of the decks. From 8 to 14 kips, the cracks propagated through the deck and into the girder. At 20 kips, most of the existing flexural cracks closest to the joint propagated to the middle of the web of the girder. From 20 to 26 kips, new flexural cracks formed beyond existing cracks and propagated from the as-cast top surface of the deck to approximately the mid-depth of the web of the girder. From 26 to 36 kips, existing flexural cracks propagated up toward the load point and the rate of

cracking for each increment slowed. All flexural cracks that developed during testing are shown in Figures 82 through 85.

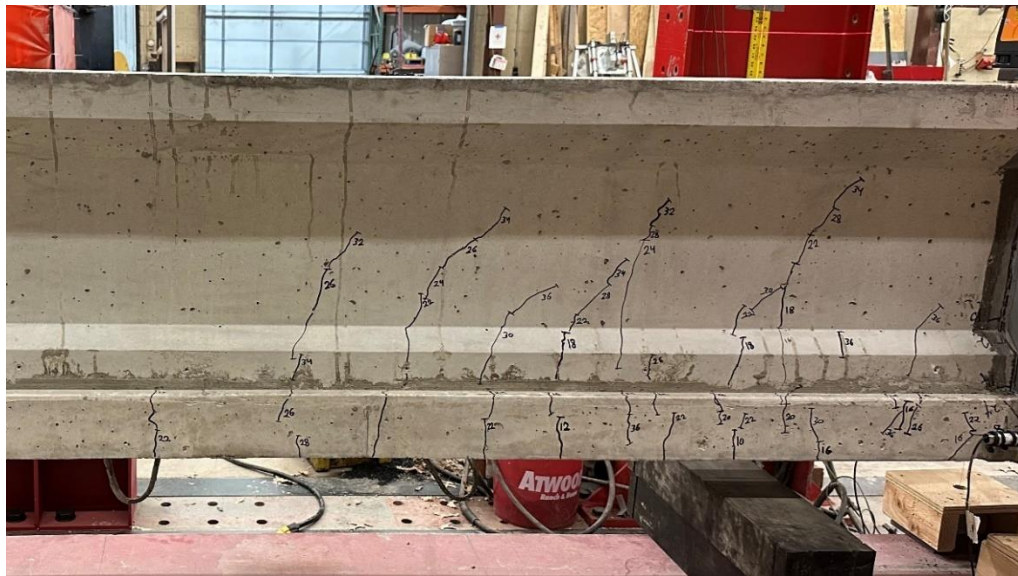
*Figure 83: East side of south girder SSDU-1 showing flexural cracks after negative moment test*

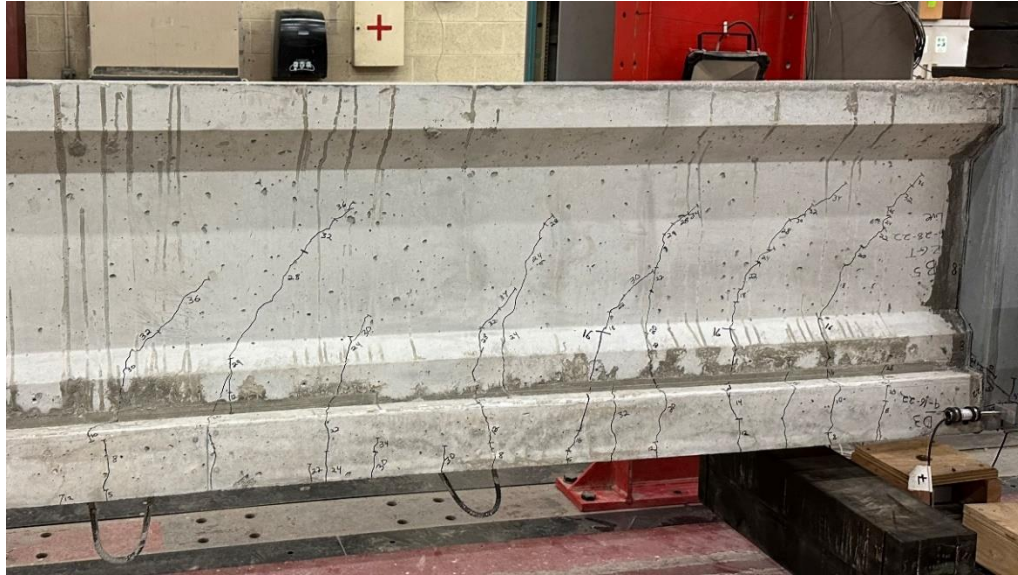
Figure 84: West side of north girder SSDU-1 showing flexural cracks as after negative moment test

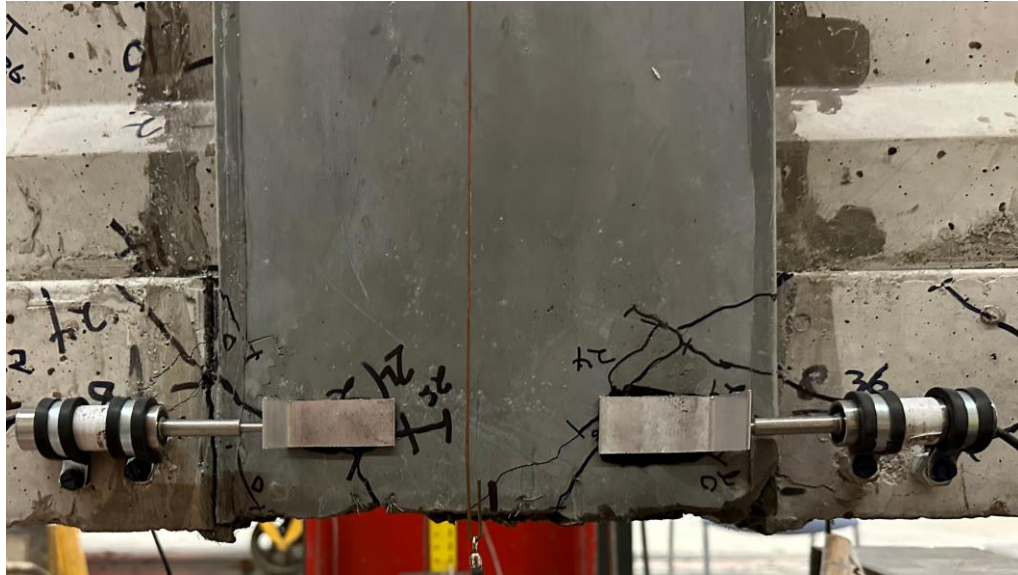
Figure 87: East side of joint SSDU-1 showing cracks near the as-cast top face of the joint under final negative moment test loading

After the test, the unmarked cracks shown in Figures 86 and 87 were discovered near the as-cast top face of the joint. The cracks are believed to have formed near the end of testing. Cracks that formed at the interface during the test are shown in Figures 88 and 89 under final loading.

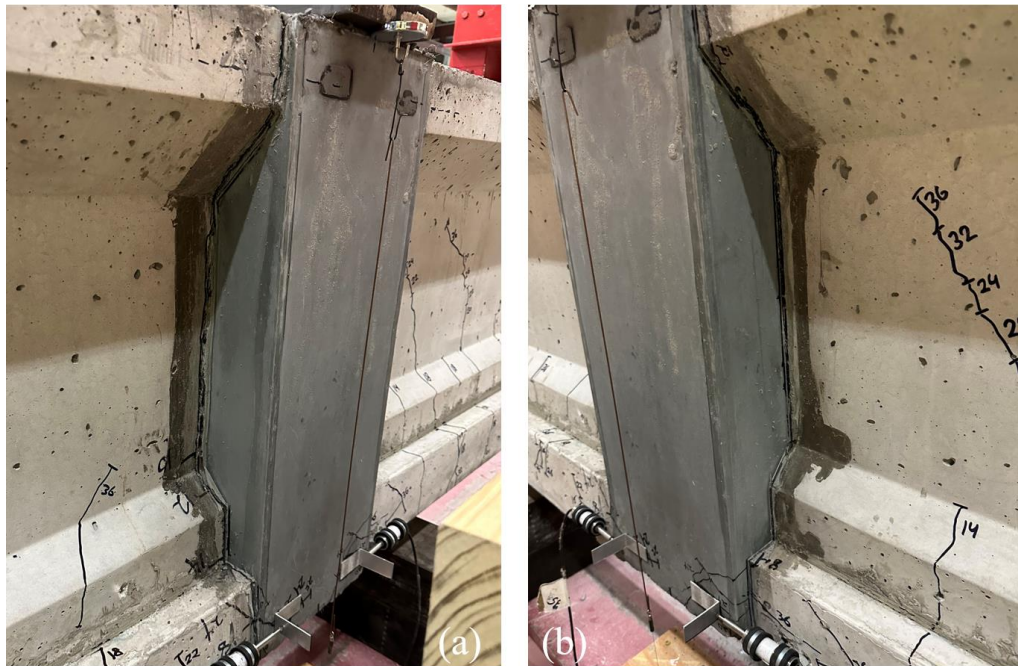
Figure 88: Southeast (a) and northeast (b) side of joint SSDU-1 showing cracking along the interfaces under final negative moment test loading

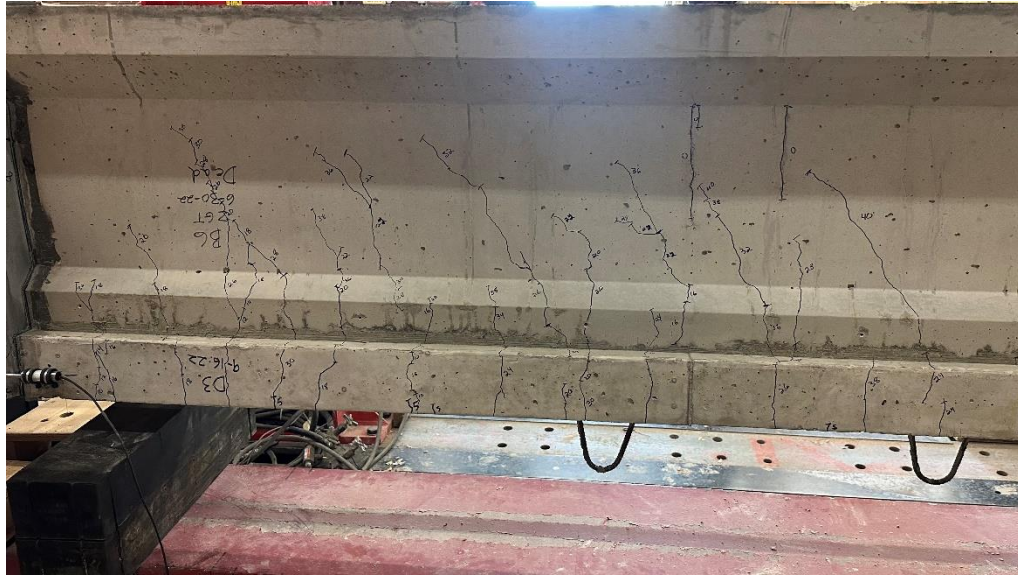
*Figure 92: East side of north girder of SSDU-2 showing flexural cracks under final negative moment test loading*

Additionally, small flexural cracks were identified intermittently along the east side of the girders near the as-cast top surface of the deck. From 8 to 16 kips, the flexural cracks propagated through the deck and into the as-cast top flange of the girder toward the load point. At 18 kips, new flexural cracks appeared from the as-cast top of the deck into the as-cast top flange of the girder. In general, the farther away a crack was from the joint, the faster it propagated through the girder toward the load point. At 20 kips, most of the existing flexural cracks closest to the joint propagated to the mid-depth of the web of the girder. From 20 to 26 kips, new flexural cracks formed beyond existing cracks and extended from the as-cast top face of the deck to approximately the mid-depth of the web of the girder.

From 26 to 36 kips, existing flexural cracks propagated up toward the load point and the rate of propagation for existing cracks slowed. From 36 to 40 kips, new flexural cracks formed beyond existing cracks and extended from the as-cast top face of the deck to approximately the mid-depth of the web of the girder. The test was stopped when the specimen could not resist additional loading. All flexural cracks that developed during testing are shown in Figures 92 through 95. Cracks that formed near the as-cast top surface of the joint are shown in Figures 96 and 97. The manually measured deflection was 9/16 in. under final loading and 3/8 in. after the load was removed.

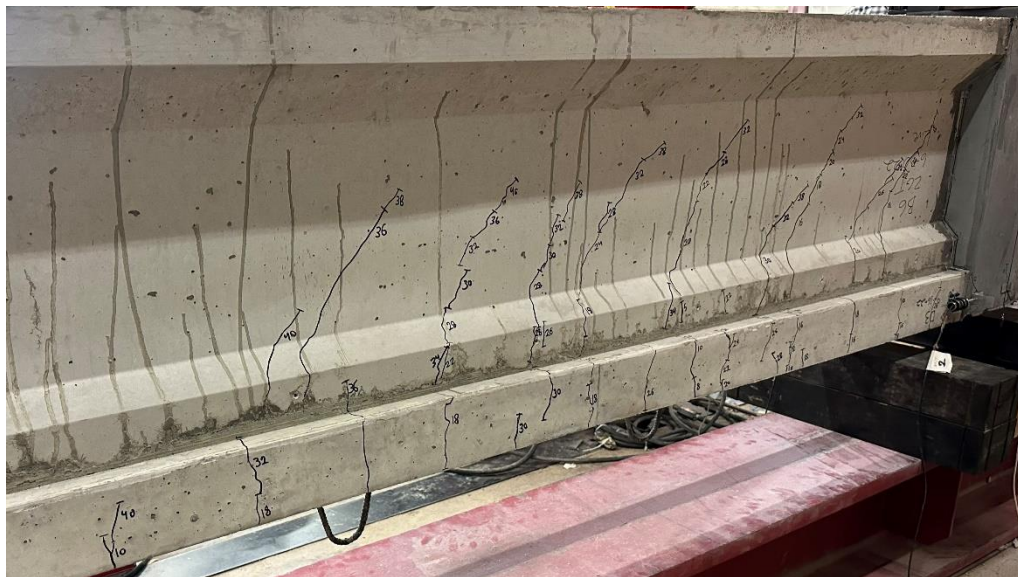
*Figure 93: East side of south girder of SSDU-2 showing flexural cracks under final negative moment test loading*

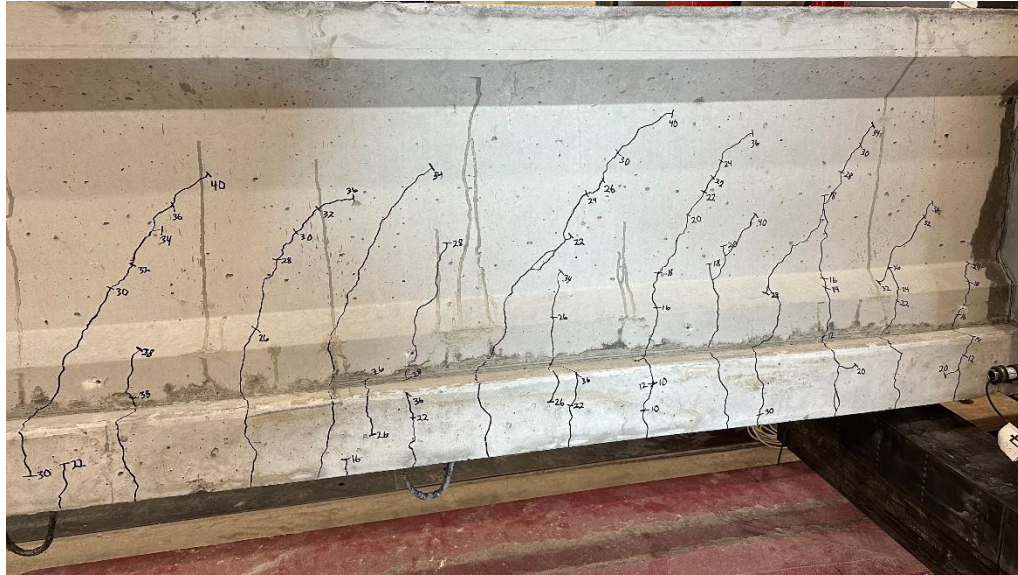
*Figure 94: West side of north girder of SSDU-2 showing flexural cracks under final negative moment test loading*

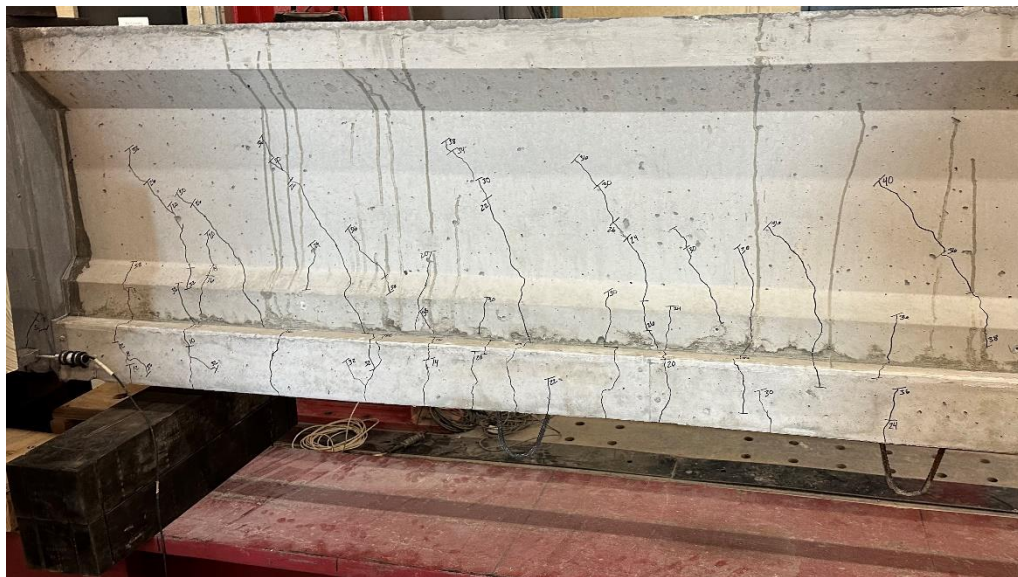
*Figure 95: West side of south girder of SSDU-2 showing flexural cracks under final negative moment test loading*

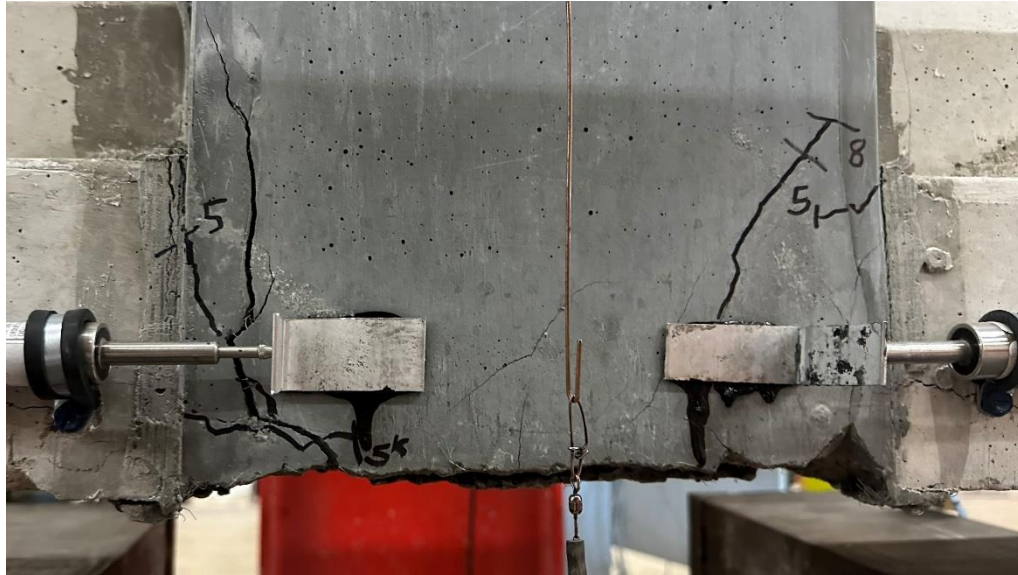
*Figure 96: West side of joint SSDU-2 showing cracks near the as-cast top face of the joint under final negative moment test loading*

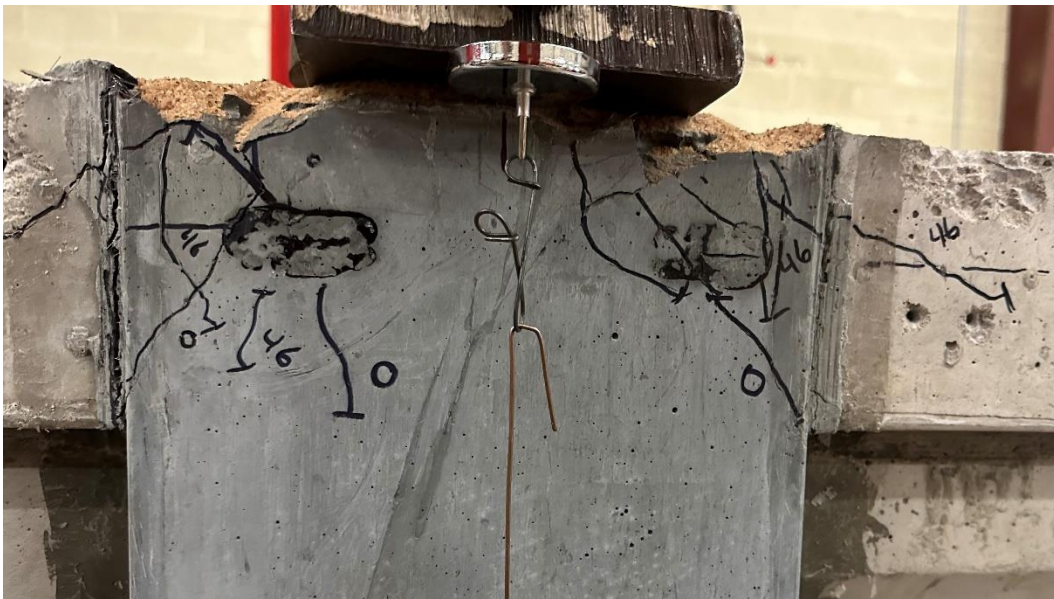
Figure 100: West side of joint SSDU-2 in positive moment orientation showing undocumented cracks near the as-cast top surface caused by negative moment testing Note: All cracks unlabeled or labeled 46 kips resulted from final loading of approximately 41.6 kips

Specimen SSDU-2 was removed from the load frame, flipped upright, and placed back in the load frame to be tested in the positive moment orientation. A closer examination of the specimen in the positive moment orientation revealed that undocumented cracks formed in multiple places near the joint. Figure 98 shows significant cracking on the as-cast top surface of the joint. The cracks at the as-cast top surface of the joint measured 0.1 in. across the widest point using a crack gauge. Figure 99 shows cracks that formed on the as-cast top face of the deck. Figures 100 and 101 show cracks that propagated along the sides of the joint. These cracks were marked before the start of positive moment testing but were mistakenly marked 46 kips. Since the maximum load recorded by the data acquisitions system was 41.6 kips, all cracks marked 46 kips should be considered to have formed between 40 and 41.6 kips, the final increment of loading.

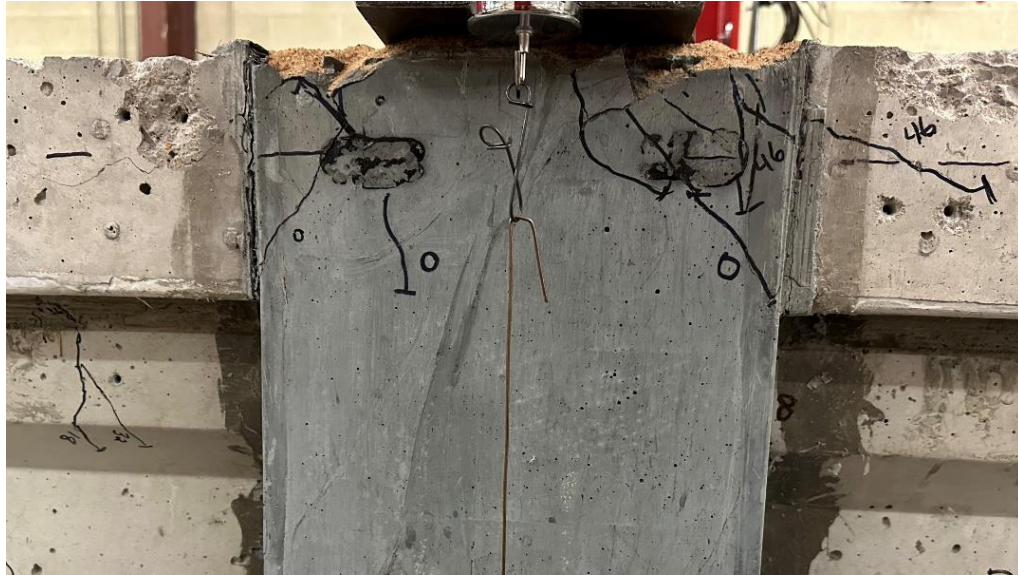
*Figure 101: East side of joint SSDU-2 in positive moment orientation showing undocumented cracks near the as-cast top surface caused by negative moment testing  
Note: All cracks unlabeled or labeled 46 kips resulted from final loading of approximately 41.6 kips*

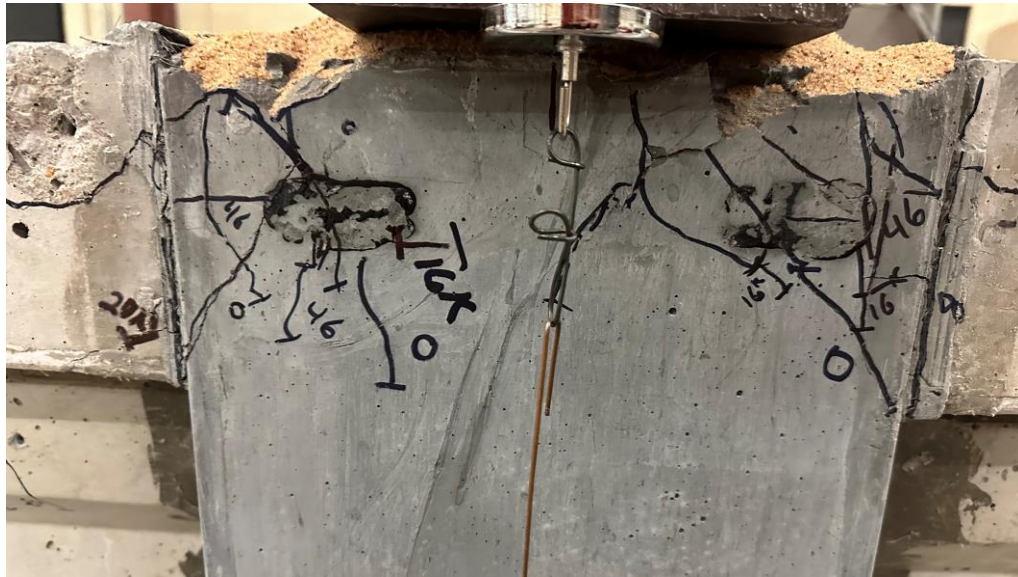
Figure 104: West side of joint SSDU-2 showing cracks near as-cast top face after final positive moment test loading

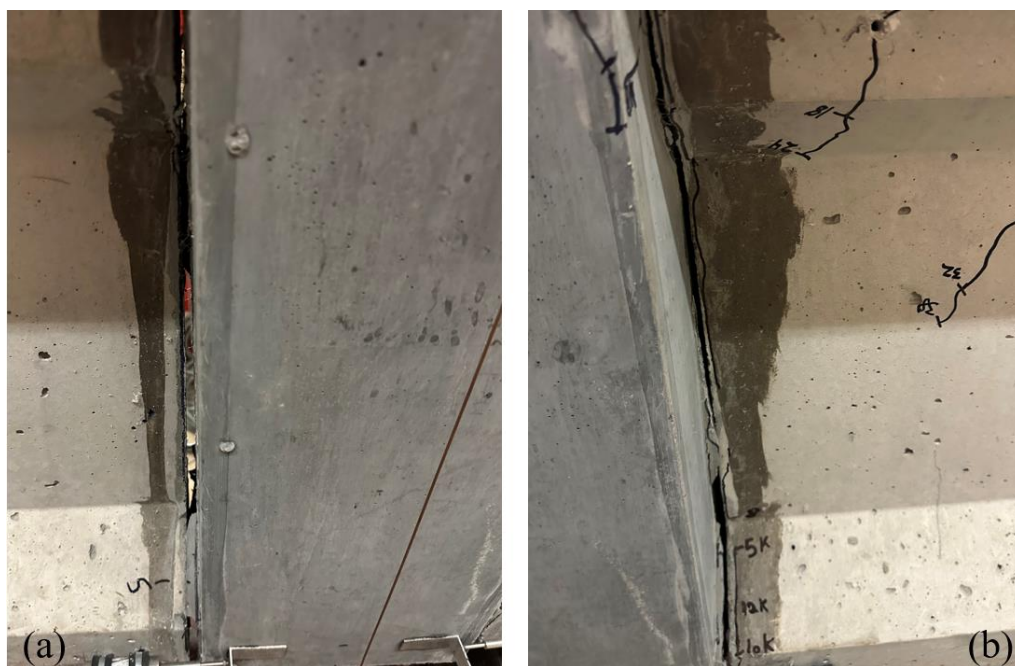
Figure 105: East side of joint SSDU-2 showing cracks near the as-cast top face after final positive moment test loading

was marked beyond this point. At 22 kips, very distinct cracking sounds were heard from existing cracks near the as-cast top surface of the joint and strand locations. Just before reaching 26 kips, a popping sound was heard coming from near the strand locations and the applied load decreased. The test was stopped just beyond 26 kips due to the specimen experiencing a significant decrease in load-carrying capacity and showing signs of strand pullout. Cracking near the as-cast top surface of the joint is shown in Figures 104 and 105. The manually measured deflection was 2-1/2 in. under final loading and 2-1/16 in. after the load was removed. Figures 106 and 107 show joint separation on both sides of the specimen after loading was removed.

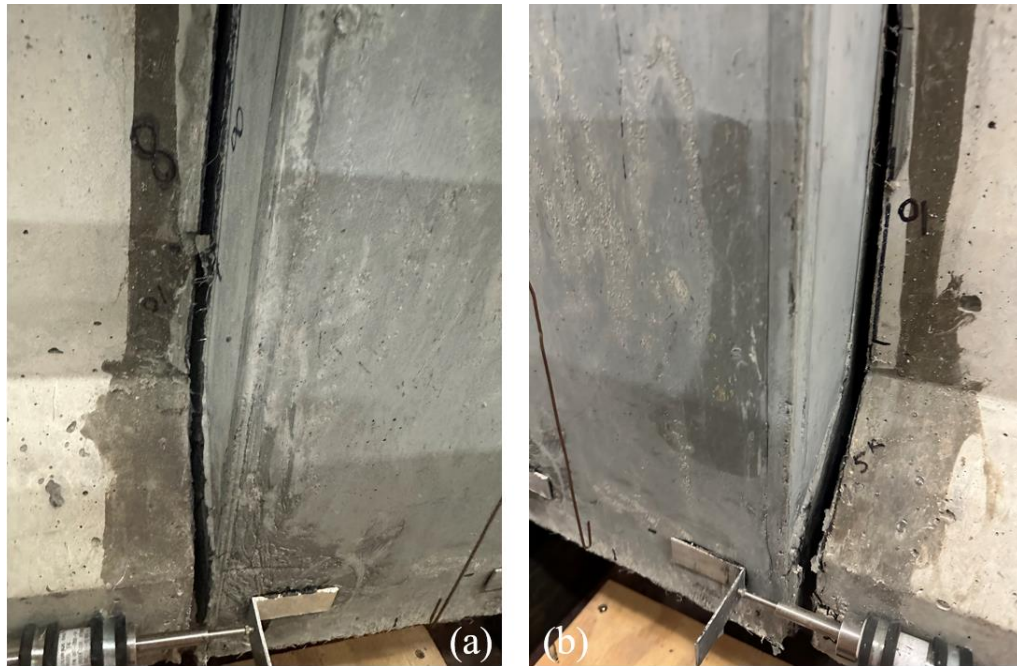
Figure 106: Southeast (a) and northeast (b) side of joint SSDU-2 showing cracking along the as-cast bottom of the interfaces after final positive moment test loading
