PITTING AND STRESS CORROSION CRACKING ~

IN ALLOY 200

Submitted to the Faculty of the Graduate College of the Oklahoma State University in partial fulfillment of the requirements for the degree of MASTER OF SCIENCE December, 1991 . .

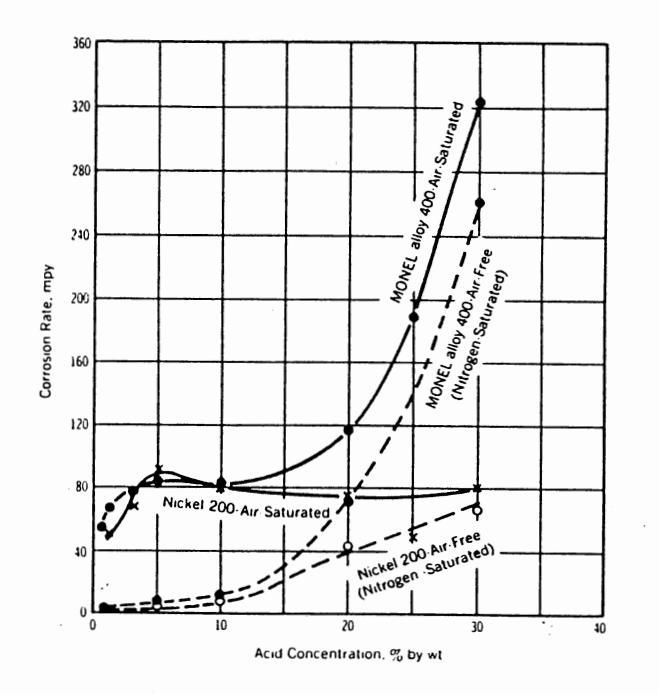
Figure 1. Corrosion of Alloy 200 in hydrochloric acid solution at 30 deg.C (From Friend¹⁹)

Alloy 200 can be used with unaerated sulfuric acid solutions at low or moderate temperature, although it is usually less resistant than nickel-copper alloys. In dilute solutions, the corrosion rate is increased by a high degree of aeration. Alloy 200 is moderately resistant to corrosion by hydrochloric acid, although its usefulness is limited to dilute solutions. Increasing temperature increases the corrosion rate of nickel in hydrochloric acid solutions as indicated by the test results in 5% acid shown in Figure. 1. Corrosion is also increased by the presence of air or oxygen.

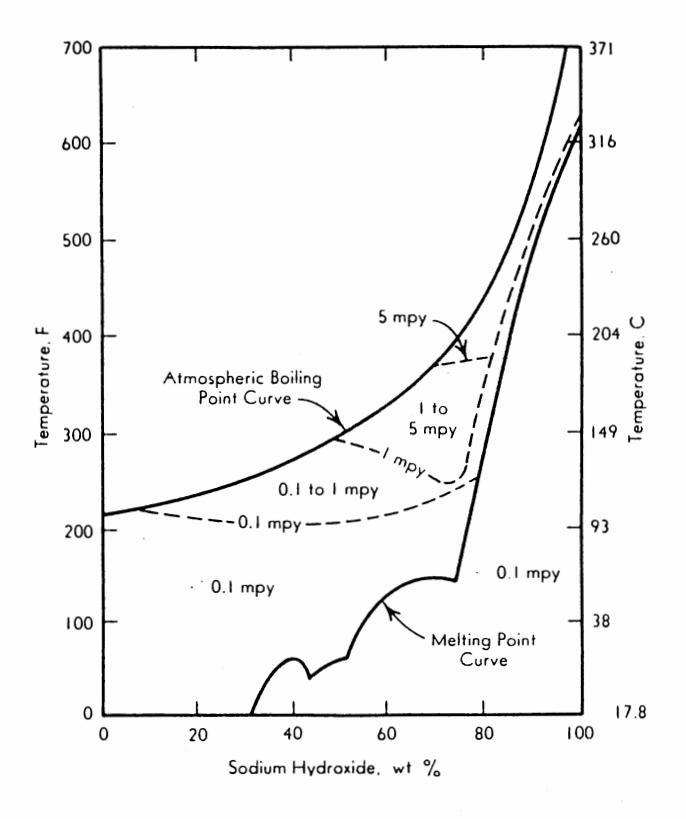
Figure 2. Isocorrosion chart for Alloy 200 in sodium hydroxide (From Friend¹⁹)

The outstanding corrosion resistance characteristic of Alloy 200 is its resistance to caustic soda and other alkalies. Ammonium hydroxide is an exception. The isocorrosion chart for nickel is shown in Figure. 2, is used as a general guide. Because of the presence of chlorates in caustic, the corrosion rates increase significantly. Every effort should be made to remove as much of them as possible. Oxidizable sulfur compounds also tend to increase the corrosivity of caustic to Alloy 200. Oxidizable acid salts such as ferric, cupric, and mercuric chlorides should be used with Alloy 200 only in low concentrations. The addition of such oxidizing salts as chromates, dichromates, nitrates, and peroxides to mineral acids may make them highly corrosive to nickel.

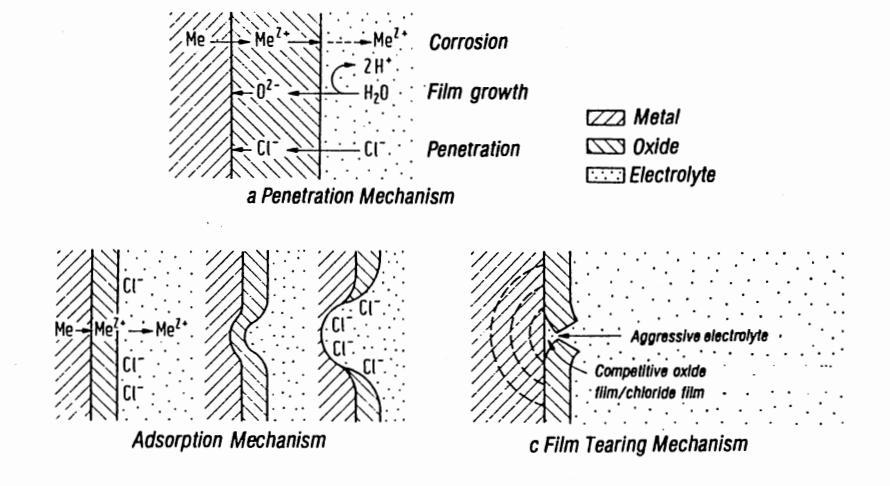
Figure 3. Schematic sketch of three possible initiation processes for pitting: (a) through incorporation of anions into the oxide, (b) through island adsorption of anions on the passive oxide, and (c) through tearing of the passive oxide (From Kaesche²⁴)

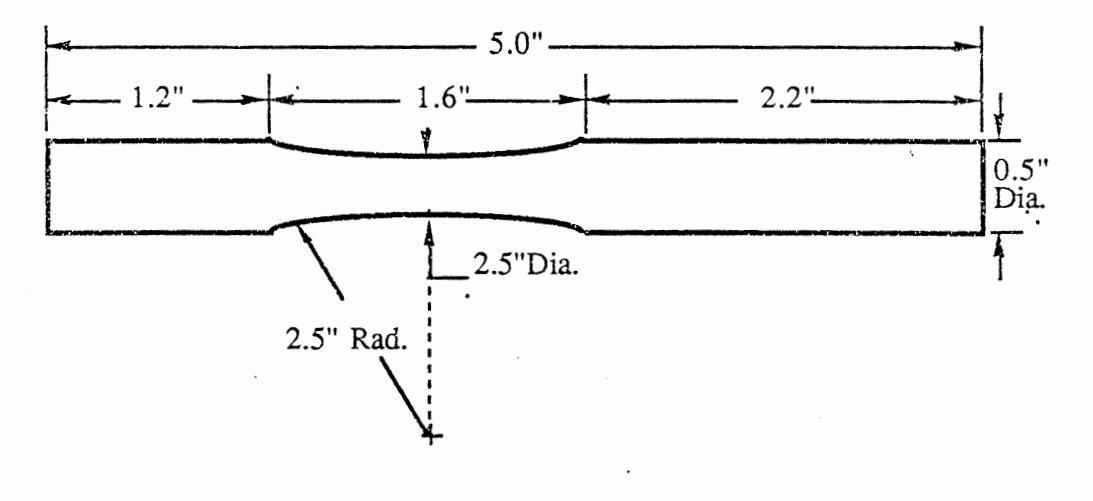
Figure 6. Geometry of Tensile specimen (From Zaheer¹⁵)

The tensile specimens were waisted with a 0.25 inch minimum diameter that gradually increases to 0.5 inch at the shoulders at the end of each gauge length. Figure. 6 shows the geometry of a tensile specimen. An advantage of this geometry is the strain gradient, hence a damage gradient, along the gage length, which maximizes the information obtained from each test. The samples were heat treated for 1 hour at 750 C, furnace cooled for 4 hours and air cooled to room temperature. The approximate grain size obtained by this annealing treatment is $35 \,\mu$ m. After heat treatment, the samples were finished to 600

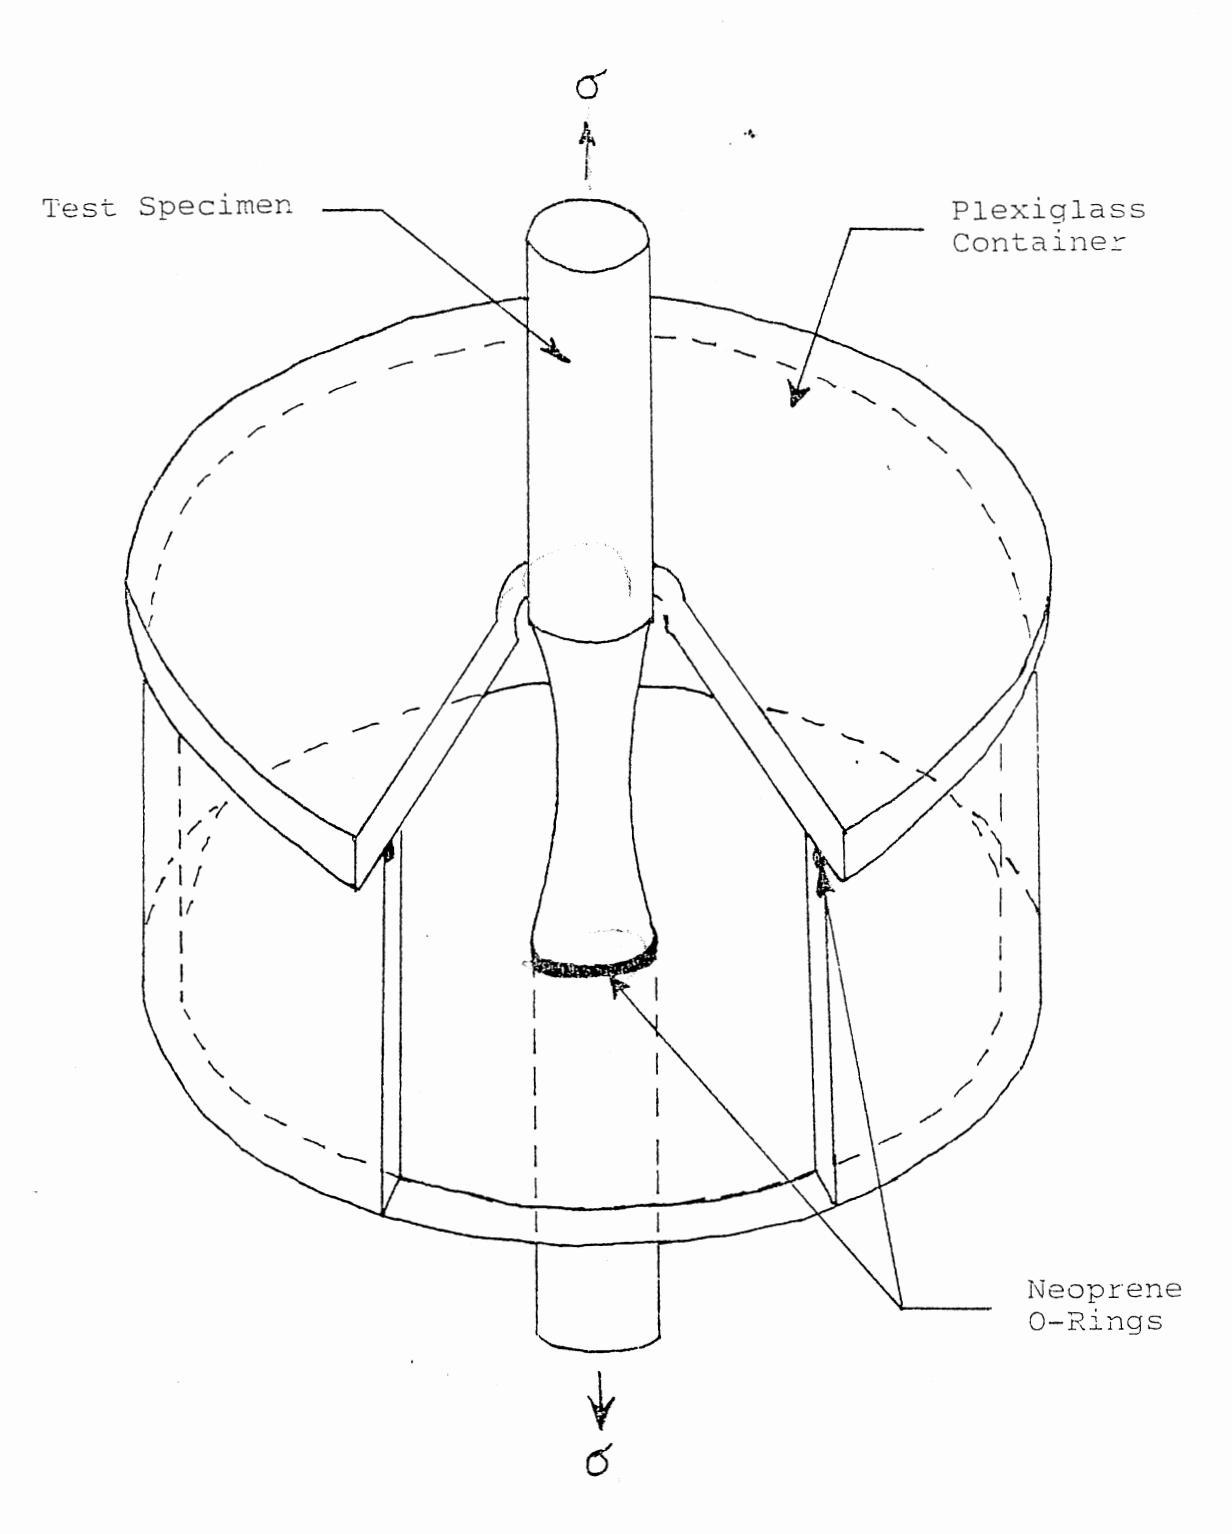
Figure 7. Schematic of specimen arrangement on MTS machine (From Everhart¹¹)

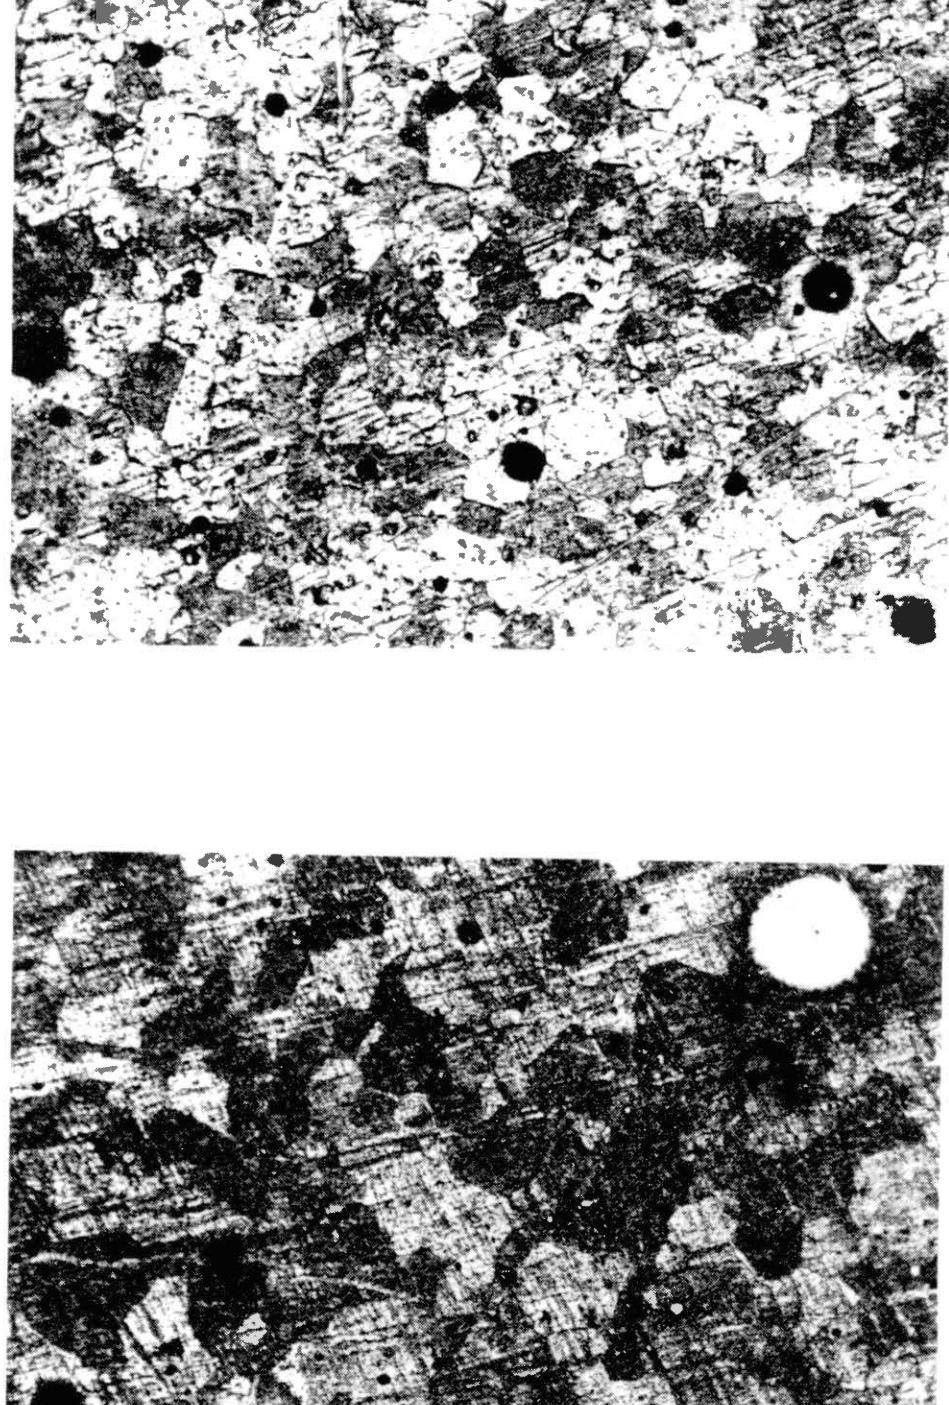
Figure 10. The Pitting attack of Alloy 200 in 0.004M Ferric chloride solution for 12 hours shows few small size pits (180X)

Figure 11. The Pitting attack of Alloy 200 in 0.002M Ferric chloride solution for 12 hours shows some small size pits (180X)

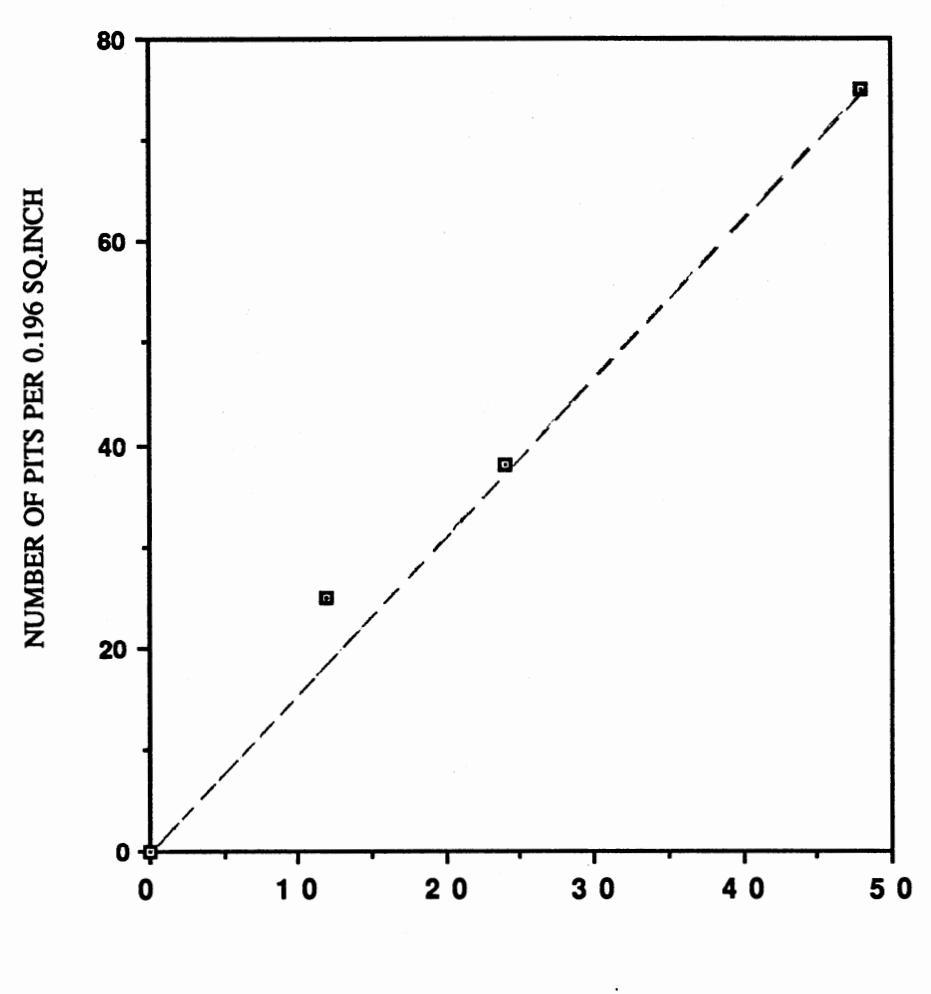
Figure 13. Effect of Time of immersion in 0.004M Ferric chloride

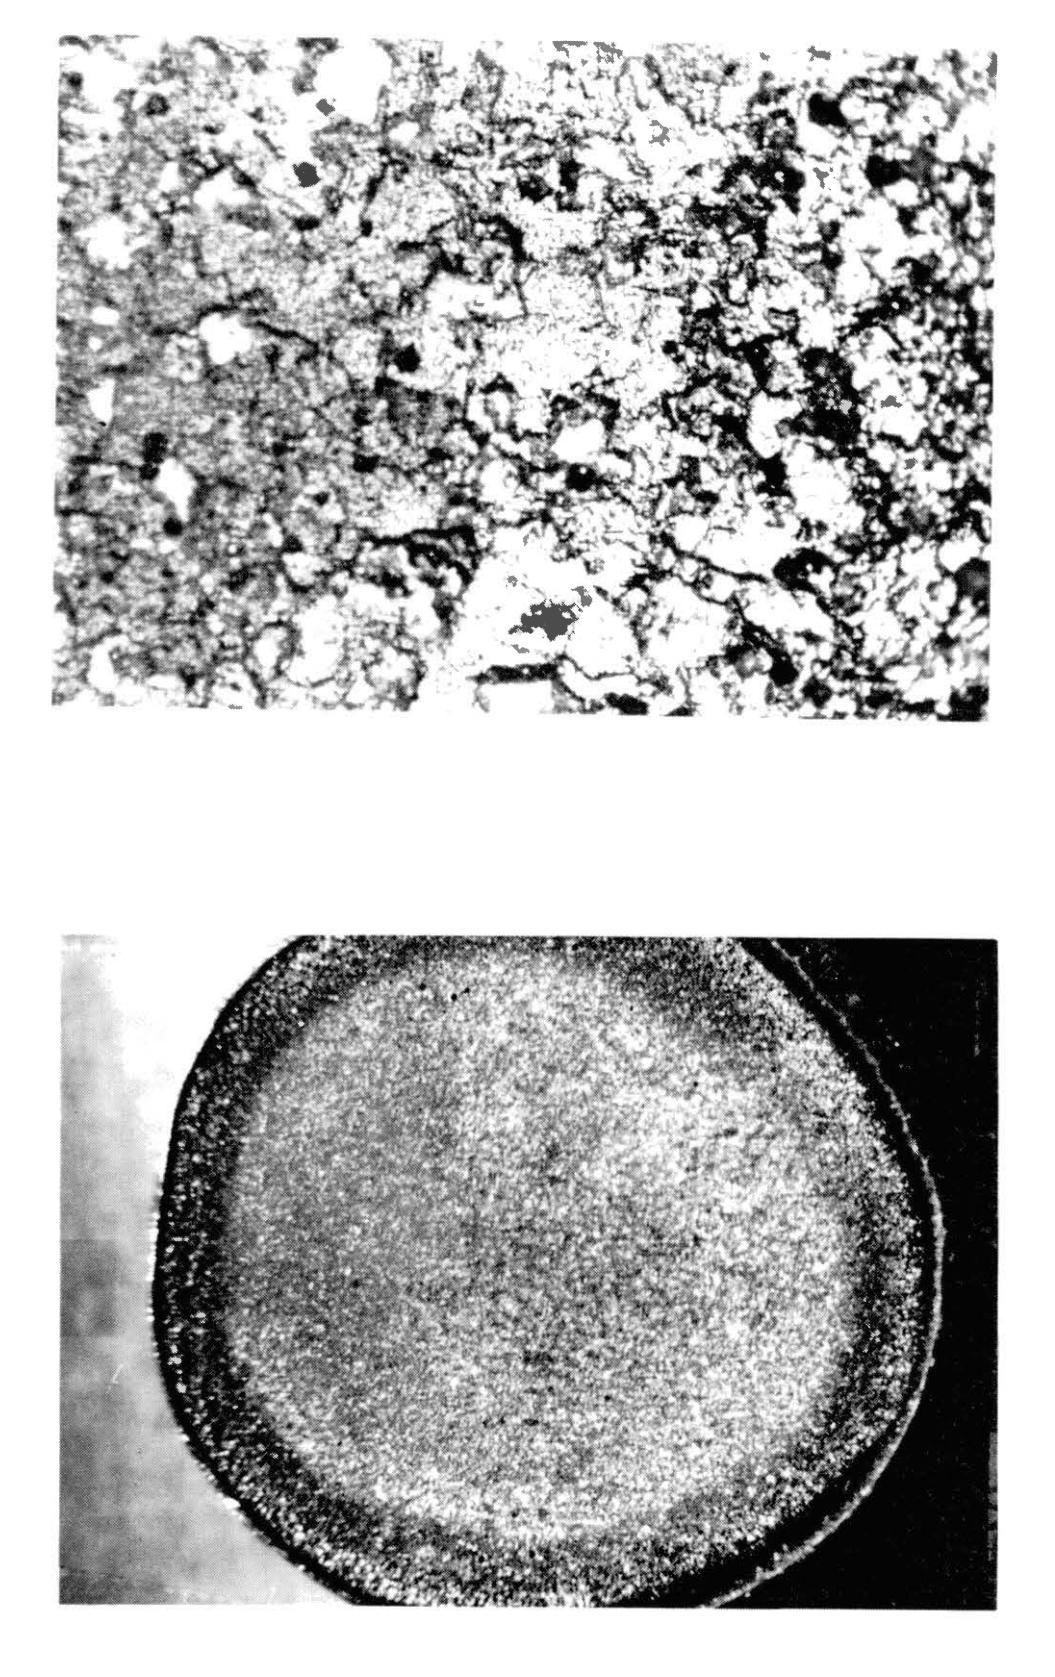
Figure 18. The Pitting attack of Alloy 200 in 0.176M Cupric chloride solution for 12 hours shows few small size pits and slight crevice attack on bottom surface (14X)

Figure 19. The Pitting attack of Alloy 200 in 0.0586M Cupric chloride solution for 12 hours shows few big and small size pits on top surface (180X)

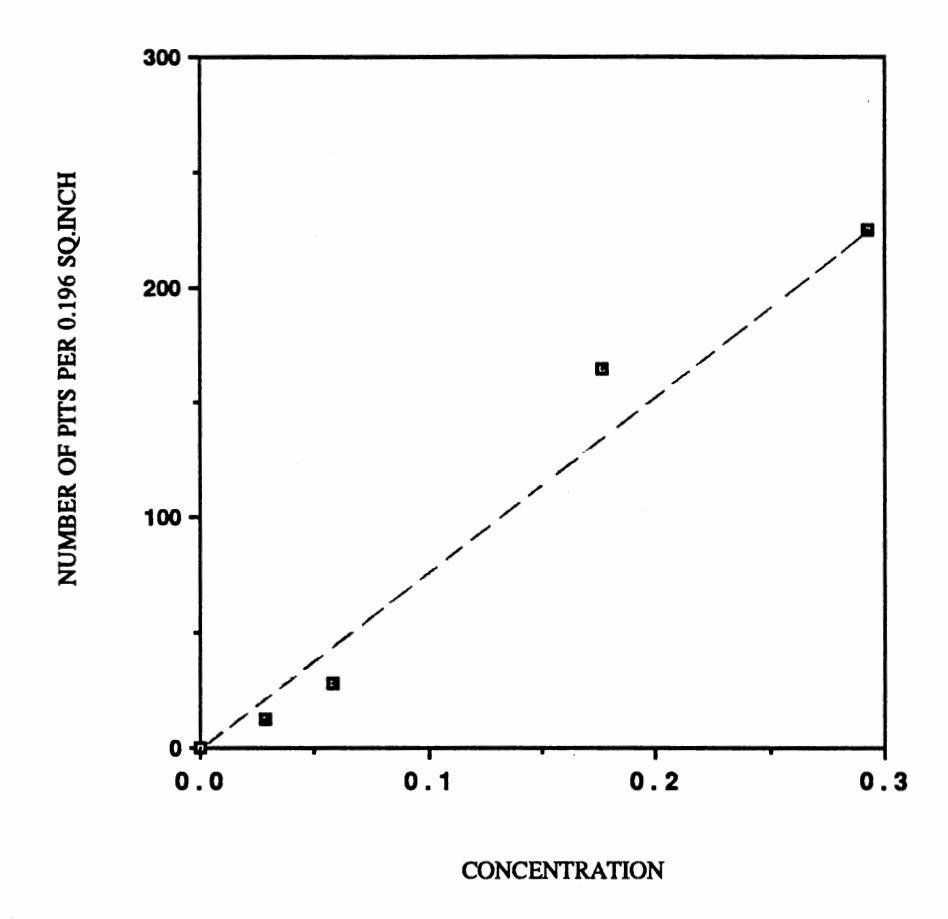
Figure 21. Effect of Concentration on Pitting Behavior in Cupric chloride at 24 hours duration

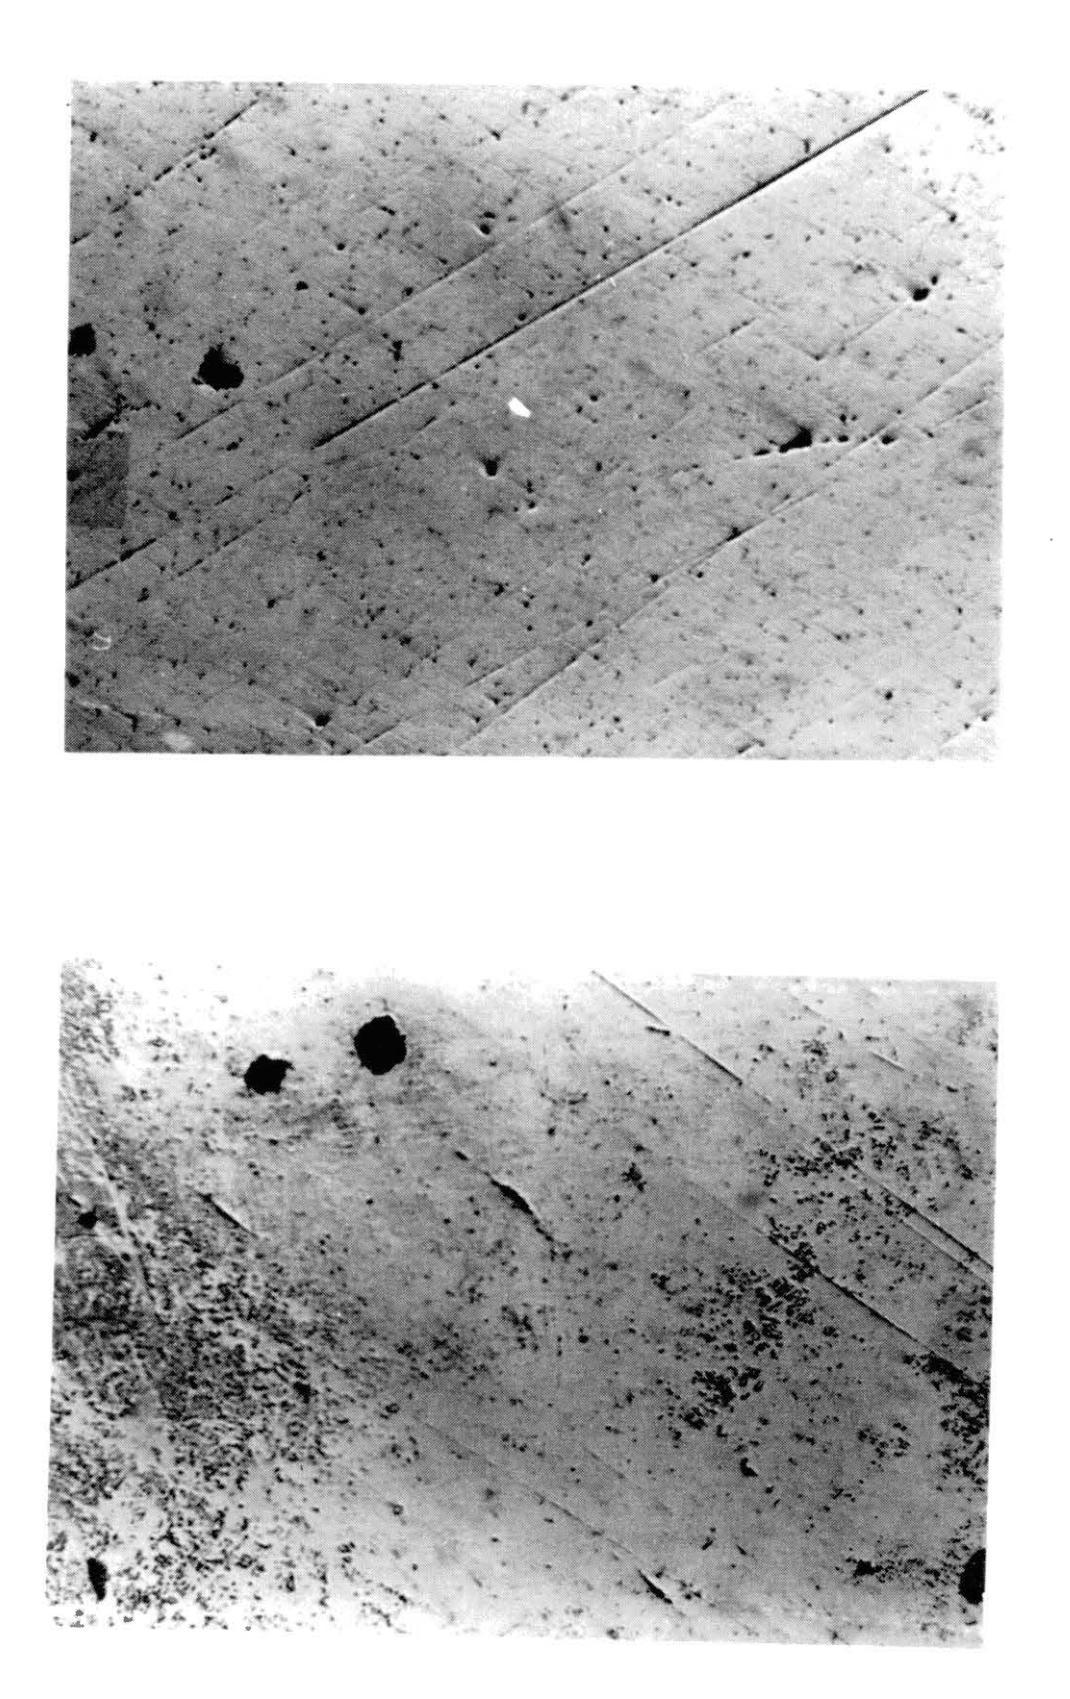
Figure 24. The Pitting attack of Alloy 200 in 0.006M Cupric chloride solution for 12 hours shows few deep pits on top surface (180X)

Figure 25. The Corrosion attack of Alloy 200 in 0.029M Cupric chloride and 10% Hydro chloric acid shows severe general corrosion and few pits (180X)

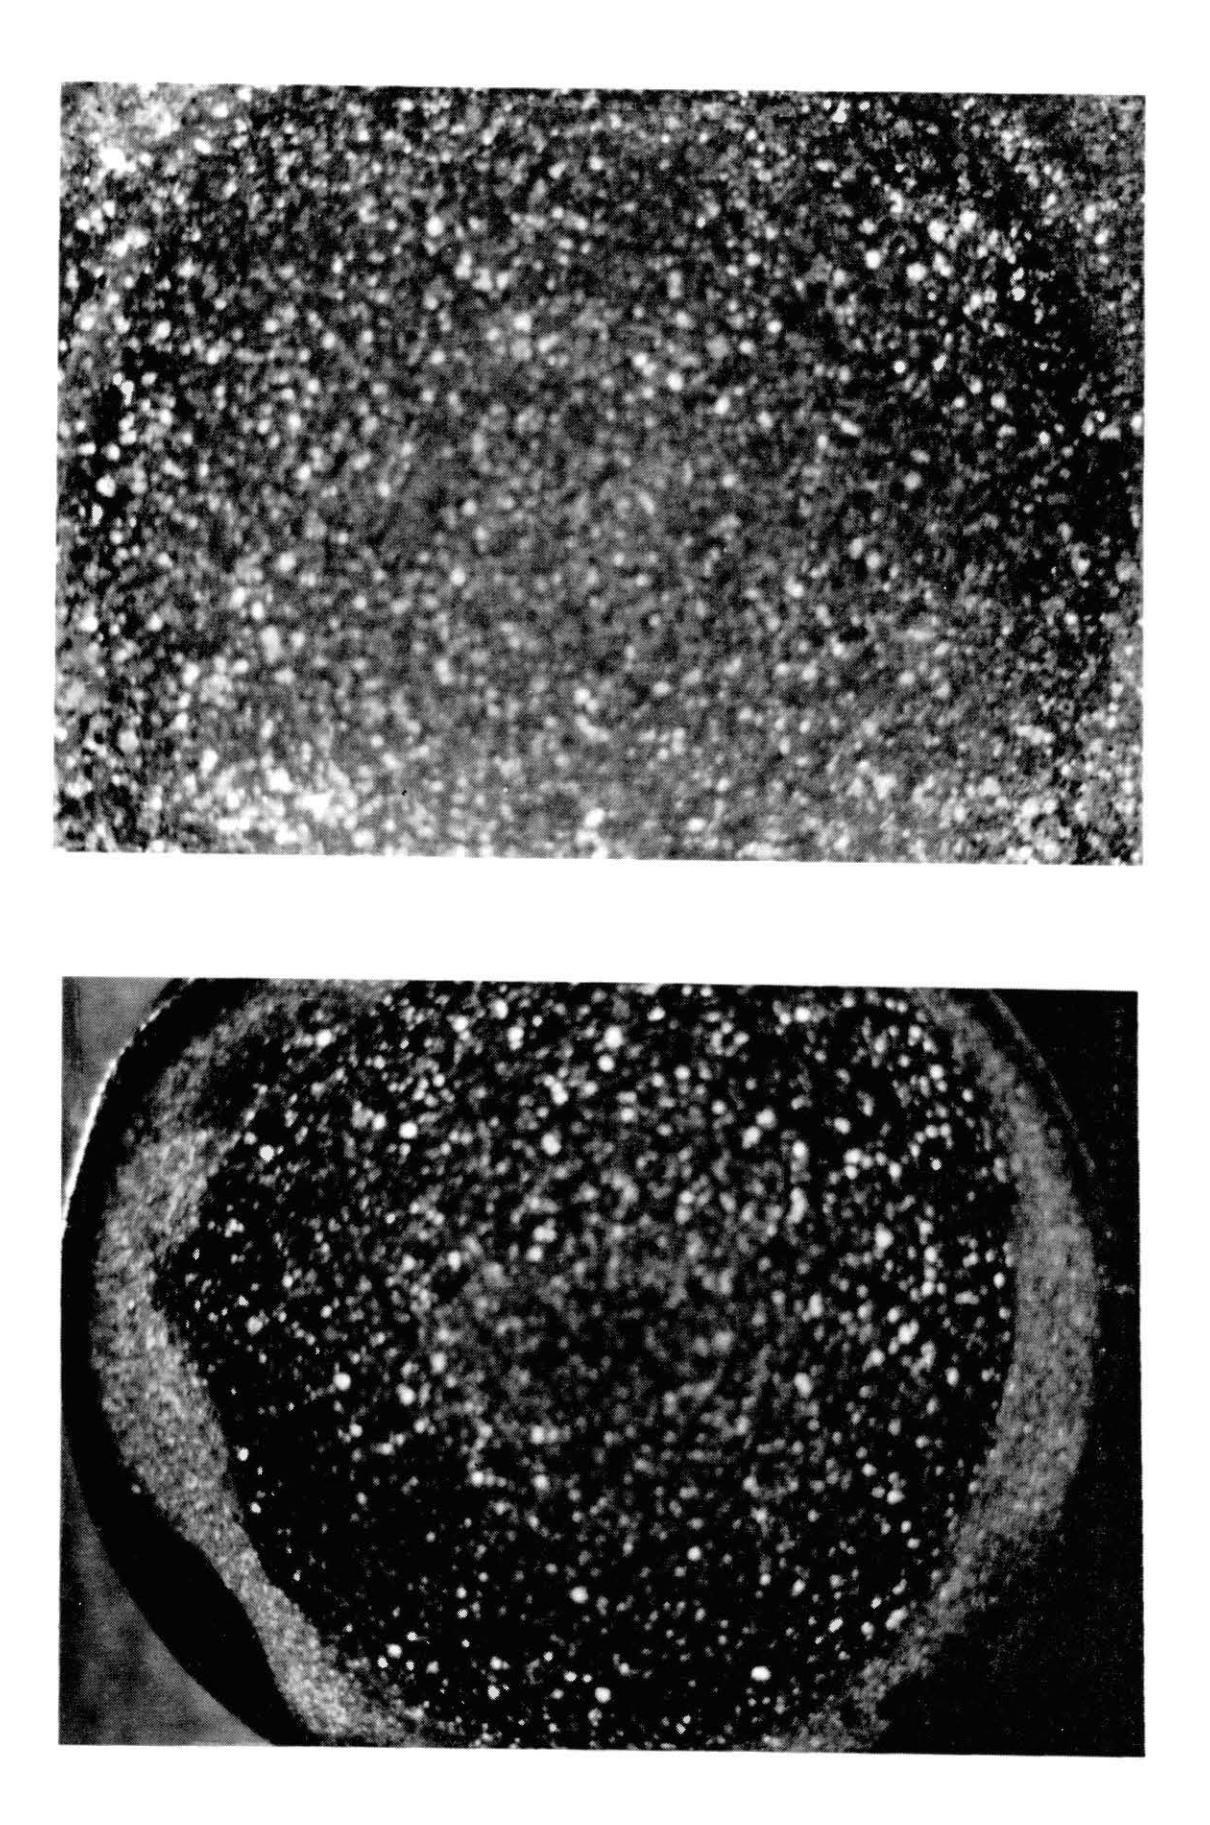
Figure 28. The corrosion attack of Alloy 200 in 0.044M Ammonium persulfate solution for 24 hours shows Pitting attack leading to General corrosion and slight Crevice attack (180X)

Figure 29. The Pitting attack of Alloy 200 in 0.022M Ammonium persulfate solution for 48 hours shows small size deep pits on top surface (180X)

When the solution concentration is reduced to 0.134M, the corrosion attack is similar to that of at 0.219M, but at slightly lesser degree. Some shallow pits and crevice attack has occurred on bottom face. Figure. 27 shows the nature of attack at 0.134M. At 0.044M concentration, the pits are not very deep as observed for 0.219M and 0.134M, but the general corrosion has occurred on both faces. For 24 hours immersion, a slight crevice attack is observed. Refer Figure. 28.

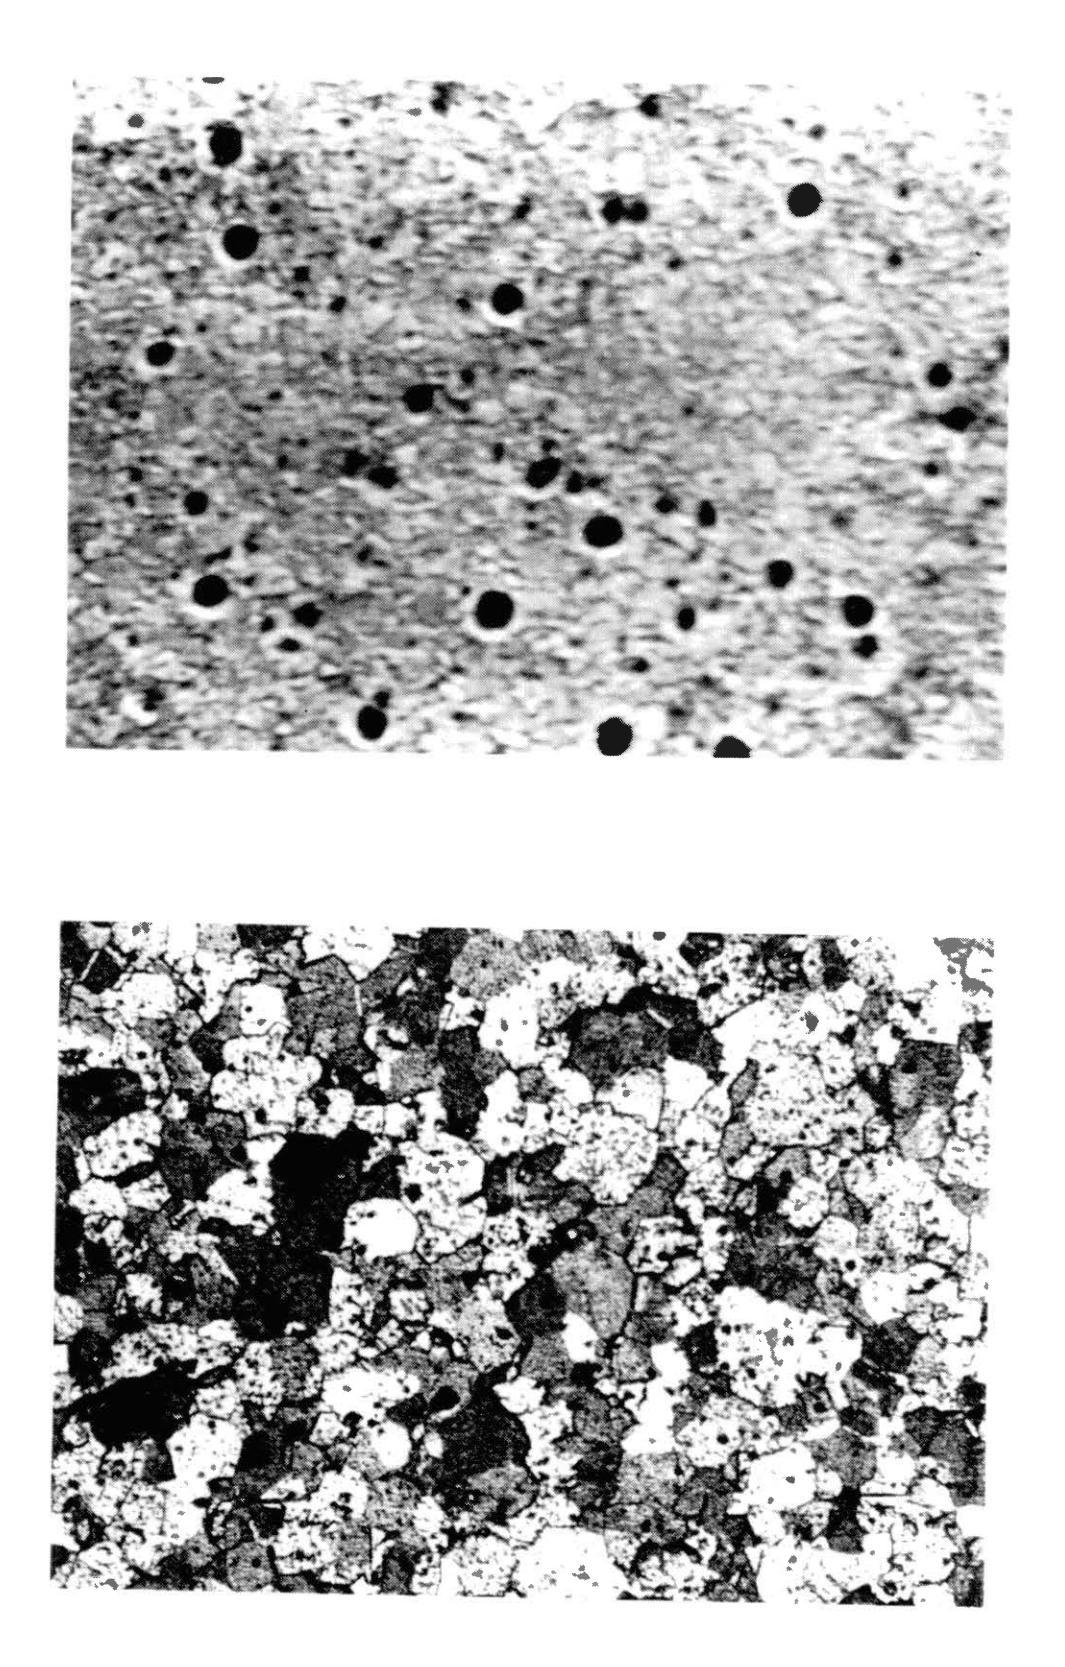
Figure 34. The Pitting attack of Chemically polished Alloy 200 in 0.03M Cupric chloride solution for 24 hours shows Pitting leading to General attack (180X)

Figure 35. The Pitting attack of Chemically polished Alloy 200 in 0.044M Ammonium persulfate solution for 24 hours shows many small size pits leading to General attack (180X)

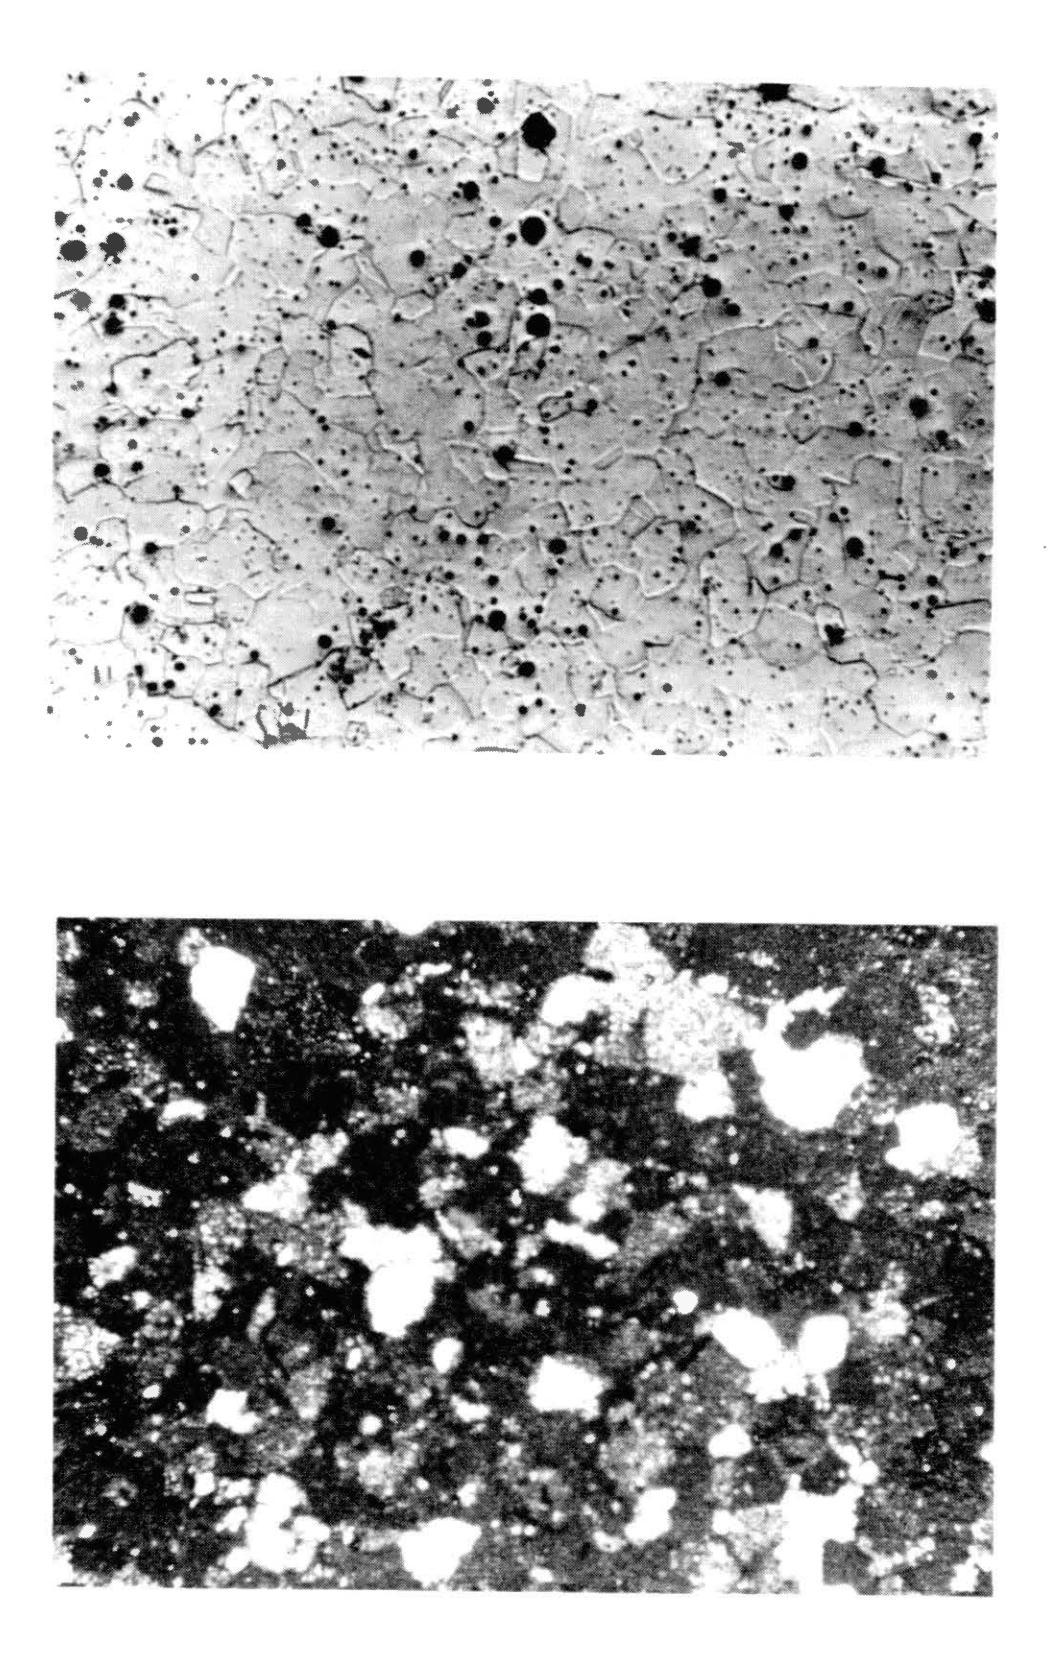
Figure 36. The Pitting attack of Chemically polished Alloy 200 in 0.02M Ferric chloride solution for 48 hours shows many small size pits (180X)

Figure 37. The Pitting attack of Chemically polished Alloy 200 in 0.006M Cupric chloride solution for 48 hours shows few small size pits (180X)

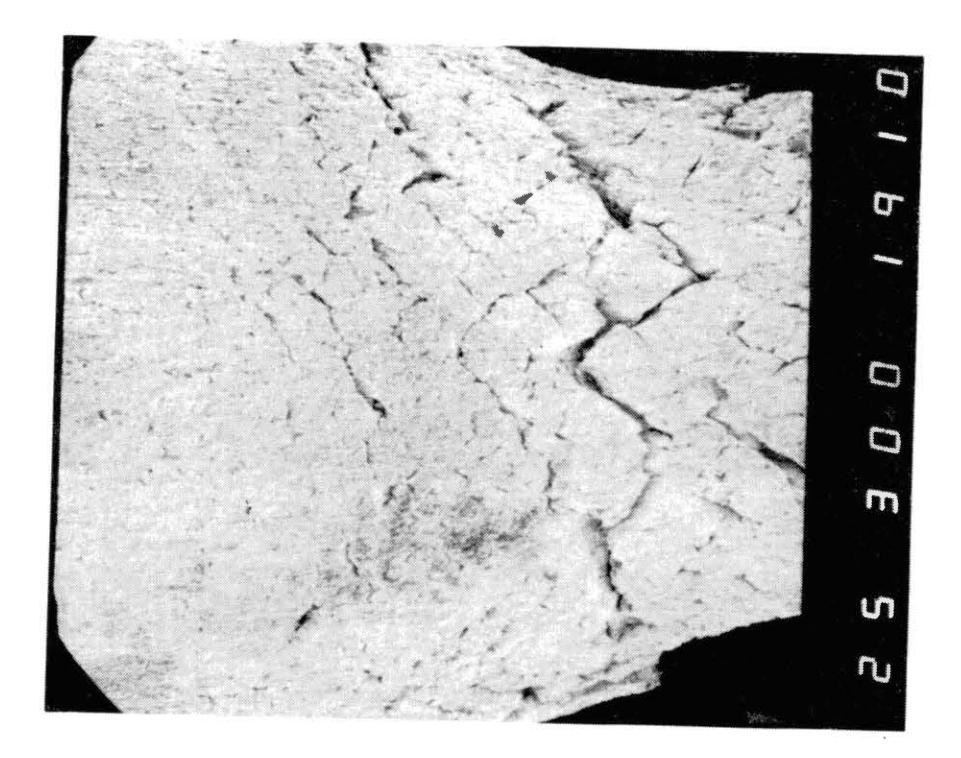
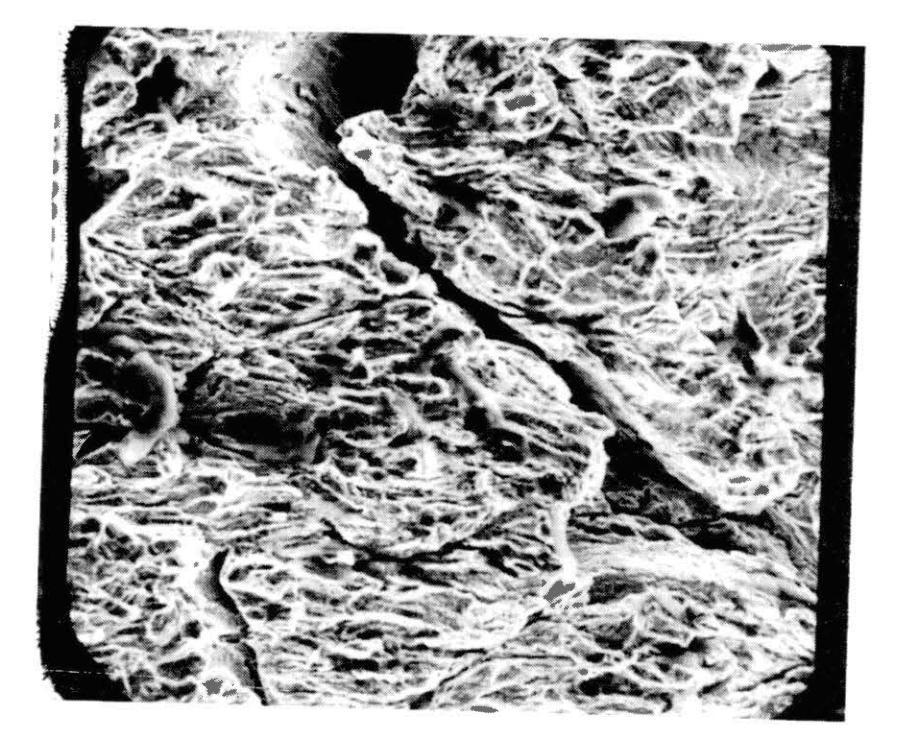
Figure 41. The test details of the Figure 40 at higher magnification (2000X)

Figure 42. The test details of Figure 39. The surface away from the fracture vicinity, showing General attack and elongated pits in the form of longitudinal cavities. The cracking is minimal (500X)

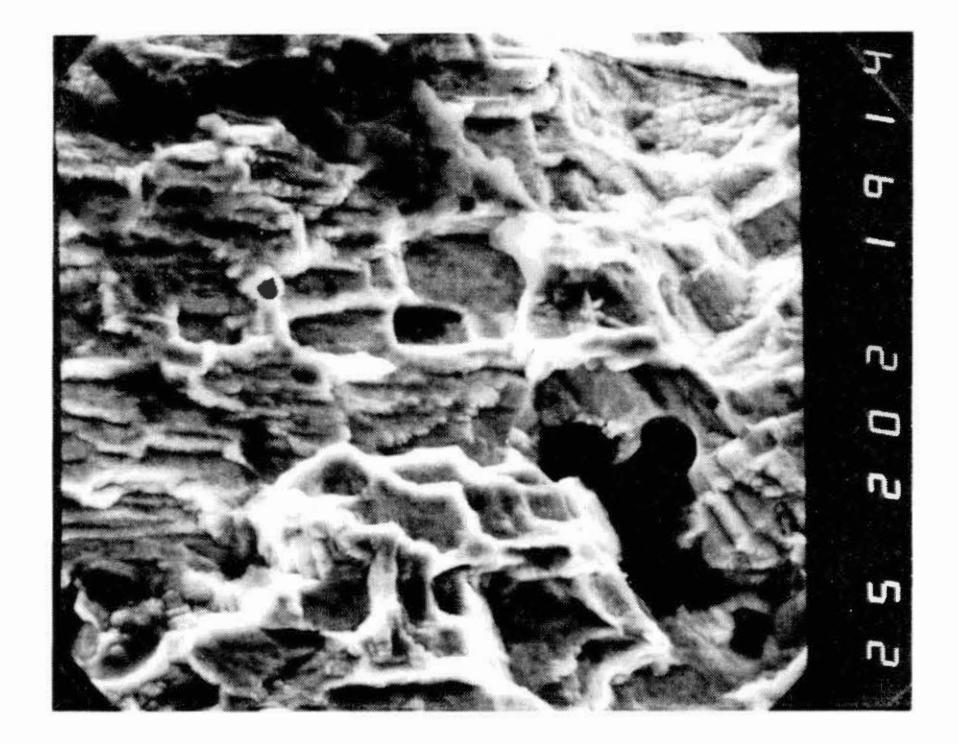
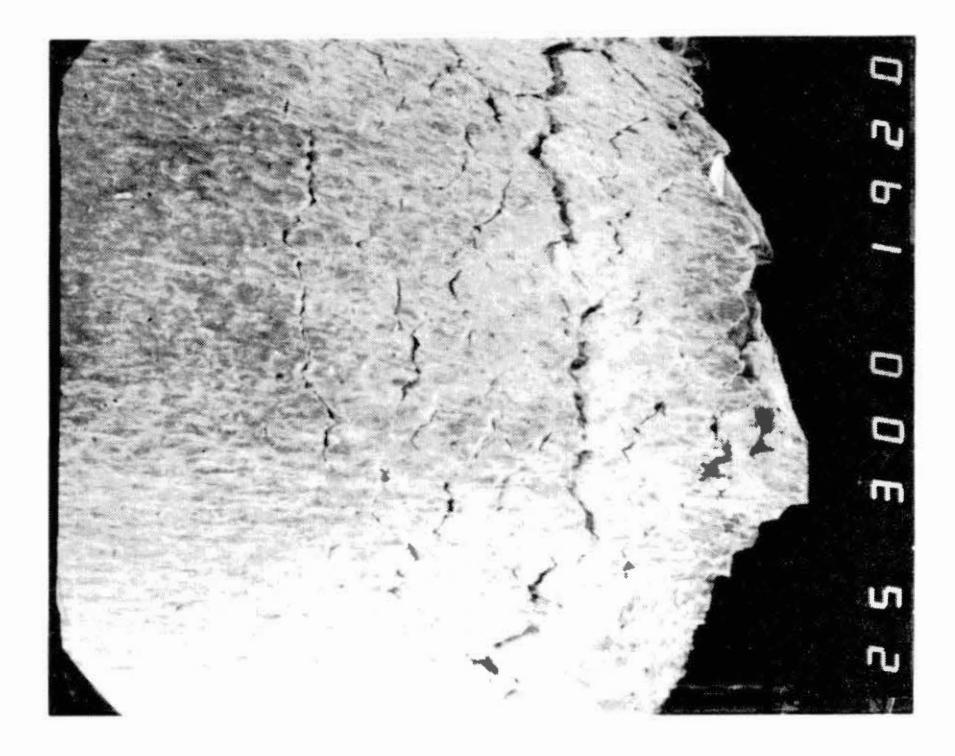
Figure 45. The test details of Figure 44 showing Pitting attack leading to General corrosion and gaping cracks (500X)

Figure 46. The test details of the Figure 45 at higher magnification (2000X)

For the third test, the concentration of solution was reduced to 0.12M and a time rate of 5×10^5 seconds at 20% range. This time and stroke range was used for all the subsequent tests in different environments. No elongated pits were observed on sample surface. Some general corrosion and small pits are visible. Some transgranular cracks have been observed near fracture location on both ends (Figures 44, 45, and 46). This cracking is less extensive than in specimen #1, and 2. These cracks tend to be blunted near fracture zone. Figures 47, and 48 show elongated pits away from the fracture. No crevice corrosion has been observed. In the vapor zone, some small pits were noticed.

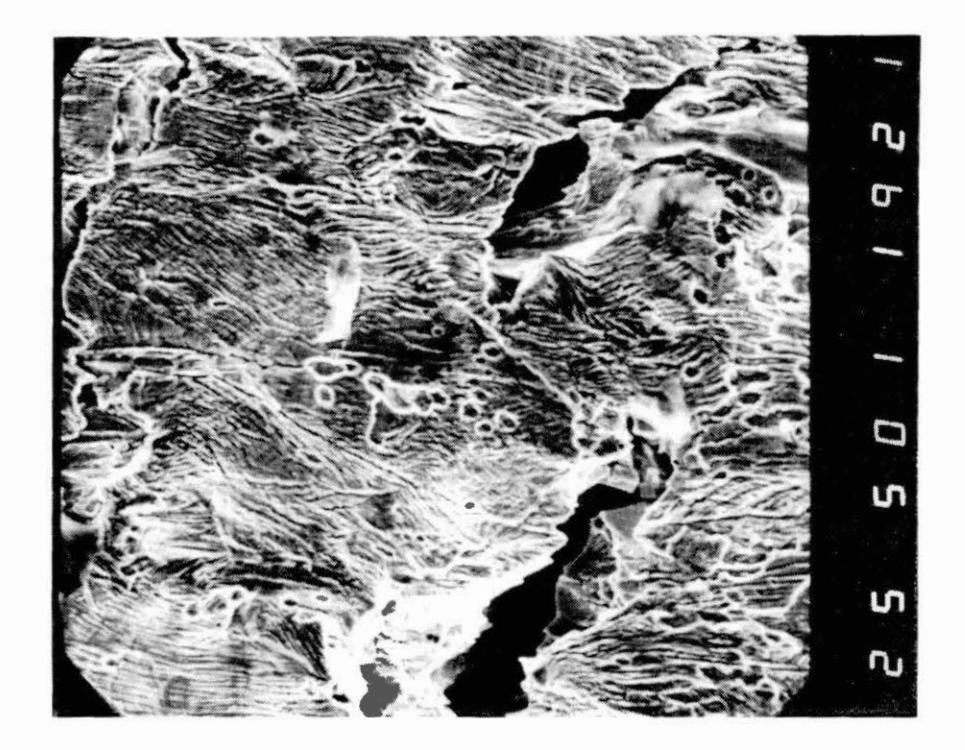
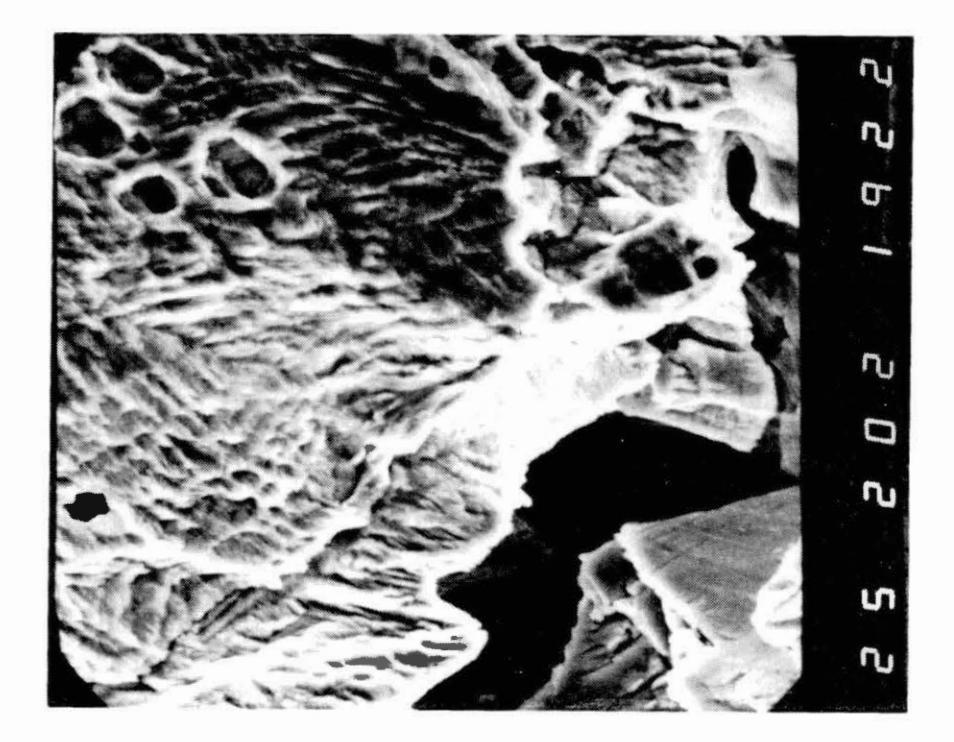
Figure 47. The test details of the Figure 44. The surface away from the fracture vicinity showing some corrosion and longitudinal cracks. The corrosion attack is less severe than in Figure 42 (500X)

Figure 48. The test details of the Figure 47 at higher magnification (2000X)
