PITTING AND STRESS CORROSION CRACKING ~

IN ALLOY 200

Submitted to the Faculty of the Graduate College of the Oklahoma State University in partial fulfillment of the requirements for the degree of MASTER OF SCIENCE December, 1991 . .

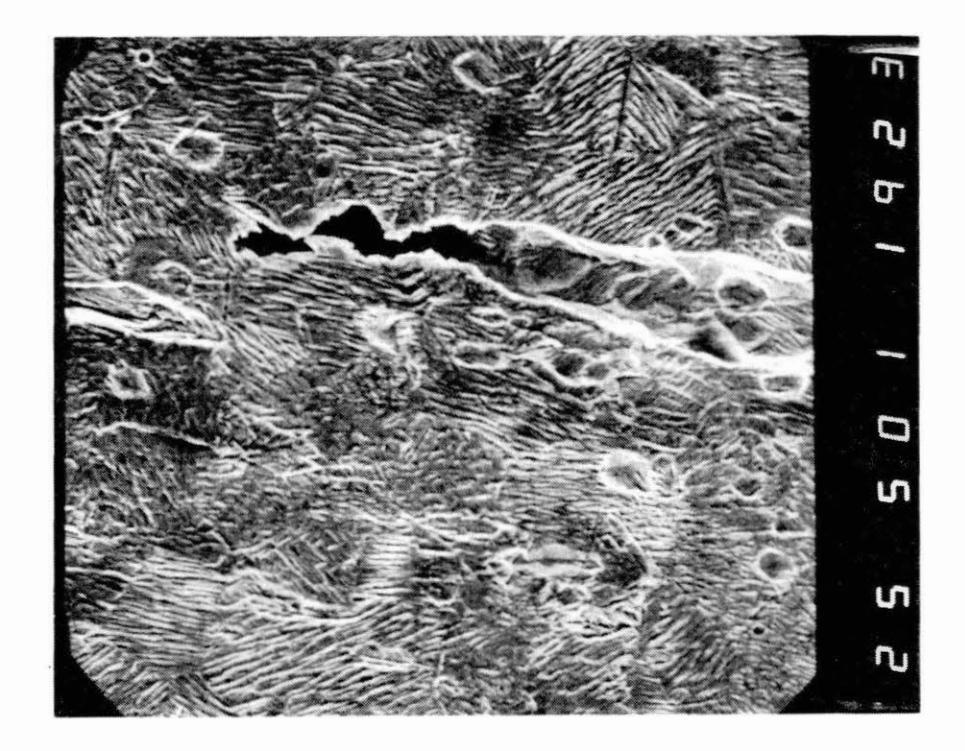
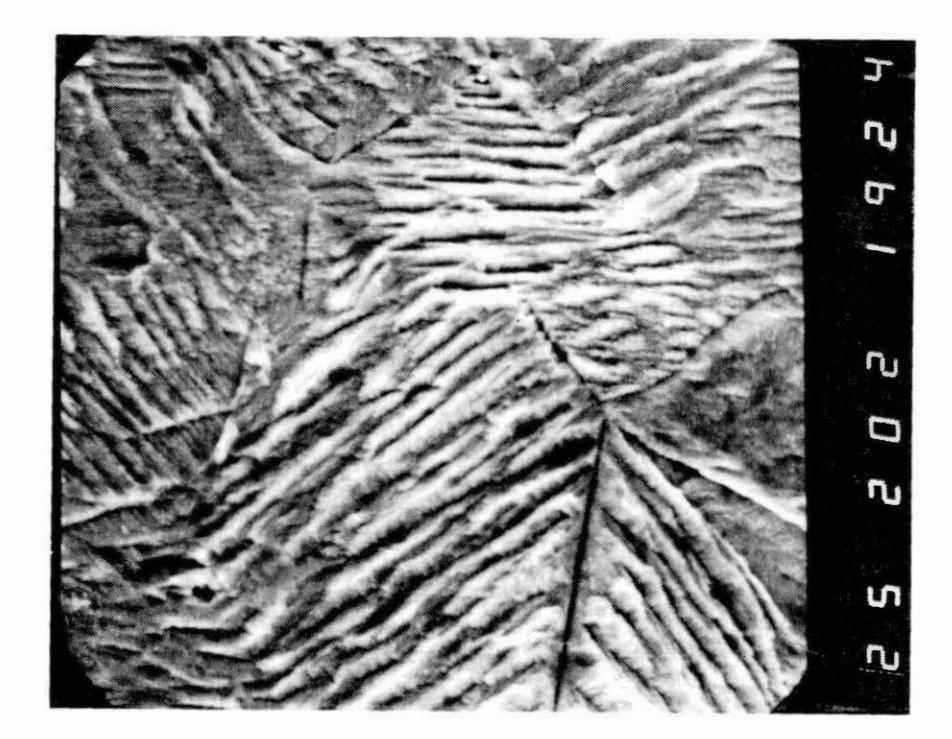
Figure 49. The side view of the fracture zone in 0.02M ferric chloride solution. The surface shows many small pits and cracks. The gaping is less extensive than in Figures 39 and 44 (30X)

Figure 50. The test details of Figure 49 showing less corrosion attack and cracking compared to Figures 40 and 45 (500X)

In the fourth test, the concentration was 0.02M and the other conditions are same as mentioned above. The observations showed that little cracking has occurred near fracture location (Figures 49, 50, and 51). Both ends have etching near shoulders. Some small pits are seen away from the fracture (Figure 52). In the vapor zone, the surface became dull and has some pitting attack. The extent of corrosion attack was less severe than other specimens in ferric chloride solutions.

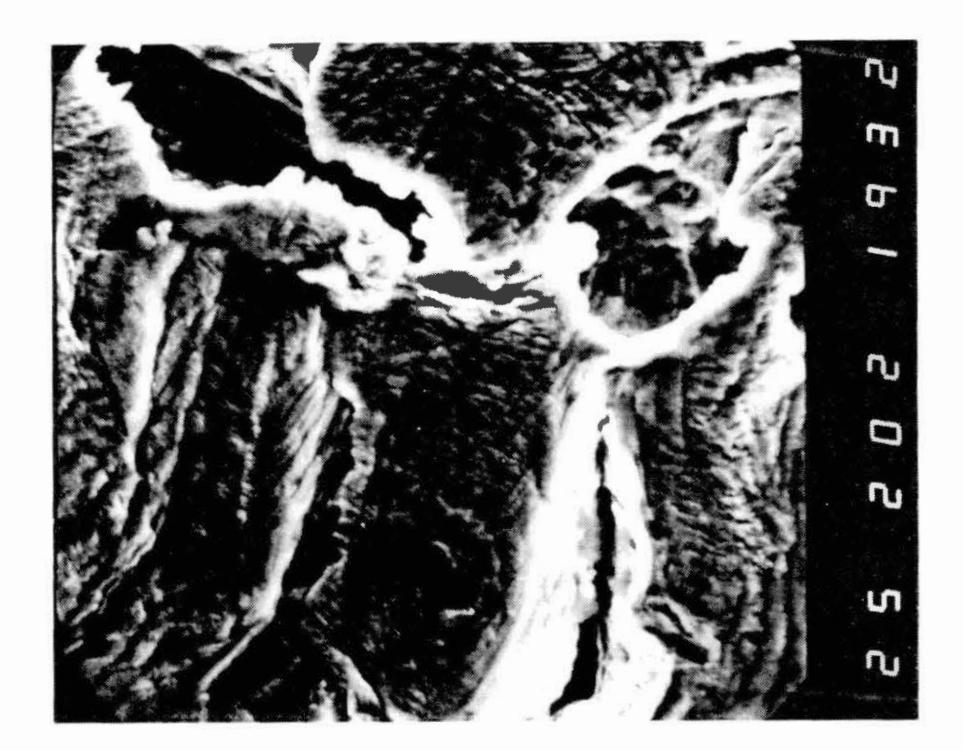
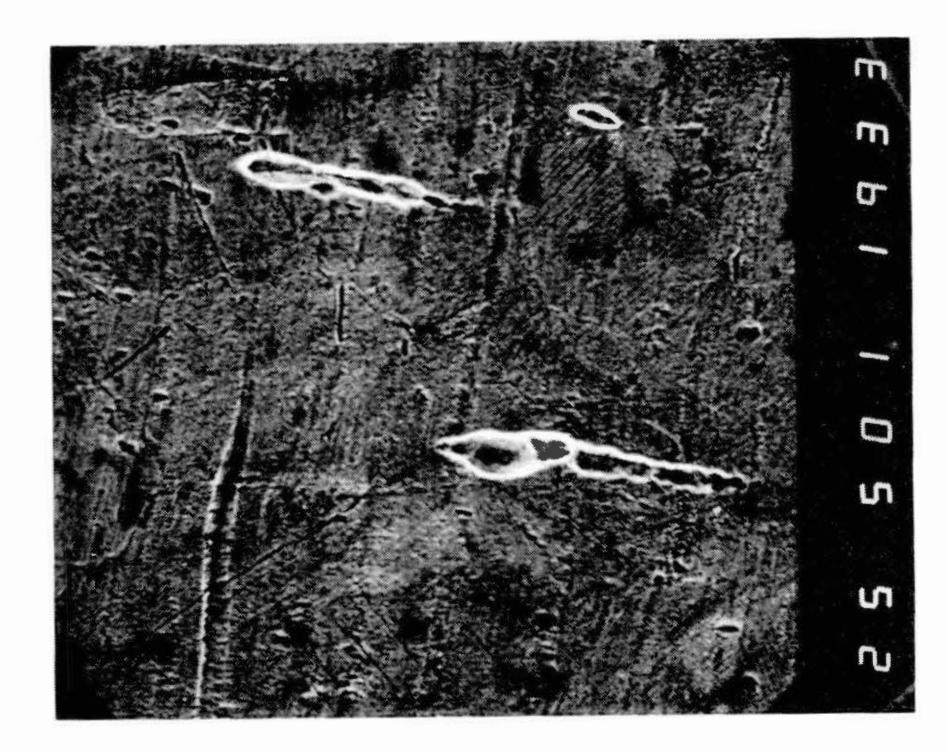
Figure 51. The test details of figure 50 at higher magnification (2000X)

Figure 52. The test details of Figure 49. The surface away from the fracture vicinity showing some elongated pits. The corrosion attack is less severe than in Figures 42 and 47 (500X)

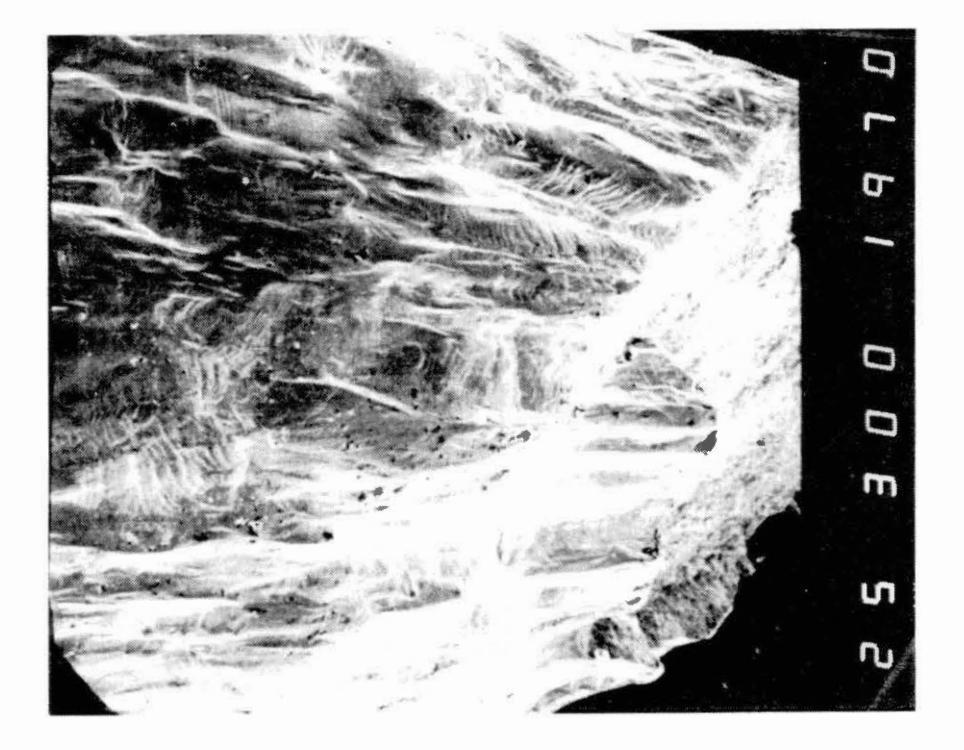
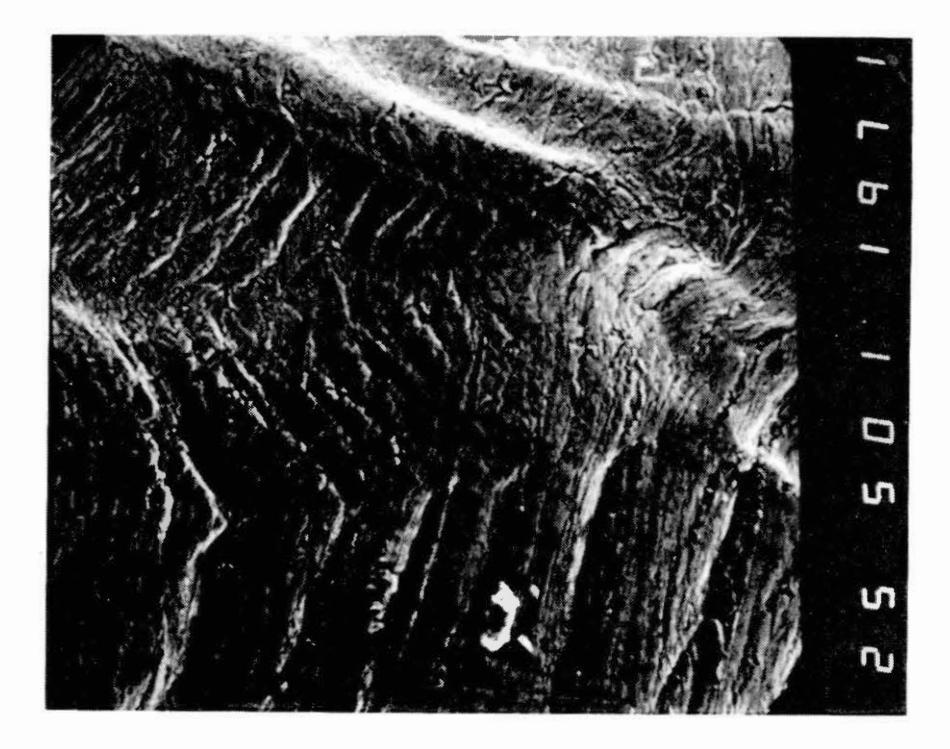
Figure 55. The side view of the fracture zone in 0.04M Ammonium persulfate solution. The cracking is minimal compared to tests in Ferric chloride solutions. Numerous pits are visible on the fracture surface (30X)

Figure 56 The test details of Figure 55 showing little cracking and corrosion attack compared to Figure 54 (500X)

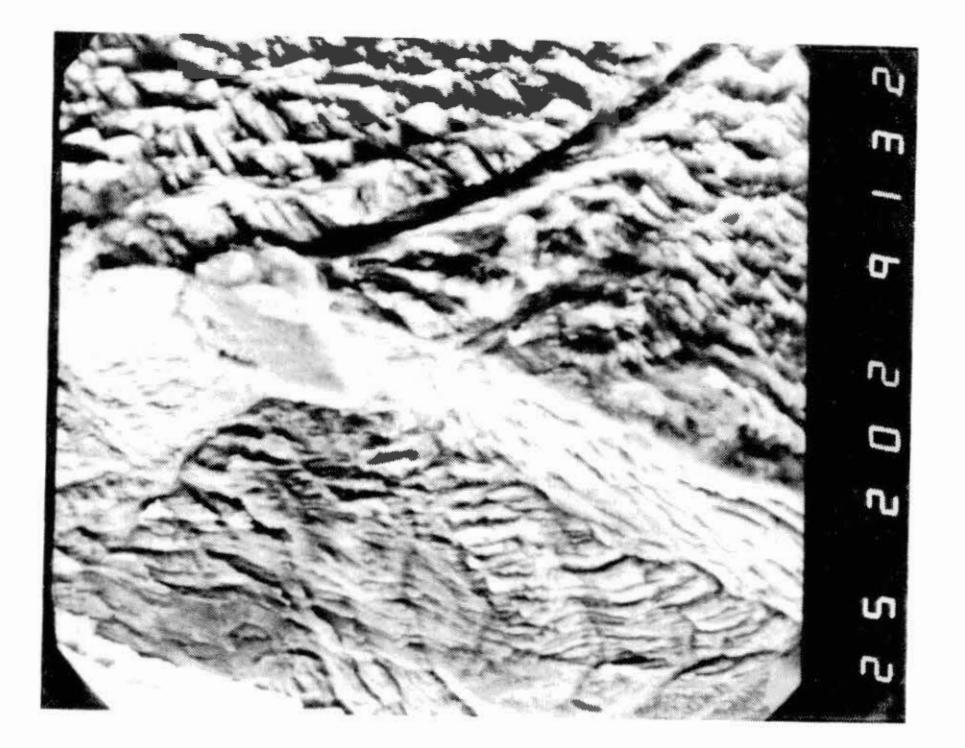
Figure 57. The test details of the Figure 56 at higher magnification (2000X)

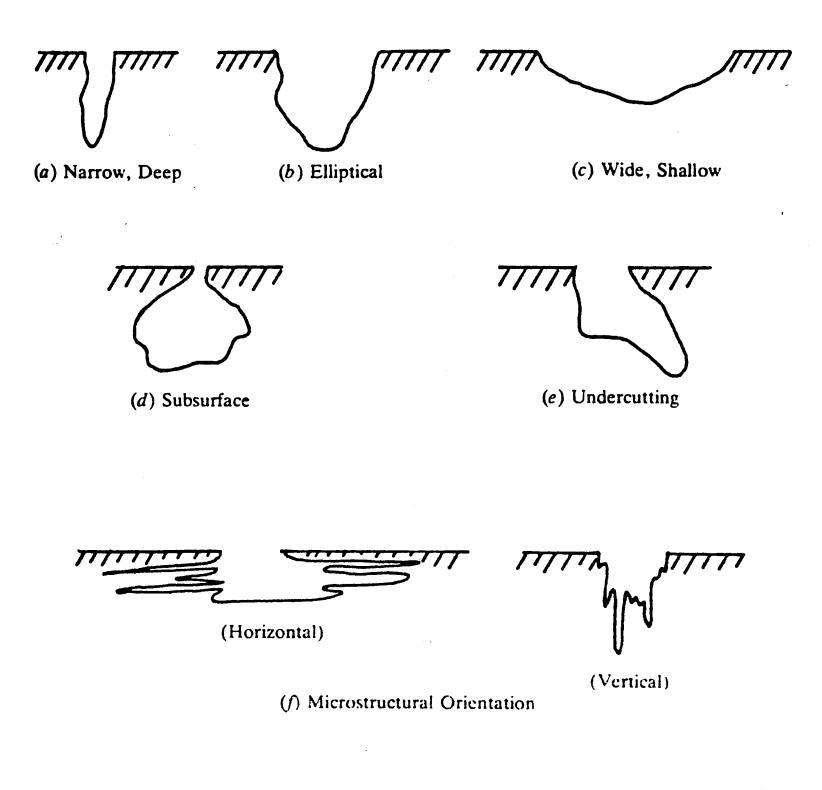
Figure 58. Various Configurations of Pits (From ASTM⁴⁴) were observed inside the indentation. The tests were conducted up to 8 days of immersion. Further experimentation at longer durations should have been carried out. This technique has shown successful results in case of austenitic stainless steels. The indentation operation sets up residual tensile stresses in and around the indentation. Although the magnitude of these residual stresses has not been quantitatively determined, the stresses vary from very low elastic stresses at the edge of indentation to high plastic stresses in the indentation.
