JOHNSON, Robert Marland, 1939-THE RELATION BETWEEN SURFACE DAMAGE AND FILM STRENGTHENING EFFECTS.

The University of Oklahoma, Ph.D., 1967 Engineering, metallurgy

THE RELATION BETWEEN SURFACE DAMAGE

AND FILM STRENGTHENING EFFECTS

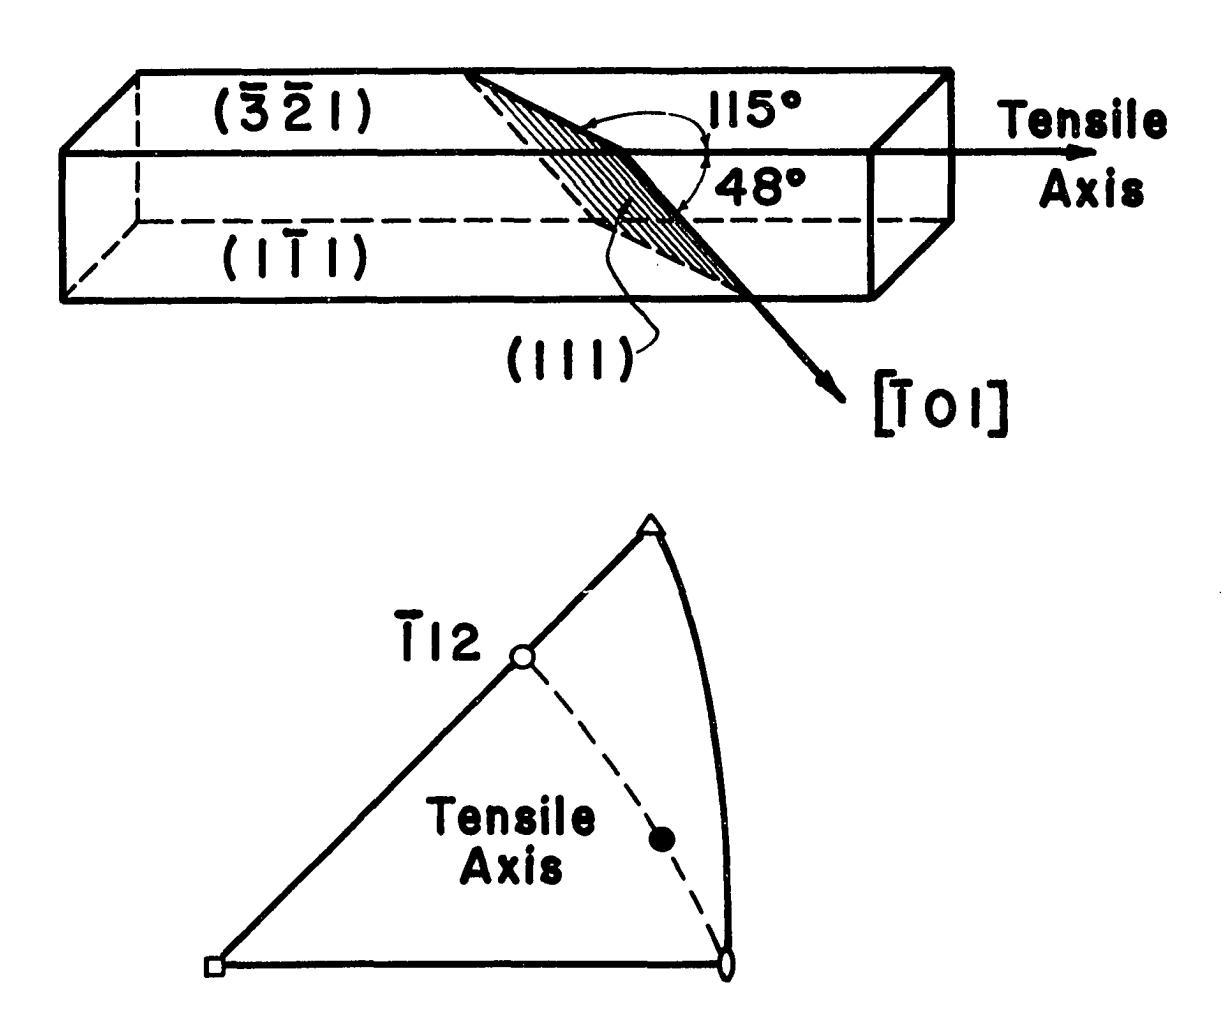
FIGURE 1

GEOMETRIC REPRESENTATION AND STEREOGRAPHIC PLOT OF THE ORIENTATION OF THE CRYSTALS USED of (111) (38, 43, 44). With the particular orientation used the surface remained in the (111) orientation throughout easy glide.

The copper crystals grown for this study were oriented for long easy glide as shown in Figure 1. Theory (21, 41) and experiment (42) indicated that larger surface effects occur in easy glide rather than in the later stages of deformation.

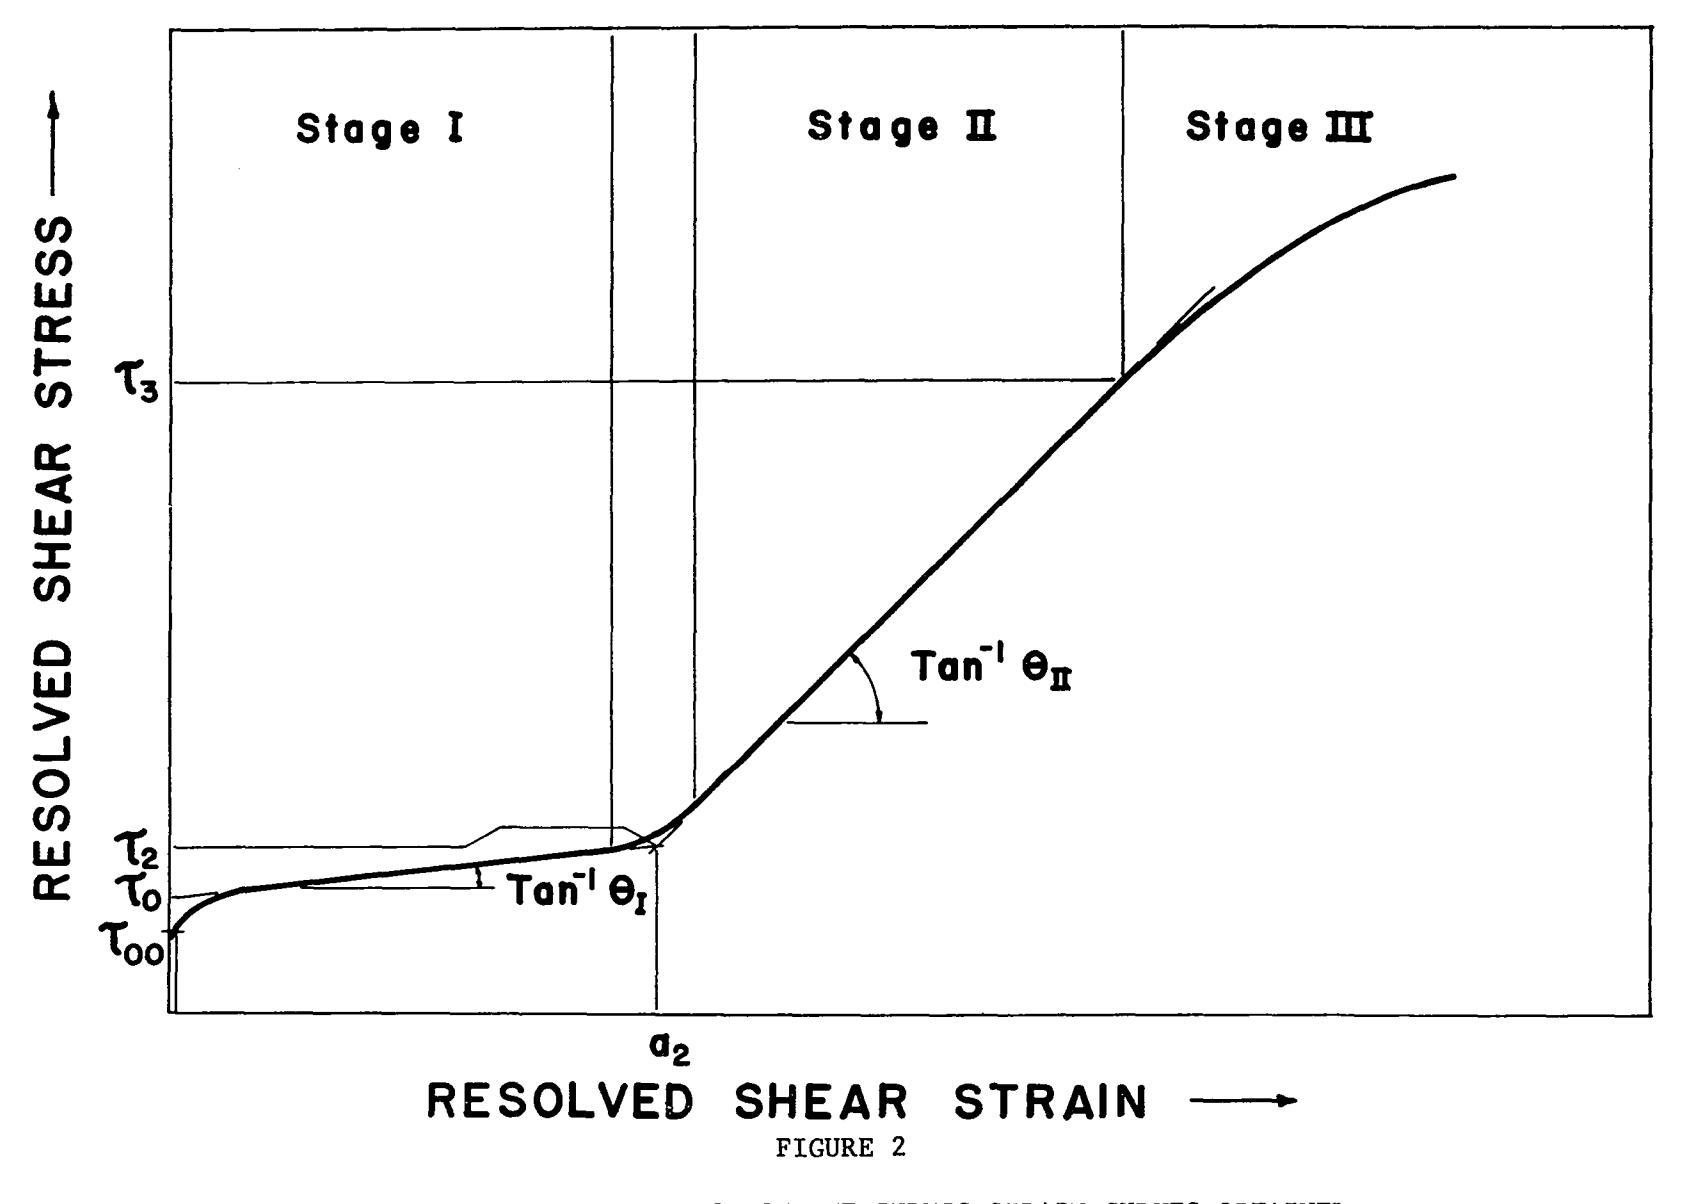
IDEALIZED REPRESENTATION OF THE STRESS-STRAIN CURVES OBTAINED FROM COPPER CRYSTALS. The stages of plastic flow and the deformation parameters are indicated. τ_{00} is taken at a shear of 2 x 10⁻⁴.

The results of the mechanical tests are presented as resolved shear stress-resolved shear strain curves. Parameters were determined from the stress-strain curves according to Figure 2. The critical resolved shear stress, τ_0 , was defined as the intersection of an extrapolation of the linear portion of easy glide and an extrapolation of the elastic response. In order to permit comparison of stress-strain curves early in the plastic region a stress value, τ_{00} , defined at a shear strain of 2 x 10⁻⁴ was found to be useful. The extent of easy glide, a_2 , and the stress at the end of easy glide, τ_2 , were taken at the intersection of the extrapolation of the linear portions of Stage I and Stage II. τ_3 , the stress at the end of Stage II, was taken at the deviation of the curve from the linear portion of Stage II. The slopes of easy glide and linear hardening, stages I and II, are represented as θ_T and θ_{TT} respectively.

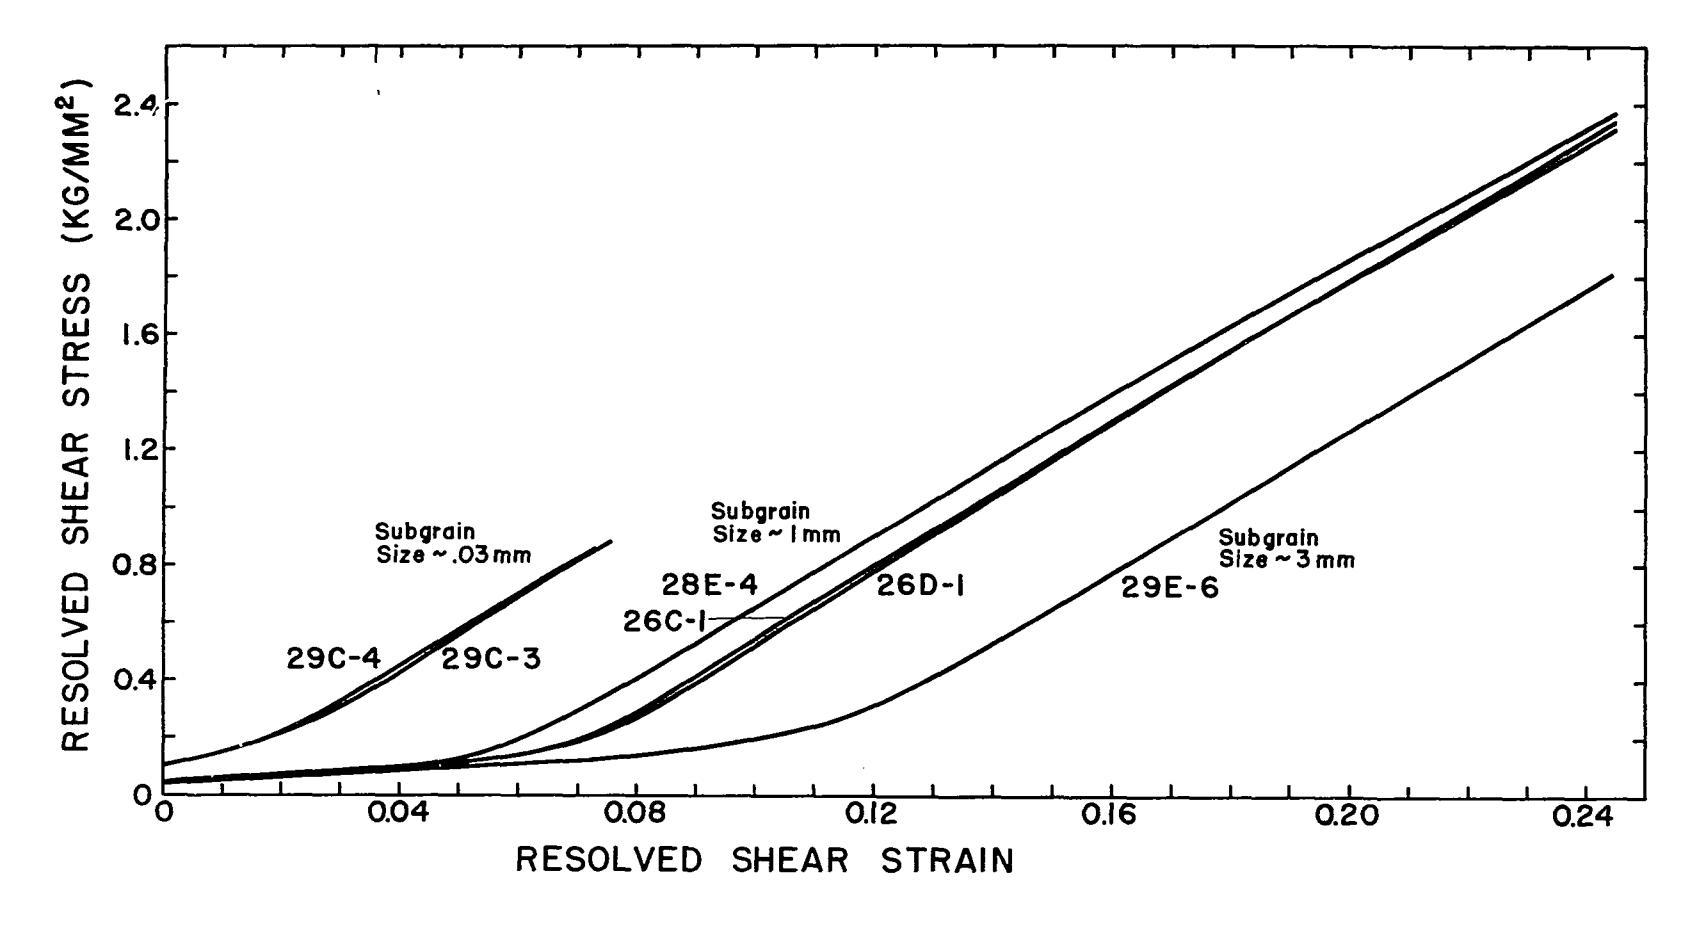
FIGURE 3

STRESS-STRAIN CURVES FOR UNCOATED SPECIMENS INDICATING THE EFFECT OF SUBGRAIN SIZE (After Block)-(16)

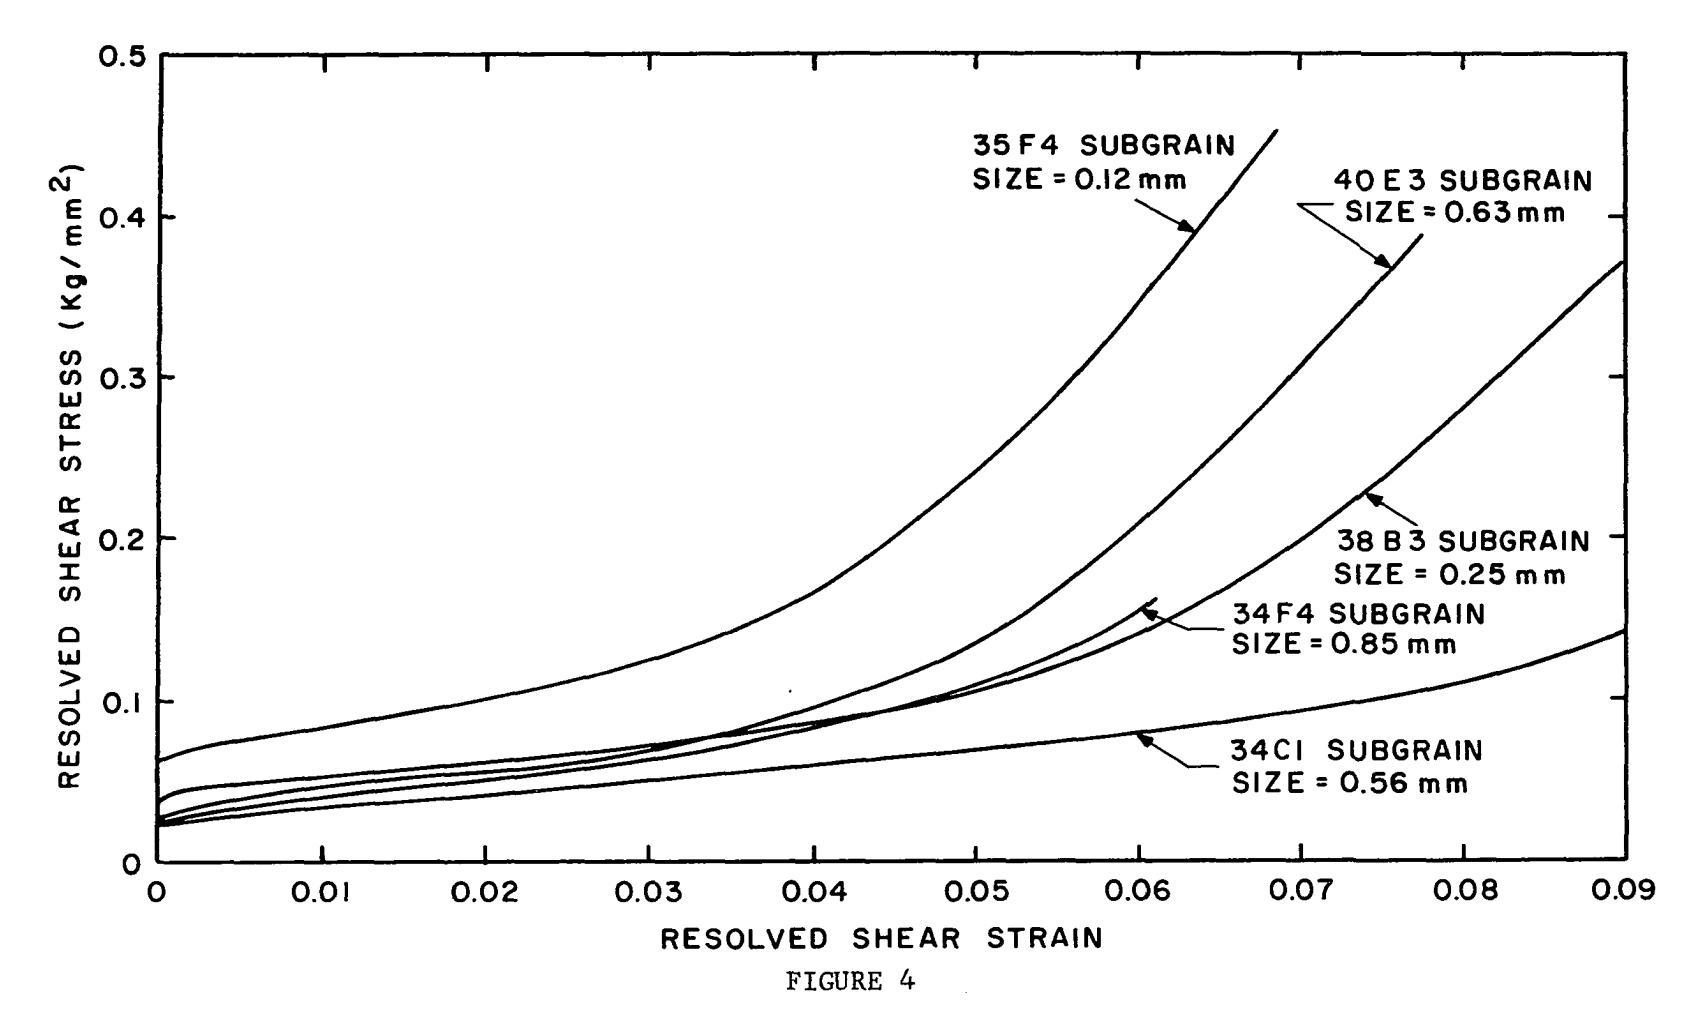
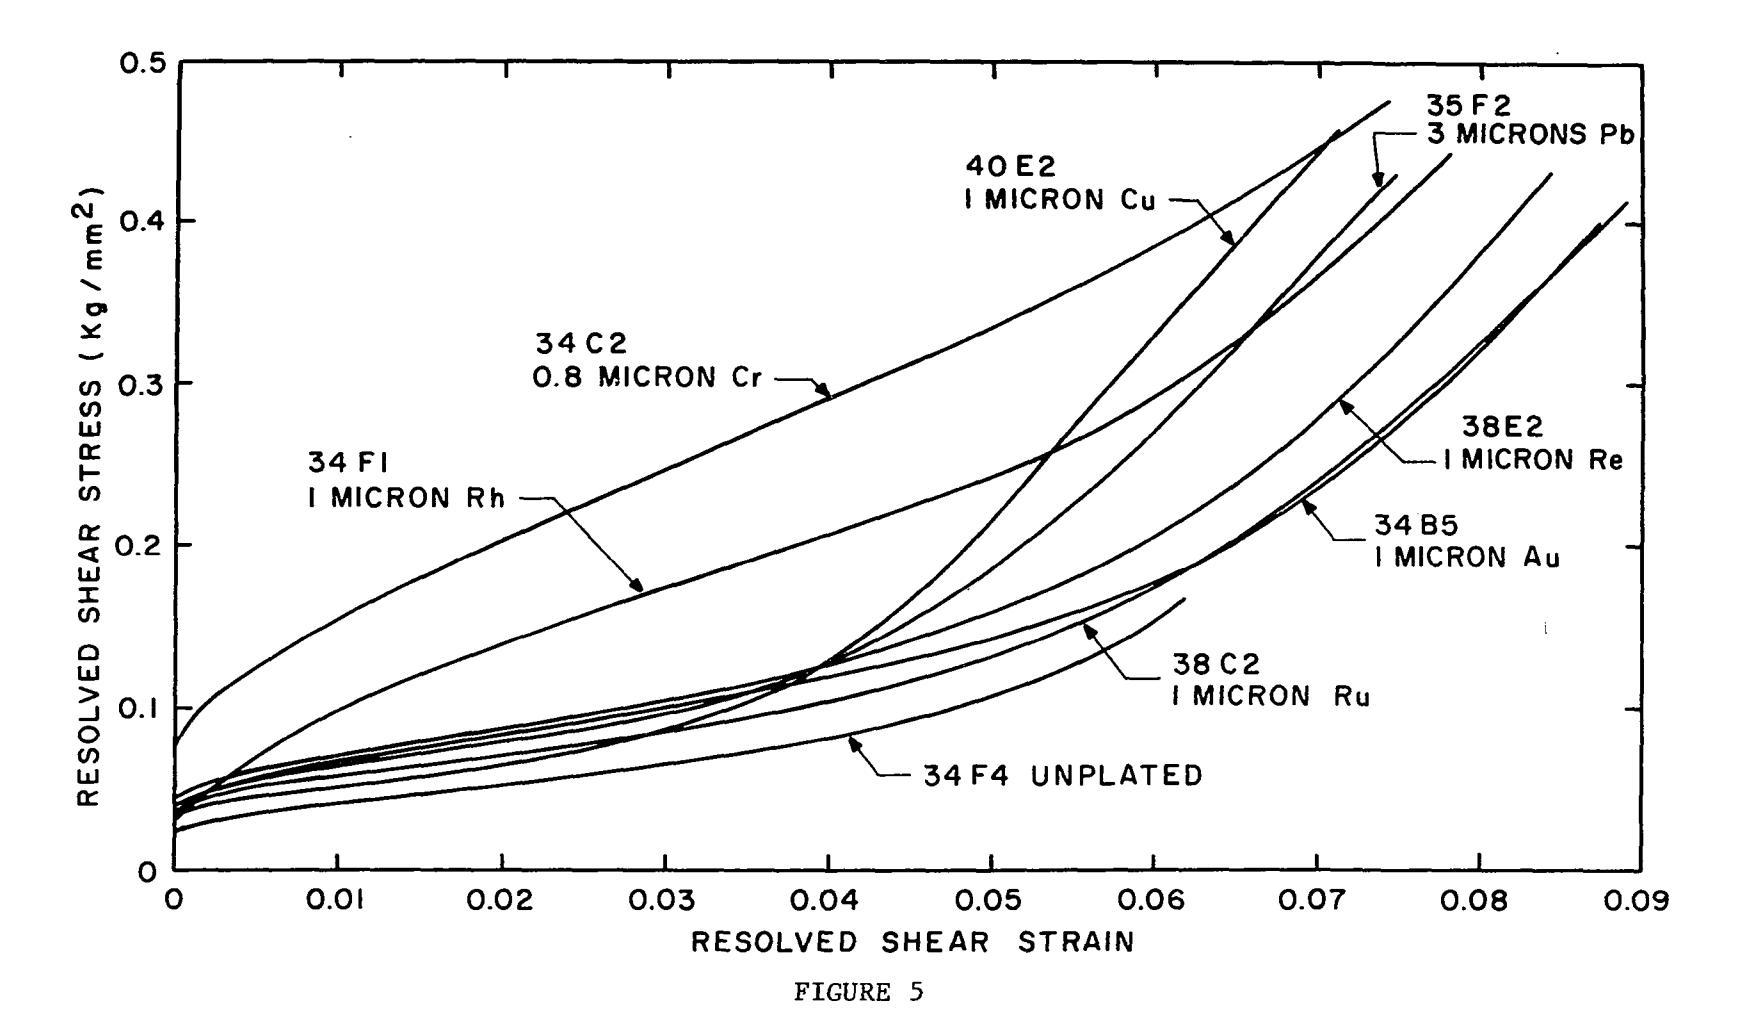
STRESS-STRAIN CURVES FOR COATED SPECIMENS INDICATING THE EFFECT OF VARIOUS COATINGS. The curve for an uncoated specimen is included for comparison.

The strengthening effects produced by electroplated coatings of lead, gold, copper, chromium, rhodium, ruthenium, and rhenium are shown in the curves of Figure 5. A stress-strain curve for an uncoated crystal is provided for reference. Appendix A lists values of particular parameters taken from the stress-strain curves for plated and unplated crystals. τ_{00} is a calculated value for the flow stress at 2 x 10⁻⁴ shear from the empirical formula given above, $\tau_{00} - \tau_{00}$ is a measure of the increase in initial flow stress of the plated crystal compared with that of an unplated crystal. $\tau_0 - \tau_{00}$ is a measure of the strain hardening rate before the linear portion of Stage I is achieved. $\theta_{\rm I}/\theta_{\rm I}$ unplated is the ratio of the slope of easy glide for a particular crystal to the average slope of easy glide for all unplated crystals.

The curves of Figure 5 show no regular relationship between the shear modulus of the coating and the strengthening it produces. Average shear moduli for the various coatings are presented in Table 2. Rhenium and ruthenium have the highest shear moduli of all of the coatings used. However, the general strengthening in Stage I produced by 1 micron deposits was approximately the same as obtained with gold and copper coatings of the same thickness and a lead coating 3 microns thick. The only large strengthening effects were observed with a 1 micron coating of rhodium and a chromium coating slightly less than 1 micron thick. The absence of a shear modulus dependency was implied by Garstone, Honeycombe, and Greetham (14) in their tests of chromium and nickel coatings on a copper crystal. Both chromium and nickel have approximately the same elastic modulus. However, no strengthening effect was observed with the nickel coating while a substantial strengthening was produced by the chromium coating. In the absence of any dependence upon the shear modulus of the coating, mechanisms which involve elastic repulsion of dislocations from the coating-substrate interface appear to be unimportant as a cause of the strengthening due to surface films which has been observed.

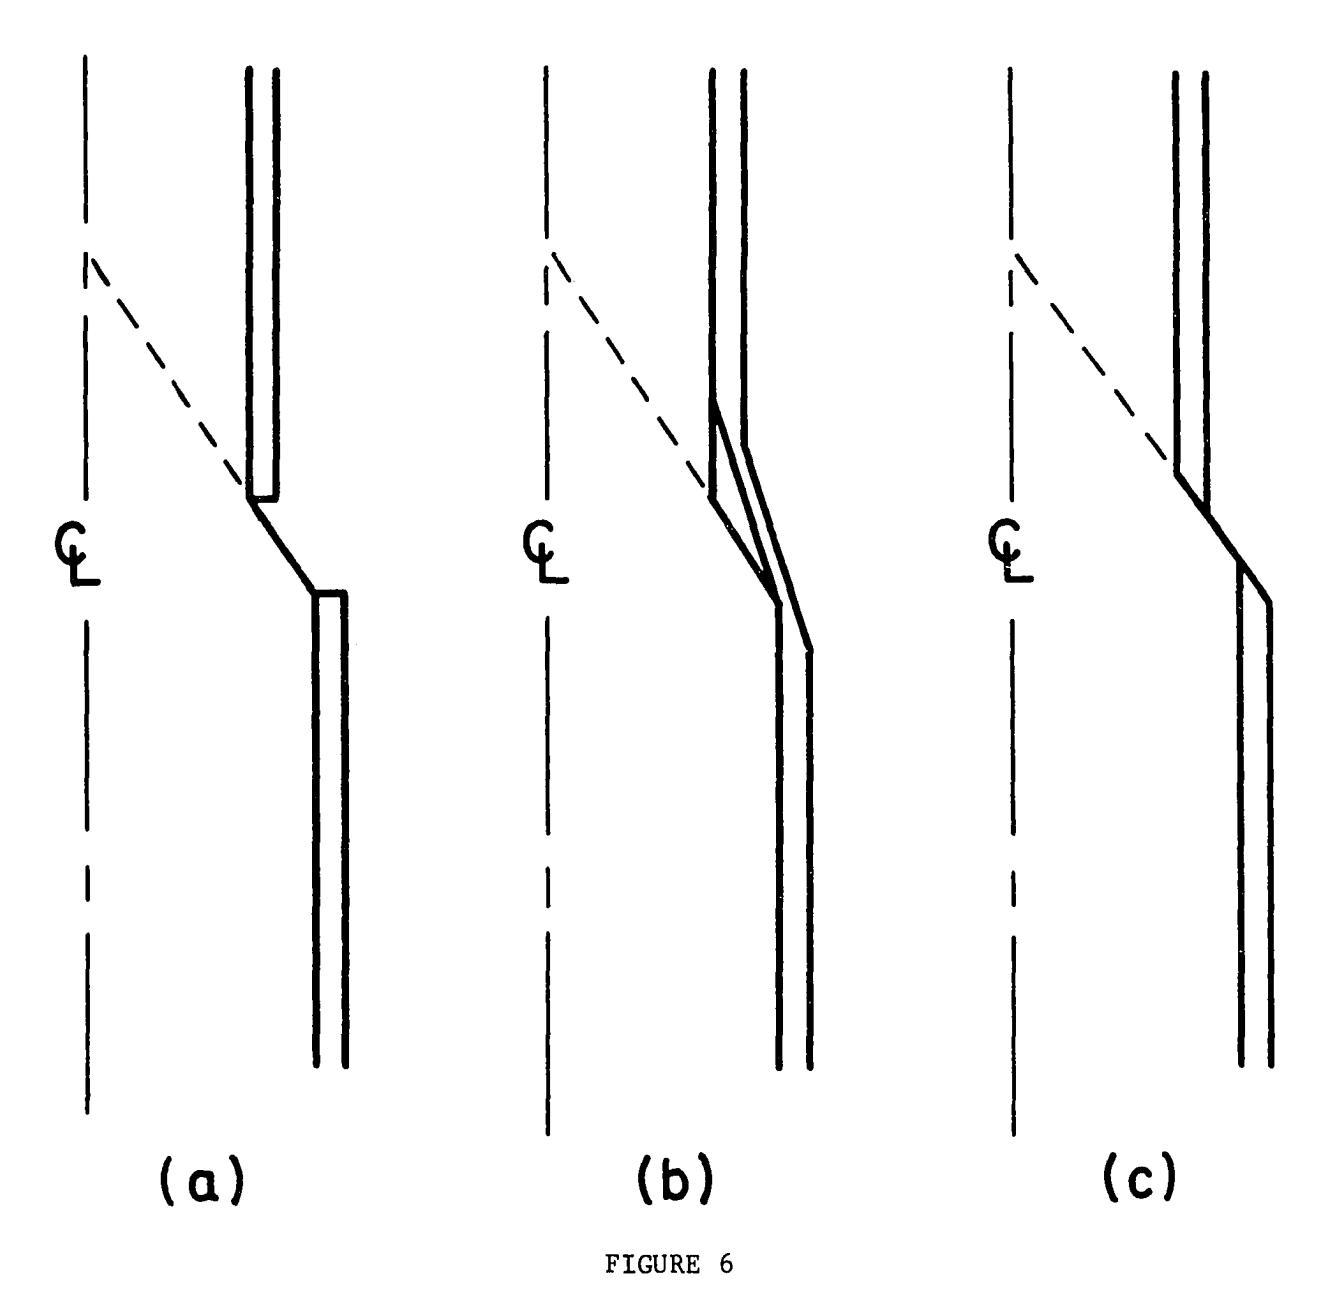
SCHEMATIC DIAGRAMS OF WAYS IN WHICH A FILM MAY ACCOMMODATE SLIP IN THE SUBSTRATE

- (a) Film cracks along slip traces
- (b) Film is initially detached without cracking
- (c) Film shears off

of particular importance. However, the adherence to the substrate and whether the coating is ductile or brittle may also be important considerations. Figure 6 illustrates three different mechanisms by which a coating might accommodate plastic deformation of the substrate. In case (a) the coating is considered to fracture brittlely (Figure 6a) allowing the dislocations generated within the substrate to move out of the crystal at the exposed slip plane trace. Case (b) considers a coating which is not strongly adherent so that it may detach during deformation (Figure 6b). It has been shown (49) that once detachment begins it may be expected to occur over large areas with fracture occurring later in the deformation or not at all. The final situation, case (c), involves shear in the coating (Figure 6c). Obviously, epitaxial coatings will behave differently from polycrystalline coatings. Brame and Evans (13) have thoroughly considered the mechanism by which dislocations move from a substrate crystal through an epitaxial coating of different lattice parameter. They conclude that as lattice misfit increases shear of the coating tends to become difficult and brittle fracture is more likely to occur.

The situation described in Figure 6c is simplified conceptually if the coating is not epitaxial. Dislocations generated in the substrate are accommodated in the boundary between substrate and coating in much the same way that they are accommodated in grain boundaries during plastic deformation of polycrystalline aggregates. The accommodation induces shear in the coating which results in a step at the surface.

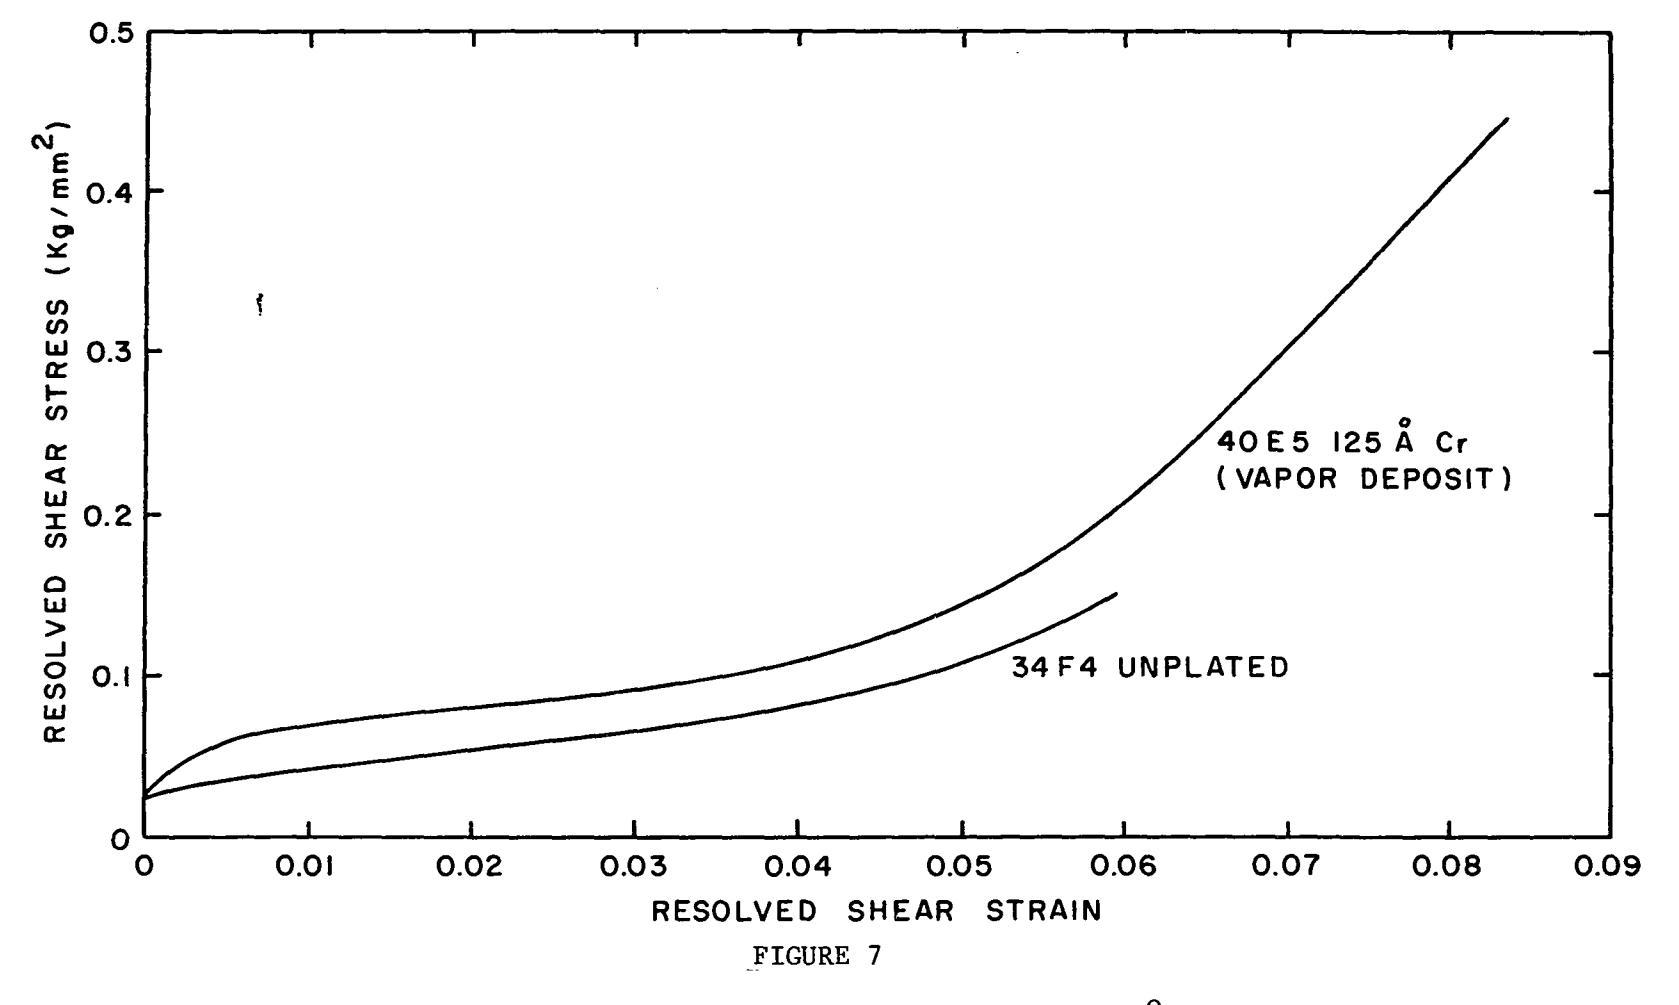
STRESS-STRAIN CURVES FOR A SPECIMEN WITH A 125 Å VAPOR DEPOSITED Cr FILM AND FOR AN UNCOATED SPECIMEN

curve for this specimen and an uncoated crystal are presented in Figure 7. It is certainly to be expected that a chromium coating of this thickness should be sufficient to anchor the free ends of surface sources. However, the critical resolved shear stress was virtually unaffected. These results demonstrate that the effect of coatings on surface dislocation sources is not of major importance in producing the observed strengthening effects.

The stress-strain curve for a crystal having a 125 Å evaporated chromium coating is shown in Figure 7. The flow stress throughout most of Stage I as well as the extent of easy glide are about the same as obtained from the specimen tested with only the damaged surface layer resulting from a 0.8 micron chromium electroplate. However, there were important differences which appear early in easy glide. The interpretation of these results requires consideration of the behavior of the coating during plastic deformation and therefore will be treated in the next section.

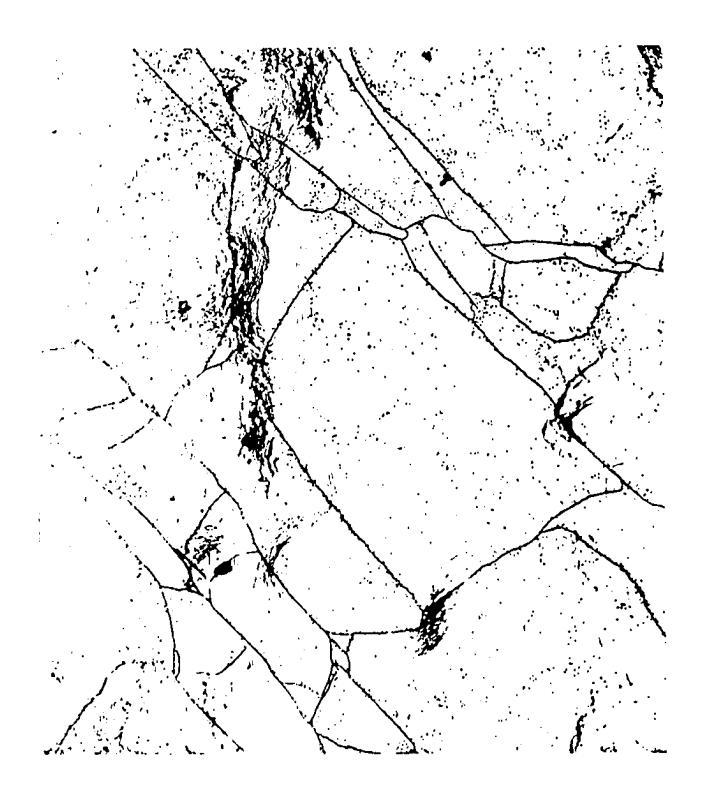
FIGURE 8a

A REPRESENTATIVE AREA OF A SPECIMEN ETCHED TO REVEAL DISLOCATIONS. 50X

A copper crystal was chemically polished and etched to reveal dislocations. A representative area of the etched crystal is shown in Figure 8a. Dislocations were arranged in subgrain boundaries and scattered within the subgrains. The dark shadows which appear on the photomicrographs are caused by undulations in the surface. After polishing, the crystal was electroplated with a 0.5 micron chromium coating which was immediately removed in hydrochloric acid. This was followed by chemical polishing which removed approximately a 1 micron layer of copper from the surface; the crystal was again etched to reveal dislocations. Figure 8b shows the same area as Figure 8a after the plating and removal treatment.

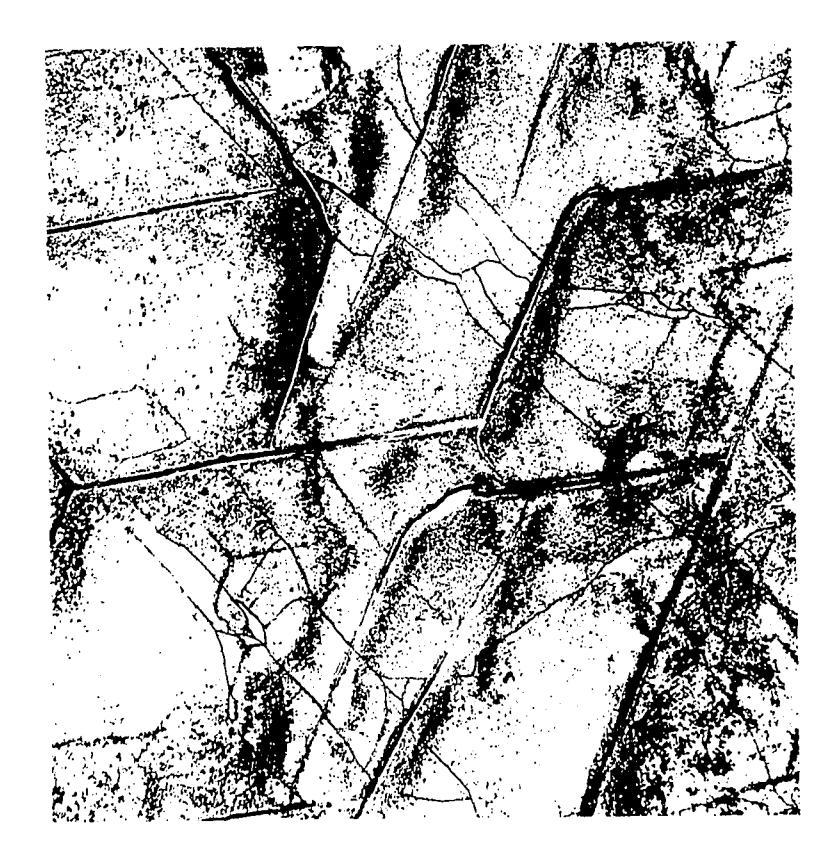
FIGURE 8b

SAME AREA SHOWN IN FIGURE 8a AFTER PLATING WITH 0.5 MICRON Cr, REMOVING THE PLATE IN HC1, POLISHING AWAY A 1 MICRON LAYER OF Cu AND ETCHING TO REVEAL DISLOCATIONS. 50X

The broad dark lines and the areas immediately adjacent show extremely high dislocation densities indicating that the substrate crystal has undergone localized plastic deformation. These lines are believed to be evidence of cracks resulting from residual stresses in the electro-deposit. The formation of these cracks tends to relieve stresses in the coating and causes shear in the substrate near the substrate-coating interface. Continued removal of copper from the surface by chemical polishing revealed the depth to which this damage extended. Figure 8c shows the same area as in the previous photomicrograph after removal of approximately 2 microns of copper from the surface of the crystal. The density of dislocations beneath and adjacent to the crack traces is considerably lower than in the previous photomicrographs. The clusters of fine lines which are in evidence in this photomicrograph and the next are due to terracing of the surface caused by the prolonged chemical polishing. Figure 8d shows the surface after 3 microns of copper have been removed. Some of the damage due to cracking of the coating has disappeared at this depth. In many large areas the dislocation density is equivalent to the initial density before electroplating. It was established that the damage due to a 0.5 micron chromium coating extended approximately 5 microns below the coating-substrate interface.

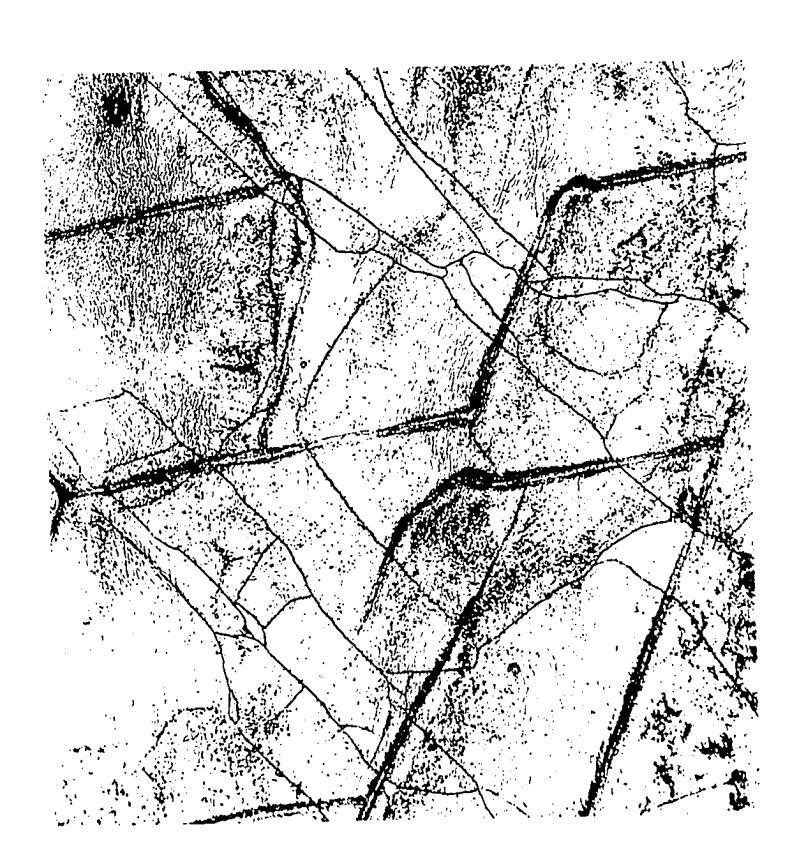
FIGURE 8c

SAME AREA AS IN FIGURE 8a AFTER REMOVAL OF 2 MICRONS OF Cu AND REETCHING. 50X

cracking of the 0.5 micron chromium electro-deposit (Figure 8c). The depth to which the substrate was damaged by the 125 $\stackrel{0}{\text{A}}$ evaporated film was only about 2 microns.

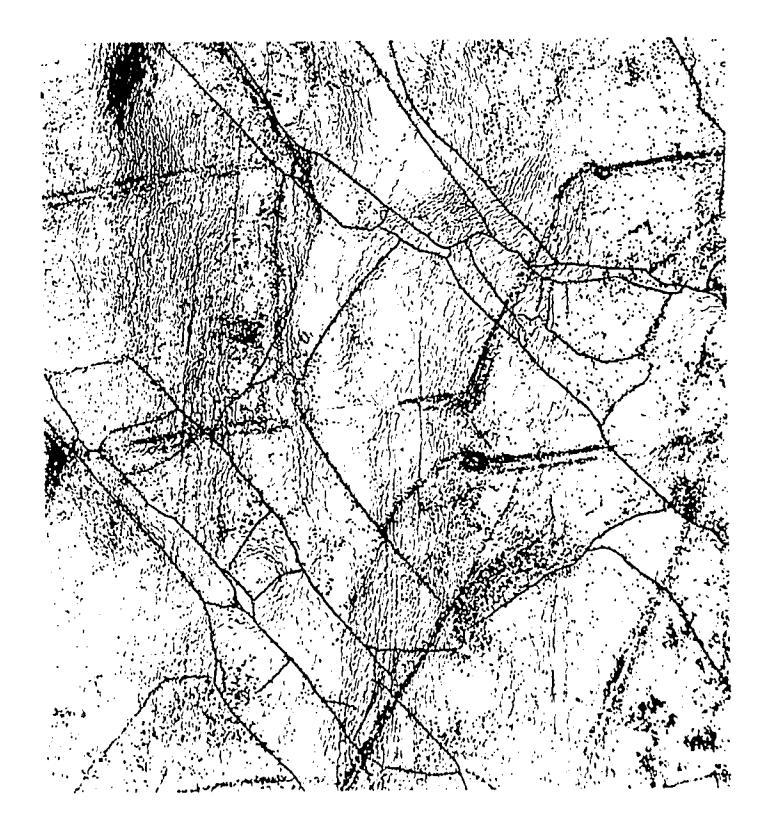
FIGURE 8d

SAME AREA AS IN FIGURE 8a AFTER REMOVAL OF 3 MICRONS OF Cu AND REETCHING. 50X

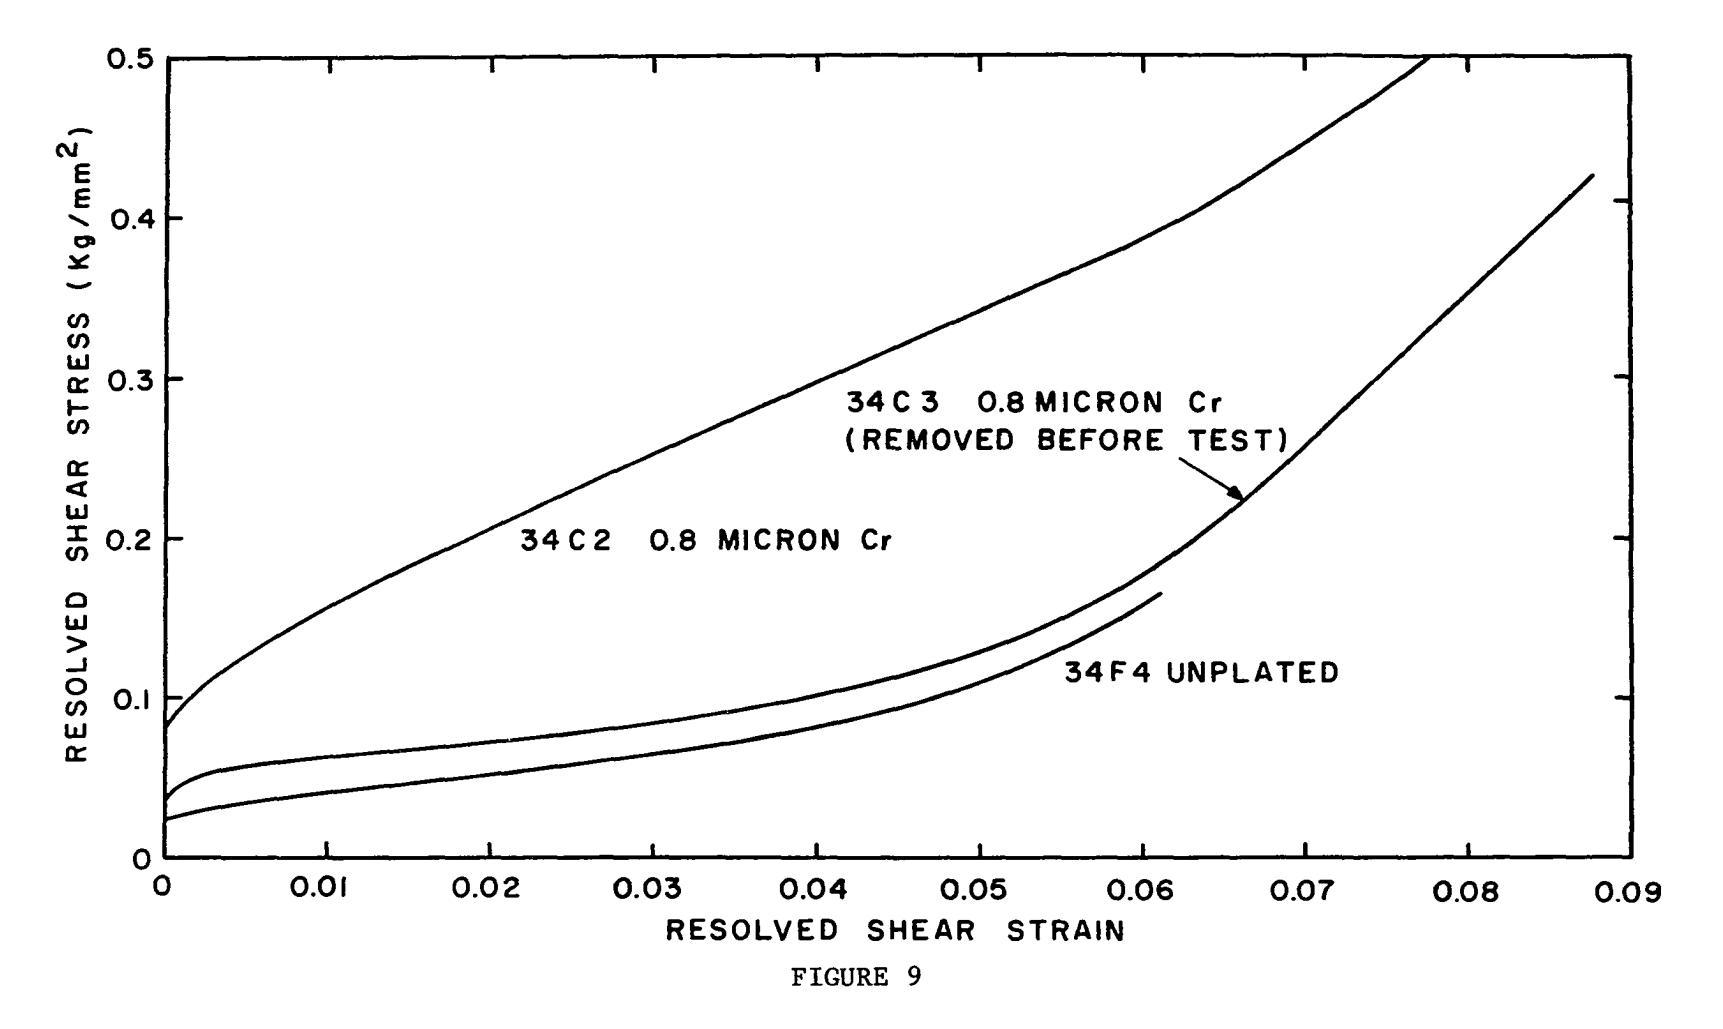
STRESS-STRAIN CURVE FOR A SPECIMEN ELECTROPLATED WITH 0.8 MICRON OF Cr AND THEN THE Cr REMOVED IN HC1 BEFORE TESTING. An uncoated and a coated specimen are included for comparison.

The degree to which a damaged surface layer affected the mechanical behavior was determined by the following experiment. A crystal was electroplated with a 0.8 micron coating of chromium. The chromium deposit was removed in hydrochloric acid and the crystal tested without further treatment. Figure 9 shows the stress-strain curve resulting from this test with curves for an unplated crystal and a coated crystal for comparison. It was found that a 0.8 micron chromium deposit damaged the substrate to a depth of approximately 15 microns.

The damaged surface layer produced by the above treatment was effective in raising the critical resolved shear stress and decreasing easy glide. However, the magnitude of the effect is considerably less than was observed when the coating was not removed prior to testing.

Figure 9 provides sufficient data for an estimate of the film strength of the 0.8 micron chromium coating. At zero extension the difference between the load carried by the coated specimen and the specimen which had its coating removed before testing was approximately 1.7 lbs. This load difference corresponds to a stress of 108,000 psi in the coating, a value which is not unreasonably large. Similar calculations cannot be made at strains greater than zero since film cracking increases the amount of surface damage in the coated specimen.

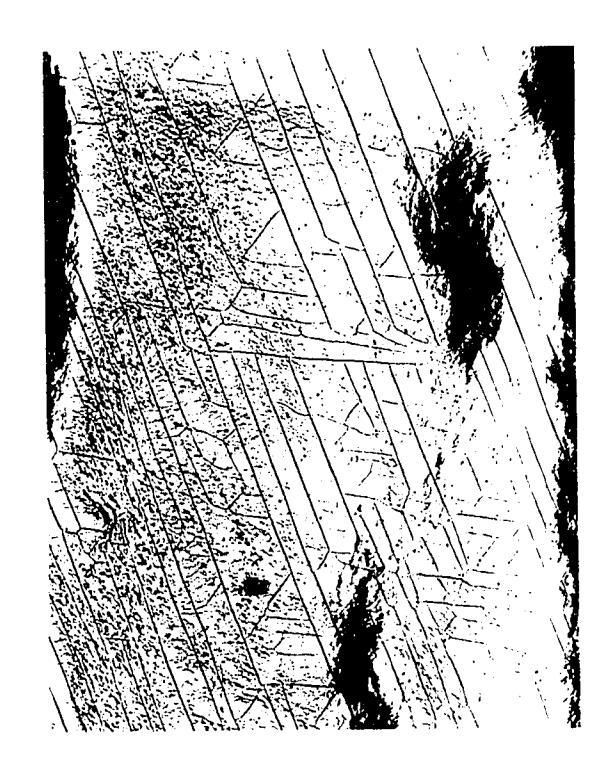
FIGURE 10a

SPECIMEN COATED WITH 125 Å Cr BY VAPOR DEPOSITION. 50X

The vapor deposit exhibited fine cracks prior to deformation (Figure 10). This caused a shallow layer of surface damage. The strength of the coating and the layer of damage did not make a significant contribution to the flow stress at the elastic limit. However, further cracking of the coating accompanied the onset of plastic deformation. The initial portion of Stage I was characterized by a high slope reflecting the increasing damage and high strain hardening rate at the surface. There was evidence that the vapor deposited coating tended to exhibit gross detachment as deformation of the substrate proceeded. It is believed that the coating lost its effectiveness in producing damage at the surface when the load-extension curve became parallel to the curve for the uncoated specimen.

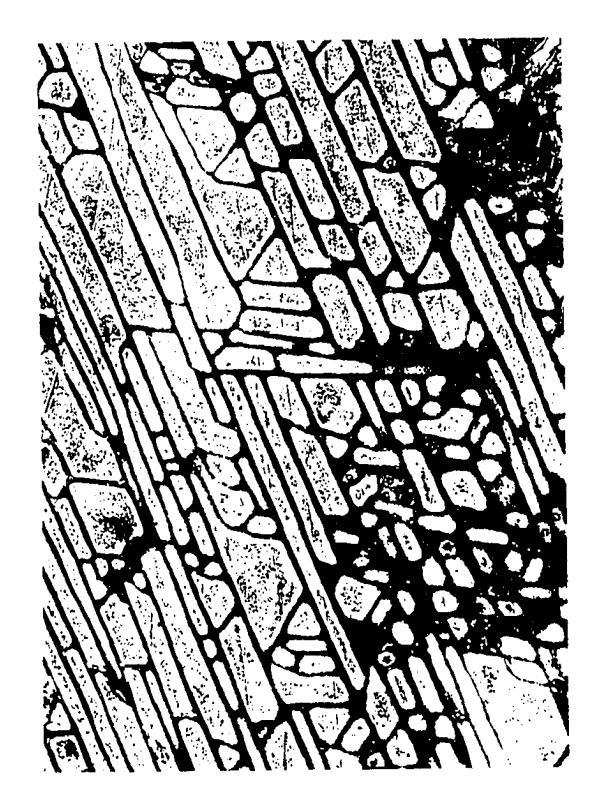
FIGURE 10b

SAME AREA AS IN FIGURE 10a AFTER Cr REMOVED IN HC1 AND THE SPECIMEN REETCHED. 50X . .

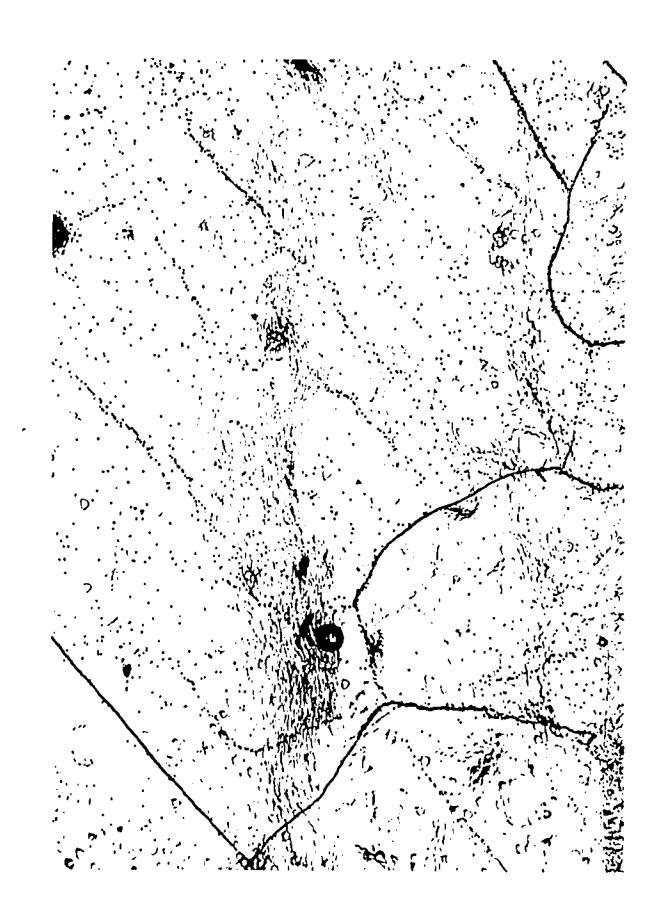
FIGURE 11

SURFACE OF A CRYSTAL ELECTROPLATED WITH A 1 MICRON COATING OF Re, THE COATING THEN REMOVED IN H₂O₂ AND THE CRYSTAL ETCHED TO REVEAL DISLOCATIONS. 50X

Figure 11 is a photomicrograph of the surface of a copper crystal which had been electroplated with a 1 micron coating of rhenium. The rhenium was removed in hydrogen peroxide and the specimen was lightly polished and etched to reveal dislocations. Less than 1 micron of copper was removed from the surface during polishing. The dislocation arrangement is typical of that observed in an annealed crystal. There is no indication of damage to the substrate crystal due to application of the coating. A 1 micron coating of rhenium did not produce a large strengthening effect (Figure 5).

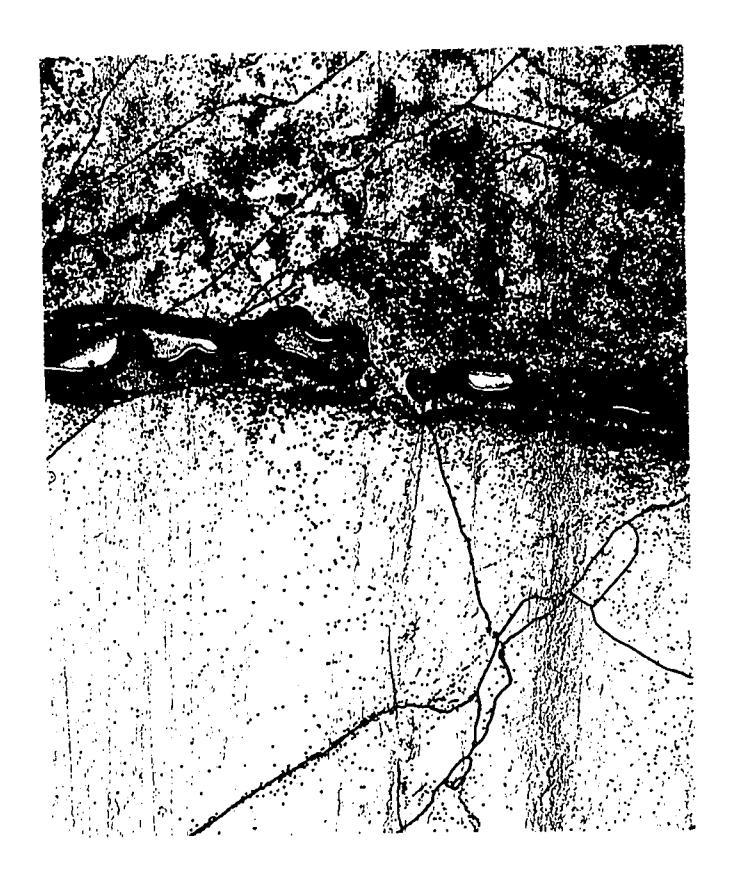
FIGURE 13

DAMAGED SURFACE OF A CRYSTAL ELECTROPLATED WITH A 1.7 MICRON COATING OF Cr OVER A 500 Å FLASH OF Re. The plates were removed by stripping in H_2O_2 and the crystal then etched to reveal dislocations. 50X

hydrogen peroxide and polishing the surface to a depth of 2 microns. The top of the micro shows the region of the crystal which was plated while the lower part shows an adjacent protected portion of the crystal. The underlying rhenium flash tends to shield the substrate from damage due to the rhodium coating. Nevertheless, a considerable degree of damage was induced by the rhodium film. The damaged layer extended to a depth of 25 microns. In order to provide a basis for comparison, a 1.7 micron chromium coating was applied over 500 Å of rhenium and removed by stripping. The degree of damage due to the chromium coating applied in this manner is shown in Figure 13. The depth of damage was about 12 microns.
