JOHNSON, Robert Marland, 1939-THE RELATION BETWEEN SURFACE DAMAGE AND FILM STRENGTHENING EFFECTS.

The University of Oklahoma, Ph.D., 1967 Engineering, metallurgy

THE RELATION BETWEEN SURFACE DAMAGE

AND FILM STRENGTHENING EFFECTS

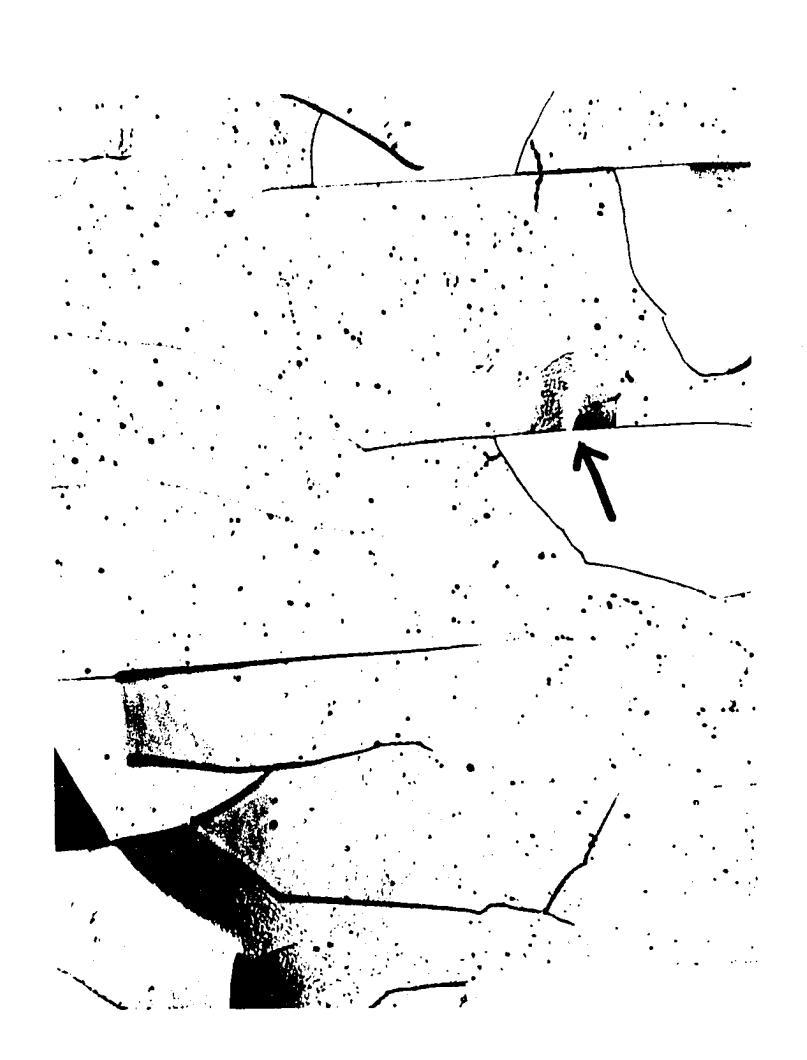
# FIGURE 14b

HIGHER MAGNIFICATION OF SAME AREA SHOWN IN FIGURE 14a. 500X

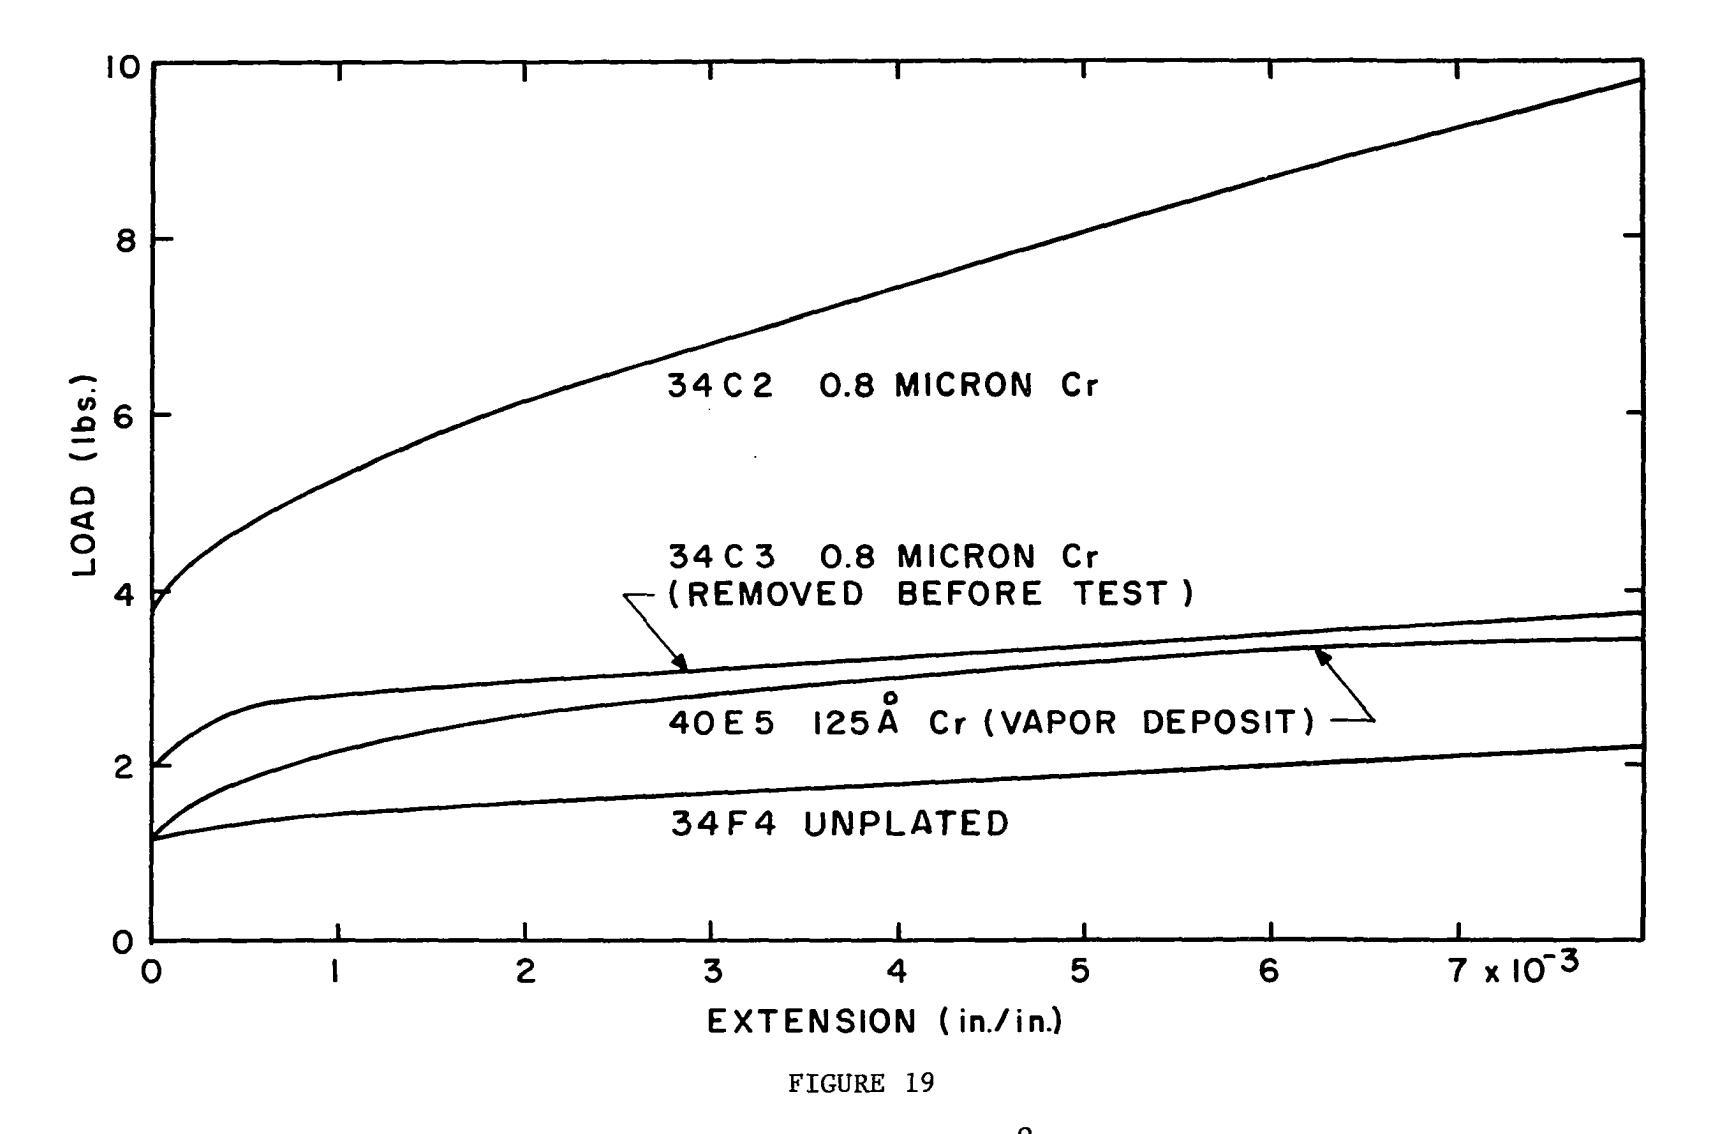
LOAD-EXTENSION CURVES FOR A SPECIMEN WITH A 125 Å VAPOR DEPOSITED Cr COATING, A SPECIMEN WITH A 0.8 MICRON ELECTROPLATED Cr COATING WHICH WAS REMOVED BEFORE TESTING, A SPECIMEN WITH A 0.8 MICRON ELECTROPLATED Cr COATING, AND AN UNPLATED SPECIMEN

The behavior of the specimen having a 125 Å chromium vapor deposit also must be interpreted in terms of film rupture during deformation. Figure 19 shows tracings of the initial portions of the load-extension curves as plotted directly by the Instron machine for all the specimens represented in figures 7 and 9. Variations in dimensions among specimens

were small and therefore the stress-strain behavior for these specimens may be compared using the curves of Figure 19. The specimen tested with a 125  $\stackrel{0}{A}$  vapor deposit showed a flow stress at the onset of plastic deformation approximately equivalent to the flow stress in an uncoated crystal. However, the initial strain hardening rate is about the same as observed with a 0.8 micron coating of chromium. As plastic deformation continues, the flow stress quickly levels off at about the same value obtained with just the damaged layer resulting from the 0.8 micron chromium electrodeposit.

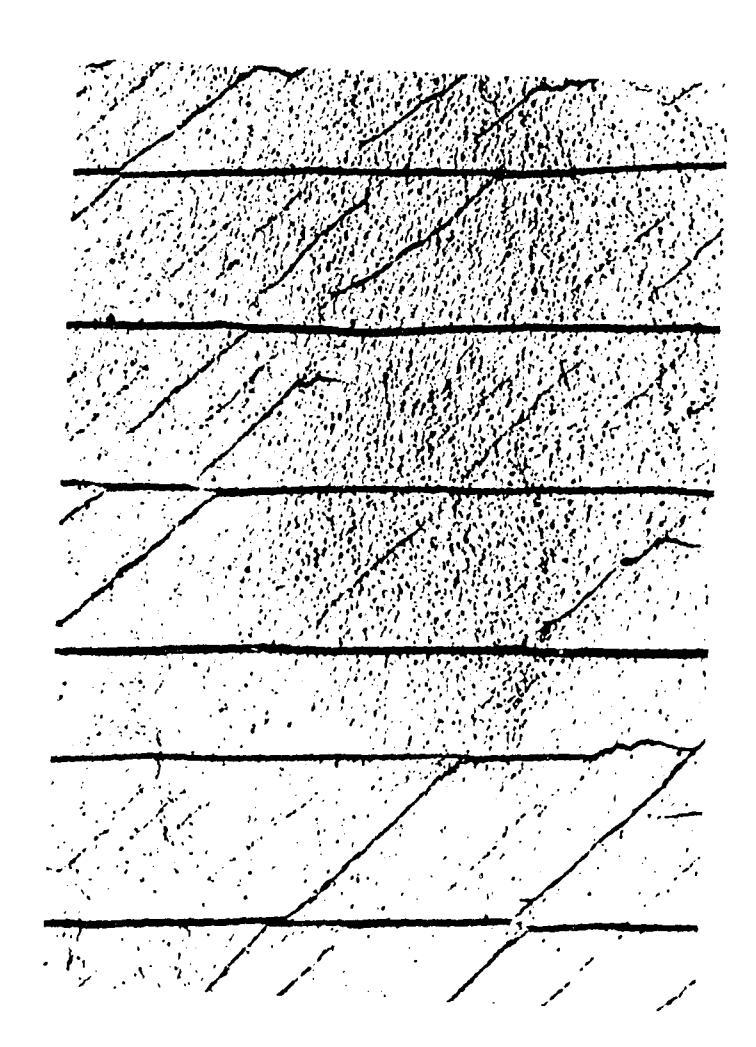
## FIGURE 21

SURFACE OF A CRYSTAL TESTED INTO STAGE III WITH A 1 MICRON Cr ELECTROPLATE. 500X intense. However, because of its thinness, it was transparent to the passage of dislocations moving toward the surface. The layer of damage which resulted from only the application of the 0.8 micron chromium coating was relatively thick but not sufficiently intense to impede a major portion of the dislocations moving toward the surface. Therefore, this damaged layer is also relatively transparent to the motion of dislocations moving toward the surface.

into Stage III. The network of cracks was extremely fine indicating continued cracking throughout deformation of the substrate. However, no detachment was observed. Thus continual cracking might be expected to produce continual deformation of the sub-surface layer contributing to the strengthening of the substrate crystal. The decreasing rate of work hardening throughout plastic deformation is consistent with the continued decrease of the strength contribution made by the coating as it continually cracks.
