AN IN VITRO MECHANICAL COMPARISON OF

TPLO PLATES

Submitted to the Faculty of the Graduate College of the Oklahoma State University in partial fulfillment of the requirements for the Degree of MASTER OF SCIENCE OR ARTS May 2010

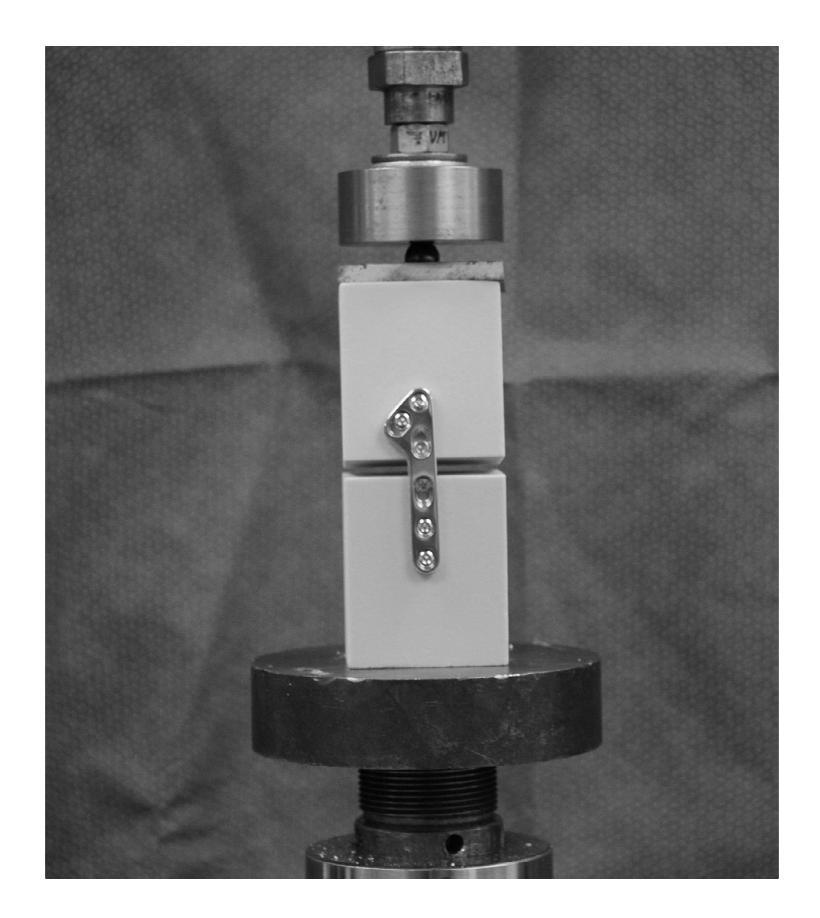
Figure 1: View of a LocP construct positioned and loaded in the material testing system prior to axial compressive load to failure testing. Note the customized loading platform atop the construct.

8800D controller, Instron corporation, Norwood, MA) in gap closing axial compressive load to failure and fatigue cycling. Each construct was mounted into the testing device using a customized loading platform to allow for rotation in all planes during loading. The customized loading platform was comprised of a 60mm x 40mm x 6.5mm steel plate with a machined small round depression 10mm in diameter located in the center of the plate. The platform was designed to fit precisely with the top of each construct so that the compressive load was applied in exactly the same manner for in each construct. The loads were therefore applied to the constructs such that all compressive loading was applied 20mm from the medial aspect of the construct, or the surface in which the plate was placed, and parallel to the long axis of each plate. This was placed atop all constructs during testing. A 12.75mm diameter steel ball bearing was placed in the depression of the steel plate as the specimen was loaded into the materials testing machine. The materials testing machine was fitted with a corresponding 30mm thick steel cylinder 60mm in diameter with a 10mm diameter machined depression in the center of the cylinder for communication with the steel ball bearing. The bearing and machined depressions were lubricated prior to testing each construct. The customized loading platform was developed to eliminate variability in loading of each construct, and to facilitate rotation of the proximal portion of the construct in any direction during axial loading. For load to failure testing in axial compression, six constructs of each plate type underwent loading applied at a continuous rate of 2mm/min until failure or closing of the gap (See Figure 1).

Failure was defined as plastic deformation of the implant, gap closing on the side opposite the plate, screw pullout, screw bending, screw breakage, or significant foam compression around and between screws. For gap closing to occur, a 4.1 degree bend in the plate would be experienced by all plates on each construct.
