# Vibration-based Health Monitoring of Earth Structures

M. A. Mooney,<sup>1,\*</sup> P. B. Gorman<sup>2</sup> and J. N. Gonzalez<sup>2</sup>

Vibration-based health monitoring (VBHM) has successfully been used to assess the structural damage to bridges, buildings, aircraft, and rotating machinery. There is significant incentive to apply VBHM techniques to the damage detection and conditional assessment of earth structures (geostructures), e.g., foundations, dams, embankments, and tunnels, to improve design, construction, and performance. An experimental program was carried out to explore the efficacy of VBHM of earth structures. A vibratory roller compactor, instrumented with triaxial accelerometers to continuously measure drum and frame vibrations, was operated on a number of underlying material structures with varying properties. Time-domain and frequency-domain analyses of the coupled machine/earth structure response were performed to glean machine vibration features that reflect changes in underlying structural properties. Results illustrate that drum and frame acceleration amplitudes were fairly insensitive to changes in underlying media stiffness; however, drum acceleration

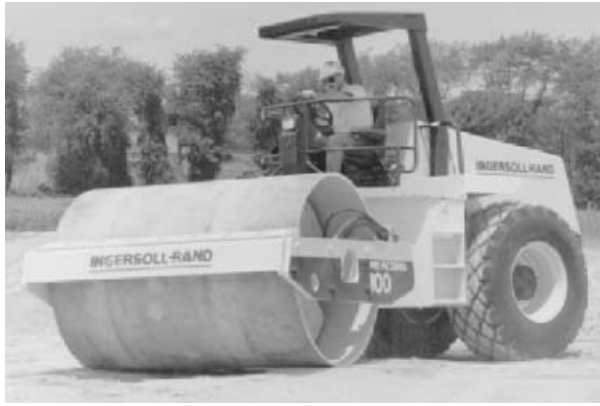
**Figure 1** Vibratory roller compactor (courtesy of Ingersoll-Rand Corporation).

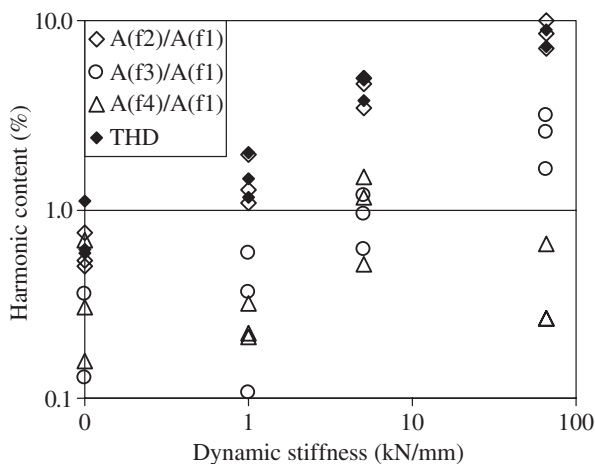
**Figure 7** Normalized harmonic content and total harmonic distortion as percentage during vibration on nonstationary materials.

stiffness (see Figure 7). Note that the decoupling during vibration on 1-m PCC yields significant nonlinearity and thus harmonic content. Table 3 and Figure 7 illustrate that the percentage of harmonic content in the drum acceleration is more sensitive to underlying material stiffness than drum acceleration amplitude. While normalized drum acceleration amplitude increased 24% from operation on rubber to operation on 150-mm PCC, the THD increased over 1000% from operation on rubber to operation on 150-mm PCC.

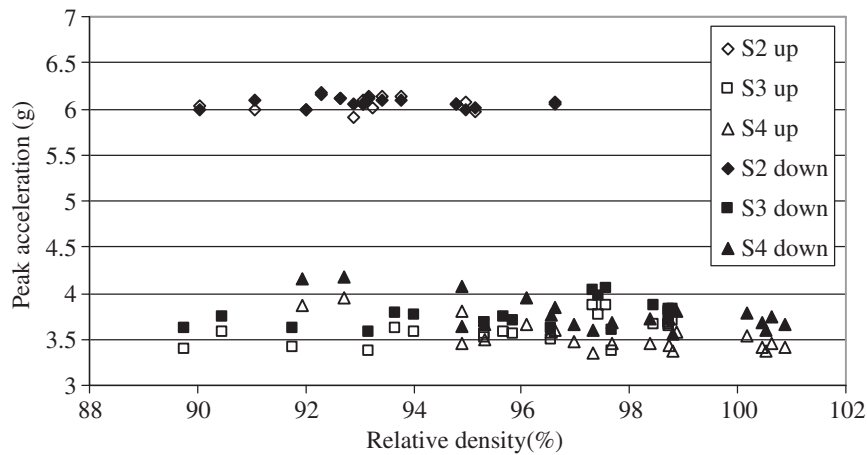
**Figure 9** Peak drum accelerations during compaction of sand (vibration frequency for each test: 29 Hz for S3 and S4; 38 Hz for S2).

Peak vertical drum accelerations measured at locations A–D during compaction of sand beds S2, S3, and S4 are presented in Figure 9 versus percent compaction. Percent compaction is defined as the percentage ratio of dry density (dry soil mass/total volume) to a standard Proctor maximum dry density for that particular

The data presented in Figure 9 represents average upward (open symbols) and downward (filled symbols) drum acceleration amplitudes measured as the compactor passed over points A–D during five successive passes of the roller compactor. Each data point is the average of 2 s worth of data taken during drum passage over 1 m of test bed (see points A–D in Figure 8). The acceleration levels measured at any time during compaction reflect machine vibration upon a complex body of ‘involved’ soil (i.e., the soil that is stressed by the vibrating drum at a given time and location). The involved soil ahead of the drum is less dense than the involved soil behind the drum. Hence, the drum and frame vibration characteristics during any pass reflect machine vibration on soil that varies from pre-pass density ahead of the roller to post-pass density behind the drum. It should be noted that associated density and DPI values were measured after each pass.

Figure 9 illustrates the effect of vibration frequency on drum acceleration. Test beds S3 and S4 were compacted at  $f_{\text{vib}} = 29$  Hz while test S2 was performed at  $f_{\text{vib}} = 38$  Hz; hence the increased drum accelerations for test S2. Figure 9 shows that the downward drum acceleration exceeds the upward drum acceleration by 10–15% throughout compaction of beds S3 and S4, yet remains symmetric at the 38 Hz compaction of bed S2. Therefore, the difference between upward and downward drum acceleration does not appear to be sensitive to the changes in soil properties during sand compaction.

Drum vibration amplitudes exhibited little change during compaction of beds S2, S3, and S4 (Figure 9); however, when normalized by  $F_{\text{vib}}$ , a slight increase is observed as soil densifies and stiffens (see Figure 10). A significant hurdle for vibration-based condition monitoring of soil compaction is the inherent operational variability due to shifting vibration frequency. The Ingersoll-Rand SD-100D employs open-loop manual frequency control (lever-controlled). Further, hydraulic power is shared by the drive motor, steering motor, and vibration motor. For safety reasons, steering and drive receive highest priority. As a result, vibration frequency varies during operation (see Figure 8) and tends to decrease as the underlying soil stiffens. For example,  $f_{\text{vib}}$  varied by  $\pm 2$  Hz, during compaction of beds S3 and S4. Figure 10 shows that the normalized peak to peak acceleration generally
