# ANALYSIS OF WEB WRINKLING IN ACCUMULATORS

B. K. Kandadai, N. J. Michal and A. Patil Kimberly-Clark Corporation

## **ABSTRACT**

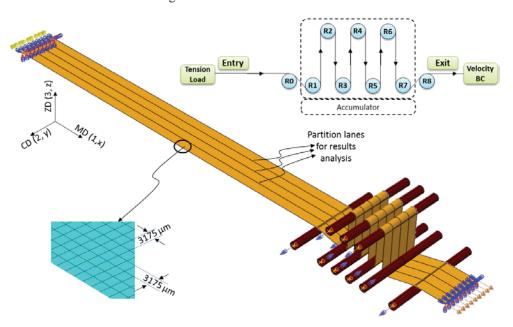
Figure 2 – Schematic representation of the FE model set up

The model is set up such that the wrinkling mechanics of a moving web over multiple rollers in a manner such as that found in accumulators can be studied for various span lengths, roller misalignments, web properties, and surface interaction properties. Consider an initial configuration of the model wherein the web path through an accumulator is as shown in Figure 2.

In this model, the web layer is modeled as an elastic layer while the rollers are modeled as rigid cylindrical shells. The model in the initial configuration is set up such that all the rollers are parallel to the y-axis as shown in Figure 2. Within the accumulator, rollers R1, R3, R5 and R7 represent the lower (fixed) carriage rollers while rollers R2,

R4, R6 represent the moving (top) carriage rollers. Rollers R0, R8 serve to maintain a fixed web wrap angle entering the exiting the accumulator. All the rollers in the model can rotate about their respective axis but are constrained in all other directions. In order to keep the computational time to a reasonable level, the vertical motion of the top carriage rollers is not modeled. Instead the rollers are set at a fixed height from the rollers in the lower carriage and misaligned to a pre-determined value when studying the wrinkling dynamics of the web in a misaligned accumulator.

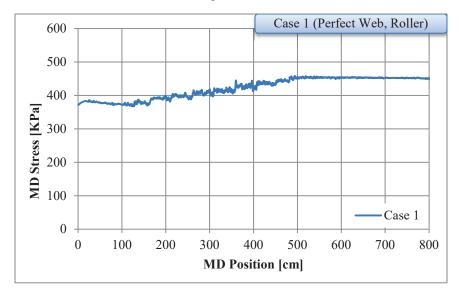
Figure 4 – MD stresses in the web along its length at different CD locations for Case (1)

To facilitate easier analysis, MD web stresses along the length of the web is shown at the center line of the web in Figure 4. In this case, the tension increases from a nominal

$0.75~\mathrm{N/cm}$  in the entry span to about  $0.92~\mathrm{N/cm}$  at the exit span due to the bearing drag in the rollers of the accumulator and was expected.

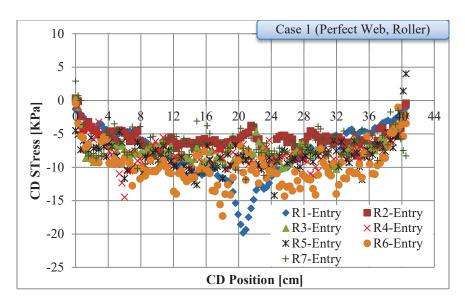
Figure 5 – CD stress in the web at the entry of all rollers in the accumulator in Case (1)

CD in-plane stresses at the entry of each roller in the accumulator is shown in Figure 5. The data indicates that the web is under compressive stress in each span. This is due to the Poisson contraction of the web in CD that arises from web tension. Critical stress to wrinkle as predicted by Good et al [13] that was derived from shell theory [14, 15] is shown in Equation 3. This value was calculated at 94 KPa. Note that the magnitude of the compressive stresses shown in the figure is very small and will not cause wrinkles since the stresses are significantly lower compared to 94KPa. The local minimum seen in Figure 5 at entry of Roller 1 is due to the long entry span prior to roller 1. This data is presented to illustrate the nature of the CD stresses in a perfect system thus serving as a bench mark for other cases presented henceforth.

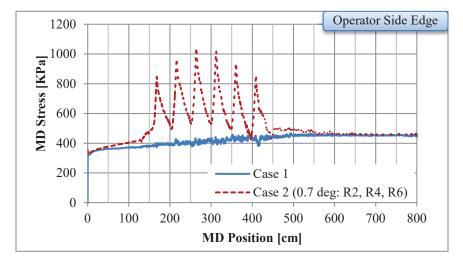
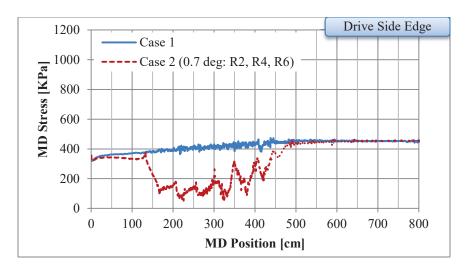
Figure 6 – Comparison of MD stresses in the web along its length at different CD locations between Case (1) and Case (2)

MD web stresses for the operator side edge, center line of the web and drive side edge of the web is shown for the case wherein the rollers R2, R4 and R6 in the accumulator are misaligned in the z-direction at 0.7 degrees. The misalignment on the rollers cause the drive side of the rollers R2, R4, R6 to be closer to the fixed carriage rollers thus essentially producing slack in the web in that side. The effect of roller misalignment on the MD stresses is evident from Figure 6. In order to achieve normal entry as the web approaches each roller in the accumulator, the web bends and steers laterally towards the slack side. This causes an uneven stress distribution such that the operator side is the "tight side" and the drive side is the "slack side". However the nominal average web stress remains similar to that shown in case (1). Note that the peaks in the figure occur where the web contacts a roller within the accumulator.

Similar trends are observed when the misalignment is increased to 0.55 degrees. However the intermittent wrinkles that appear on rollers R4-R7 stay for a longer time period (about 3 seconds) before disappearing. In the last time step, a wrinkle is present on roller R7 as indicated by the circle with a solid line. The CD stresses post wrinkle formation is smaller than that seen for the case of misalignment=0.45 degrees. Once the wrinkle forms, the instability is characterized by lowering of the CD stresses at the wrinkle site as well as the adjoining regions. For this misalignment, while a wrinkle is not seen in roller R6 at this time step, it does appear that the minimum CD stresses at the entry of this roller is significant as indicated by the arrow in the graph and by a dotted circle in the contour plot as shown in Figure 6(c).

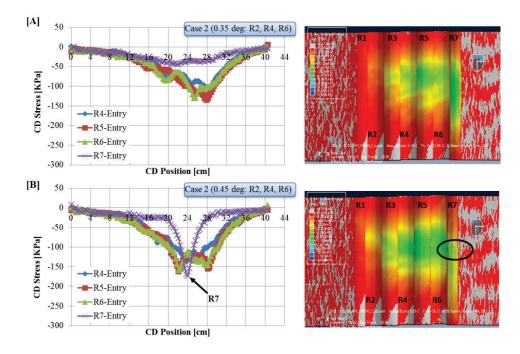
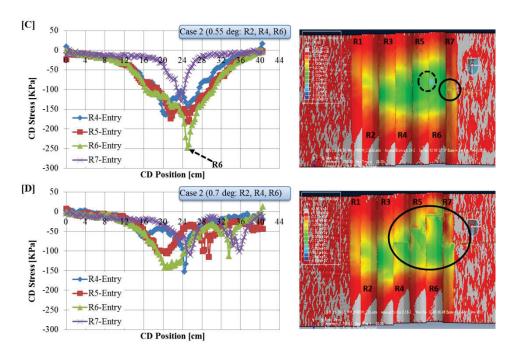
Figure 7 – CD stresses in the web at the entry of rollers R4-R7 and contours of CD stresses in the web for rollers R1-R7.

CD stresses at entry of rollers R4 through R7 is shown in Figure 7 along with a contour plot of the stresses for rollers R1 through R7 for four different misalignment values. This figure indicates the CD stress behavior at one instance of time when the web has travelled a distance that is about 7.1 times width of the web. This is the last time step in the simulation. Four different values of 0.35, 0.45, 0.55 and 0.7 degrees were chosen to understand the level of misalignment needed to cause severe wrinkling in the accumulator. CD stresses for rollers R1 through R3 is not shown in the figure as wrinkles were not observed on these rollers for the levels of misalignment studied. For misalignment = 0.35 degrees, no wrinkles are formed. It is evident from the Figure 6(a) that the CD stresses are significantly higher than that predicted by Equation 3 at the entry of rollers R4-R6. For example, the minimum CD stress at R5 for case 2[a] is about 140 KPa as compared to the 94 KPa calculated using Equation 3.

When the misalignment is further increased to 0.7 degrees, persistent wrinkles that "walk" from one side to the other form on rollers R4 through R6. The CD stresses at the entry of rollers R4-R6 are lower compared to that observed for the case of misalignment=0.55 degrees. Observe that a wrinkle is seen on each roller from R4 to R6 with two wrinkles seen on R7. As explained above, once the wrinkle forms, the instability is characterized by lower CD stresses around the wrinkle (Compare the magnitude of stresses at the entry of each roller in figures 7(c) and 7(d))

- When the accumulator carriage is misaligned, Figures 7, 8 and 10 indicate that the level of misalignment required to cause a wrinkle/s is much less in an accumulator as compared to individual rollers.
- Hence more rollers within the accumulator will require more precision on alignment.

- The CD stresses in Figure 7, 8 indicate that Equation. 3 underestimates the critical CD stress required to cause wrinkles for the nonwoven web that was studied.
- If the movable carriage of the accumulator is misaligned, the web steers towards the slack side in each span causing an overall gross movement of the web material at the exit of the accumulator.

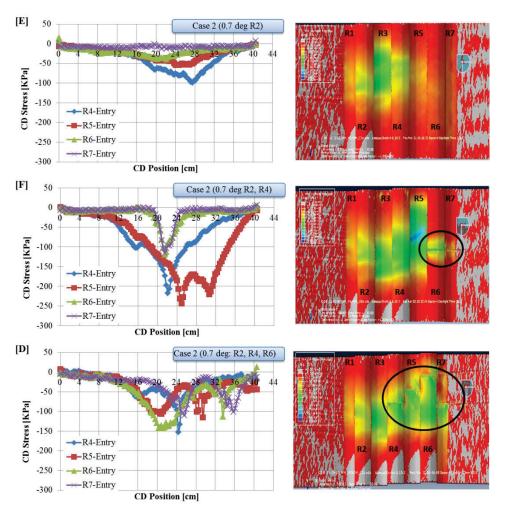
Figure 8 – Comparison of CD stresses for cases wherein one, two or all three top carriage rollers are misaligned.

CD stresses at the entry of rollers R4-R7 is shown in Figure 8 for the analyses described above. When only one roller is misaligned at 0.7 degrees, wrinkles do not form on any of the rollers (Case 2(e)). When two rollers are misaligned at 0.7 degrees, wrinkles are present on rollers R6, R7 at the last time step (Case 2(f)). At that same time step, in the case wherein all three accumulator top carriage rollers are misaligned at 0.7 degrees (R2, R4, R6) wrinkles are present on rollers R4-R7. Case 2(d) is included in Figure 8 for comparison purposes and contains the same data as presented in Figure 7[d].

The behavior of minimum CD stress for wrinkle formation and post wrinkle formation is similar to that described in the preceding section. It is evident from the figure that for a given accumulator, roller misalignment required to produce severe wrinkling decreases with increase in number of rollers that are misaligned in the system. In the accumulator discussed herein, the web encounters a misaligned roller in both the entry and exit spans with misalignment in the same direction (see Figure 9 for visual interpretation) thus causing wrinkling behavior to get progressively worse. Hence the web steers continuously to only one side.

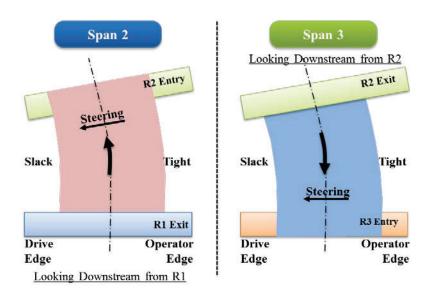
Figure 9 – Schematic of web behavior in spans 2 and 3.

When one of the movable carriage rollers, namely R2, is misaligned, the web steers laterally towards the slack side to achieve normal entry into roller R2 as shown in Figure 10. (also schematically shown in Figure 9). Note that the analysis does not indicate that the overall steering at the exit of the accumulator has reached steady state. While the wrinkling mechanics of the web doesn't change, it is likely that the web will get steered to one side till equilibrium is reached. When two of the movable carriage rollers R2 and R4 are misaligned, the web steers significantly to slack side as compared with the case when only R2 is misaligned. Observe that the steerage of web is significant as it enters the misaligned rollers R2 and R4 while very low as it exits the roller R2 and into roller R3 and also when it exits roller R4 and into roller R5. When all three rollers R2, R4 and R6 in the movable carriage are misaligned, the overall steering is much higher than in the previous cases. The steerage of web is significant as it enters the misaligned rollers R2, R4 and R6 but low as it enters roller R3 and R5. The amount of steering within the accumulator thus describes the compounding effect of several misaligned rollers within the accumulator.

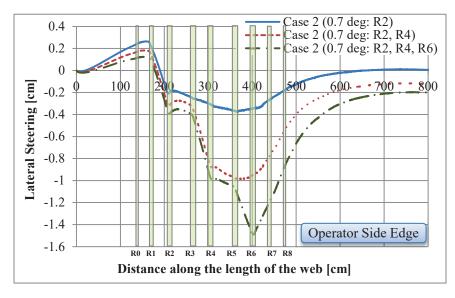
Figure 10 – Comparison of lateral steering for cases wherein one, two or all three top carriage rollers are misaligned.

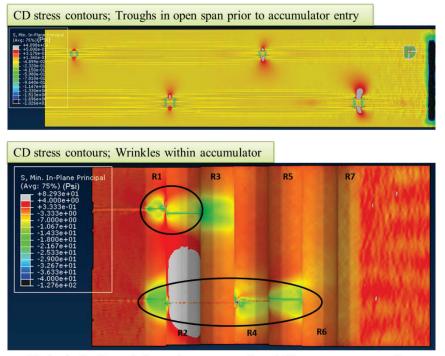
Circles in the figure indicate the presence of a wrinkle on one or more rollers

Figure 11 – CD stresses due to web imperfections at the entry of rollers R1-R5.

CD stresses at the entry of each roller at the time step when the web has moved 7.1 times the width the web is shown in Figure 12. Wrinkles are present on rollers R0 (not shown in Figure 11), R1, R2, R4 and R5 as indicated by the minimum CD stress at each of these rollers. Note that the CD stresses are not substantial to produce a wrinkle on Roller R3 (Also, observe Figure 11 for contour plot). Note that the staggered arrangement of imperfections cause parallel wrinkles on rollers R1 and R2. Figures 11 and 12 indicate that an imperfect web can form wrinkles even if perfect alignment of rollers can be achieved within an accumulator.

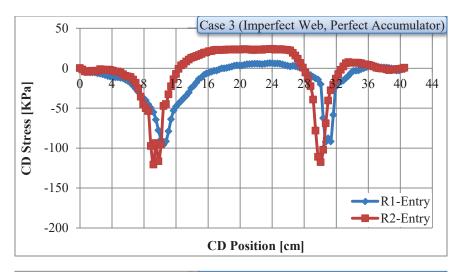
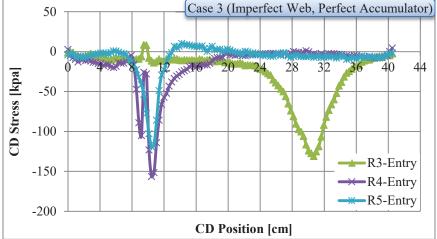
Figure 12 – CD stresses due to web imperfections at the entry of rollers R1-R5.

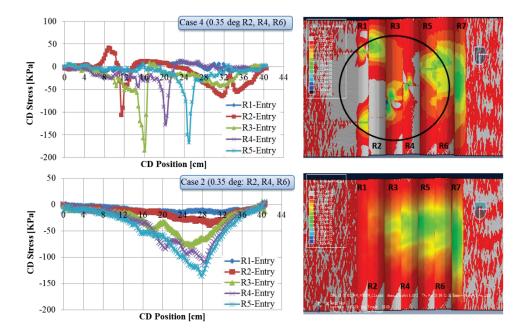
Figure 13 – CD stresses due to web imperfections and misaligned rollers within accumulator.

Data presented in Case (2) indicates that a minimum misalignment of 0.45 degrees on rollers R2, R4 and R6 is required to initiate wrinkles within the accumulator when the incoming web material has no imperfections. When an imperfect web enters a misaligned accumulator, data presented in Figure 13 indicates that a misalignment of 0.35 degrees is enough to cause significant wrinkling within the accumulator. A misalignment of 0.35 degrees on a 97.2 cm wide roller is equivalent to a distance of 0.6 cm for vertical offset on one side. This data indicates that the misalignment required to cause severe wrinkling of webs in accumulators is much less when the incoming web has imperfections in the form of thickness variations or material property variations (not studied in this paper).

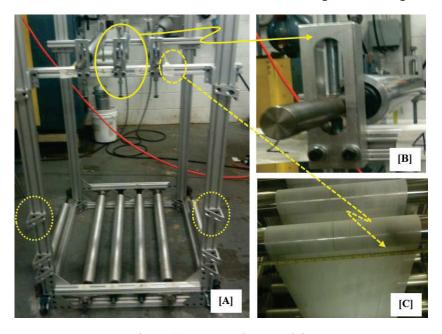
Figure 14 – Accumulator Module

A seven roll roller accumulator was designed for use on a pilot line with three rollers on the top representing the "moving carriage" rollers [1] and four rollers on the bottom representing the fixed position rollers with load cell feedback from the entrance and exit rollers. The rollers were 3.0" diameter aluminum dead shaft idlers. They were mounted on support rails that could be raised to different heights (five in this study) to achieve length to width ratios that ranged from 0.69 to 2.96. Experiments were completed at two

The top rollers were mounted in a bracket that allowed vertical adjustment at both ends as indicated by the solid circle in Figure 14[A] with the details indicated in Figure 14[B]. The thread pitch of the adjuster bolts and the number of turns were used to calculate individual roller misalignment during the study. Typically the adjustments were made on the front side by turning the hex bolts one half turn at a time (180 degrees) which was equivalent to a vertical motion of about 0.1 cm. Scales were mounted at the entrance and exit (as indicated by dashed circle in Figure 14[A] with details indicated in Figure 14[c]) to document the position of each edge and to calculate width loss and/or shift in web position after misalignment.

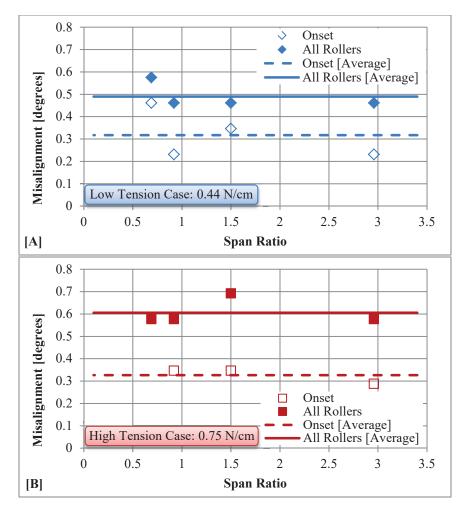
Figure 15 – Misalignment needed to cause wrinkles within accumulator at different span heights and tensions

Given a span height, when the misalignment was increased, wrinkles were observed first on the last carriage roller R6. When a continuously moving wrinkle (walking wrinkle) was seen in this roller, the condition is designated as "Onset". With more misalignment we observed that continuous walking wrinkles formed on all the carriage rollers (R2, R4, R6). This was identified as "Complete" because all of the rollers had continuous wrinkles. Due to bearing drag, the tension at the exit of the accumulator increased compared to the entrance tension. For an average entry tension of 0.44 N/cm ("low tension") and 0.76 N/cm ("high tension"), the average exit tension was about 0.57 N/cm and 0.88 N/cm respectively. This range of tension was selected based on common settings used in nonwoven converting processes. The average tension through the accumulator was about 0.51 N/cm and 0.81 N/cm for the low and high tension cases respectively. Thus the "high tension" case represents an increase of about 59% in average web tension from the "low tension" case. The amount of misalignment required to form wrinkles within the accumulator for the low and high tension cases are summarized in Table 3 for different span heights and graphically represented in Figure 15.

Based on the data shown in Figure 15, following general observations can be summarized:

- Misalignment of the top carriage rollers that is required to initiate wrinkles on one roller (last roller R6) is significantly lower than that is required to cause continuous walking wrinkles on all rollers.
- For both low and high tension cases, the misalignment required to initiate walking wrinkles on roller R6 ("Onset") is about 0.32 degrees.
- Misalignment required to cause continuous walking wrinkles on all the rollers increased to about 0.49 and 0.61 degrees for low and high tension cases respectively.
- This increase is considered small and hence the effect of web tension on critical misalignment required to form wrinkles in accumulator for the nonwoven studied is minimal.

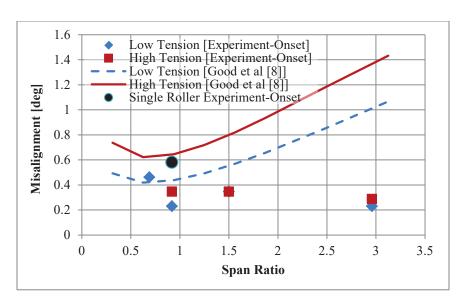
Figure 16 – Misalignment needed to cause wrinkles within accumulator at different span heights and tensions

- The difference in behavior is further illustrated in Figure 16. Data presented in Figure 16 illustrates that Equation 4 cannot be applied directly for calculating the critical misalignment required to cause wrinkles on all rollers within an accumulator.
- Note that the wrinkle criterion calculated by multiplying Equation 4 by a factor of two compares well the experimental data for a single roller.
- However this equation does not take into consideration the compounding effect of misalignment in multiple rollers thus over estimating the critical misalignment for accumulators.

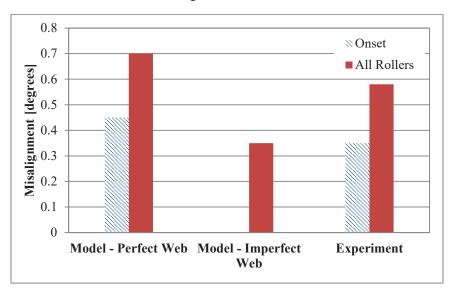
Figure 17 – Misalignment needed to cause wrinkles within accumulator at different span heights and tensions

Comparison of FE model to the experimental results is shown in Figure 17 and the associated data is shown in Table 4. Note that the model was completed only for the case of high web tension (0.74 N/cm) and a span height of 0.9. In addition, note that the model showed continuous walking wrinkles on rollers R3-R7 in the case of a perfect web moving through the accumulator while the experiments showed continuous walking wrinkles on roller R1-R7. The increase in misalignment needed to cause wrinkles on rollers R3-R7 was typically about one half to one full turn of the adjuster bolts in experiments. One half turn of the adjuster bolt is equivalent to a misalignment of 0.057 degrees. The nonwoven web used in this study was inherently inhomogeneous and imperfect. For the case of imperfect web moving through an accumulator model results indicate that even at 0.35 degrees of misalignment continuously walking wrinkles can be observed through most of the accumulator. Overall the experimental values fall between the model results for perfect and imperfect web scenarios analyzed thus giving credibility to the model results.

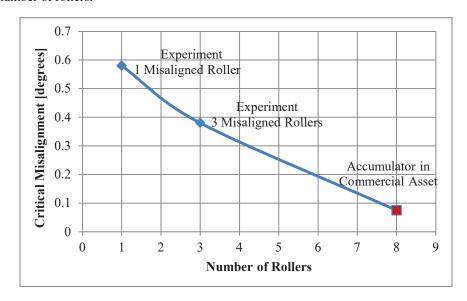
Figure 18 – Critical misalignment needed to cause wrinkles within accumulator for different number of rollers

Another experiment was conducted to understand the difference between one roller being misaligned as compared to all of the top rollers. The span height was set to provide a length to width ratio of 0.92. Tension was set to the previous high tension case of 0.74 N/cm. A single roller required 0.58 degrees of misalignment to initiate wrinkle within the accumulator. Recall that all three rollers only needed 0.35 degrees of misalignment to initiate a walking wrinkle (Figures 16 & 17). This experimental result points to the model results described previously. For the accumulator described in Michal [1, 2], practical experience indicates that severe wrinkling only requires 0.075 degrees of misalignment for an eight roller carriage arrangement for a similar nonwoven web. Figure 18 illustrates the impact of number of rollers on critical misalignment required to cause severe wrinkling within the accumulators. It appears that the critical misalignment required to cause severe wrinkling within the accumulator is inversely proportional to the number of rollers.
