Radiation testing of electronics for the CMS endcap muon system

The electronics used in the data readout and triggering system for the Compact Muon Solenoid (CMS) experiment at the Large Hadron Collider (LHC) particle accelerator at CERN are exposed to high radiation levels. This radiation can cause permanent damage to the electronic circuitry, as well as temporary effects such as data corruption induced by Single Event Upsets. Once the High Luminosity LHC (HL-LHC) accelerator upgrades are completed it will have five times higher instantaneous luminosity than LHC, allowing for detection of rare physics processes, new particles and interactions. Tests have been performed to determine the effects of radiation on the electronic components to be used for the Endcap Muon electronics project currently being designed for installation in the CMS experiment in 2013. During these tests the digital components on the test boards were operating with active data readout while being irradiated with 55 MeV protons. In reactor tests, components were exposed to 30 years equivalent levels of neutron radiation expected at the HL-LHC. The highest total ionizing dose (TID) for the muon system is expect

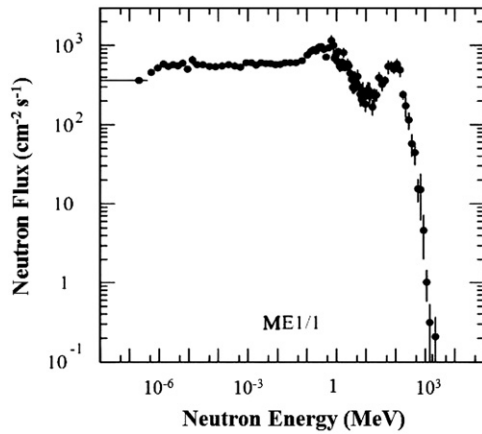
Fig. 1. Energy spectrum of neutron exposure for the innermost chambers of the CSC system, based on simulations from the first phase of LHC operation [7].

ME1/1 CSCs are the innermost chambers within CMS and are exposed to the highest rate of radiation, largely from neutrons. Fig. 1 shows the simulated energy spectrum of neutrons crossing the ME1/1 region. Fig. 2 shows how the neutron fluence in the endcap region is expected to vary with distance from the beam line. In the area of highest neutron flux, the total fluence for neutrons with energy $E > 100$ keV is about $6 \times 10^{11} \text{ cm}^{-2}$ [7], and the TID is 1780 rad over 10 years of normal LHC operation. However, for HL-LHC these rates are expected to be five times higher, as summarized in Table 1. These data form the baseline for determining the radiation tolerance of the CSC electronics.

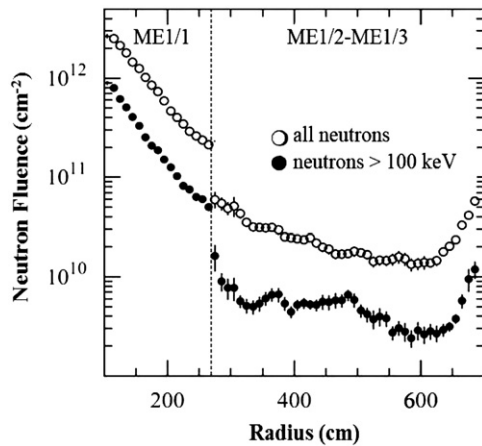
Fig. 2. Expected neutron fluence in the Station 1 region of the CMS endcap for the first phase of LHC operation, shown as a function of the distance from the beam line [7].

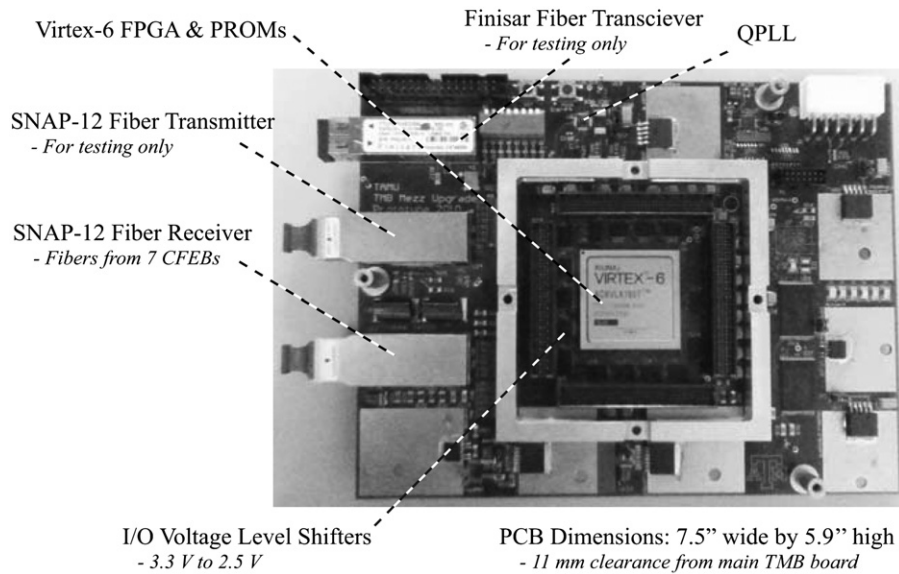
Fig. 3. Top-side view of a TMB mezzanine test board, as used in SEU tests for digital components.

Reflex Photonics Snap12 simplex receiver and transmitter opto-couplers, and the TI SN74CB3T bus exchange level shifter. A printed circuit board containing these components was developed and assembled (Fig. 3) as a test bed for the measurements of radiation tolerance. During the board design, special attention was given to the location of the parts on the board, allowing sufficient space for a collimated beam to irradiate each component one-by-one with no overlap.

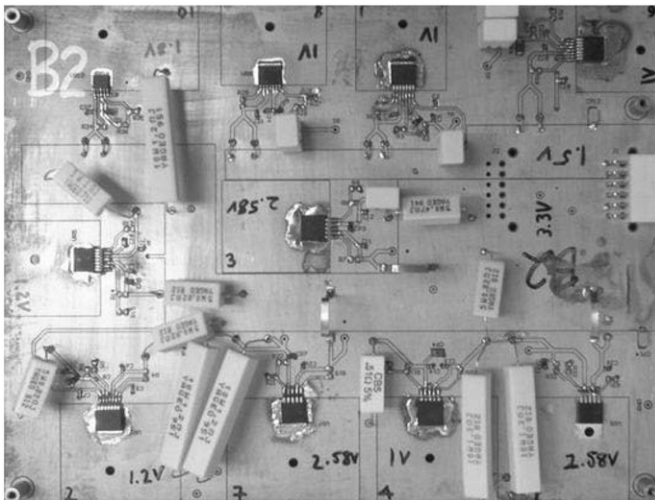
Fig. 4. One of the voltage regulator test boards that was exposed to 1 MeV neutrons in the TAMU NSC reactor.

necessary for providing power to the digital components. Custom designed voltage regulator test boards were assembled (Fig. 4) for testing the performance of multiple samples for each component.

Eleven different voltage regulator models from five different manufacturers were mounted on custom-designed voltage regulator test boards (Fig. 4). The boards were placed in the large-sample irradiation chamber, and they were not powered during exposure. The voltage, current and temperature performance of each circuit was tested before and after each exposure in order to determine their radiation tolerance. At least two samples of each regulator were tested, and consistent pattern was observed in the results.

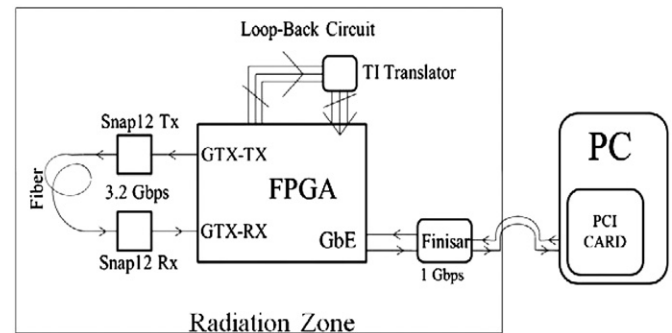
Fig. 5. Diagram of the test circuits used on the TMB mezzanine test boards, indicating the five digital devices tested in the TAMU cyclotron.

This section provides a description for each type of component tested and explains the procedures used to carry out the tests in each case; an overview of the test configuration used for the digital components is shown in Fig. 5. For the non-digital parts, each was tested with dedicated load resistors tuned to emulate the realistic conditions for normal CMS operation. Results are presented for SEU susceptibility and radiation survivability, based on measurements such as SEU counts, voltage levels, total fluence and the dose during each exposure.

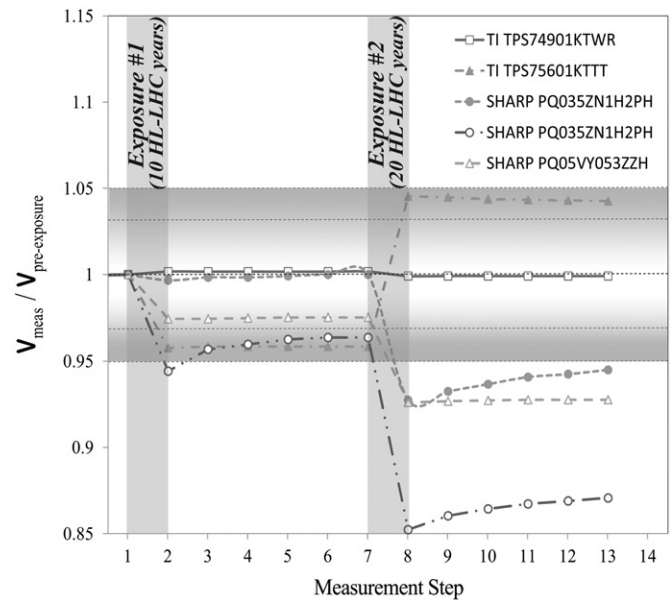
Fig. 6. Examples of voltage regulator output stability after each radiation exposure, showing the change in voltage output for regulators that survived the full exposure level. After each exposure the output voltages were measured under power at 30 min intervals. Voltage regulator deviations greater than 5% are not acceptable for CSC electronics.

In Fig. 6, a representative sample of results from five different regulators is shown. The vertical axis represents the ratio of the measured voltage (after exposure) to the pre-exposure voltage; the horizontal axis shows the measurements taken in 30-min time intervals after each radiation exposure. Observing a constant result with value ≈ 1 over time indicates that the regulator is a stable, reliable choice for our design. As seen from the figure, several regulators break down after exposure and fail to regulate; some of the samples perform well after the first 10 krad exposure, and then fail after the final 20 krad exposure. Some chips show a small degree of recovery over time, but they remain outside of the acceptable performance range of $\pm 5\%$ voltage variation.

Three of the six Max8557ETE regulators showed 0 V output after the second exposure, while the other three show approximately 3% decrease in voltage. This is the only observed case of complete failure for a regulator due to radiation. Several other

regulators showed more than 5% change in voltage, and regardless of the mechanism, these are all unacceptable for use in CSC electronics.
