Final Report O.R.A. 157-622

# EFFECTIVENESS OF RIVERBANK PROTECTION AND RIVER CONTROL IN OKLAHOMA

By  
Jimmy F. Harp, PhD  
Professor  
and  
Mathew Thomas  
Research Assistant

August 15, 1989

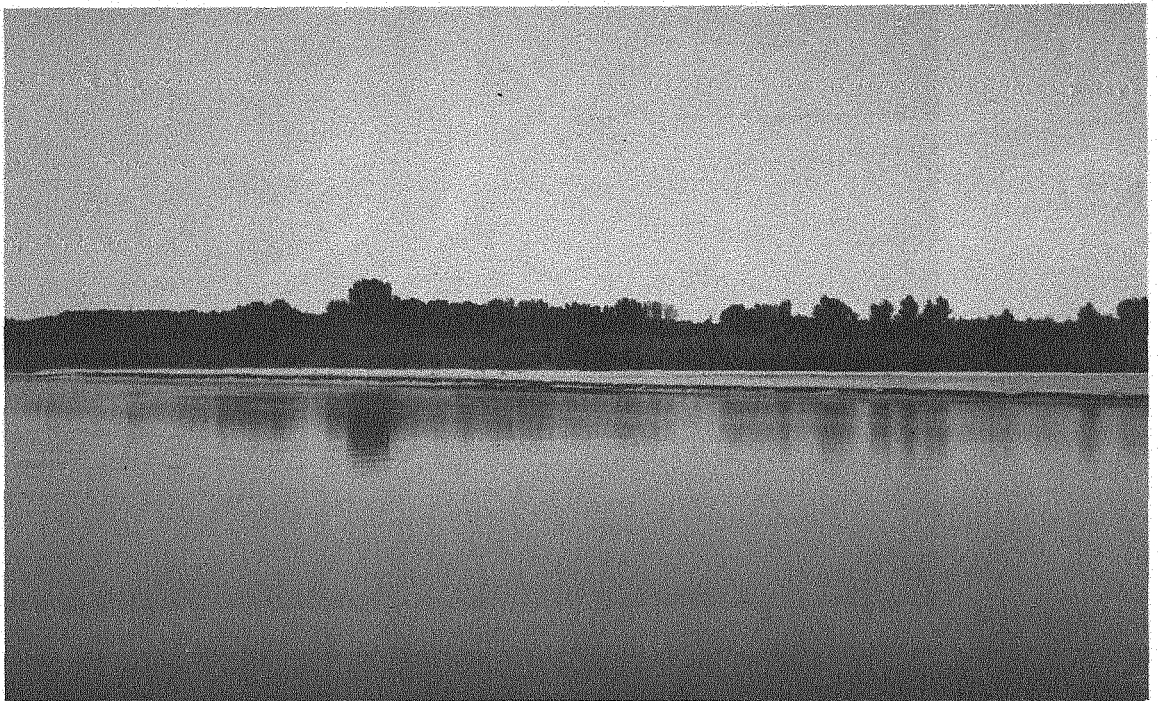
FIGURE 34d

Sandbar in Midstream

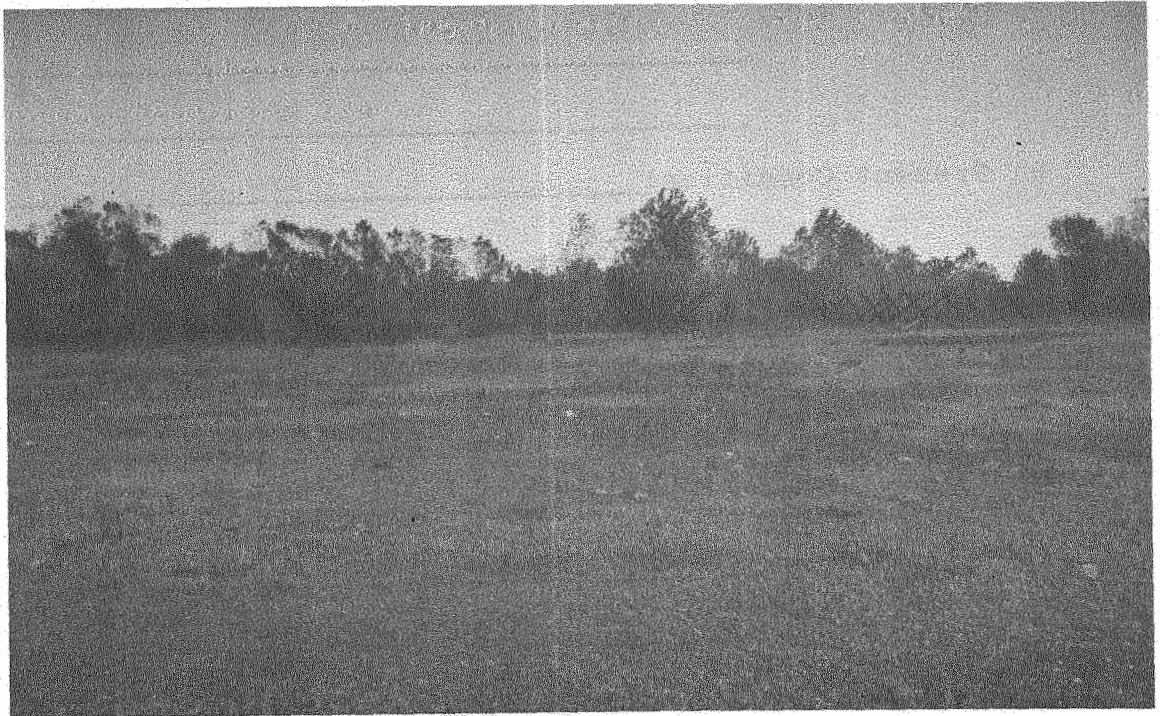
FIGURE 46b

View in a Kellner Jetty Field

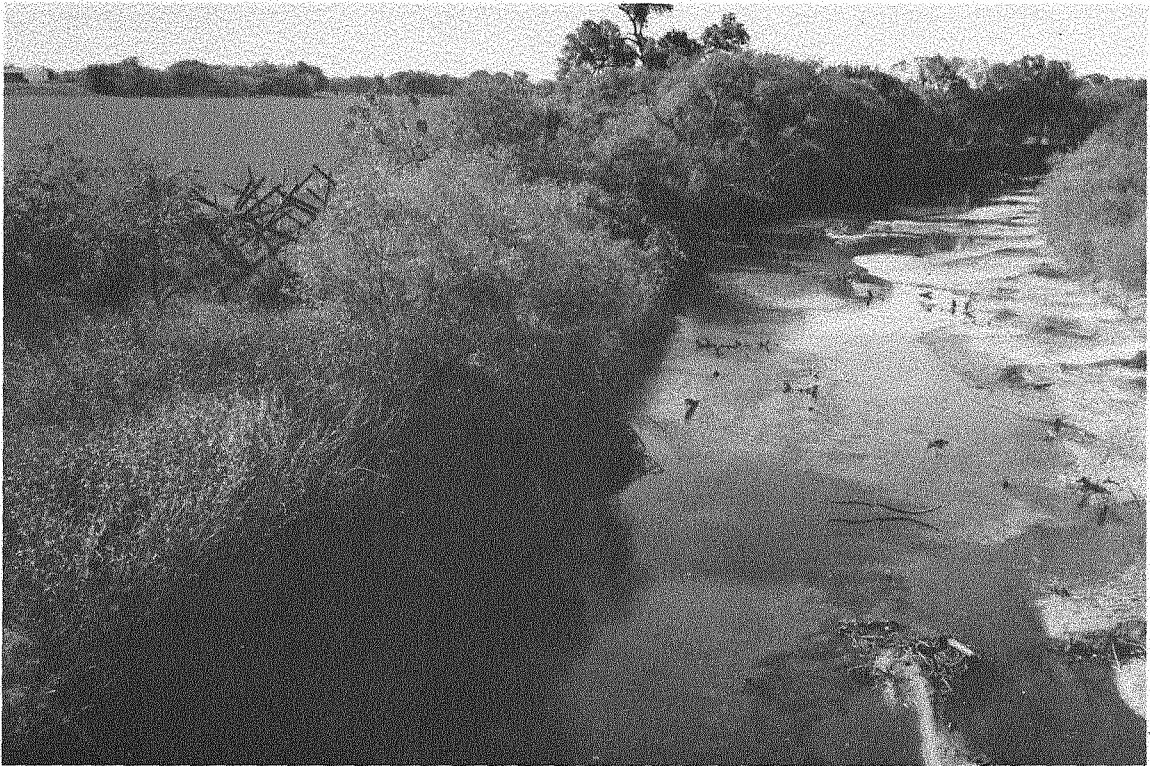
FIGURE 46c

Upstream View of the River

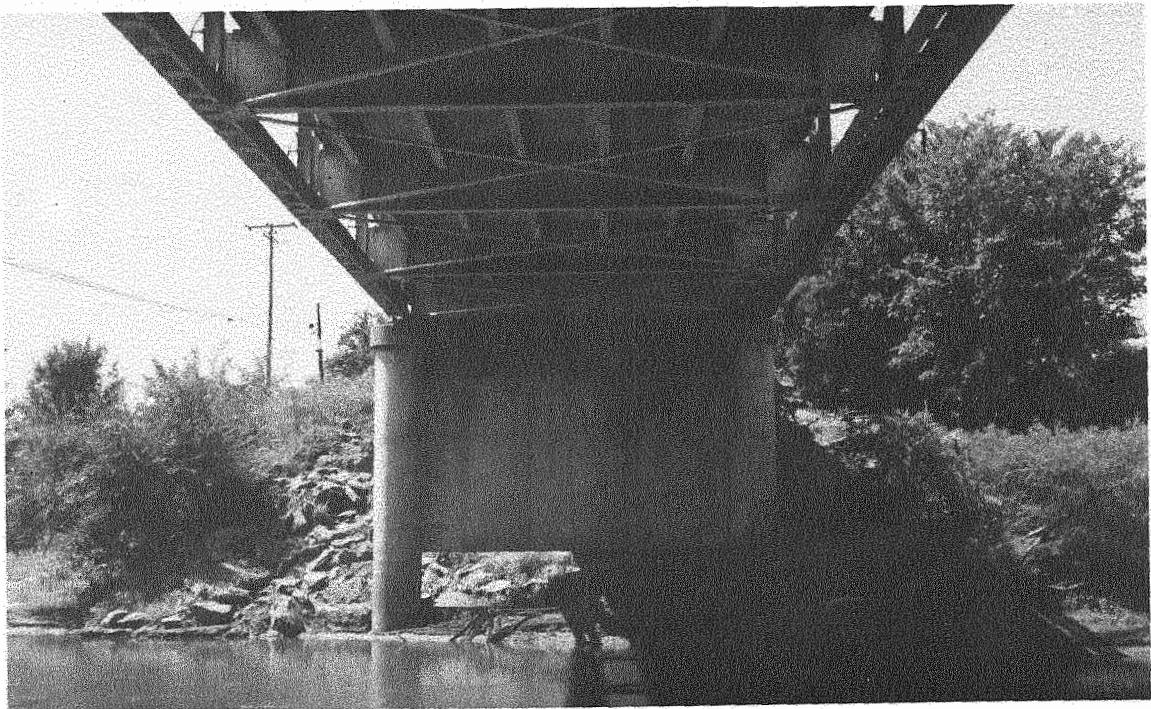
FIGURE 61b

View of the Attacked South Bank

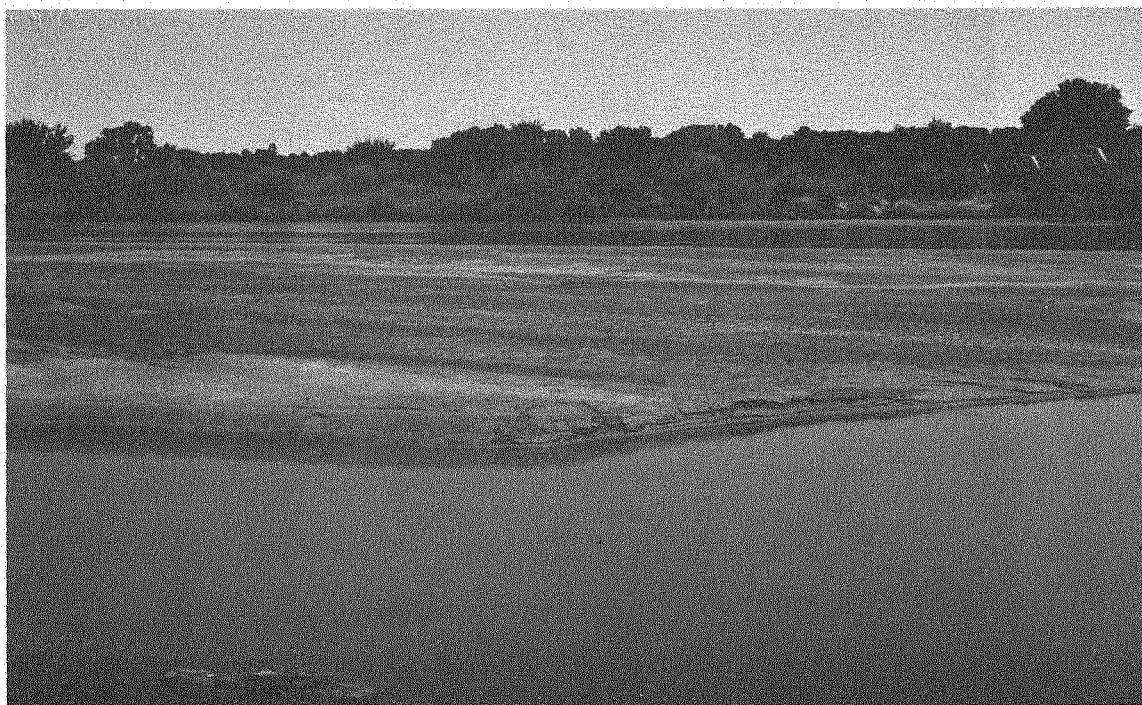
FIGURE 64b

Sandbar in the River

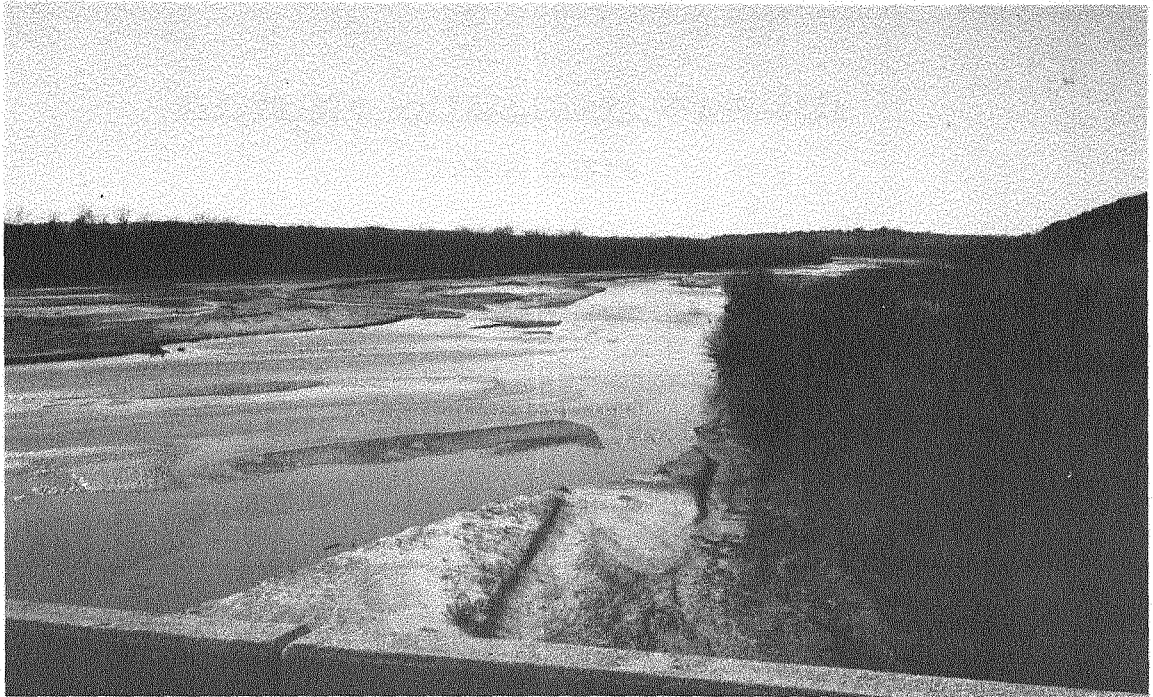
Figure 67a

Upstream View of the River

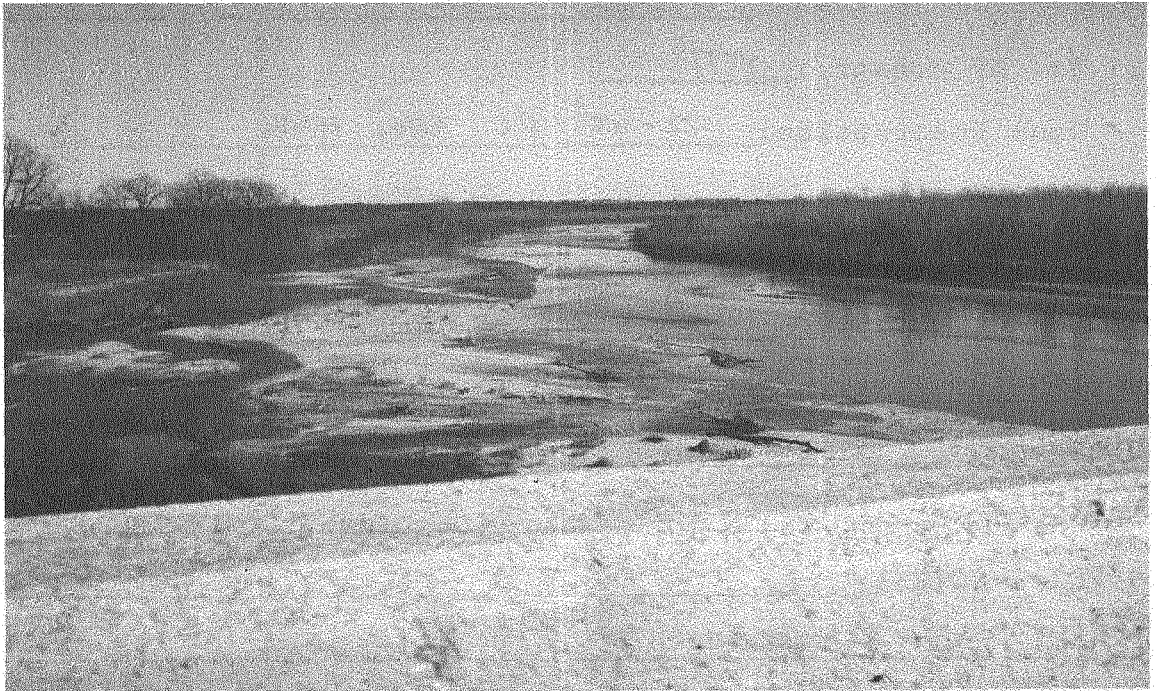
Figure 67b

Downstream View of the River

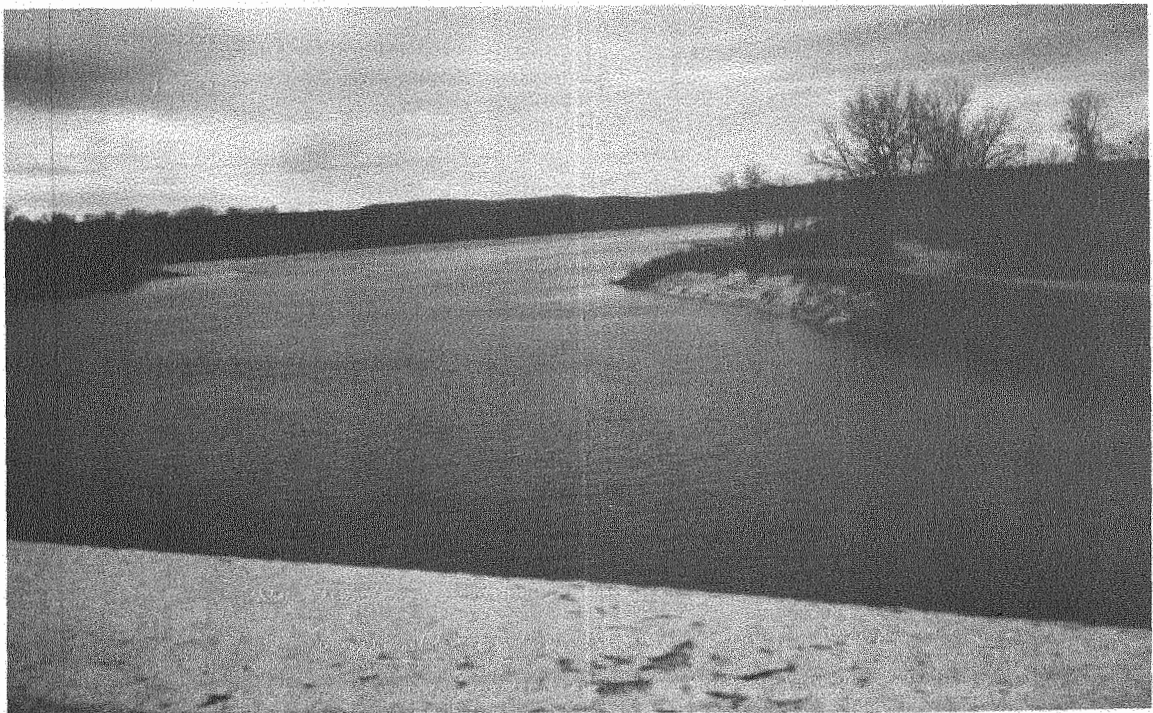
FIGURE 73d

Upstream View of the River

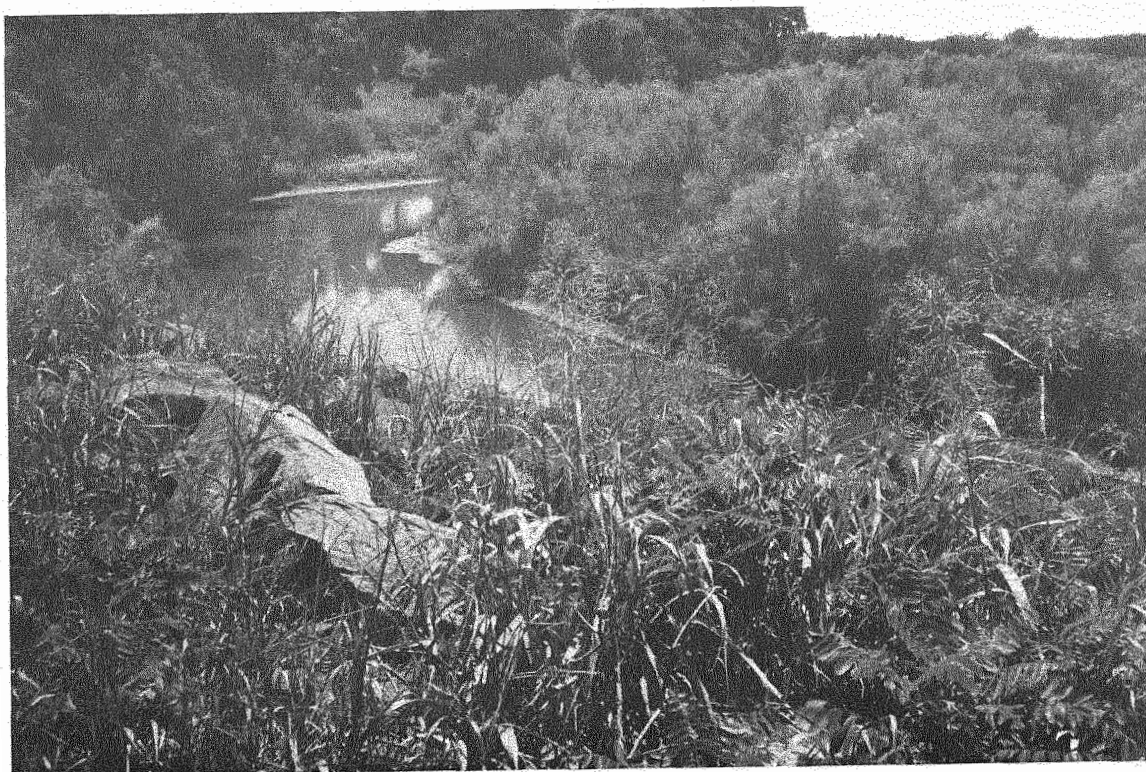
FIGURE 79c

Creek Flowing into the River

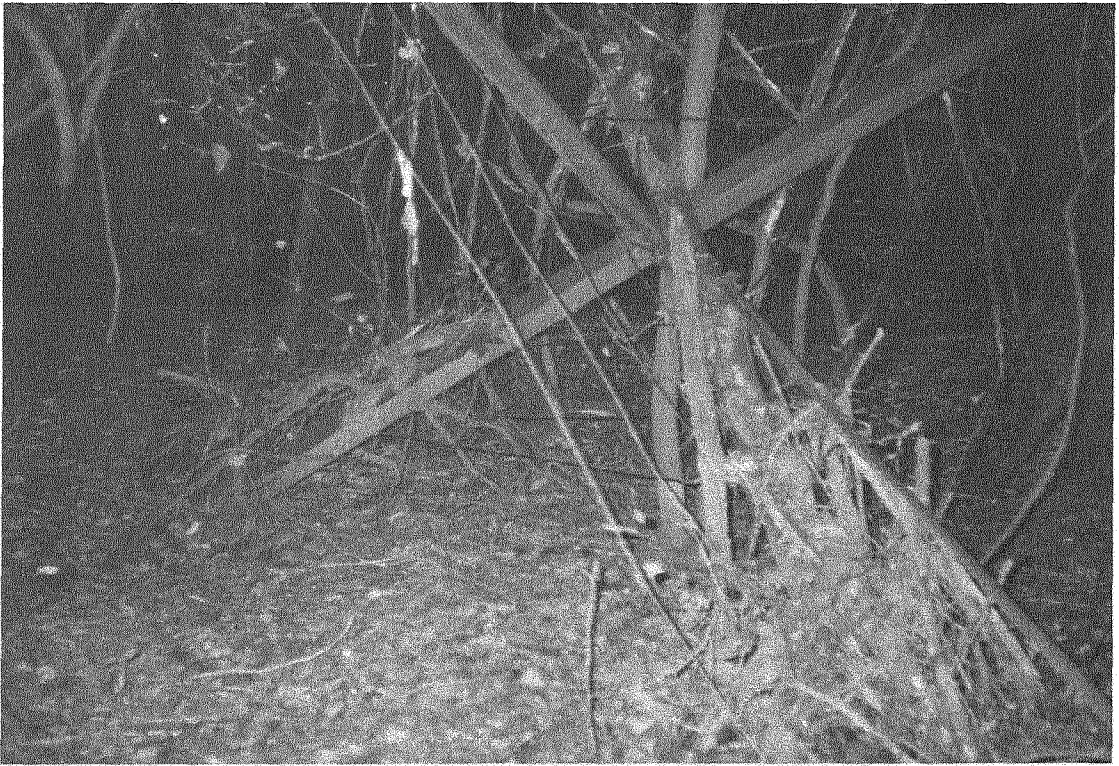
FIGURE 82c

Densely Forested Jetty Field

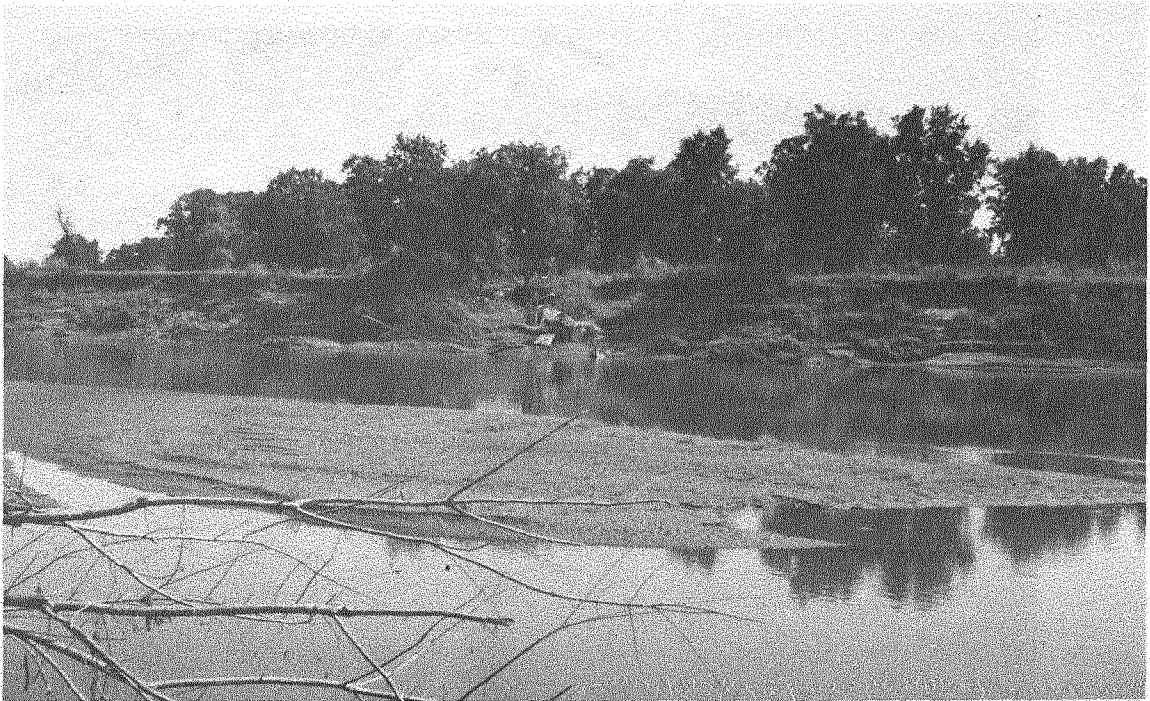
FIGURE 82d

Car Bodies Used to Prevent Erosion

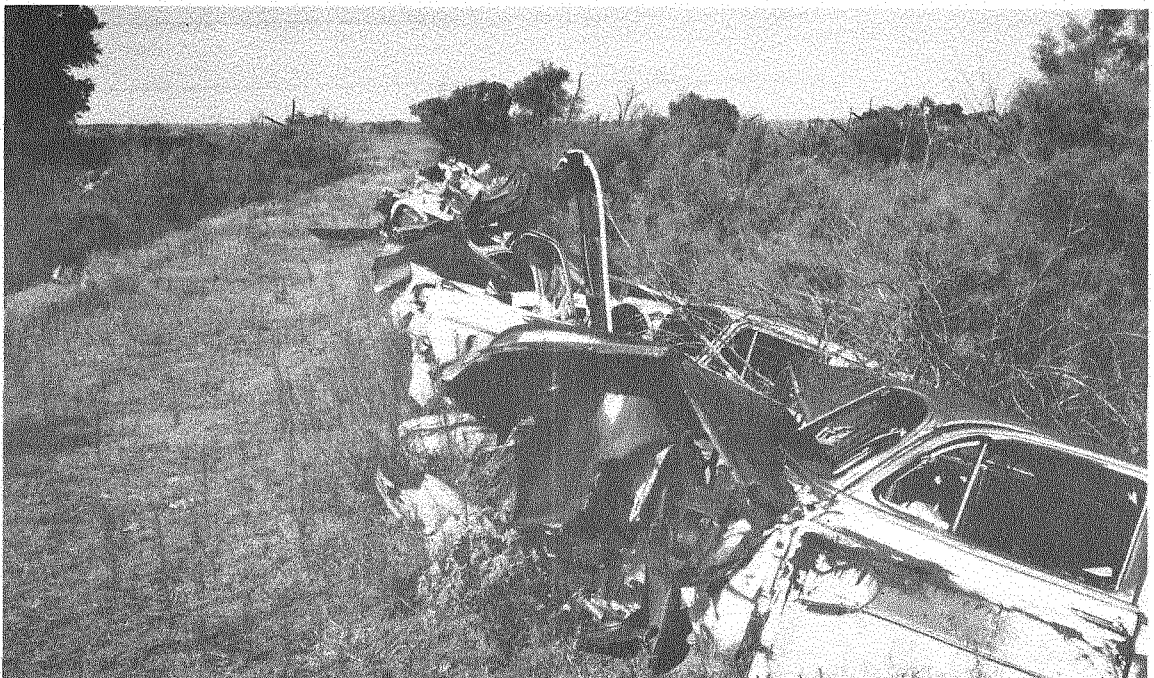
FIGURE 85b

a) Description: DUMPED BY OSHD TO PROTECT THE EARTH DIKE,  
THEY SEEM TO BE IN GOOD CONDITION.

Car Bodies for Bank Protection

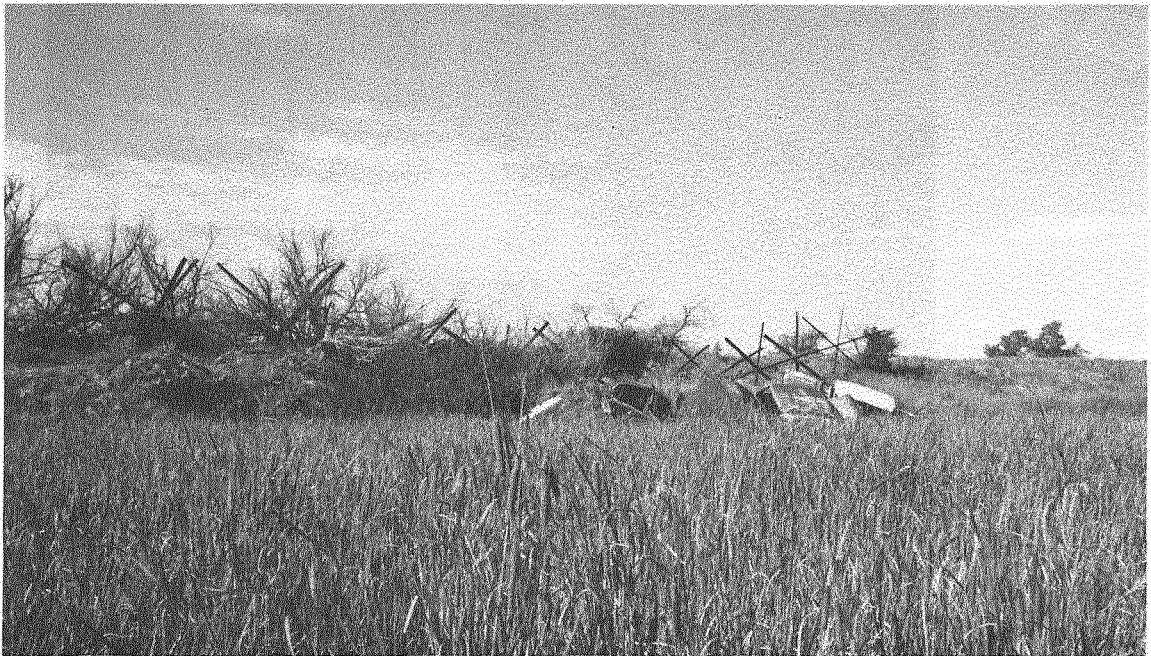
FIGURE 85c

b) Present Condition: MOST KELLNER JETTIES ARE IN GOOD CONDITION,  
AND THERE IS VERY LITTLE DRIFT WOOD PRESENT.

Views of Jetty Field

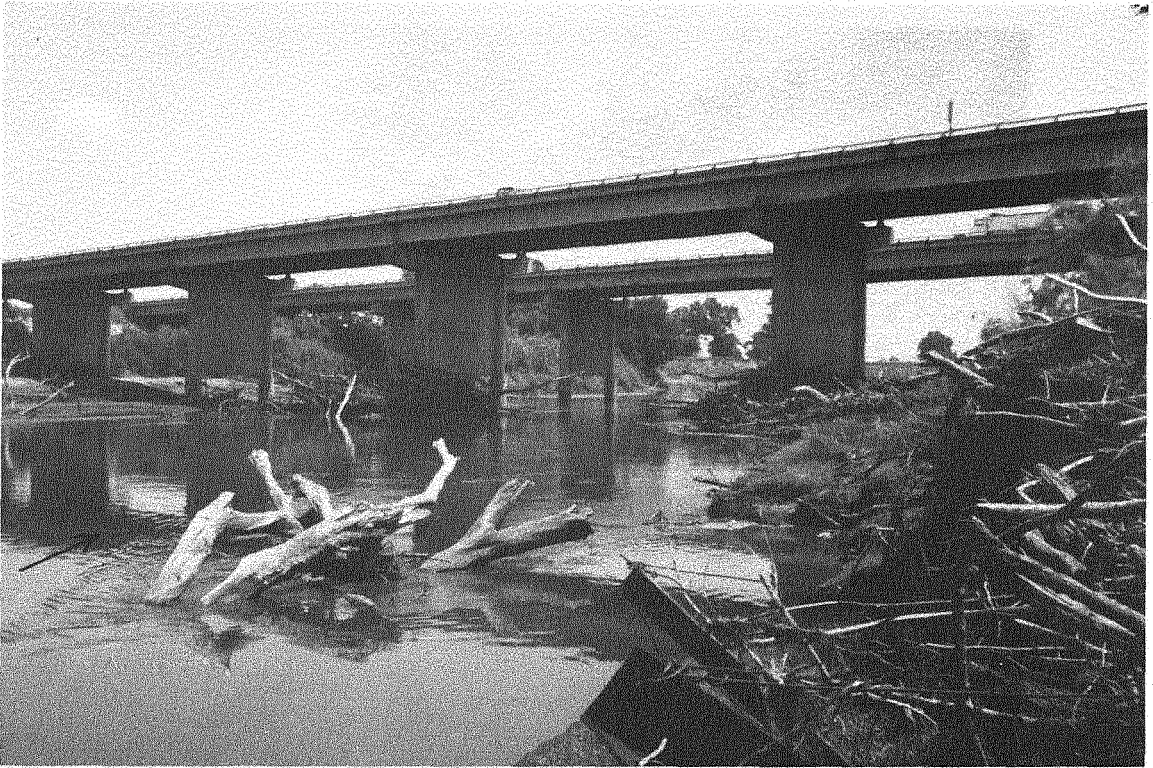
FIGURE 88a

Log Jam at Bridge Piers

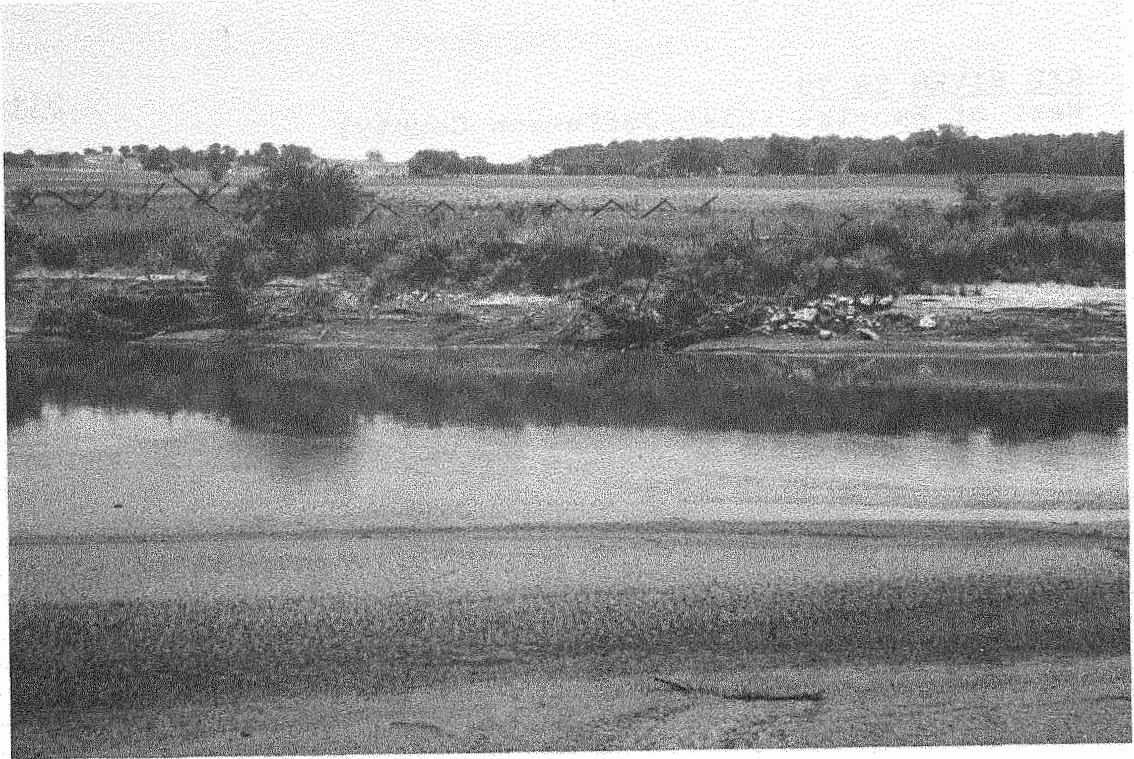
FIGURE 88e

b) Present Condition: ALL JETTIES ARE IN FAIRLY GOOD CONDITION  
EXCEPT FOR THOSE IN DIRECT CONTACT WITH THE  
WATER, WHICH NEED REPAIR, OR HAVE SUNK  
IN THE SAND.

Views of Jetty Field

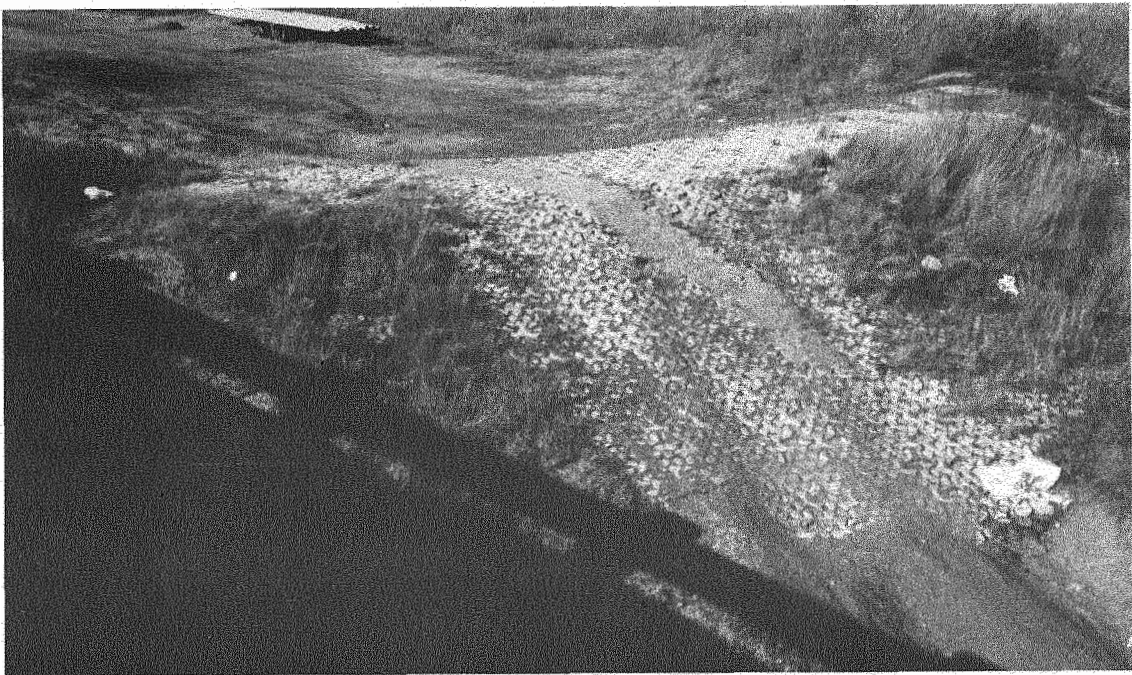
FIGURE 91b

This method of bank protection consists of placing prefabricated concrete blocks in the bank to be protected. There are many commercial sources for these products. Most of the designs are basically concentrated on the use of interlocking concrete blocks that hold the entire placement together. The voids in them also encourage the use of grass, which is also helpful in holding together the bank. The blocks are placed either by hand or by the use of specialized machines. One major factor that has to be considered in the placement of these structures is that they should be protected from undermining due to the action of the water. Very often filter fabric is used under such structures to prevent the washout of soil from beneath the blocks. Concrete revetments can also be considered as an example of one of these type of structures. A photograph showing a typical placement of cellular blocks is shown in Figure 91 (b).

View of TRILOCK Bank Protection Mattress

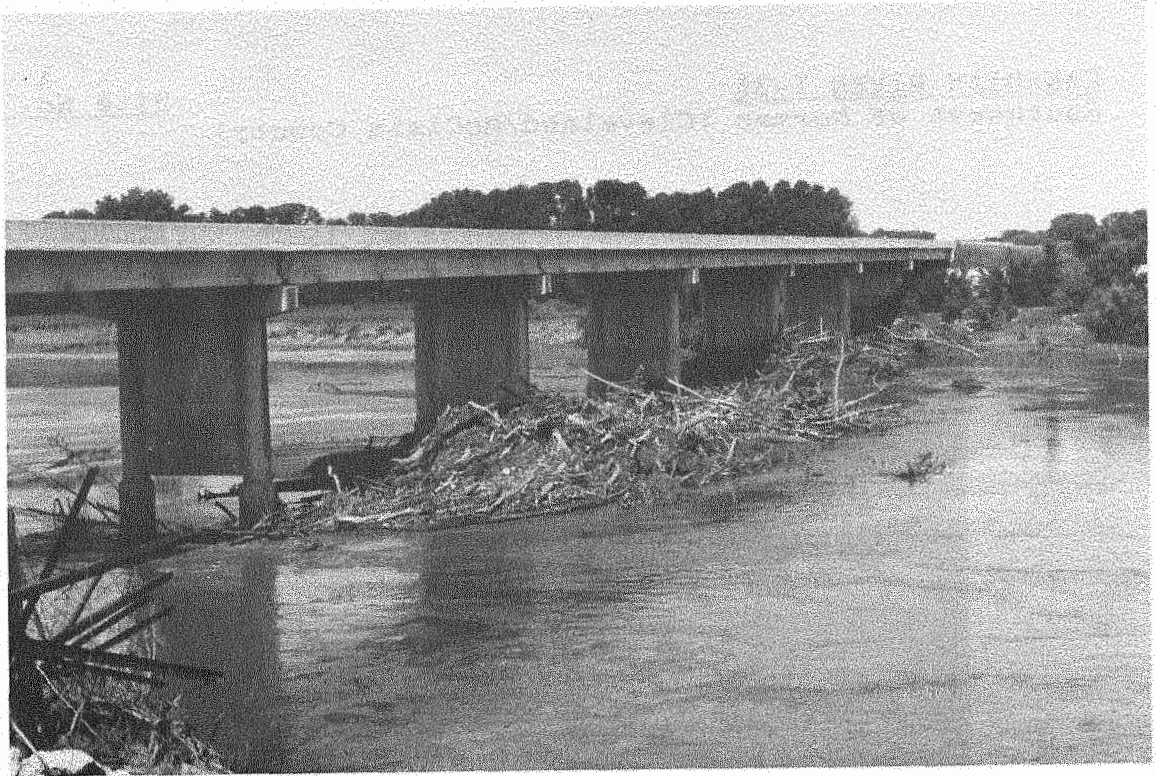
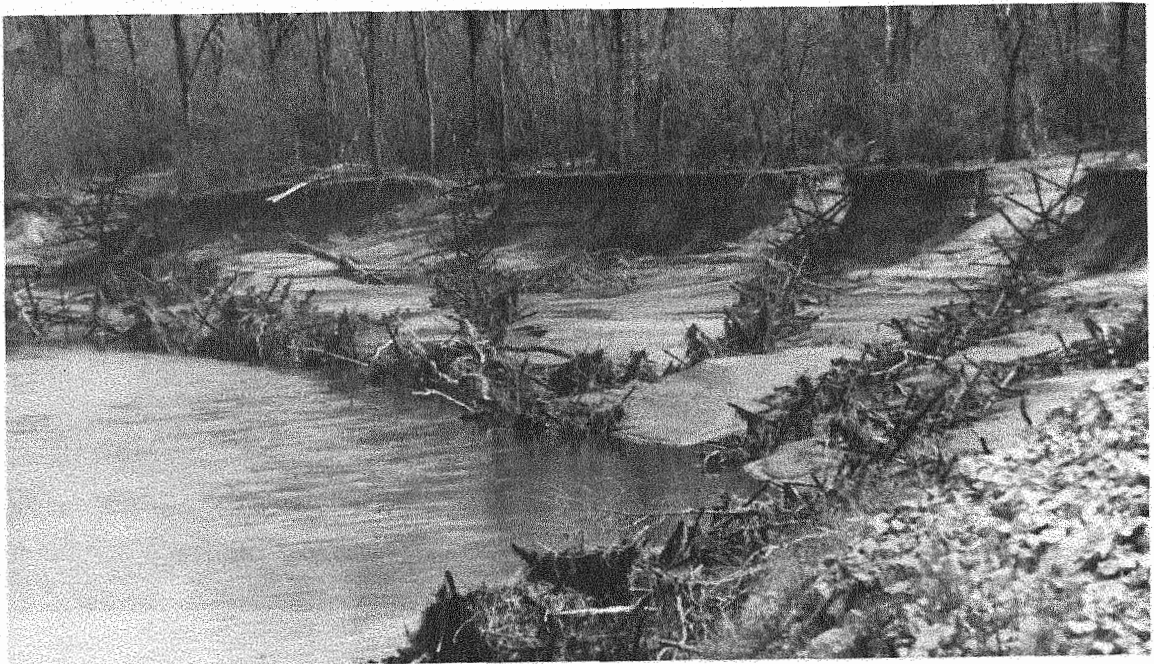
FIGURE 94c

Views of Old Kellner Jetty Field

(No Longer Existent)

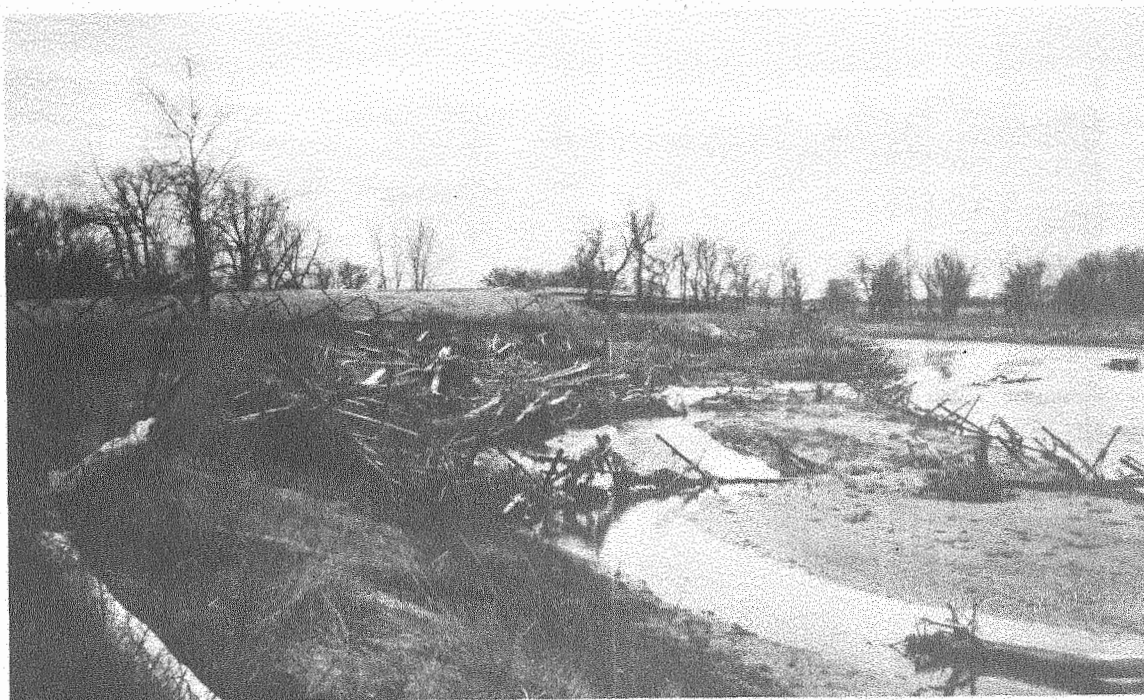
FIGURE 103c

b) Present Condition: THE KELLNER JETTY FIELD IS IN A DAMAGED  
CONDITION, BUT IT HAS EFFECTIVELY PREVENTED  
DAMAGE TO THE BANK.

Views of the Jetty Field
